Asbestos Management Survey

**11/13 FORTESS ROAD
LONDON
NW5**

30/07/2025

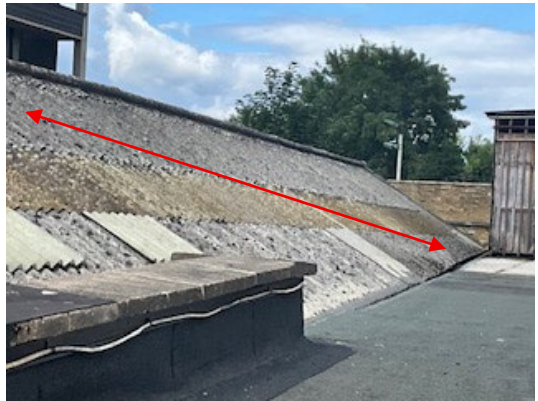
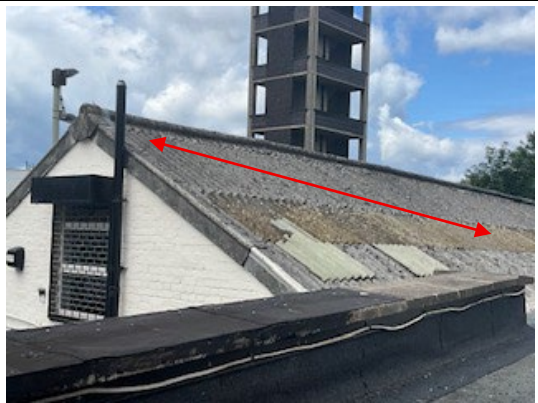
LOCATION PITCHED ROOF	
SURVEYOR STEVE ESPOSITO	Sample No 1	
DATE OF SURVEY 30/07/2025	CEMENT ROOF SHEETING

MATERIAL RISK ASSESSMENT	3
Asbestos Material	1
CEMENT	
Extent of Damage	0
GOOD CONDITION	
Surface Treatment	1
UNSEALED/AIB/LAGGING/CEMENT	
Asbestos Type	1
CHRYSTOLE (WHITE ASBESTOS)

SURVEYORS ASSESSMENT OF REMEDIAL ACTION REQUIRED	MANAGE
MATERIAL RISK ASSESSMENT	LOW POTENTIAL FOR EXPOSURE
RECOMMENDATIONS	MANAGE

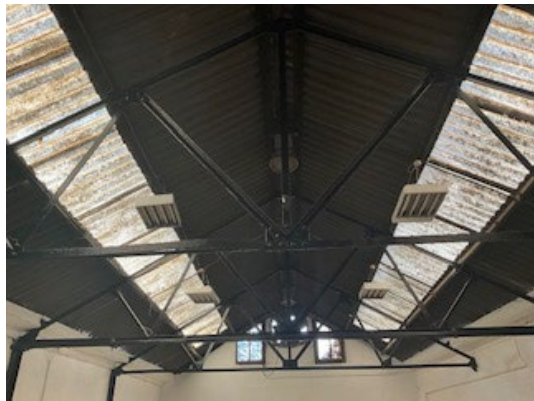
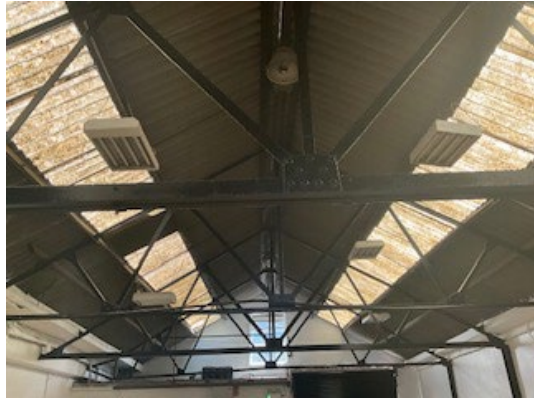
SITE DETAILS 11-13 FORTRESS ROAD LONDON NW5	FLOOR	
SURVEYOR STEVE ESPOSITO	LOCATION PITCHED ROOF	
DATE OF SURVEY 30/07/2025	Sample No 1	
	CEMENT ROOF SHEETING

Asbestos Material	1	
CEMENT		
Extent of Damage	0	
GOOD CONDITION		
Surface Treatment	1	
UNSEALED/AIB/LAGGING/CEMENT		
Asbestos Type	1	
CHRYSTOLE (WHITE ASBESTOS)

SURVEYORS ASSESSMENT OF REMEDIAL ACTION REQUIRED	MANAGE
MATERIAL RISK ASSESSMENT	LOW POTENTIAL FOR EXPOSURE
RECOMMENDATIONS	MANAGE

ADDITIONAL COMMENTS
CEMENT ROOFING IS IN GOOD CONDITION AND CAN BE MANAGED

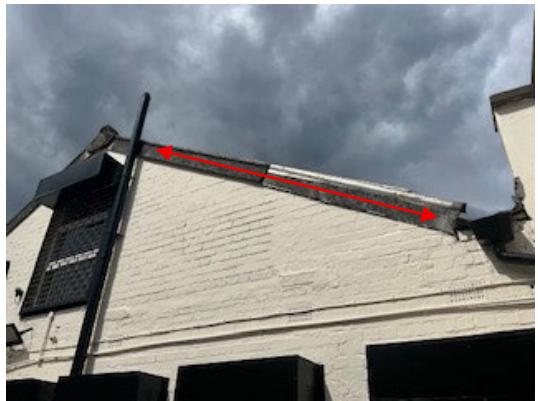
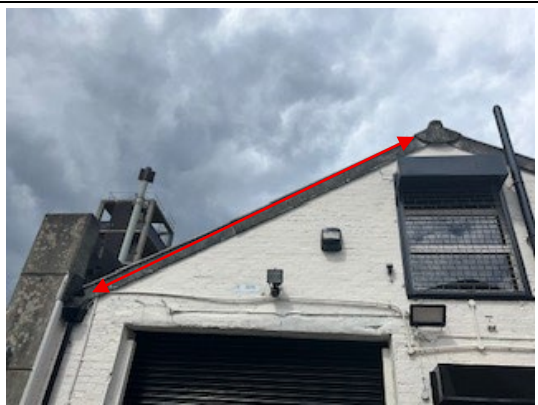
LOCATION PITCHED ROOF GABLE END	
SURVEYOR STEVE ESPOSITO	Sample No AS 1	
DATE OF SURVEY 30/07/2025	ASBESTOS CEMENT

MATERIAL RISK ASSESSMENT	3
Asbestos Material	1
CEMENT	
Extent of Damage	0
GOOD CONDITION	
Surface Treatment	1
UNSEALED/AIB/LAGGING/CEMENT	
Asbestos Type	1
CHRYSTILE (WHITE ASBESTOS)

SURVEYORS ASSESSMENT OF REMEDIAL ACTION REQUIRED	MANAGE
MATERIAL RISK ASSESSMENT	LOW POTENTIAL FOR EXPOSURE
RECOMMENDATIONS	MANAGE

ADDITIONAL COMMENTS
ASBESTOS CEMENT IS IN GOOD CONDITION AND CAN BE MANAGED

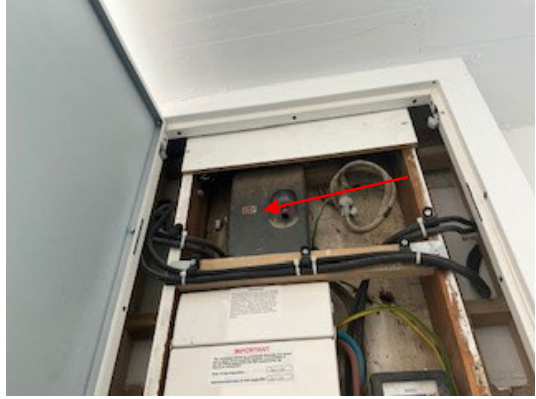
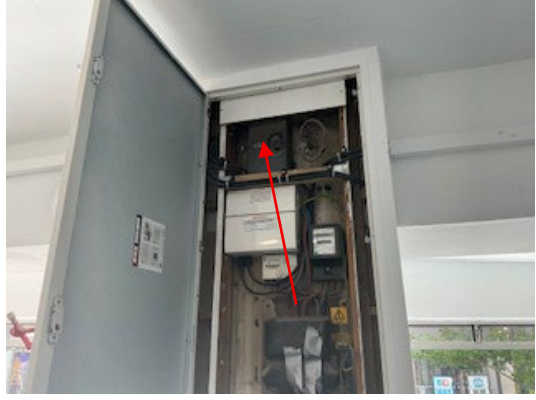
SITE DETAILS 11-13 FORTRESS ROAD LONDON NW5	FLOOR	
	LOCATION ELECTRICS CUPBOARD	
SURVEYOR STEVE ESPOSITO	Sample No	
DATE OF SURVEY 30/07/2025	STRONGLY PRESUME ELECTRIC UNIT TO CONTAIN ASBESTOS

Asbestos Material	1	
WOVEN TEXTILES		
Extent of Damage	0	
GOOD CONDITION		
Surface Treatment	1	
UNSEALED/AIB/LAGGING/CEMENT		
Asbestos Type	1	
CHRYSTOLE (WHITE ASBESTOS)

SURVEYORS ASSESSMENT OF REMEDIAL ACTION REQUIRED	MANAGE
MATERIAL RISK ASSESSMENT	LOW POTENTIAL FOR EXPOSURE
RECOMMENDATIONS	MANAGE

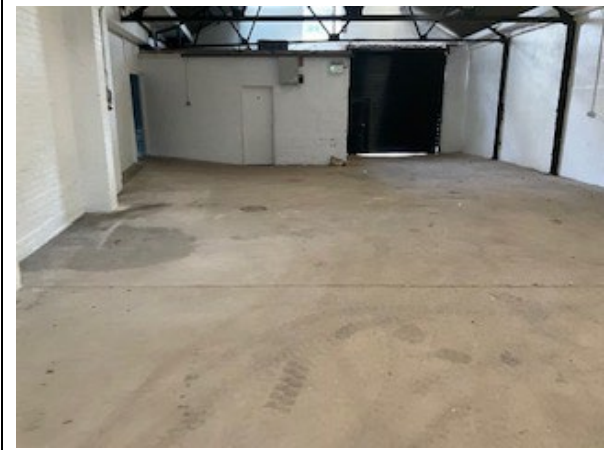
<p>GENERAL PHOTO</p> <p>NO ASBESTOS MATERIALS DETECTED</p>

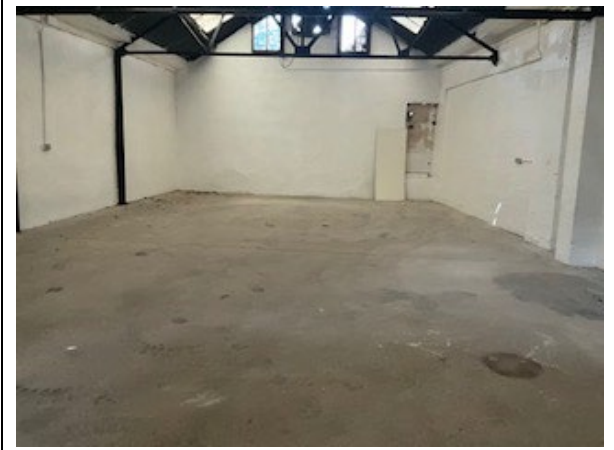
<p>GENERAL PHOTO</p> <p>NO ASBESTOS MATERIALS DETECTED</p>

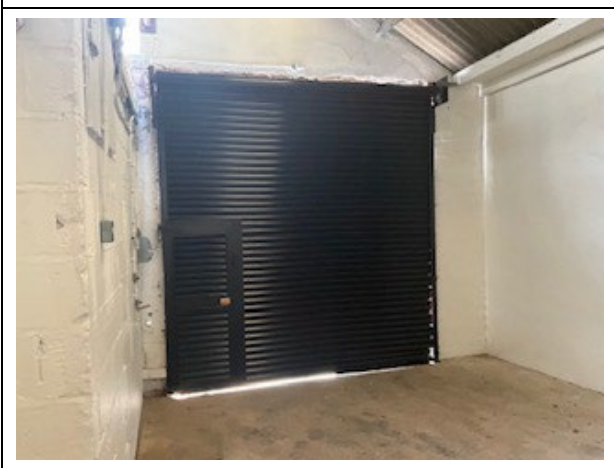
<p>GENERAL PHOTO</p> <p>NO ASBESTOS MATERIALS DETECTED</p>

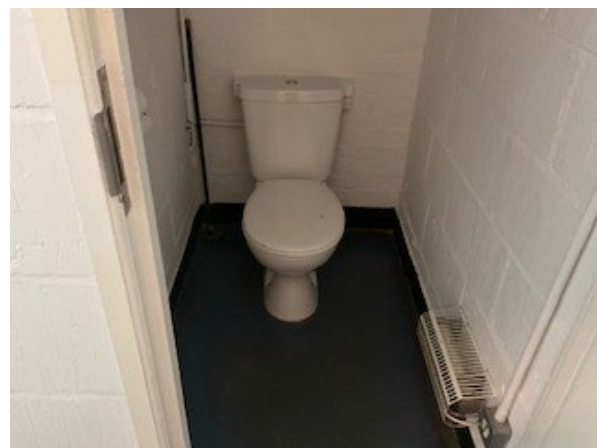
GENERAL PHOTO

NO ASBESTOS MATERIALS DETECTED

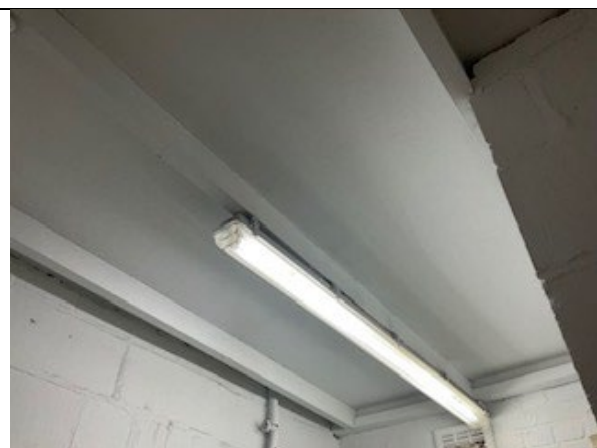
GENERAL PHOTO

NO ASBESTOS MATERIALS DETECTED

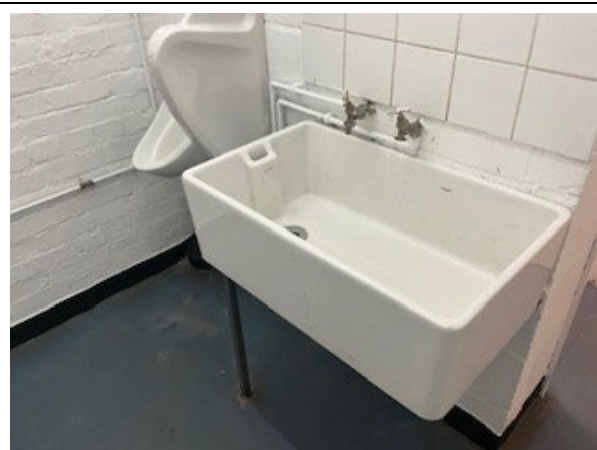
GENERAL PHOTO

NO ASBESTOS MATERIALS DETECTED

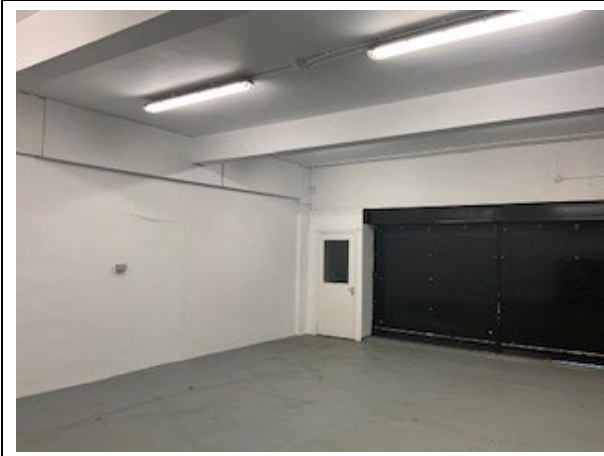
<p>GENERAL PHOTO</p> <p>NO ASBESTOS MATERIALS DETECTED</p>

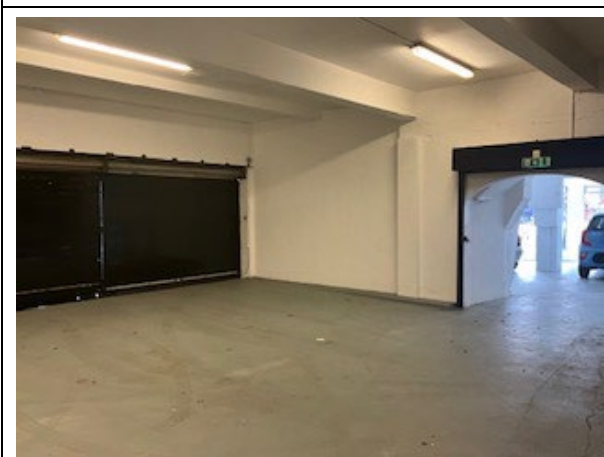
<p>GENERAL PHOTO</p> <p>NO ASBESTOS MATERIALS DETECTED</p>

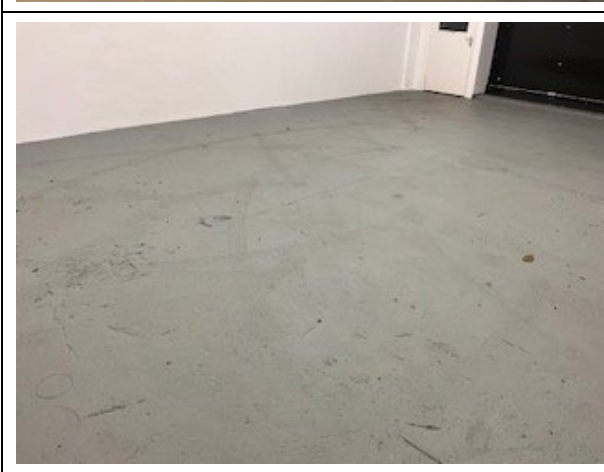
<p>GENERAL PHOTO</p> <p>NO ASBESTOS MATERIALS DETECTED</p>

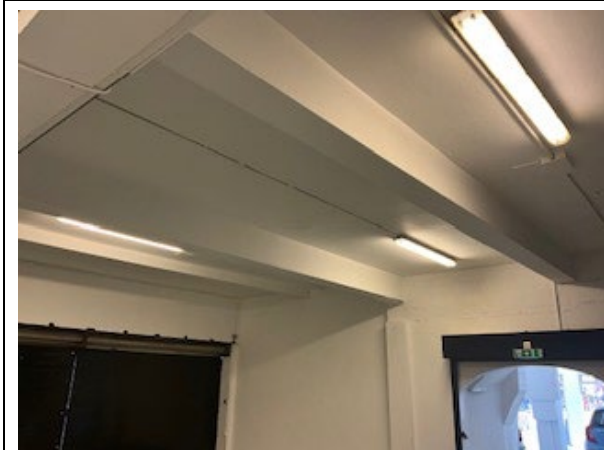
<p>GENERAL PHOTO</p> <p>NO ASBESTOS MATERIALS DETECTED</p>

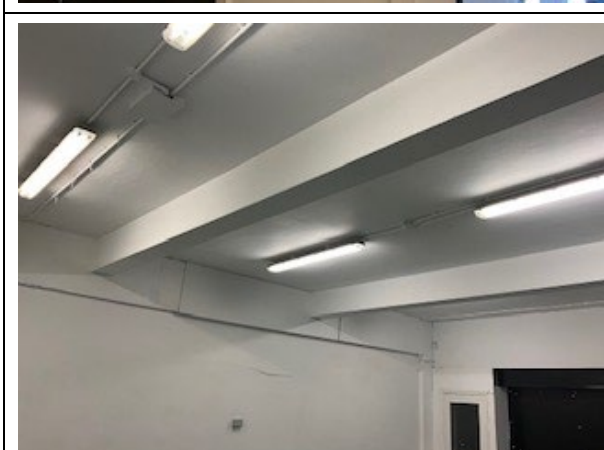
<p>GENERAL PHOTO</p> <p>NO ASBESTOS MATERIALS DETECTED</p>

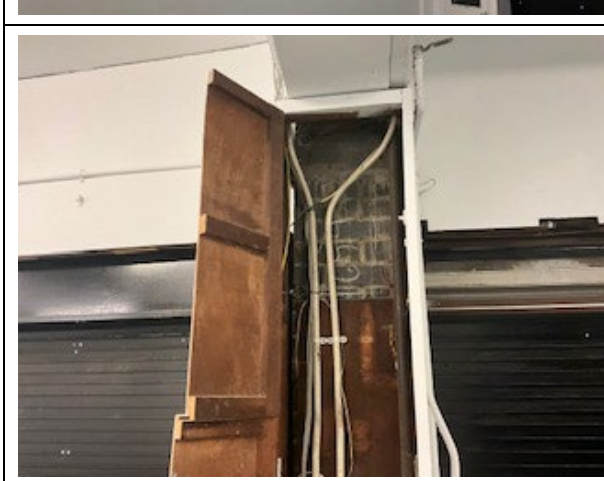
<p>GENERAL PHOTO</p> <p>NO ASBESTOS MATERIALS DETECTED</p>

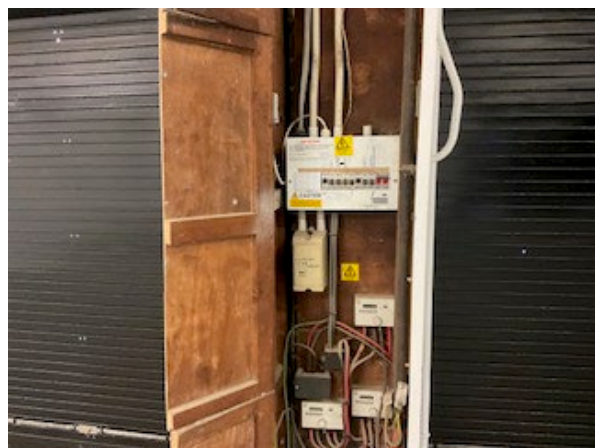
GENERAL PHOTO

NO ASBESTOS MATERIALS DETECTED

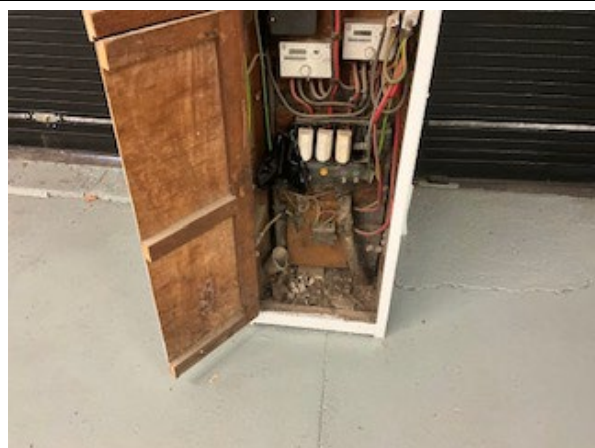
GENERAL PHOTO

NO ASBESTOS MATERIALS DETECTED

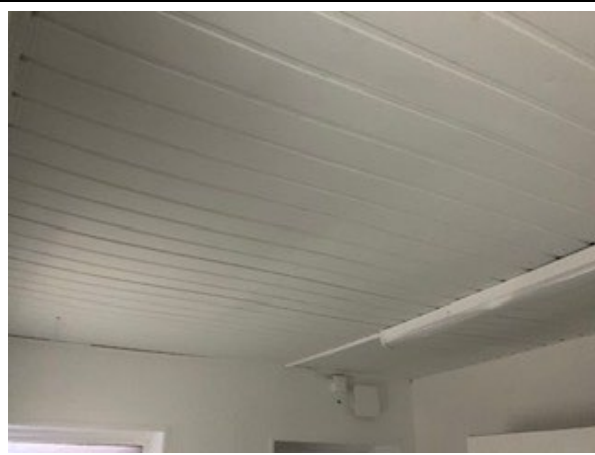
GENERAL PHOTO

NO ASBESTOS MATERIALS DETECTED

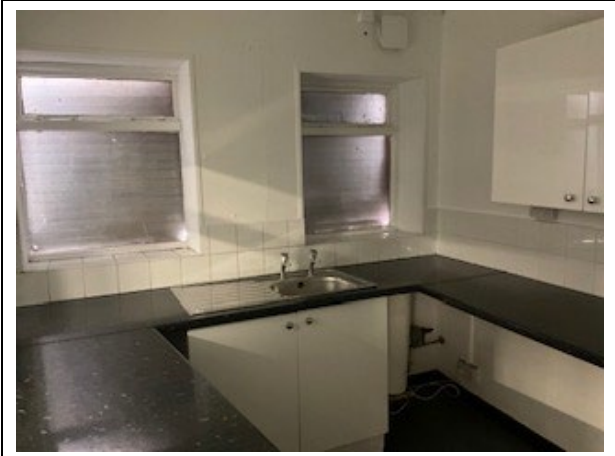
<p>GENERAL PHOTO</p> <p>NO ASBESTOS MATERIALS DETECTED</p>

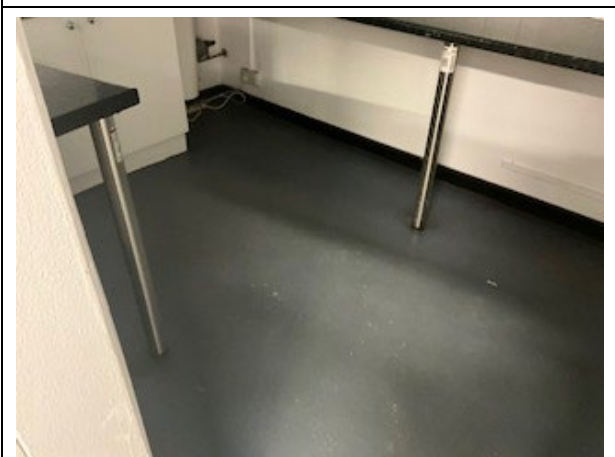
<p>GENERAL PHOTO</p> <p>NO ASBESTOS MATERIALS DETECTED</p>

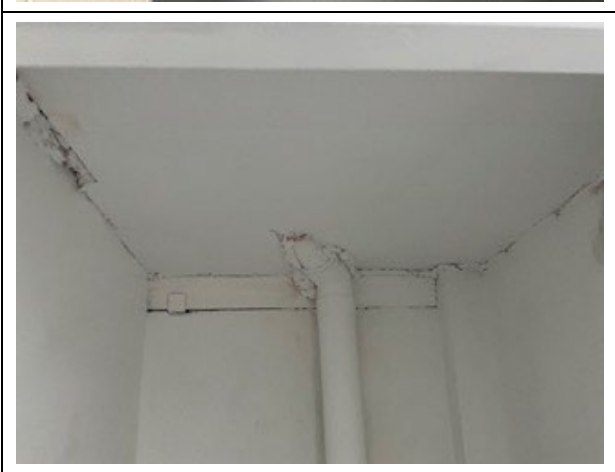
<p>GENERAL PHOTO</p> <p>NO ASBESTOS MATERIALS DETECTED</p>

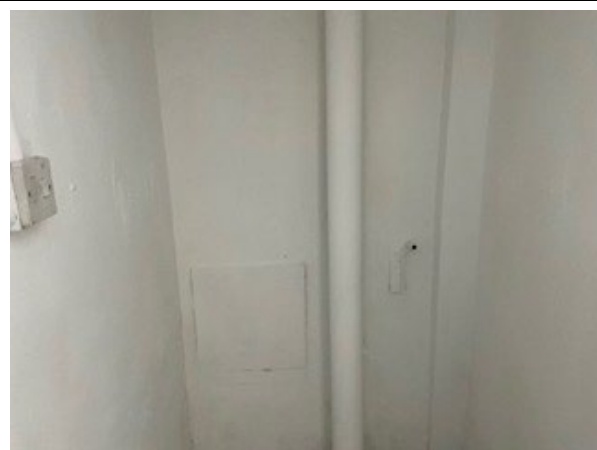
GENERAL PHOTO

NO ASBESTOS MATERIALS DETECTED

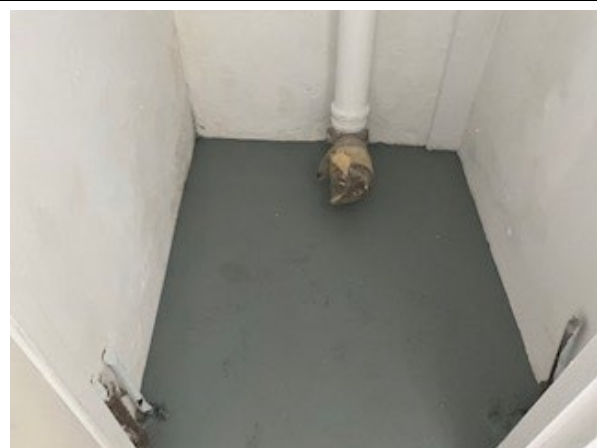
GENERAL PHOTO

NO ASBESTOS MATERIALS DETECTED

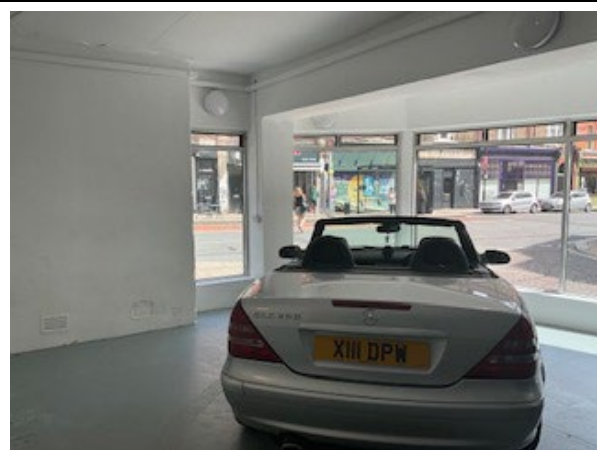
GENERAL PHOTO

NO ASBESTOS MATERIALS DETECTED
