# ASBESTOS REFURBISHMENT SURVEY REPORT

**Site Reference:** 60254 Ocean House

**Site Address:** Ocean House,  
22 Cousin Lane,  
London,  
EC4R 3TE

| Project Number: | Survey Date: | Issue Date: | Revision: | Description of Modification |
|---|---|---|---|---|
| 5d005027 | 13/04/2022 | 14/04/2022 | Original | |

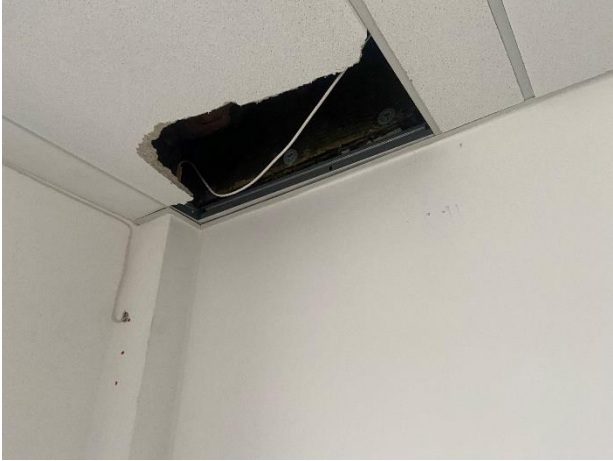
| <b>Room /Area</b> | Office | <b>Description</b> | MMMFF firebreak |
| 0 | | No ACMs Detected / 0 | |
| Within ceiling void | | | |

| No further action required. | | | |

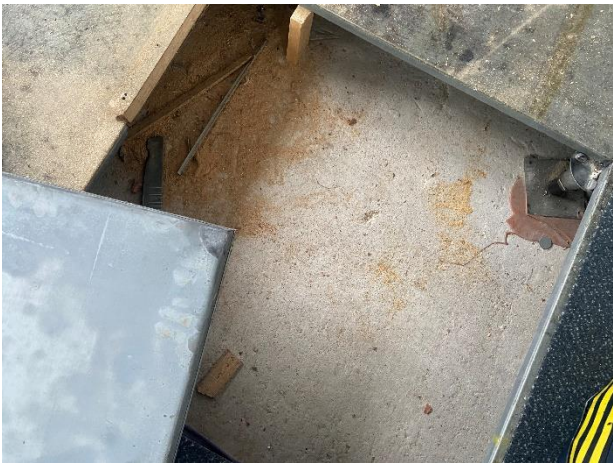
| <b>Room /Area</b> | Office | <b>Description</b> | Screed |
| 0 | | No ACMs Detected / 0 | |
| To floor in floor void | | | |

| No further action required. | | | |

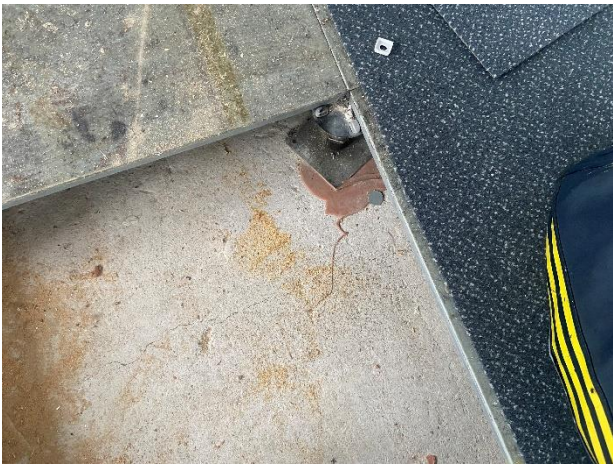
| <b>Room /Area</b> | Office | <b>Description</b> | Mastic seal |
| 0 | | No ACMs Detected / 0 | |
| To upstands in floor void | | | |

| No further action required. | | | |

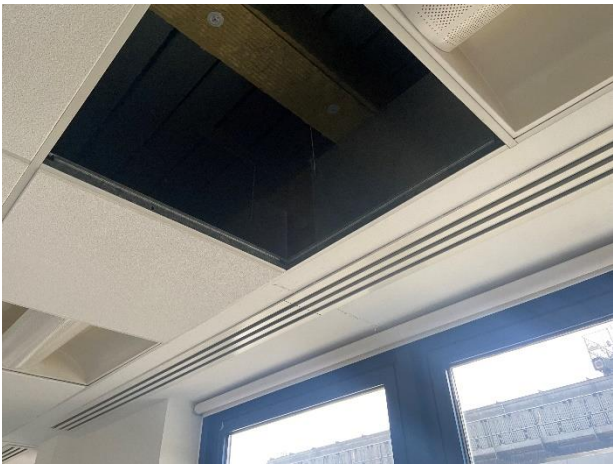
| <b>Room /Area</b> | Office | <b>Description</b> | MMMF firebreak |
| 0 | | No ACMs Detected / 0 | |
| Within ceiling void | | | |

| No further action required. | | | |

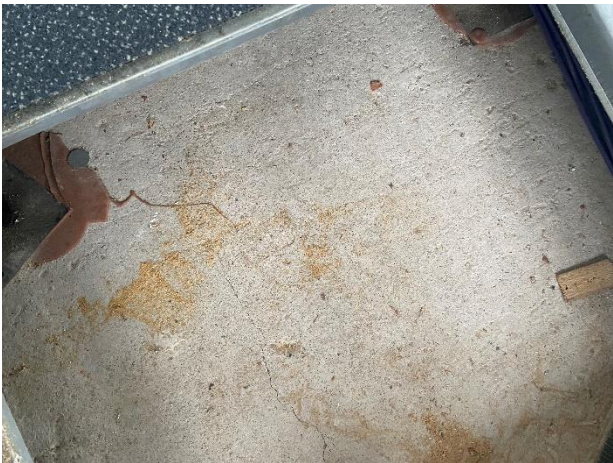
| <b>Room /Area</b> | Office | <b>Description</b> | Screed |
| 0 | | No ACMs Detected / 0 | |
| To floor in floor void | | | |

| No further action required. | | | |

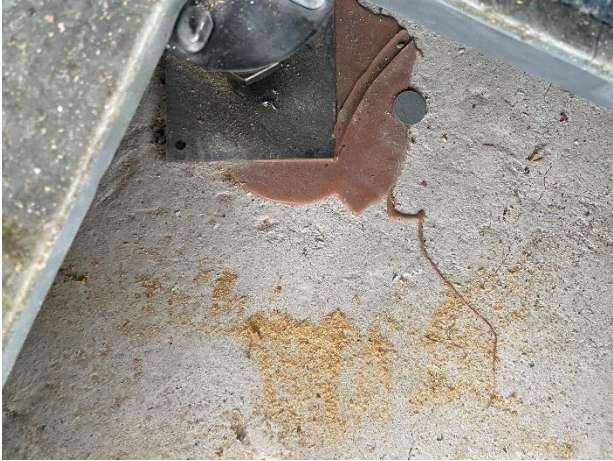
| <b>Room /Area</b> | Office | <b>Description</b> | Mastic seal |
| 0 | | No ACMs Detected / 0 | |
| To upstands in floor void | | | |

| No further action required. | | | |

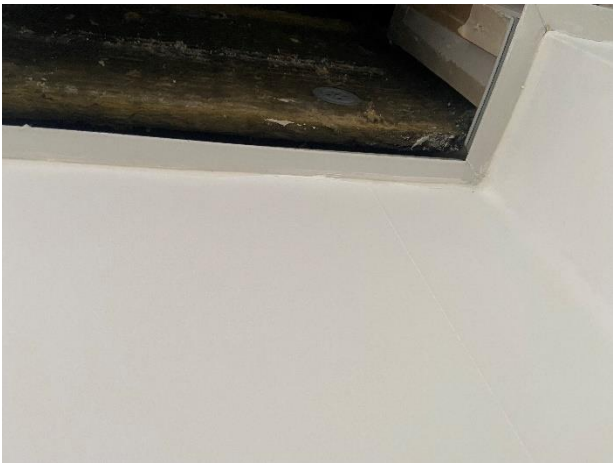
| <b>Room /Area</b> | Office | <b>Description</b> | MMMF firebreak |
| 0 | | No ACMs Detected / 0 | |
| Within ceiling void | | | |

| No further action required. | | | |

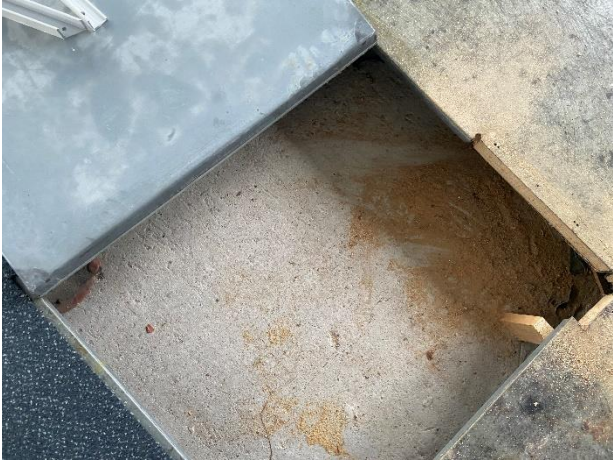
| <b>Room /Area</b> | Office | <b>Description</b> | Screed |
| 0 | | No ACMs Detected / 0 | |
| To floor in floor void | | | |

| No further action required. | | | |

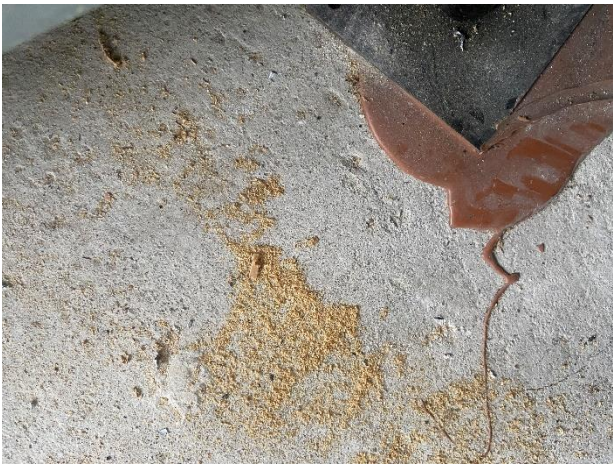
| <b>Room /Area</b> | Office | <b>Description</b> | Mastic seal |
| 0 | | No ACMs Detected / 0 | |
| To upstands in floor void | | | |

| No further action required. | | | |

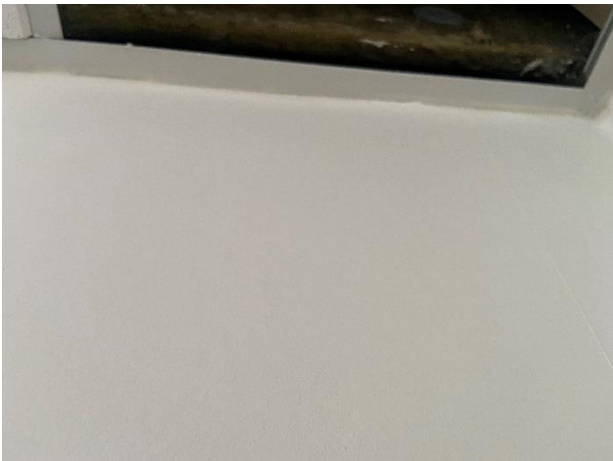
| <b>Room /Area</b> | Office | <b>Description</b> | MMMF firebreak |
| 0 | | No ACMs Detected / 0 | |
| Within ceiling void | | | |

| No further action required. | | | |

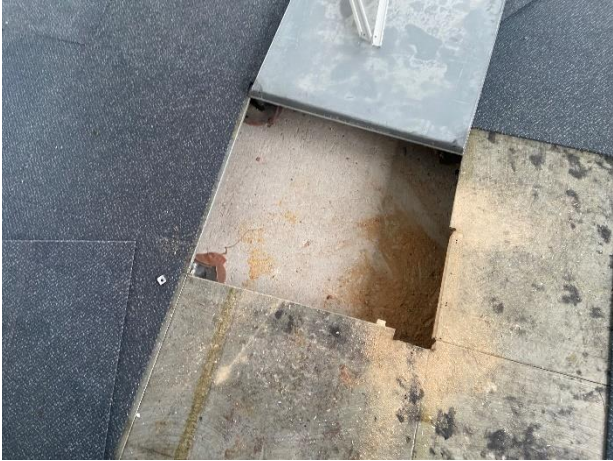
| <b>Room /Area</b> | Office | <b>Description</b> | Screed |
| 0 | | No ACMs Detected / 0 | |
| To floor in floor void | | | |

| No further action required. | | | |

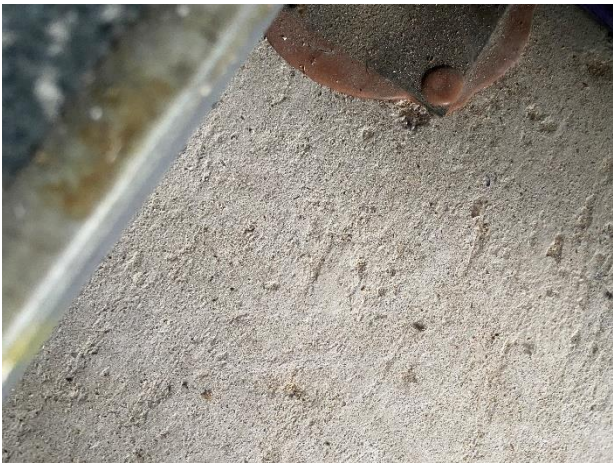
| <b>Room /Area</b> | Office | <b>Description</b> | Mastic seal |
| 0 | | No ACMs Detected / 0 | |
| To upstands in floor void | | | |

| No further action required. | | | |

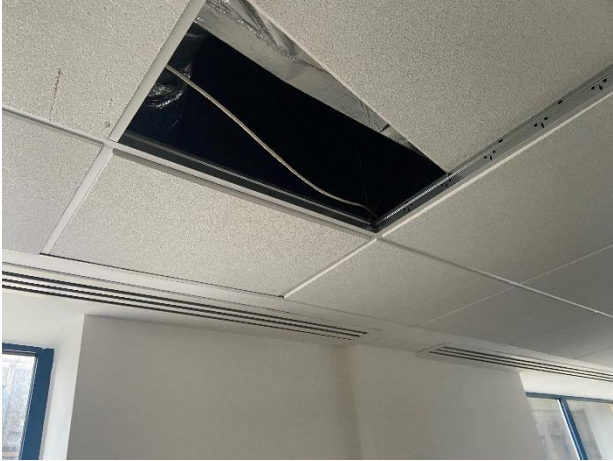
| <b>Room /Area</b> | Office | <b>Description</b> | MMMF firebreak |

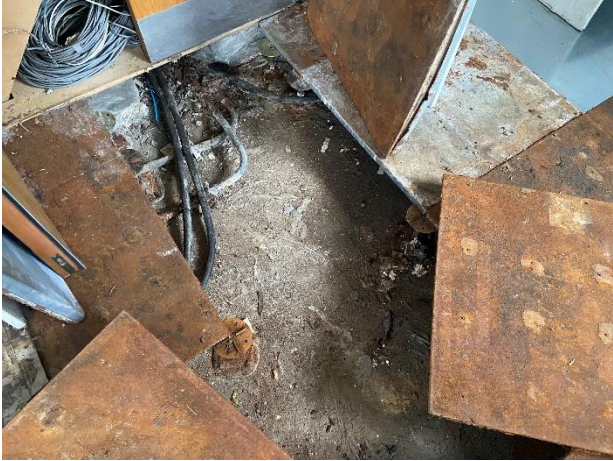
| <b>Room /Area</b> | Office | <b>Description</b> | Screed |

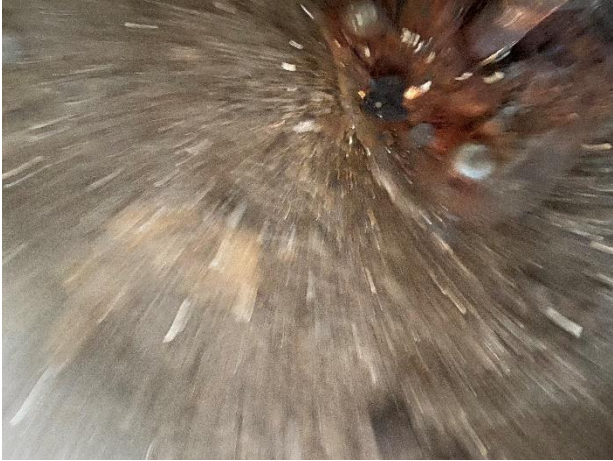
| <b>Room /Area</b> | Office | <b>Description</b> | Mastic seal |

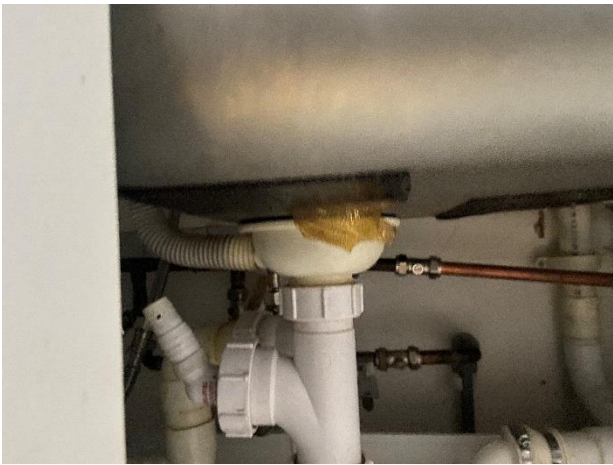
| <b>Room /Area</b> | Office | <b>Description</b> | Acoustic pad |

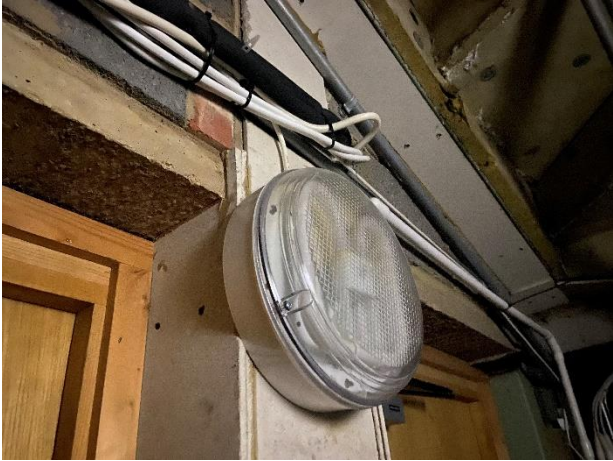
| <b>Room /Area</b> | Plant Room | <b>Description</b> | Supalux panels |
