MANAGEMENT ASBESTOS SURVEY REPORT

Site Name: 48 The Grove
Site Address: Ilkley
West Yorkshire
LS29 9EE

Date of Survey: 28th November 2019

Survey Type: Management Survey

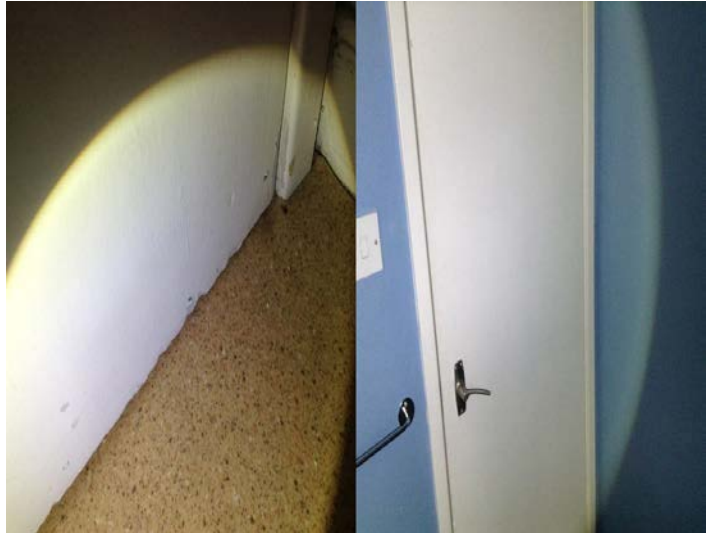
Site ID S-06594
 Location ID 002
 Building/Unit 48 The Grove
 Floor 1 (1st Floor)
 Room / Area Kitchen
 Description Board to Door
 Surveyed Yes
 Source of Information Garth Fielding
 Last Inspection Date 28/11/2019
 Lab Reference J042301/BS036514
 Survey Type Management
 Sample Number S-06594/S01

Building / Unit	Floor	Location	Item Description	Recommendations
48 The Grove	1 (1st Floor)	002 - Kitchen	Board to Door - Insulating Board	REMOVE /ENCAPSULATE /MANAGE /LABEL (AIB BOARD - SINGULAR) - The board to door is in a damaged condition. The board to door needs to be repaired and encapsulated by a licensed removal company. A management plan should then be put in place to monitor the board on a regular basis for any signs of further deterioration or damage. Should any further damage occur then the board will need to be repaired or removed by a licensed removal company as a priority. Labelling of the board is also recommended. Alternatively the board along with the door needs to be removed by suitably trained persons under controlled conditions and disposed of at a licensed facility as a priority.

MATERIAL ASSESSMENT = 7

Material	Insulating Board (2)	Surface Treatment	Unsealed board or cloth / Encapsulated lagging or spray (2)
Condition	Low Damage (1)	Sample Result	Amosite/Chrysotile
Location	Room(s) up to 100m ²	Amount	1 Door
Accessibility	Usually inaccessible

Location ID	Sample Ref	Building	Floor	Room / Area	Description	Sample Result	Quantity	Comments / Recommendations
002	S001	48 The Grove	1 (1st Floor)	Kitchen	Board to Door Insulating Board	Amosite/Chrysotile	1 Door	REMOVE/ ENCAPSULATE /MANAGE /LABEL (AIB BOARD - SINGULAR)

Recommendations The board to door is in a damaged condition. The board to door needs to be repaired and encapsulated by a licensed removal company. A management plan should then be put in place to monitor the board on a regular basis for any signs of further deterioration or damage. Should any further damage occur then the board will need to be repaired or removed by a licensed removal company as a priority. Labelling of the board is also recommended. Alternatively the board along with the door needs to be removed by suitably trained persons under controlled conditions and disposed of at a licensed facility as a priority.

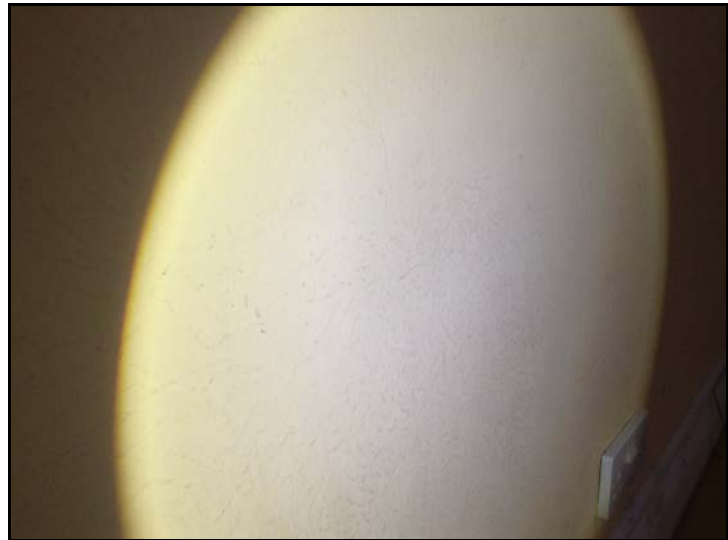
Site ID S-06594
Location ID 012
Building/Unit 48 The Grove
Floor 2 (2nd Floor)
Room / Area Office
Description Textured Coating to Walls
Surveyed Yes
Source of Information Garth Fielding
Last Inspection Date 28/11/2019
Lab Reference J042301/BS036518
Survey Type Management
Sample Number S-06594/S05

Action	Priority	Notifiable	Licensed
Additional Comments	No asbestos was identified within the sample analysed.		
Recommendations
