## MANAGEMENT ASBESTOS SURVEY REPORT

Site Name: 48 The Grove  
Site Address: 48 The Grove  
Ilkley  
LS29 9EE  
Survey carried out by: D. Holdsworth  
Date of Survey: 25<sup>th</sup> July 2012  
For and on behalf of: Westlake & Co

**Survey Type:** Management Survey

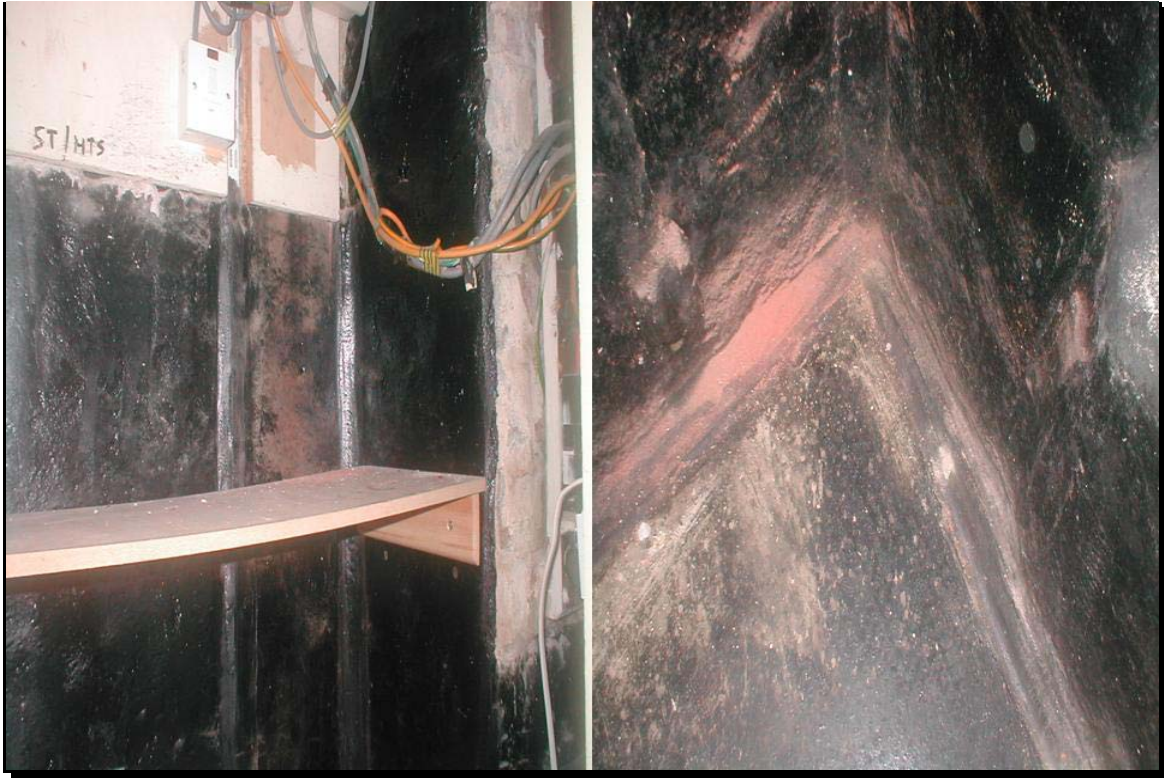
<b>Site ID</b>	3572	<b>Floor</b>	Lower Ground
<b>Location ID</b>	3572/A/0i	<b>Room / Area</b>	Throughout
<b>Building</b>	48 The Grove	<b>Description</b>	Bitumen Coating to Walls & Floor

<b>Surveyed</b>	YES	<b>Source Of Information</b>	D. HOLDSWORTH
<b>Last Inspection Date</b>	25/Jul/2012	<b>Lab Reference</b>	37317/161213
<b>Survey Type</b>	MANAGEMENT	<b>Sample Number</b>	3572/01

**Condition** **Sample Result** NO ASBESTOS DETECTED

**Comments:** No asbestos was identified within the sample analysed.

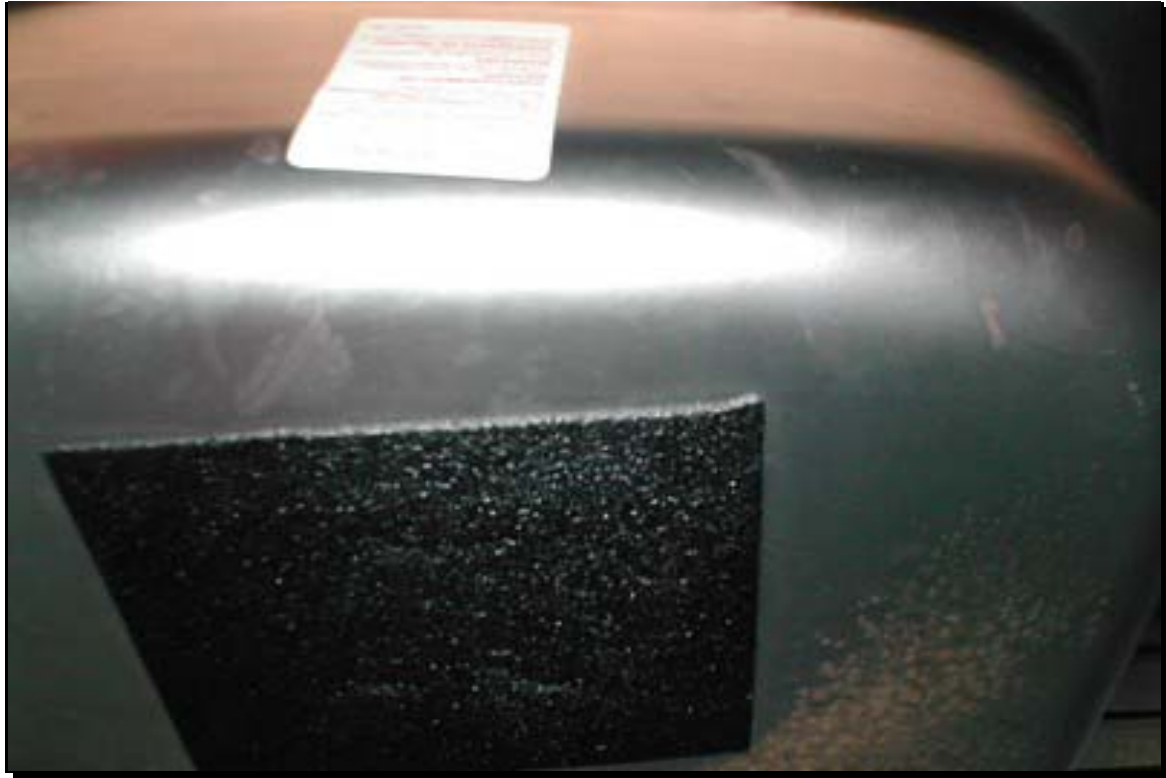
<b>Site ID</b>	3572	<b>Floor</b>	Lower Ground
<b>Location ID</b>	3572/A/0ii	<b>Room / Area</b>	Small Kitchen
<b>Building</b>	48 The Grove	<b>Description</b>	Sink Pad

<b>Surveyed</b>	YES	<b>Source Of Information</b>	D. HOLDSWORTH
<b>Last Inspection Date</b>	25/Jul/2012	<b>Lab Reference</b>	37317/161214
		<b>Sample Number</b>	3572/02
<b>Survey Type</b>	MANAGEMENT

<b>Material</b>	<b><u>MATERIAL ASSESSMENT =</u></b>	<b>Surface Treatment</b>	
<b>Condition</b>		<b>Sample Result</b>	NO ASBESTOS DETECTED

<b><u>MANAGEMENT SUMMARY</u></b>	
<b>Action</b>	<b>Priority</b>	<b>Notifiable</b>
<b>Comments:</b>	No asbestos was identified within the sample analysed.	
<b>Recommendations:</b>

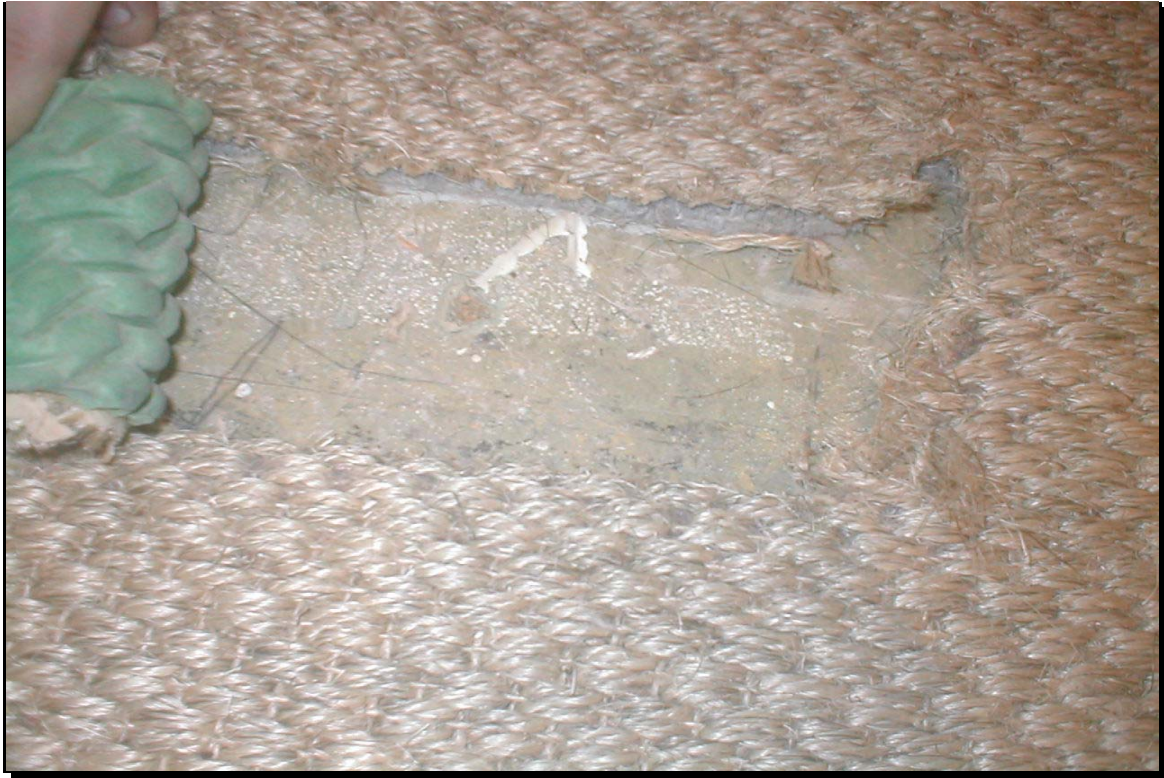
<b>Site ID</b>	3572	<b>Floor</b>	Ground
<b>Location ID</b>	3572/A/0iii	<b>Room / Area</b>	Throughout
<b>Building</b>	48 The Grove	<b>Description</b>	Flooring Material

<b>Surveyed</b>	YES	<b>Source Of Information</b>	D. HOLDSWORTH
<b>Last Inspection Date</b>	25/Jul/2012	<b>Lab Reference</b>	37317/161215
		<b>Sample Number</b>	3572/03
<b>Survey Type</b>	MANAGEMENT

<b>Material</b>	<b><u>MATERIAL ASSESSMENT =</u></b>	<b>Surface Treatment</b>	
<b>Condition</b>		<b>Sample Result</b>	NO ASBESTOS DETECTED

<b><u>MANAGEMENT SUMMARY</u></b>	
<b>Action</b>	<b>Priority</b>	<b>Notifiable</b>
<b>Comments:</b>	No asbestos was identified within the sample analysed.	
<b>Recommendations:</b>
