**ENVIRONMENTAL SCREENING FOR:**

**BUILDING 2 AND EXTERNAL LANDSCAPING  
LEEDS CITY OFFICE PARK  
HOLBECK  
LEEDS  
LS11 5BD**

**CANADA LIFE LIMITED**

**PROJECT REF: 7951**

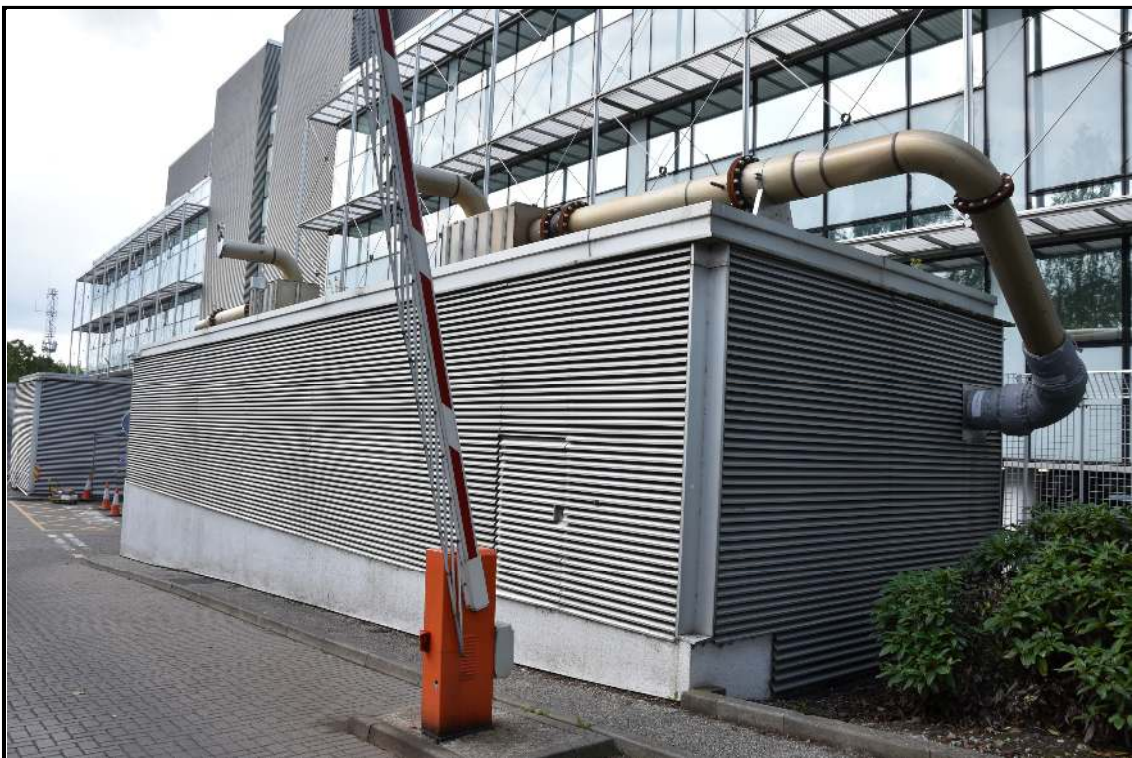
**Plate 4 Generator house outside the eastern elevation**

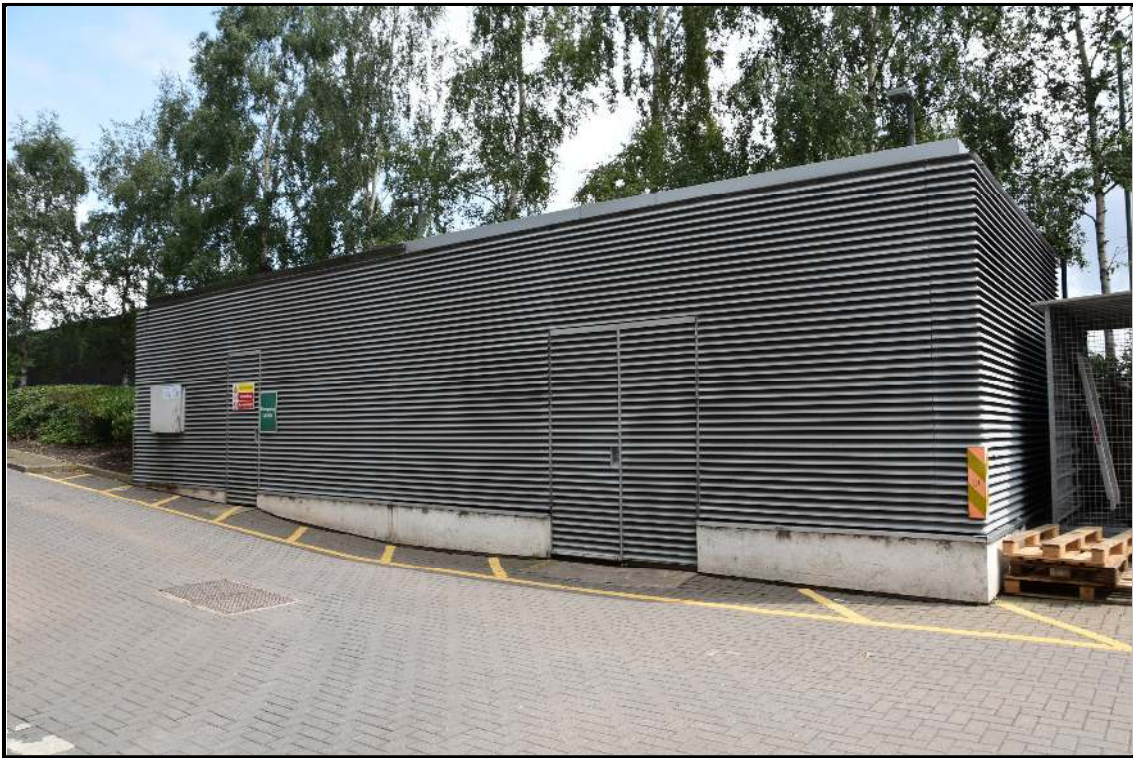
- 3.12 British Gas operate 2No emergency generators and these each have a purpose built self-contained bund inside a housing especially constructed for that purpose. Each tank contains 6,500 litres. These tanks supply 2No 1000litre day tanks located inside the purpose built generator house located externally adjacent to the eastern elevation. Both facilities are secure. No oil contamination was observed, and no olfactory odours noted. The external reinspection on 3<sup>rd</sup> March reiterated that no oil staining nor olfactory odours were detected or observed.

**Plate 5 Oil tank housing 2No 6500 litre tanks**

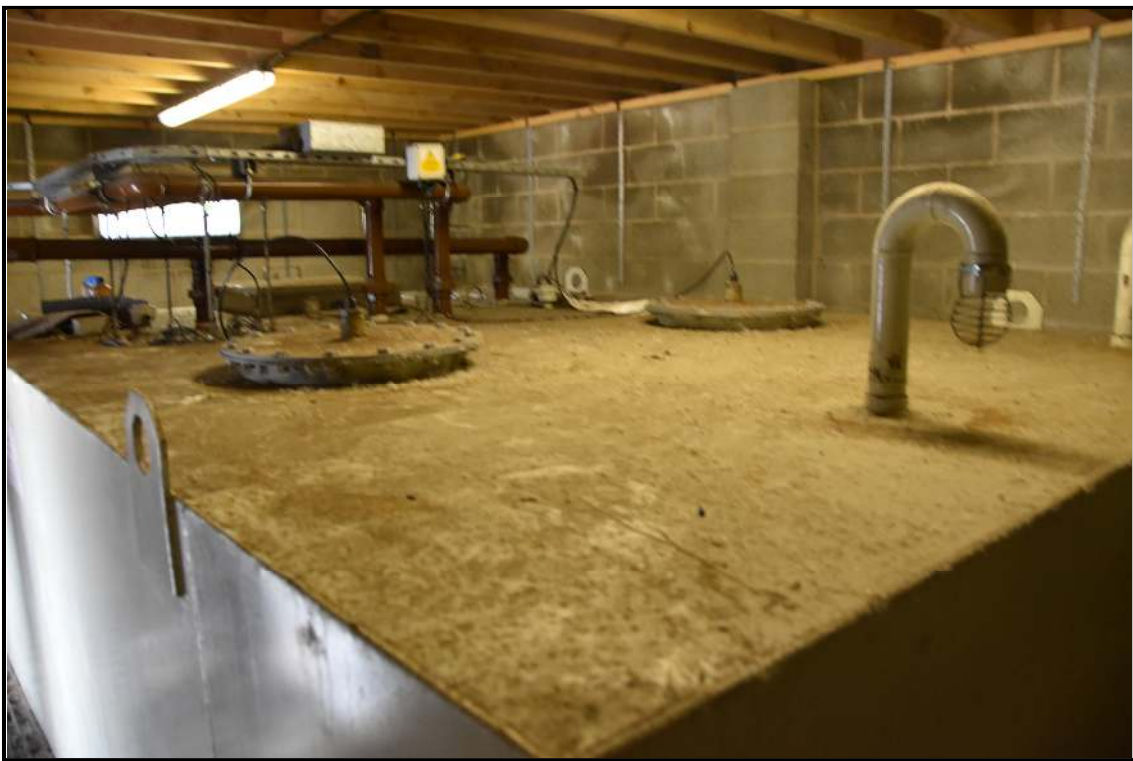
**Plate 6 Tank-no olfactory odours**

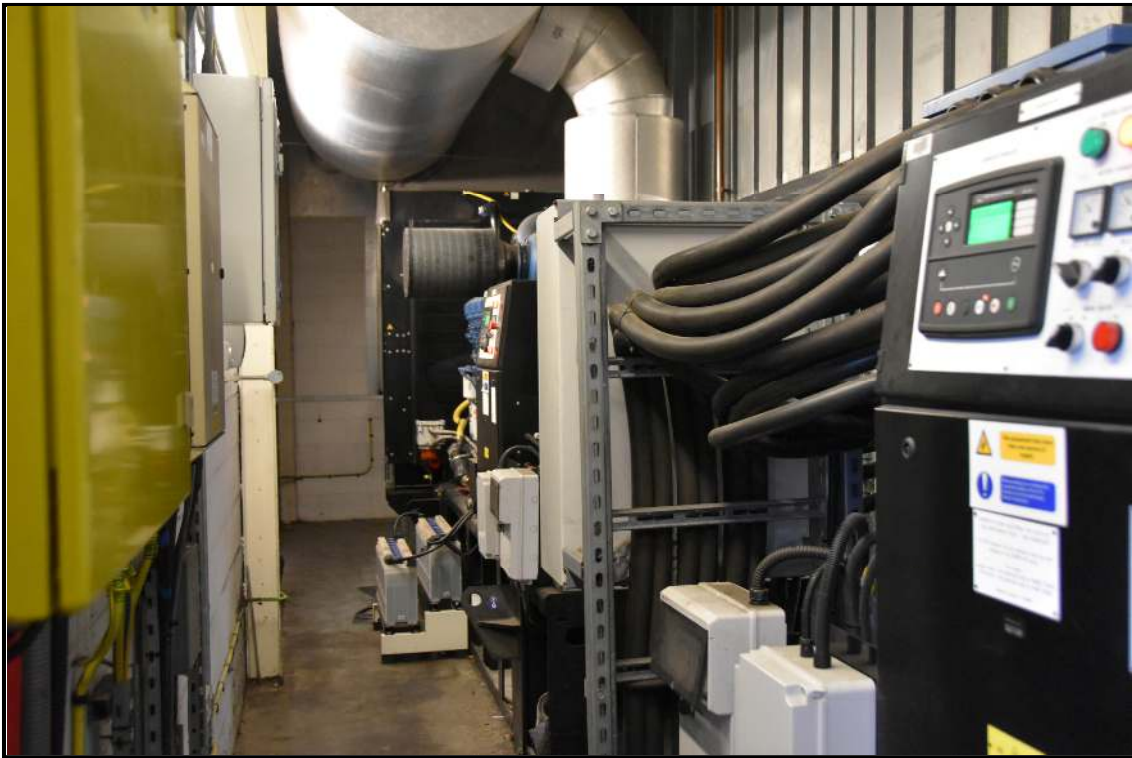
**Plate 7 Generators with day tanks**

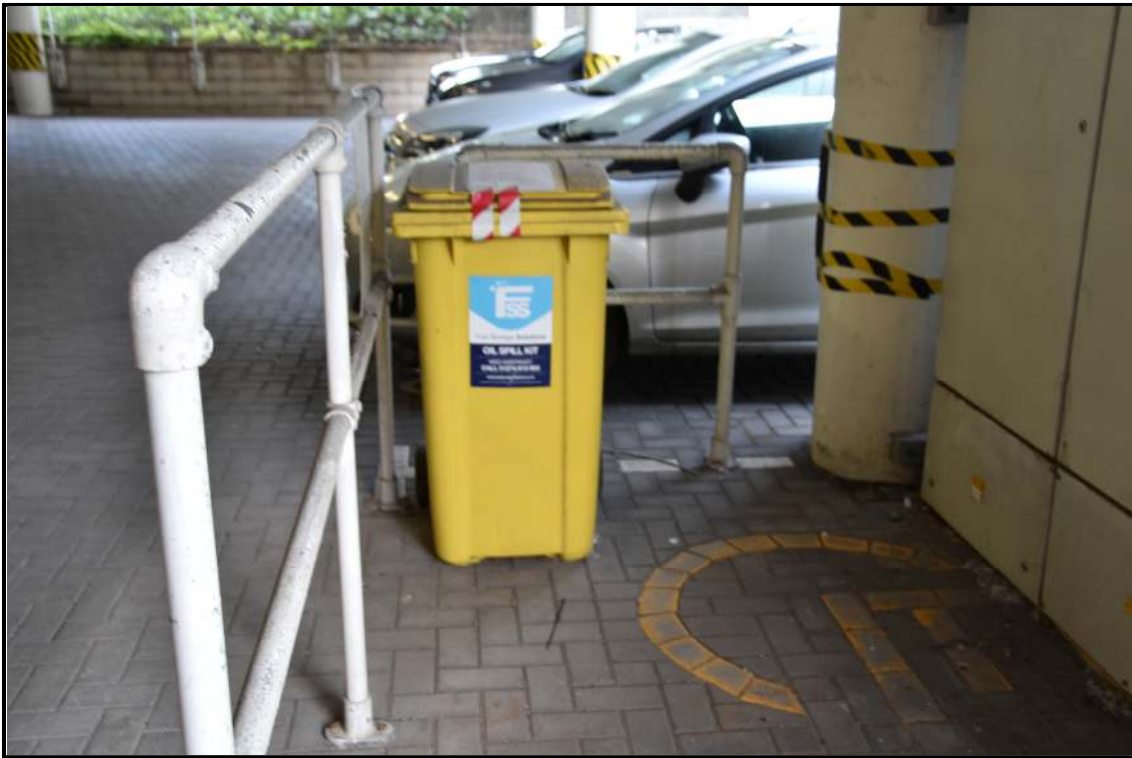
Plate 9 Spill kits available

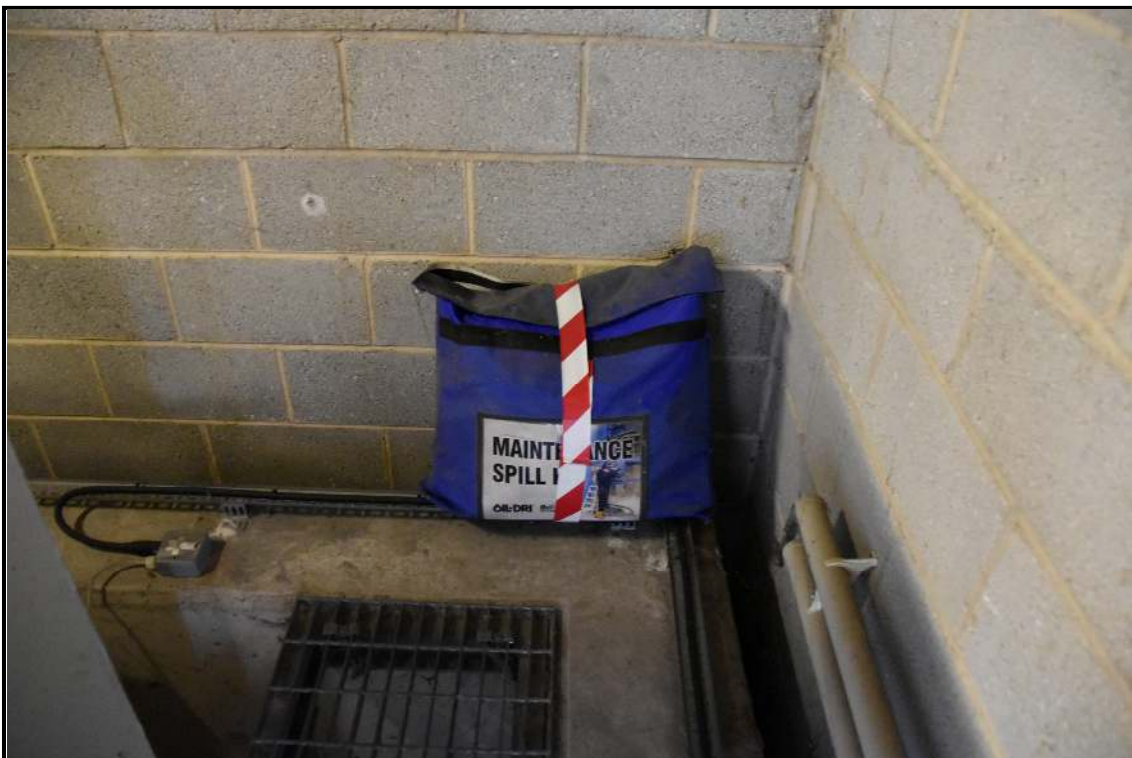
Plate 10 Spill kit in tank area

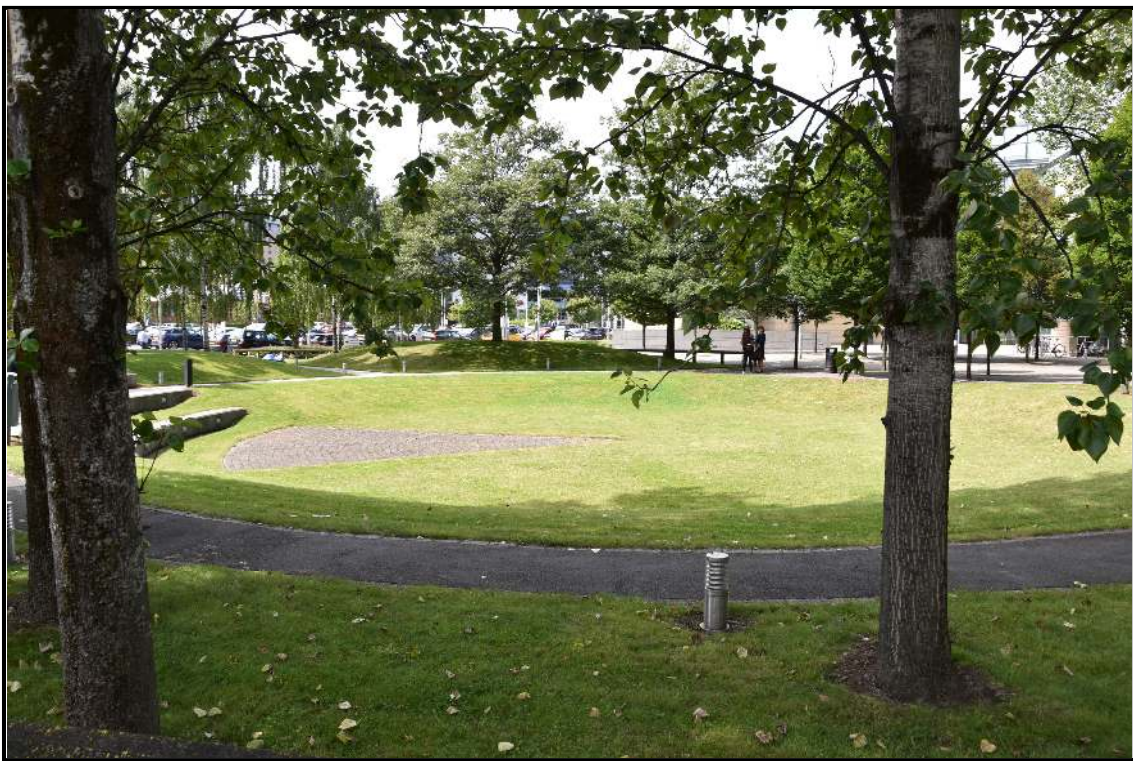
**Plate 14 Mature landscaping with no degradation**

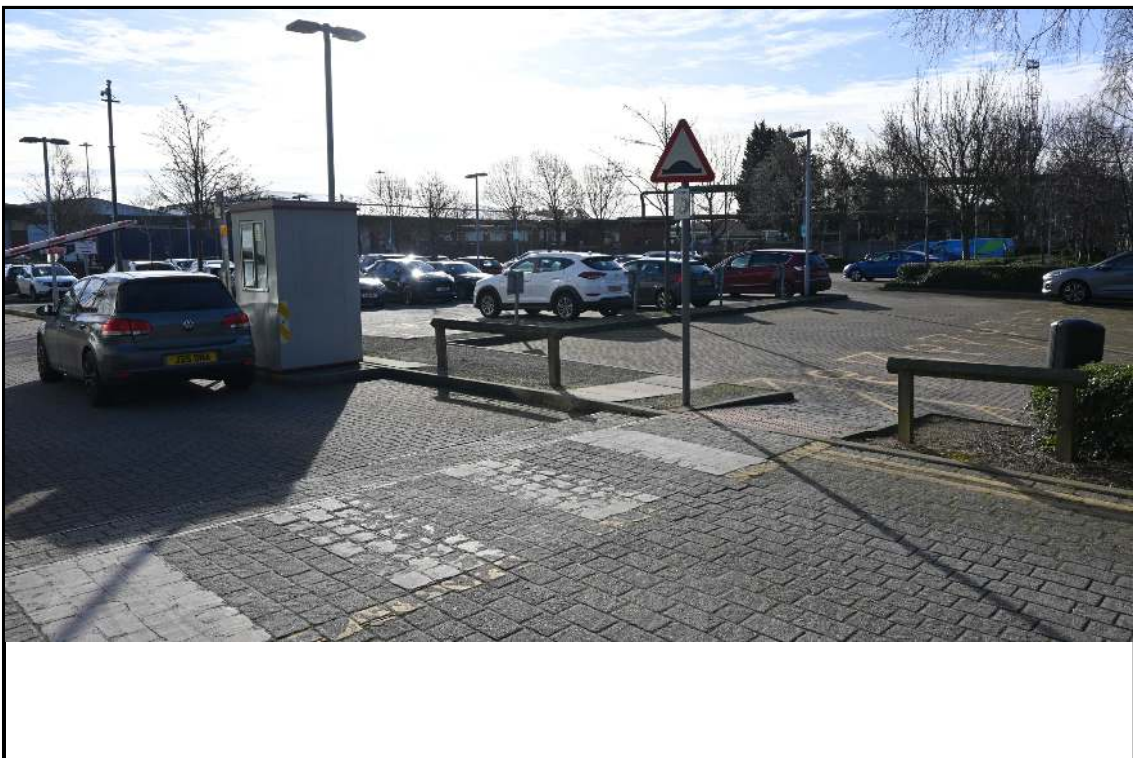
- 3.16 The inspection of 3<sup>rd</sup> March revealed that there is an extensive car park area comprising brick pavements and no evidence of damaged surface caused through either contamination or settlement was noted.
- 3.17 The landscaped areas are mature and flourishing. There was no evidence of vegetation die-back nor subsidence.
- 3.18 A pond feature exists to the west and this has no evidence of oily sheens or any contamination.
- 3.19 Although the waste management contractors are not known no waste abuses were noted.

**Plate 6 Car Park-no settlement**

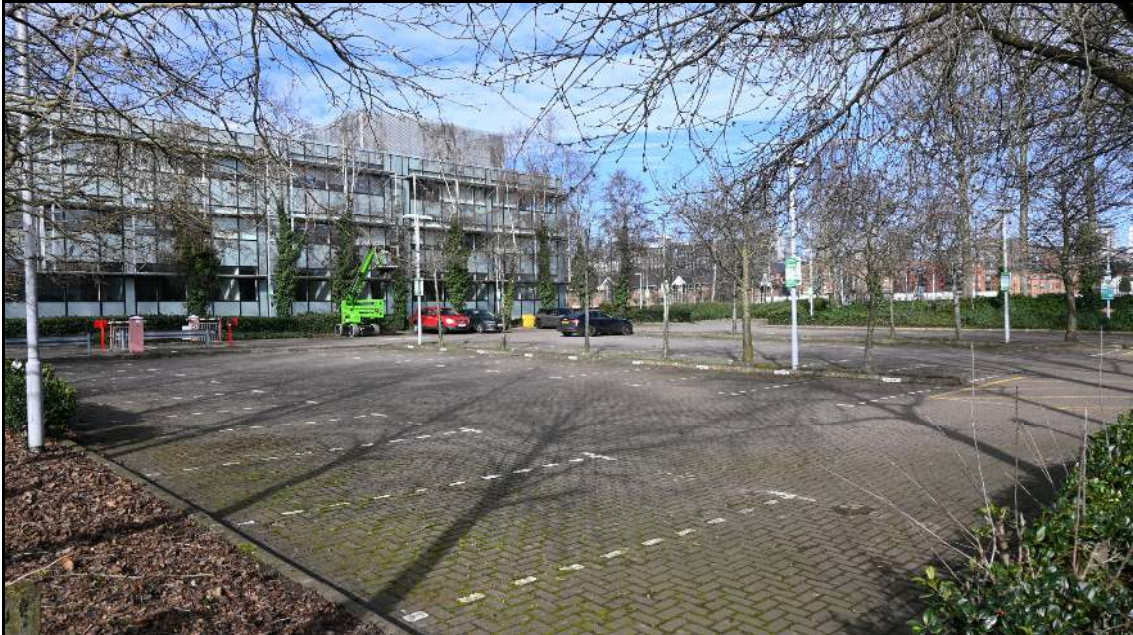
**Plate 7 Building 1 car park-no settlement**

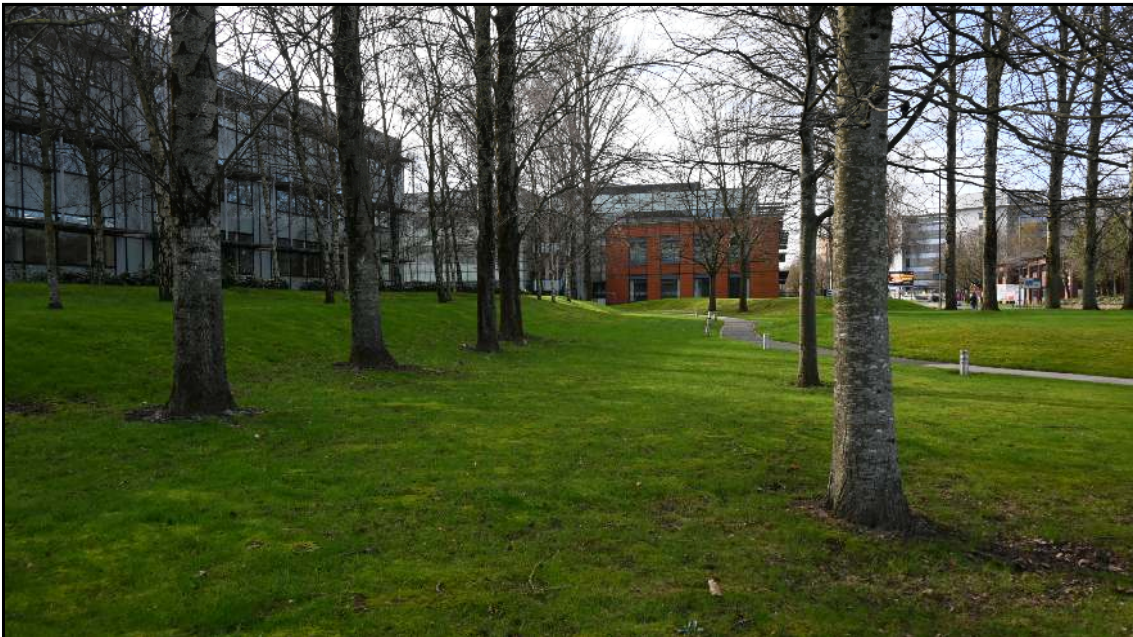
**Plate 8 Landscaping mature and with no dieback**
