LSS ASBESTOS MANAGEMENT SURVEY

**UNIT 7 PRIESTLY WAY,
MANOR ROYAL ESTATE,
CRAWLEY, RH10 9NT**

**ADAM SHANKSTER
COLRIDGE ENGINEERING LTD**

Reference: REPORT/UNIT 7 PRIESTLY WAY, MANOR ROYAL ESTATE, CRAWLEY, RH10 9NT			
Issue		Prepared by	
V1	February 2020

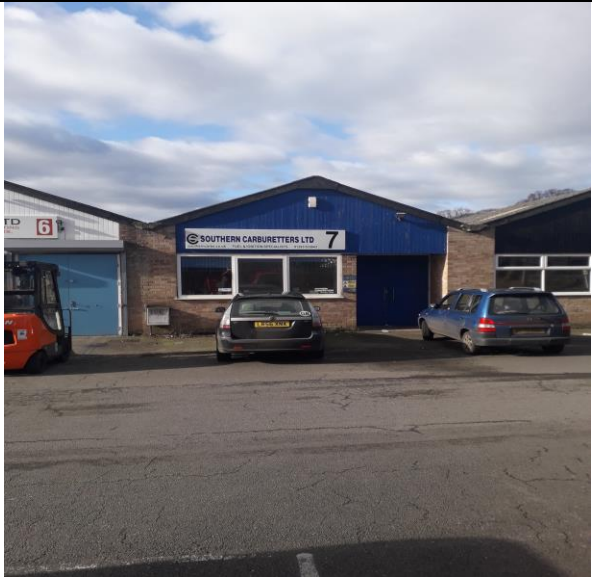
6.1 Photos 1

Asbestos Sample Sheet				
Sample Reference	2020047-P1	Survey Date:	04/02/2020	
Location Description	External	Surveyor:	Richard Carlton-Walker	
Area Inspected	Front Elevation			
Analytical Results	No asbestos found			
		Comments

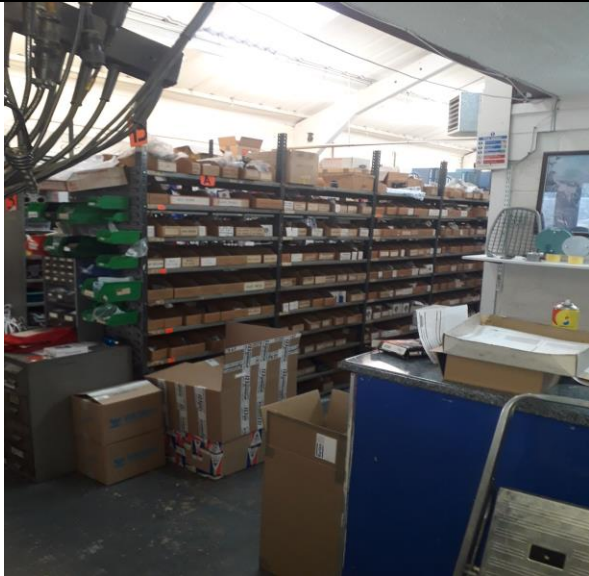
6.3 Photos 3

Asbestos Sample Sheet				
Sample Reference	2020047-P3	Survey Date:	04/02/2020	
Location Description	Shop floor	Surveyor:	Richard Carlton-Walker	
Area Inspected	All areas			
Analytical Results	No asbestos found			
		Comments

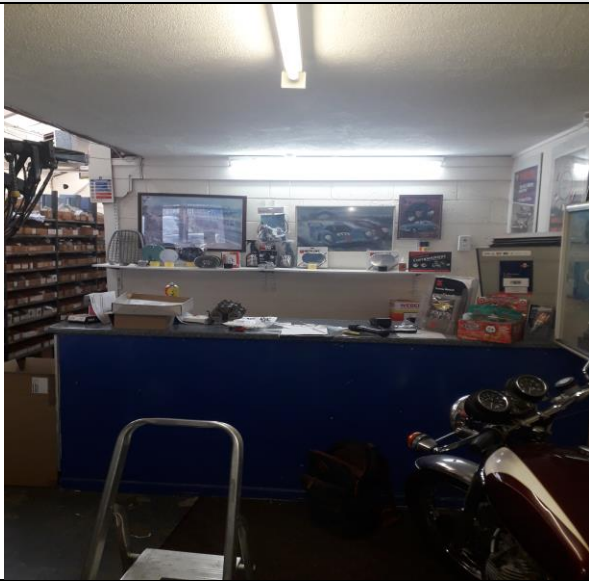
6.4 Photos 4

Asbestos Sample Sheet			
Sample Reference	2020047-P4	Survey Date:	04/02/2020
Location Description	Counter area	Surveyor:	Richard Carlton-Walker
Area Inspected	All areas		
Analytical Results	No asbestos found		
		Comments

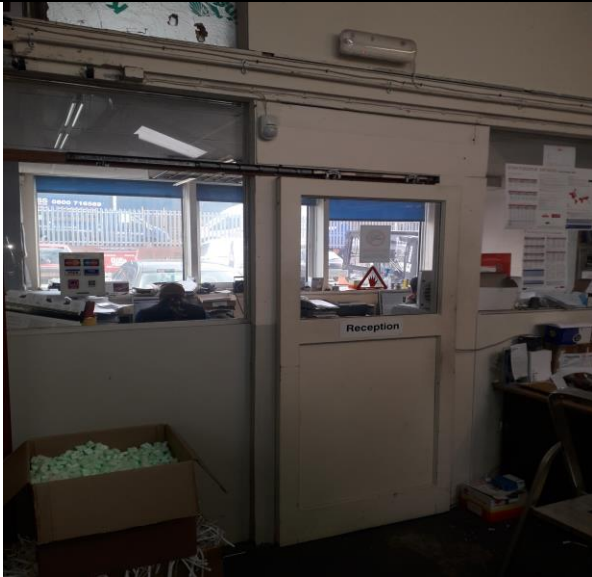
6.5 Photos 5

Asbestos Sample Sheet			
Sample Reference	2020047-P5	Survey Date:	04/02/2020
Location Description	Reception	Surveyor:	Richard Carlton-Walker
Area Inspected	All areas		
Analytical Results	No asbestos found		
		Comments

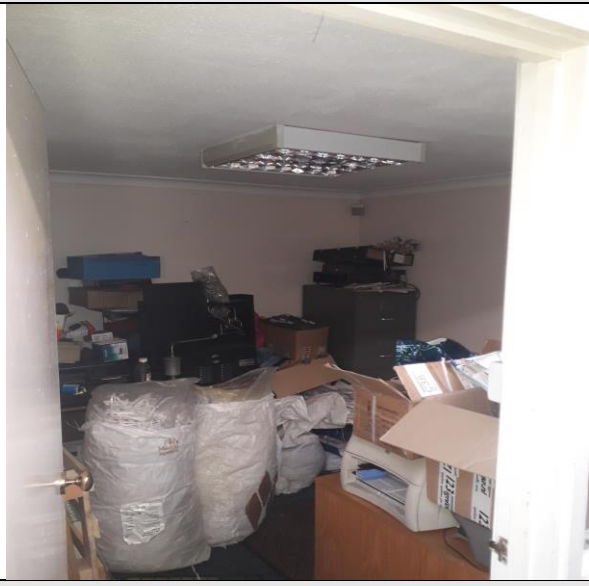
6.6 Photos 6

Asbestos Sample Sheet			
Sample Reference	2020047-P6	Survey Date:	04/02/2020
Location Description	Office 1	Surveyor:	Richard Carlton-Walker
Area Inspected	All areas		
Analytical Results	No asbestos found		
		Comments

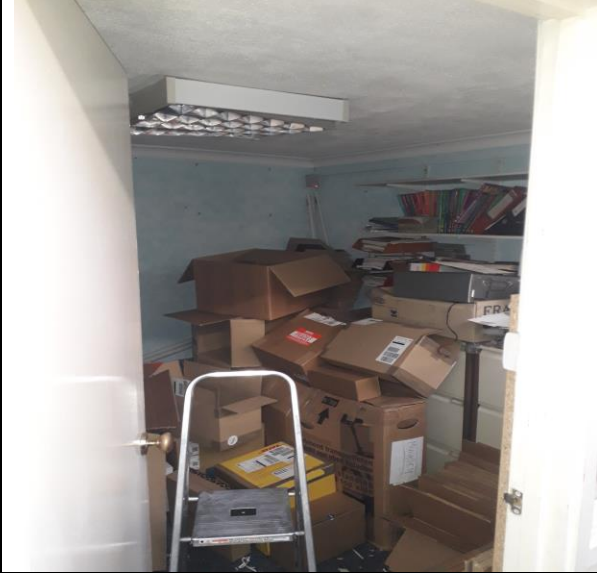
6.7 Photos 7

Asbestos Sample Sheet			
Sample Reference	2020047-P7	Survey Date:	04/02/2020
Location Description	Office 2	Surveyor:	Richard Carlton-Walker
Area Inspected	All areas		
Analytical Results	No asbestos found		
		Comments

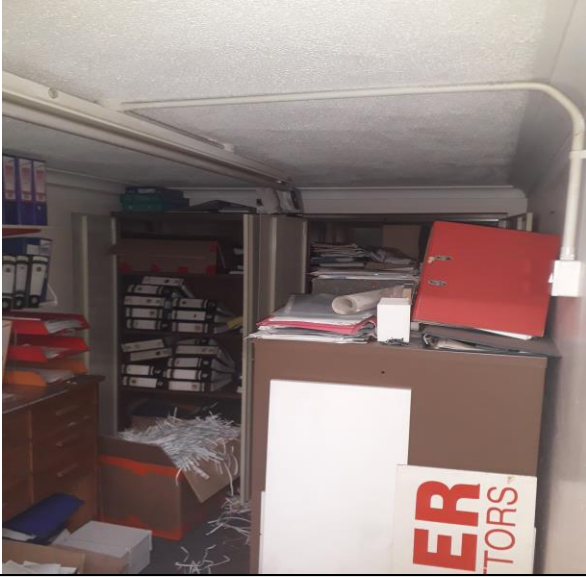
6.8 Photos 8

Asbestos Sample Sheet			
Sample Reference	2020047-P8	Survey Date:	04/02/2020
Location Description	Office 3	Surveyor:	Richard Carlton-Walker
Area Inspected	All areas	Quantity	
Analytical Results	No asbestos found		
		Comments

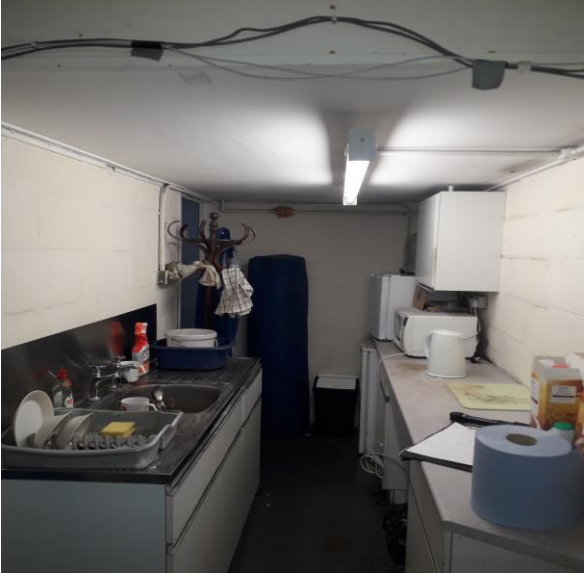
6.9 Photos 9

Asbestos Sample Sheet			
Sample Reference	2020047-P9	Survey Date:	04/02/2020
Location Description	Kitchen	Surveyor:	Richard Carlton-Walker
Area Inspected	All areas	Quantity	
Analytical Results	No asbestos found		
		Comments

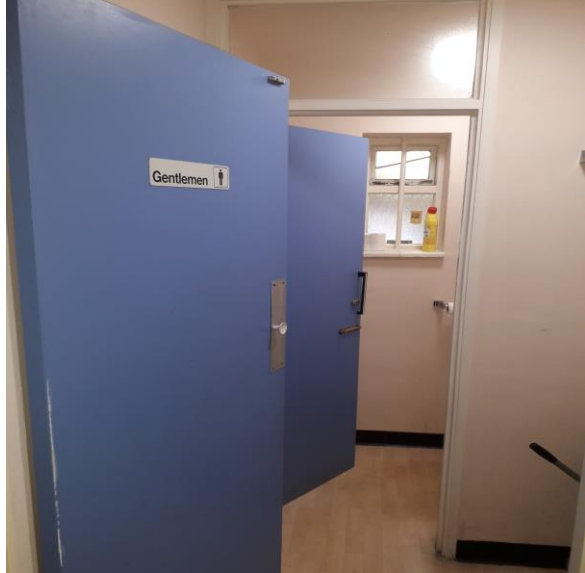
6.10 Photos 10

Asbestos Sample Sheet			
Sample Reference	2020047-P10	Survey Date:	04/02/2020
Location Description	Male Toilet	Surveyor:	Richard Carlton-Walker
Area Inspected	All areas	Quantity	
Analytical Results	No asbestos found		
		Comments

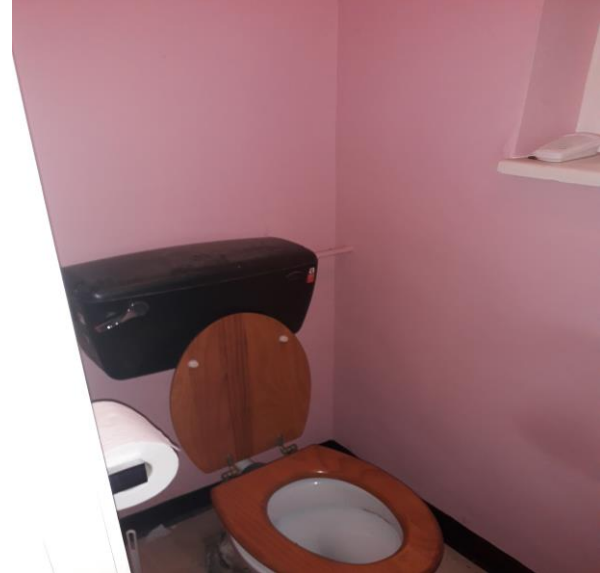
6.11 Photos 11

Asbestos Sample Sheet				
Sample Reference	2020047-P11	Survey Date:	04/02/2020	
Location Description	Female toilet	Surveyor:	Richard Carlton-Walker	
Area Inspected	Cistern	Quantity	1	
Analytical Results	Amosite asbestos found			
		Comments

Risk Assessment Score = 7		
		Product type	BAKERLITE	1
		Condition:	FAIR	1
		Surface Treatment:	REINFORCED PLASTIC	0
		Asbestos Type:	AMOSITE	2
		Accessibility	HIGH	2
		Position	INTERNAL	1
Suggested Remedial Action		Please refer to section 7 for risk assessment and section 8.0 for recommendation

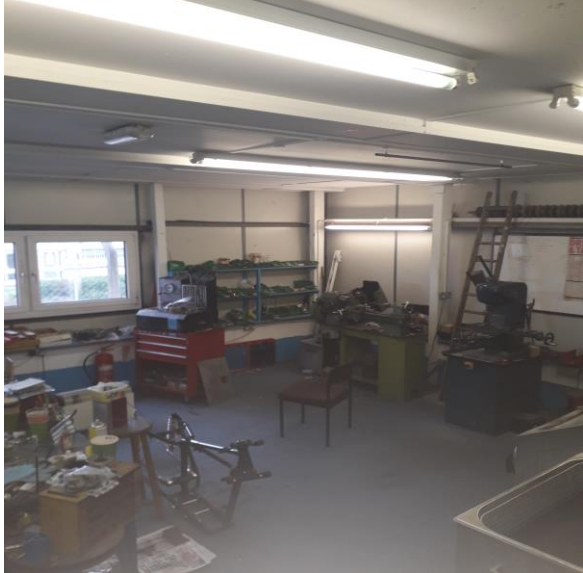
6.12 Photos 12

Asbestos Sample Sheet				
Sample Reference	2020047-P12	Survey Date:	04/02/2020	
Location Description	Workshop	Surveyor:	Richard Carlton-Walker	
Area Inspected	All areas	Quantity		
Analytical Results	No asbestos found			
		Comments

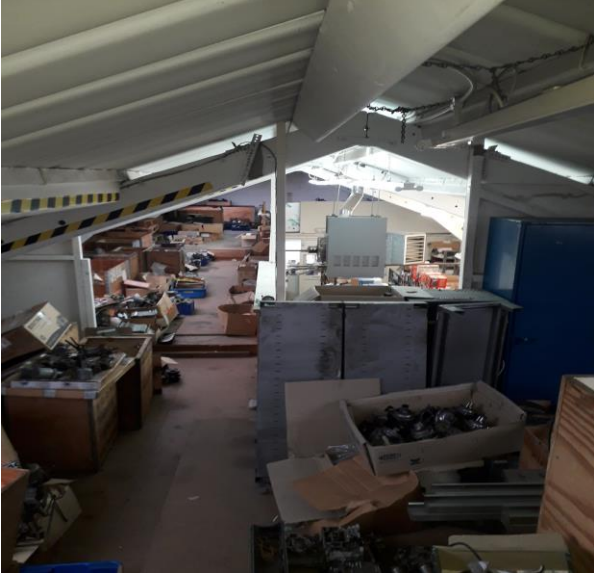
6.13 Photos 13

Asbestos Sample Sheet				
Sample Reference	2020047-P13	Survey Date:	04/02/2020	
Location Description	Mezzanine	Surveyor:	Richard Carlton-Walker	
Area Inspected	Roof	Quantity		
Analytical Results	Chrysotile asbestos found			
		Comments

Risk Assessment Score = 6		
		Product type	CEMENT	1
		Condition:	FAIR	1
		Surface Treatment:	ENCAPSULATED	1
		Asbestos Type:	CHRYSOTILE	1
		Accessibility	MEDIUM	1
		Position	INTERNAL	1
Suggested Remedial Action		Please refer to section 7 for risk assessment and section 8.0 for recommendation

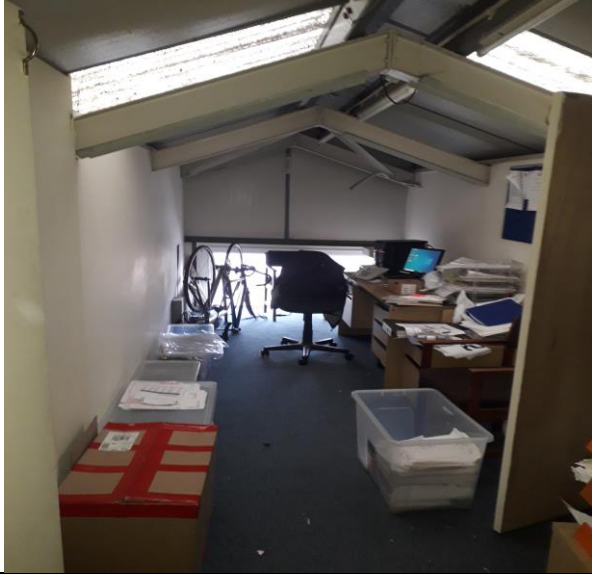
6.14 Photos 14

Asbestos Sample Sheet				
Sample Reference	2020047-P14	Survey Date:	04/02/2020	
Location Description	Mezzanine Office	Surveyor:	Richard Carlton-Walker	
Area Inspected	Ceiling	Quantity		
Analytical Results	Chrysotile asbestos found

Comments		
		Risk Assessment Score = 6		
		Product type	CEMENT	1
		Condition:	FAIR	1
		Surface Treatment:	ENCAPSULATED	1
		Asbestos Type:	CHRYSOTILE	1
		Accessibility	MEDIUM	1
		Position	INTERNAL	1
Suggested Remedial Action		Please refer to section 7 for risk assessment and section 8.0 for recommendation

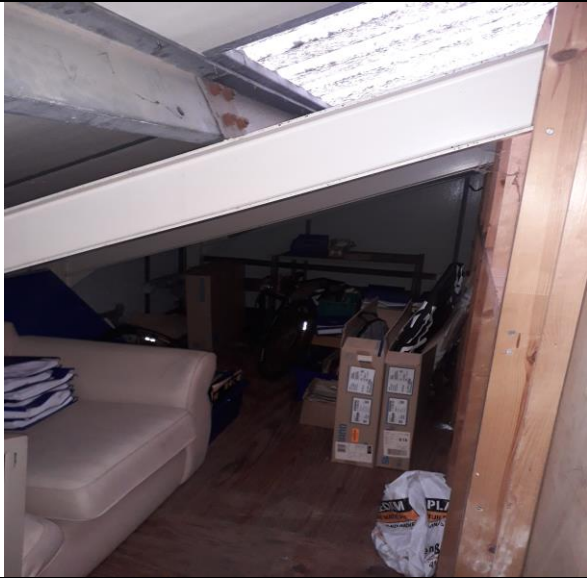
6.15 Photos 15

Asbestos Sample Sheet				
Sample Reference	2020047-P15	Survey Date:	04/02/2020	
Location Description	Mansard 1	Surveyor:	Richard Carlton-Walker	
Area Inspected	Ceiling	Quantity		
Analytical Results	Chrysotile asbestos found			
		Comments

Risk Assessment Score = 6		
		Product type	CEMENT	1
		Condition:	FAIR	1
		Surface Treatment:	ENCAPSULATED	1
		Asbestos Type:	CHRYSOTILE	1
		Accessibility	MEDIUM	1
		Position	INTERNAL	1
Suggested Remedial Action		Please refer to section 7 for risk assessment and section 8.0 for recommendation

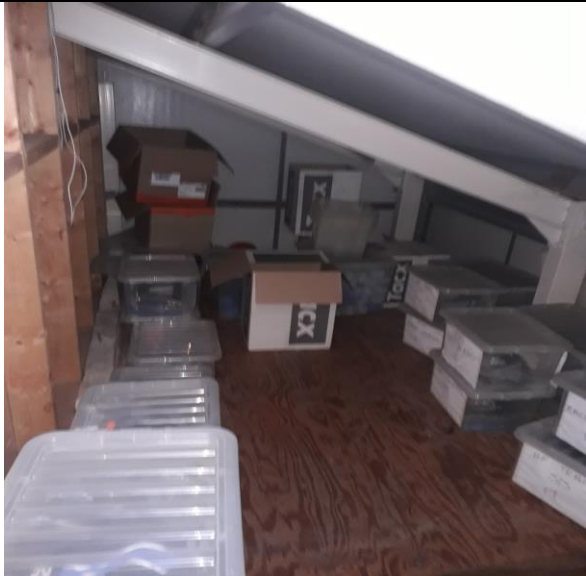
6.16 Photos 16

Asbestos Sample Sheet				
Sample Reference	2020047-P16	Survey Date:	04/02/2020	
Location Description	Mansard 2	Surveyor:	Richard Carlton-Walker	
Area Inspected	Ceiling	Quantity		
Analytical Results	Chrysotile asbestos found			
		Comments

Risk Assessment Score = 6		
		Product type	CEMENT	1
		Condition:	FAIR	1
		Surface Treatment:	ENCAPSULATED	1
		Asbestos Type:	CHRYSOTILE	1
		Accessibility	MEDIUM	1
		Position	INTERNAL	1
Suggested Remedial Action		Please refer to section 7 for risk assessment and section 8.0 for recommendation

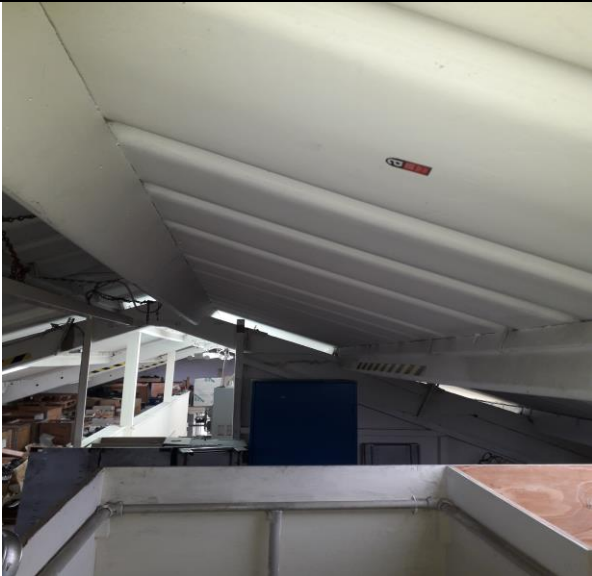
6.17 Photos 17

Asbestos Sample Sheet				
Sample Reference	2020047-P17	Survey Date:	04/02/2020	
Location Description	Roof area	Surveyor:	Richard Carlton-Walker	
Area Inspected	Ceiling	Quantity		
Analytical Results	Chrysotile asbestos found			
		Comments

Risk Assessment Score = 6		
		Product type	CEMENT	1
		Condition:	FAIR	1
		Surface Treatment:	ENCAPSULATED	1
		Asbestos Type:	CHRYBOTILE	1
		Accessibility	MEDIUM	1
		Position	INTERNAL	1
Suggested Remedial Action		Please refer to section 7 for risk assessment and section 8.0 for recommendation
