# Asbestos Management Survey Report

Concord International Limited (Cymru)  
Polo Grounds Industrial Estate, New Inn, Pontypool, Torfaen, NP4 0TW

**Site Address:**  
Polo Grounds Industrial Estate, New Inn, Pontypool, Torfaen  
NP4 0TW

**Survey Report Number:**  
J000448

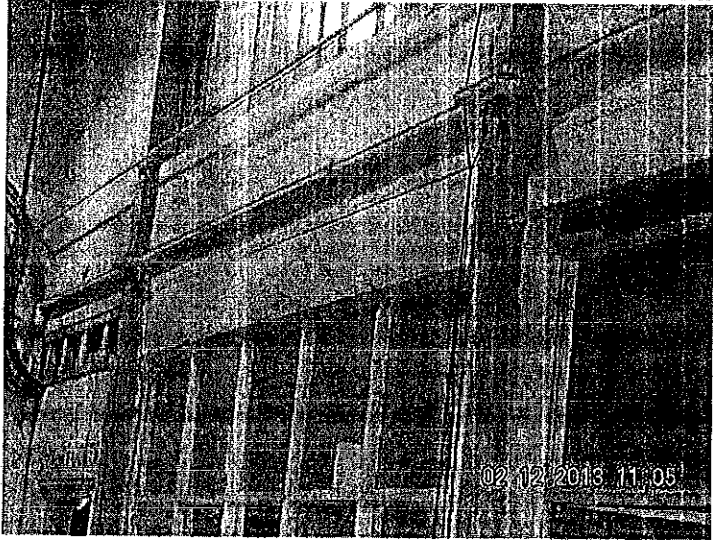
Item No: 012	Sample No: AC000071

Location: Ground Floor, Storage area, header panel	
Material type: Insulating Board	Asbestos Type: Chrysotile + Amosite

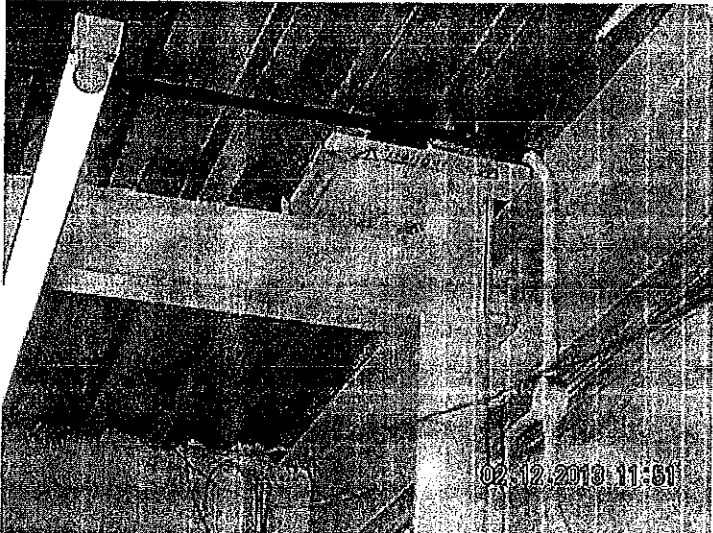
Item No: 019	Sample No: AC000073

Location: Ground Floor, Quality control, panel	
Material type: Insulating Board	Asbestos Type: Chrysotile + Amosite

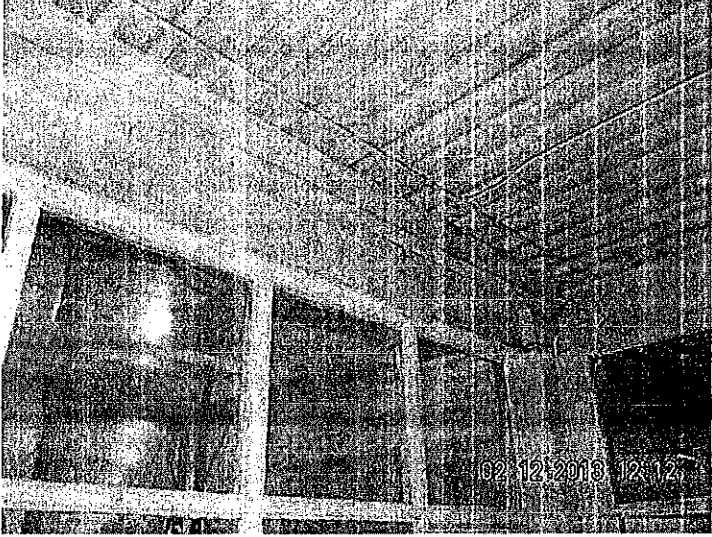
Item No: 022	Sample No: AC000071 Strongly Presumed As AC000071

Location: Ground Floor, Office 1, header panels	
Material type: Insulating Board	Asbestos Type: Chrysotile + Amosite

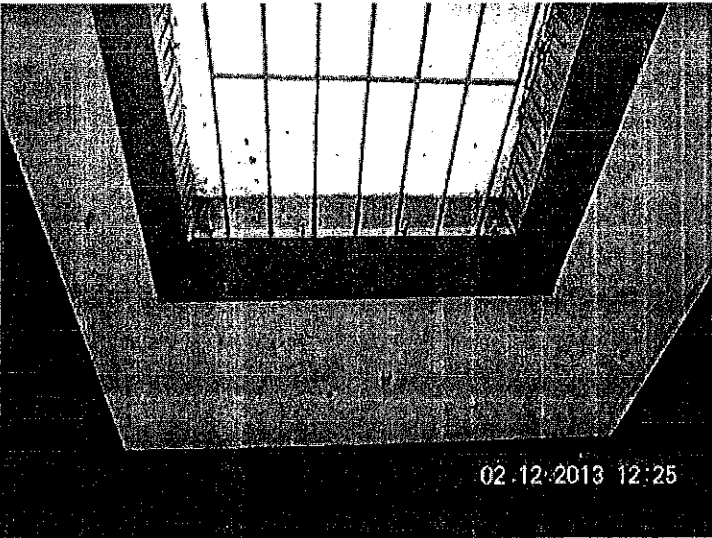
Item No: 024	Sample No: AC000075

Location: Ground Floor, Corridor 1, side panels	
Material type: Insulating Board	Asbestos Type: Chrysotile + Amosite

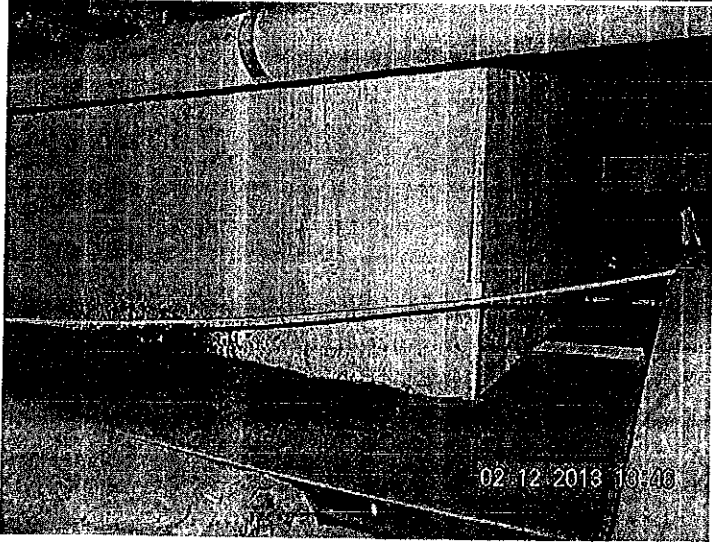
Item No: 026	Sample No: AC000075 Strongly Presumed As AC000075

Location: Ground Floor, Corridor 1, ceiling void, panels	
Material type: Insulating Board	Asbestos Type: Chrysotile + Amosite

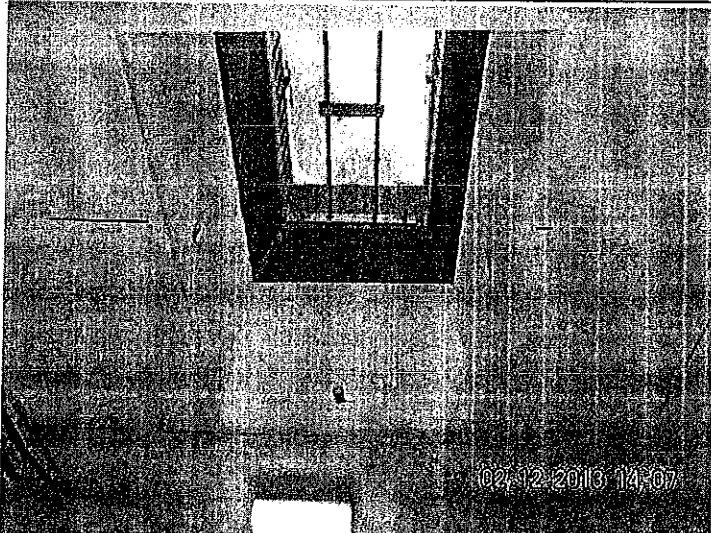
Item No: 031	Sample No: AC000075 Strongly Presumed As AC000075

Location: Ground Floor, Ladies W.C, panels	
Material type: Insulating Board	Asbestos Type: Chrysotile + Amosite

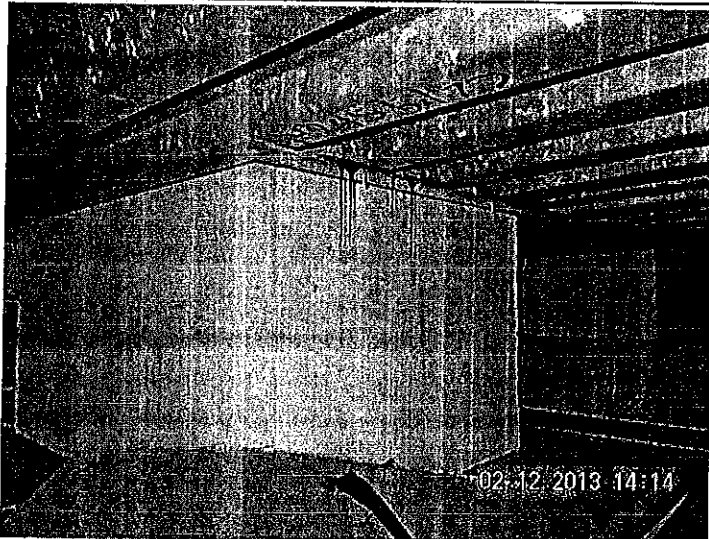
Item No: 033	Sample No: AC000075 Strongly Presumed As AC000075

Location: Ground Floor, Ladies W.C ceiling void, panels	
Material type: Insulating Board	Asbestos Type: Chrysotile + Amosite

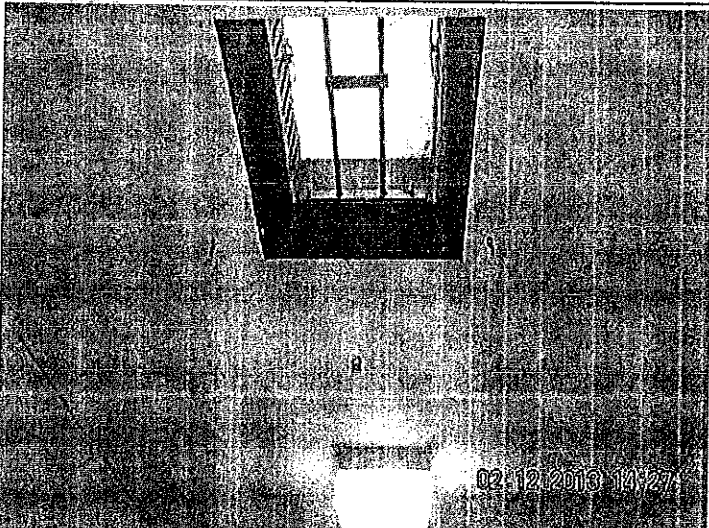
Item No: 035	Sample No: AC000075 Strongly Presumed As AC000075

Location: Ground Floor, Male W.C, panels	
Material type: Insulating Board	Asbestos Type: Chrysotile + Amosite

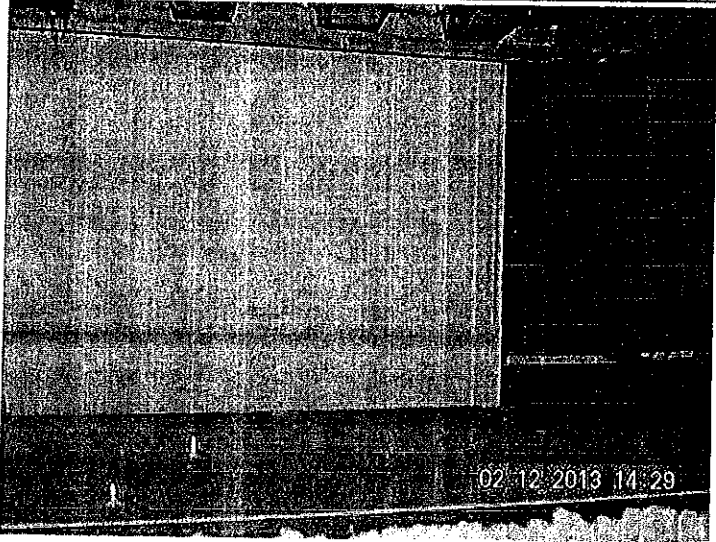
<b>Item No:</b> 037	<b>Sample No:</b> AC000075 Strongly Presumed As AC000075

<b>Location:</b> Ground Floor, Male WC, ceiling void, panels	
<b>Material type:</b> Insulating Board	<b>Asbestos Type:</b> Chrysotile + Amosite

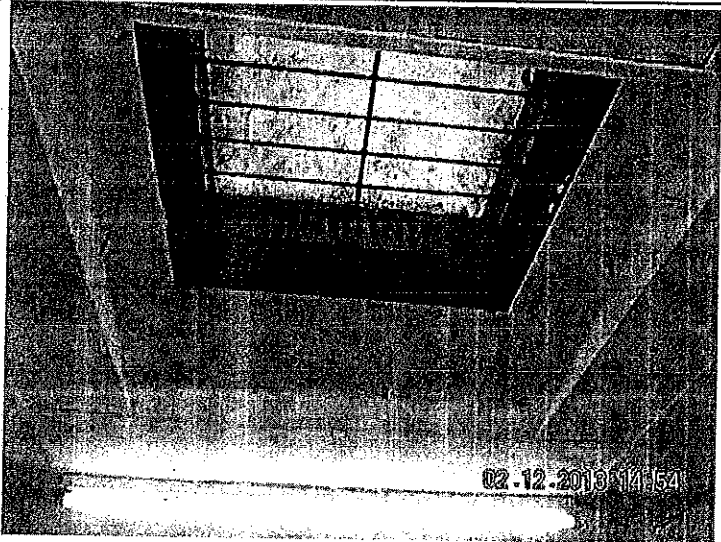
<b>Item No:</b> 039	<b>Sample No:</b> AC000078

<b>Location:</b> Ground Floor, Office 2, panels	
<b>Material type:</b> Insulating Board	<b>Asbestos Type:</b> Chrysotile + Amosite

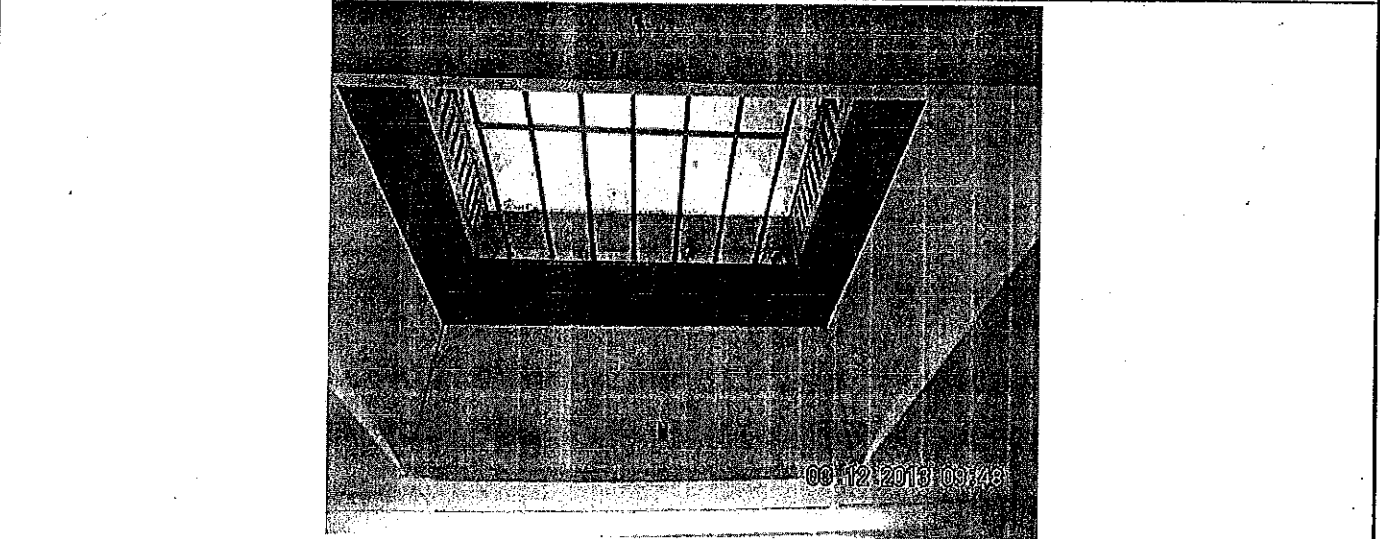
<b>Item No:</b> 050	<b>Sample No:</b> AC000078 Strongly Presumed As AC000078
---------------------	----------------------------------------------------------

<b>Location:</b> Ground Floor, Male cloakroom, panels	
<b>Material type:</b> Insulating Board	<b>Asbestos Type:</b> Chrysotile + Amosite

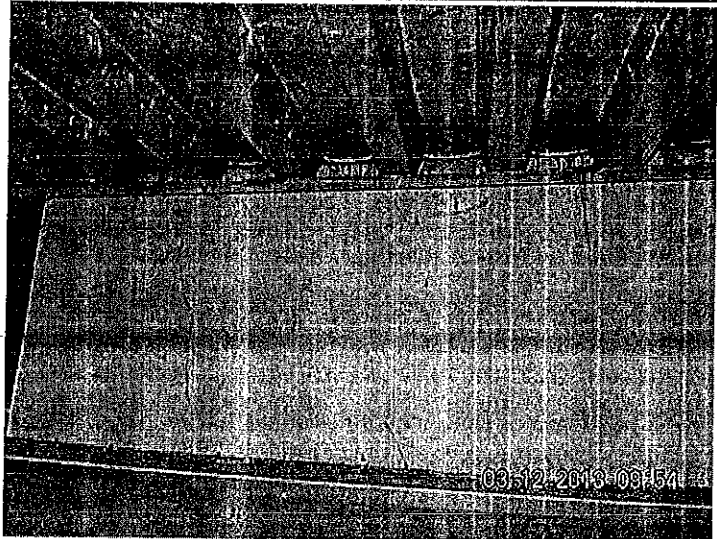
Item No: 051	Sample No: AC000078 Strongly Presumed As AC000078

Location: Ground Floor, Male cloakroom, ceiling void, panels	
Material type: Insulating Board	Asbestos Type: Chrysotile + Amosite

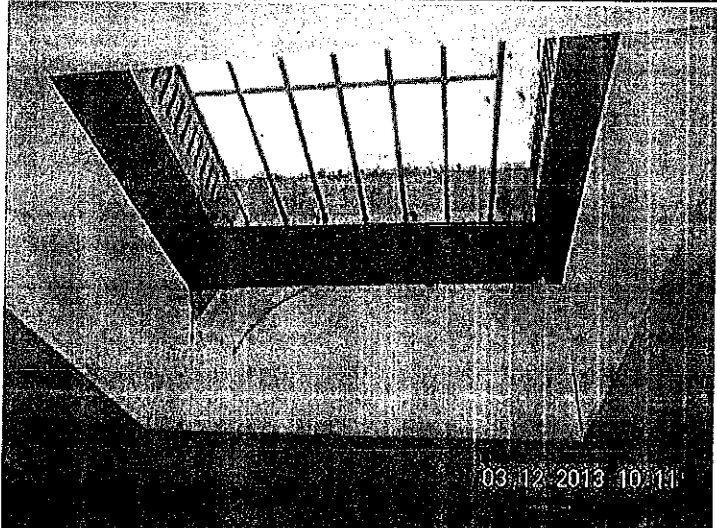
Item No: 052	Sample No: AC000078 Strongly Presumed As AC000078

Location: Ground Floor, Male toilet block, panels	
Material type: Insulating Board	Asbestos Type: Chrysotile + Amosite

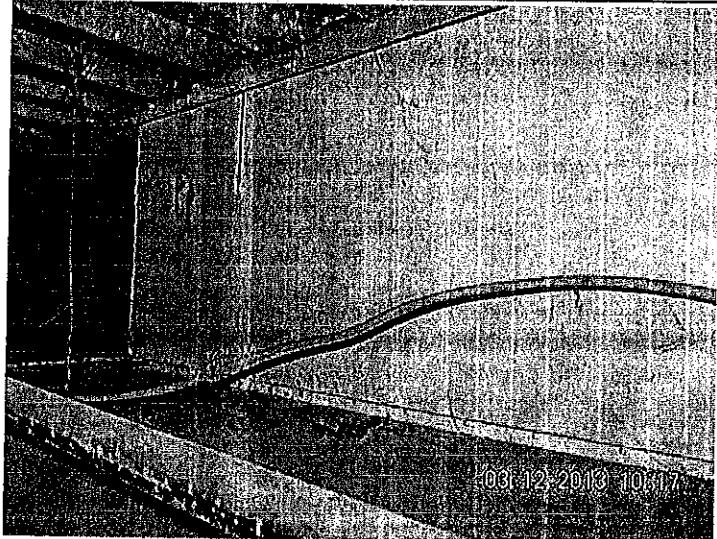
Item No: 053	Sample No: AC000078 Strongly Presumed As AC000078

Location: Ground Floor, Male toilet block, ceiling void, panels	
Material type: Insulating Board	Asbestos Type: Chrysotile + Amosite

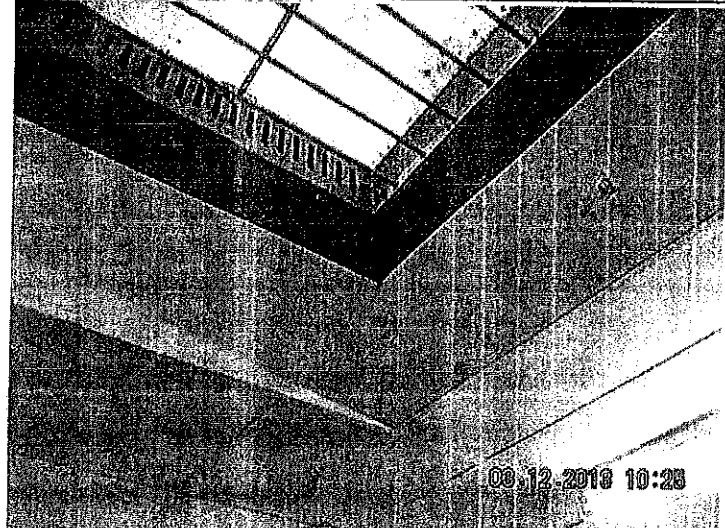
Item No: 055	Sample No: AC000078 Strongly Presumed As AC000078

Location: Ground Floor, Female cloakroom, panels	
Material type: Insulating Board	Asbestos Type: Chrysotile + Amosite

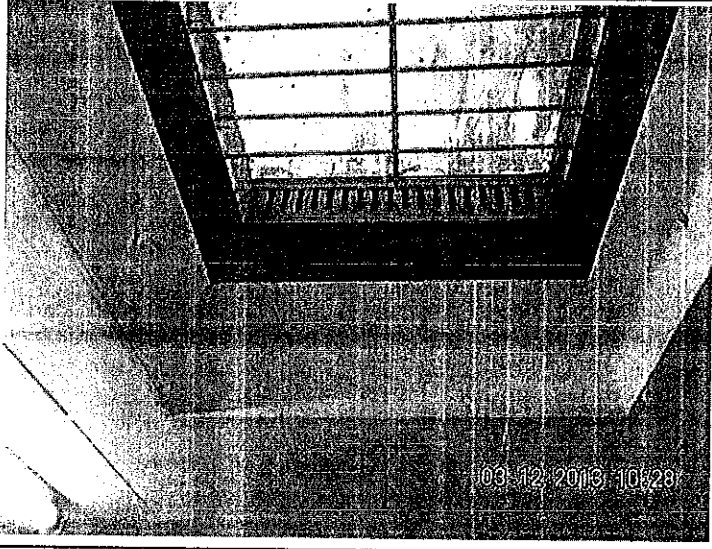
Item No: 056	Sample No: AC000078 Strongly Presumed As AC000078

Location: Ground Floor, Female cloakroom, ceiling void, panels	
Material type: Insulating Board	Asbestos Type: Chrysotile + Amosite

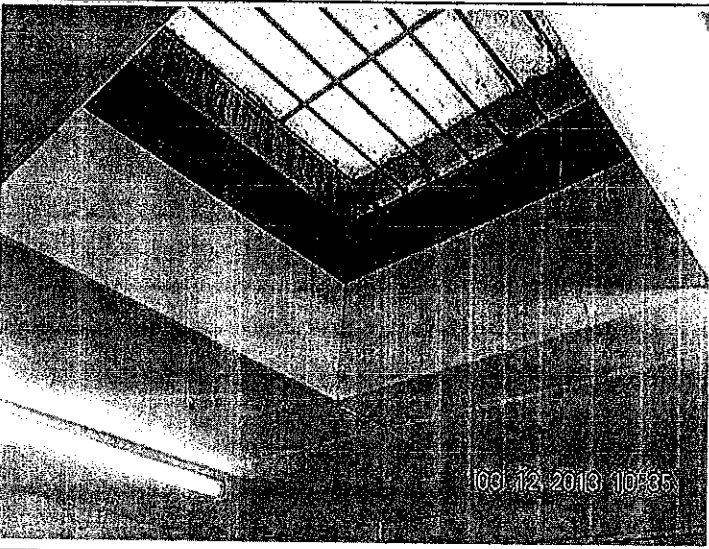
Item No: 058	Sample No: AC000078 Strongly Presumed As AC000078

Location: Ground Floor, Female toilet block, panels	
Material type: Insulating Board	Asbestos Type: Chrysotile + Amosite

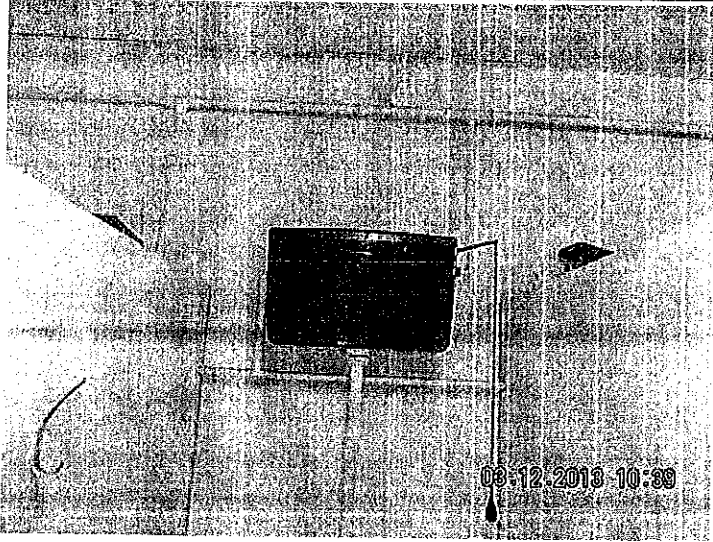
Item No: 060	Sample No: AC000082

Location: Ground Floor, Female toilet block, cistern	
Material type: Reinforced Plastic	Asbestos Type: Amosite

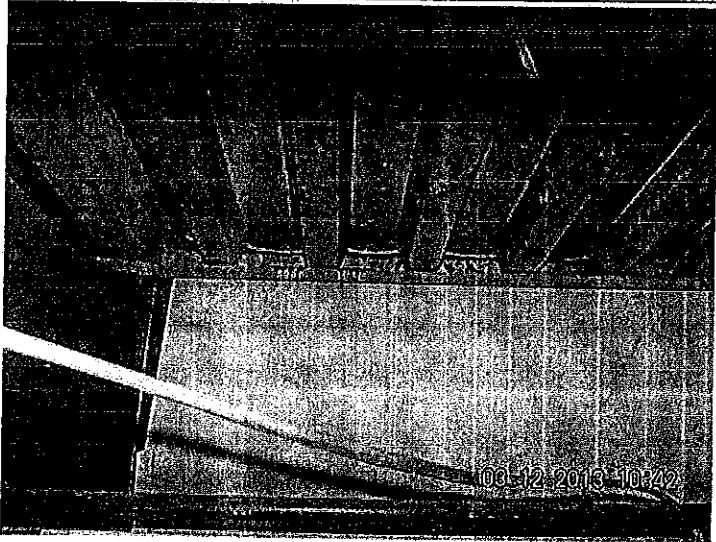
Item No: 062	Sample No: AC000078 Strongly Presumed As AC000078

Location: Ground Floor, Female toilet block, ceiling void, panels	
Material type: Insulating Board	Asbestos Type: Chrysotile + Amosite

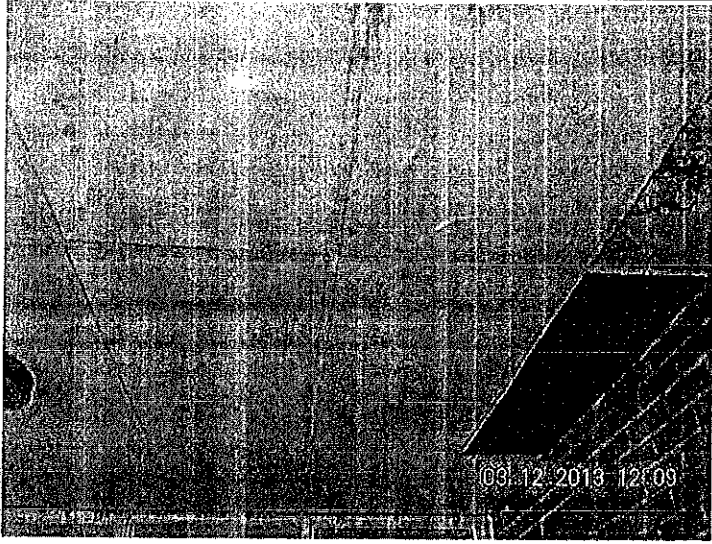
Item No: 076	Sample No: AC000093

Location: Ground Floor, External, ceiling panels	
Material type: Insulating Board	Asbestos Type: Chrysotile + Amosite

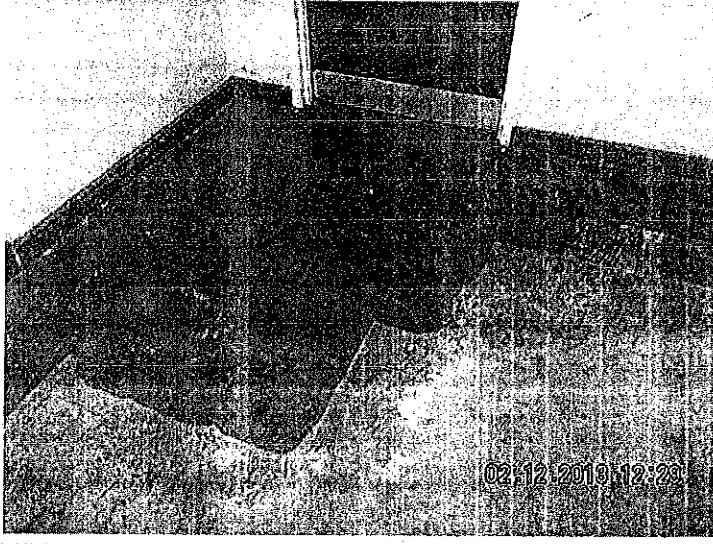
Item No: 025	Sample No: AC000076

Location: Ground Floor, Corridor 1, brown vinyl tile and adhesive	
Material type: Vinyl With Bitumen Adhesive	Asbestos Type: Chrysotile

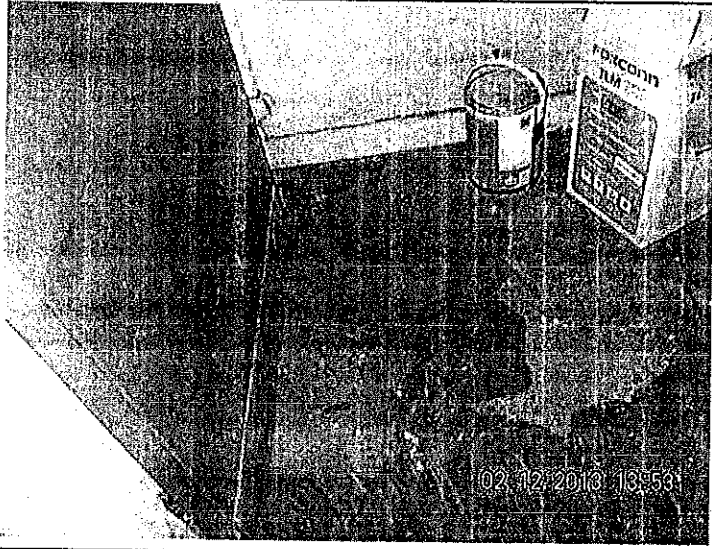
Item No: 027	Sample No: AC000076 Strongly Presumed As AC000076

Location: Ground Floor, Cleaner's store, brown vinyl tile and adhesive	
Material type: Vinyl With Bitumen Adhesive	Asbestos Type: Chrysotile

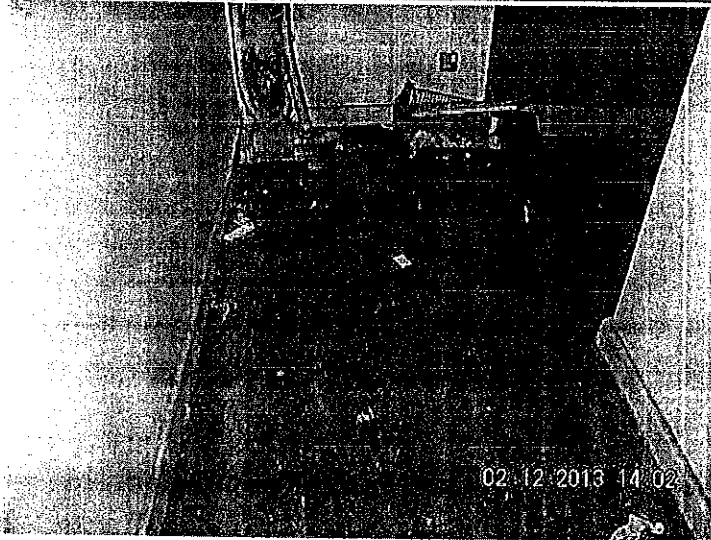
Item No: 030	Sample No: AC000076 Strongly Presumed As AC000076

Location: Ground Floor, Corridor 2, brown vinyl tile and adhesive	
Material type: Vinyl With Bitumen Adhesive	Asbestos Type: Chrysotile

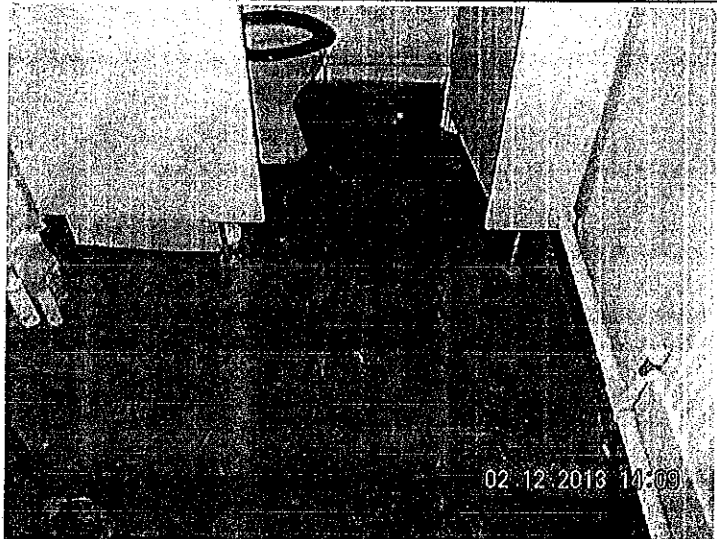
Item No: 032	Sample No: AC000076 Strongly Presumed As AC000076

Location: Ground Floor, Ladies W.C, brown vinyl tile and adhesive	
Material type: Vinyl With Bitumen Adhesive	Asbestos Type: Chrysotile

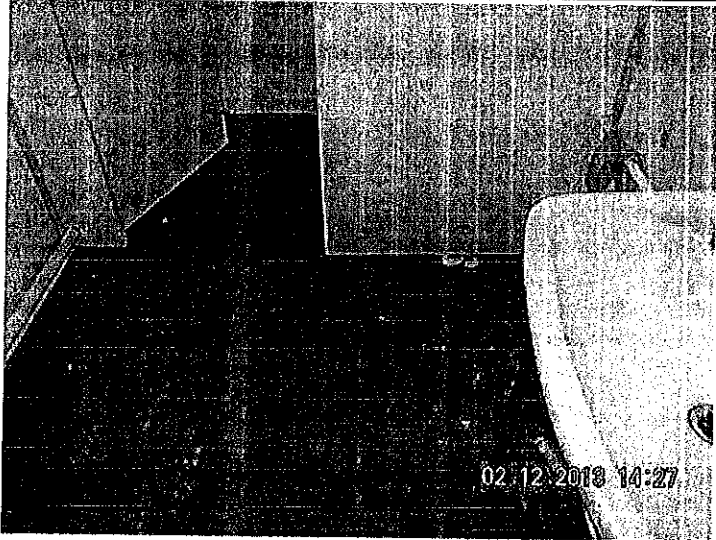
Item No: 036	Sample No: AC000076 Strongly Presumed As AC000076

Location: Ground Floor, Male W.C, brown vinyl tile and adhesive	
Material type: Vinyl With Bitumen Adhesive	Asbestos Type: Chrysotile

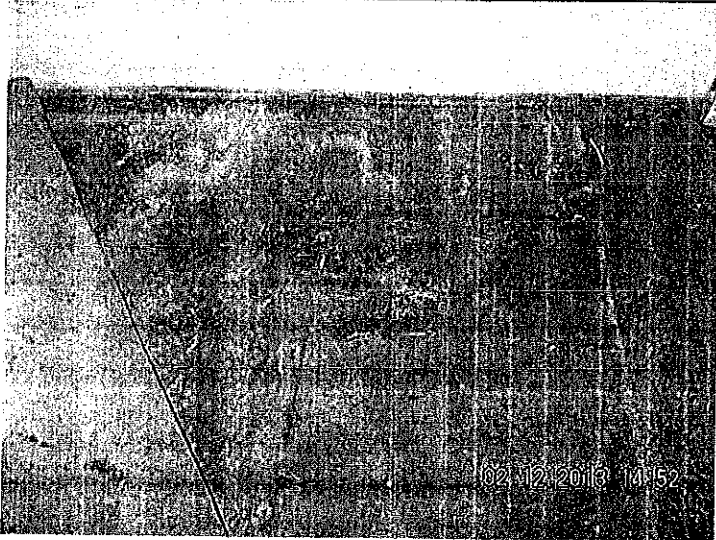
Item No: 038	Sample No: AC000076 Strongly Presumed As AC000076

Location: Ground Floor, Office 2, brown vinyl tile and adhesive	
Material type: Vinyl With Bitumen Adhesive	Asbestos Type: Chrysotile

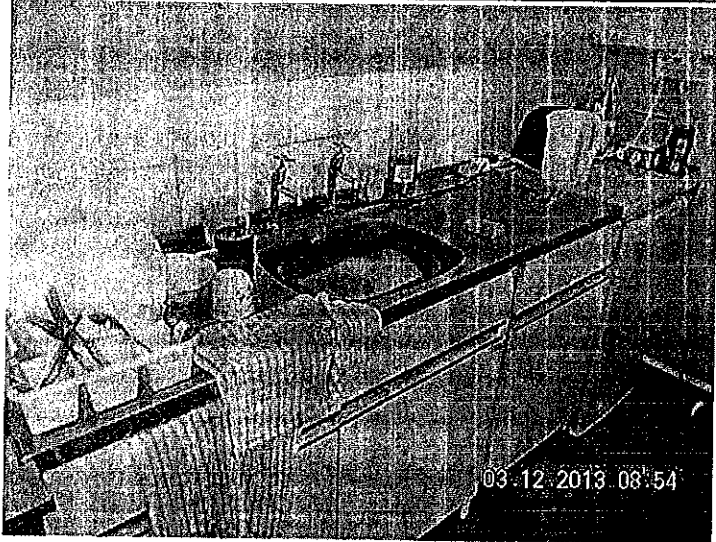
Item No: 045	Sample No: AC000081

Location: Ground Floor, Packing office, acoustic pad	
Material type: Bitumen	Asbestos Type: Chrysotile

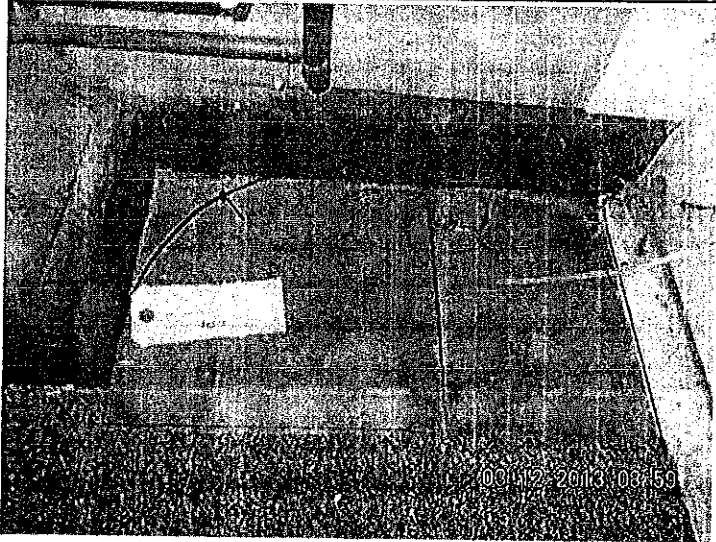
Item No: 046	Sample No: AC000080 Strongly Presumed As AC000080

Location: Ground Floor, Packing office, cream vinyl tiles and adhesive	
Material type: Vinyl With Bitumen Adhesive	Asbestos Type: Chrysotile

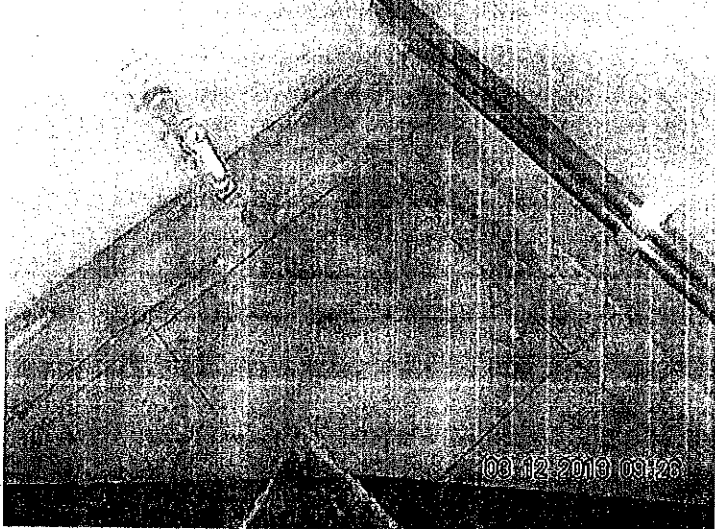
Item No: 048	Sample No: AC000080 Strongly Presumed As AC000080

Location: Ground Floor, Store 10, cream vinyl tiles and adhesive	
Material type: Vinyl With Bitumen Adhesive	Asbestos Type: Chrysotile

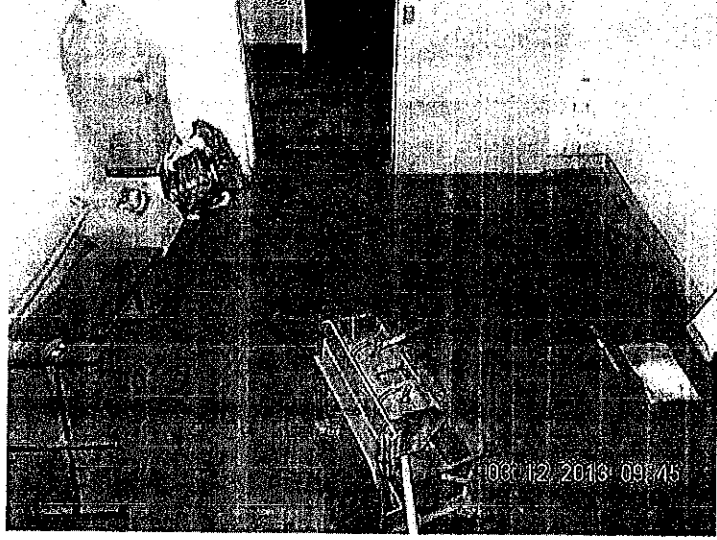
Item No: 049	Sample No: AC000076 Strongly Presumed As AC000076

Location: Ground Floor, Male cloakroom, brown vinyl tile and adhesive	
Material type: Vinyl With Bitumen Adhesive	Asbestos Type: Chrysotile

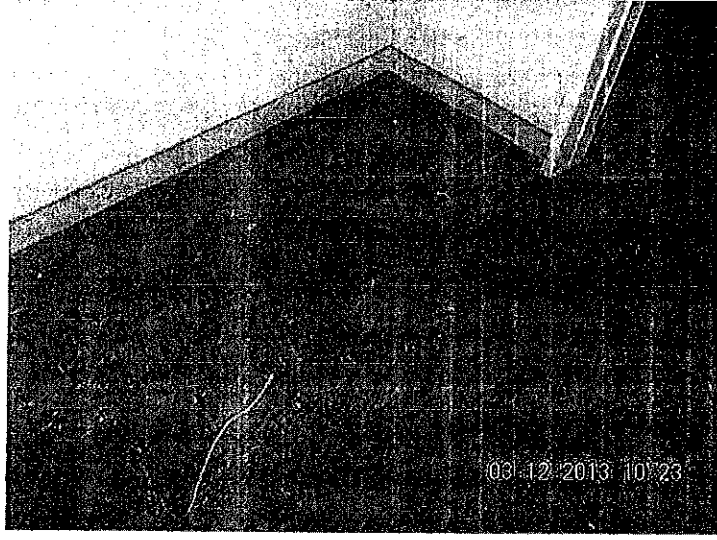
Item No: 054	Sample No: AC000076 Strongly Presumed As AC000076

Location: Ground Floor, Female cloakroom, brown vinyl tile and adhesive	
Material type: Vinyl With Bitumen Adhesive	Asbestos Type: Chrysotile

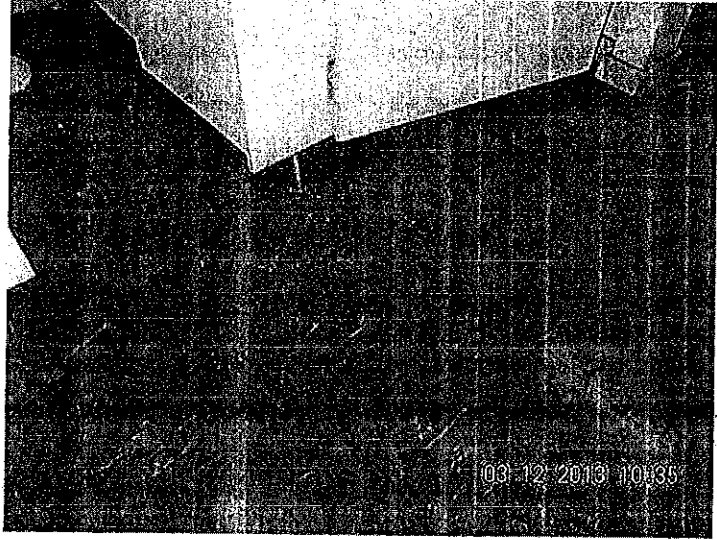
<b>Item No:</b> 059	<b>Sample No:</b> AC000076 Strongly Presumed As AC000076

<b>Location:</b> Ground Floor, Female toilet block, brown vinyl tile and adhesive	
<b>Material type:</b> Vinyl With Bitumen Adhesive	<b>Asbestos Type:</b> Chrysotile

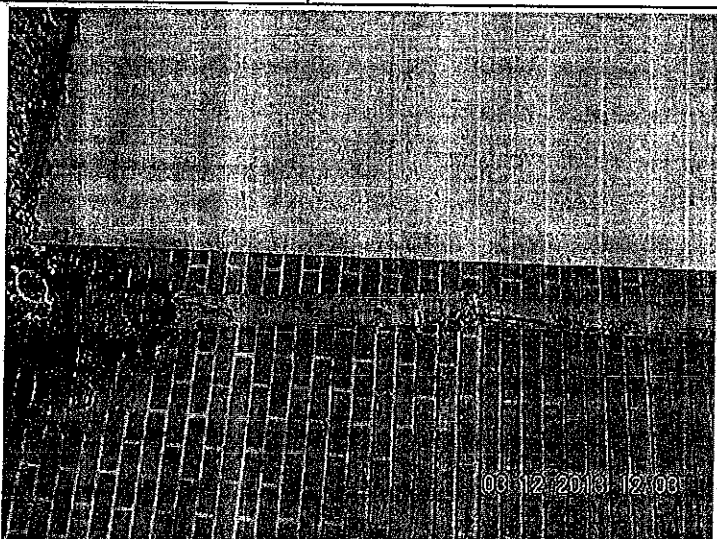
<b>Item No:</b> 074	<b>Sample No:</b> AC000091

<b>Location:</b> Ground Floor, External, down pipe	
<b>Material type:</b> Cement	<b>Asbestos Type:</b> Chrysotile

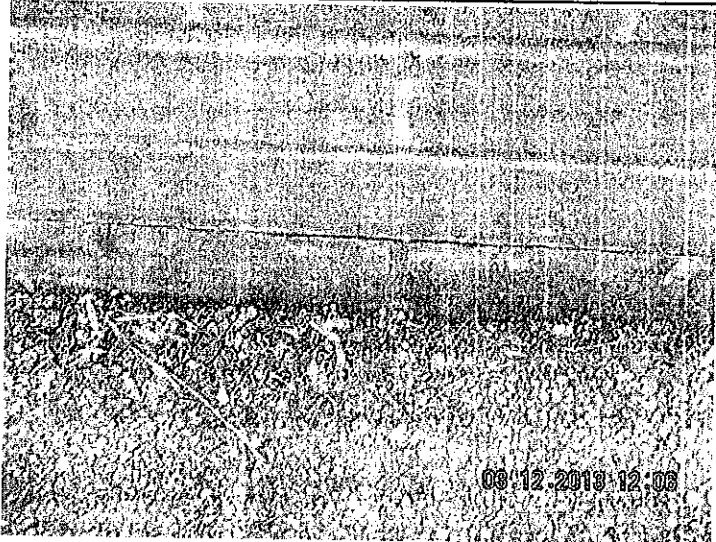
Item No: 075	Sample No: AC000092

Location: Ground Floor, External, damp proof course	
Material type: Bitumen	Asbestos Type: Chrysotile

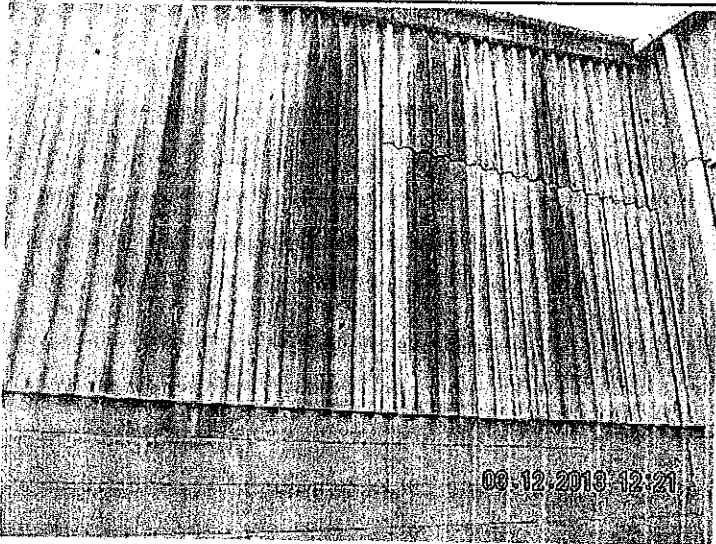
Item No: 077	Sample No: AC000094

Location: Ground Floor, External, cladding	
Material type: Cement	Asbestos Type: Chrysotile

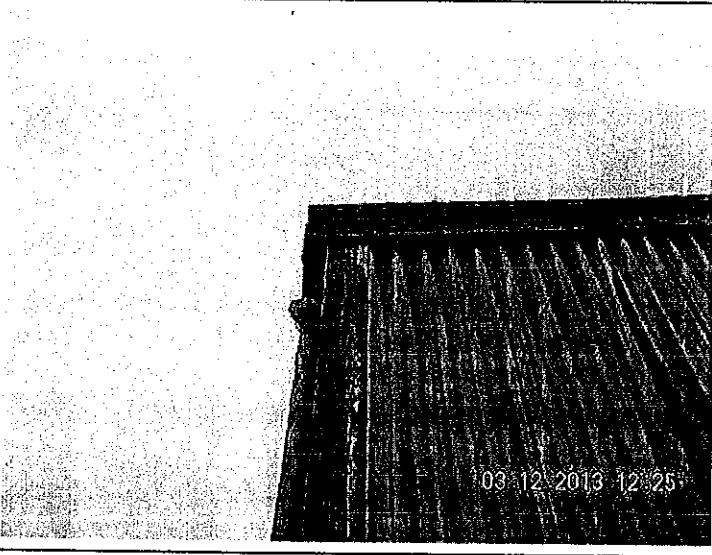
Item No: 078	Sample No: AC000095

Location: Ground Floor, External, end capping	
Material type: Cement	Asbestos Type: Chrysotile

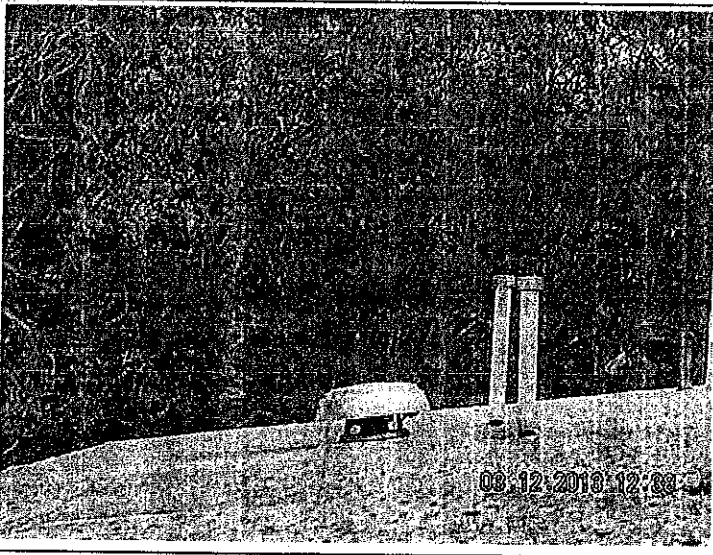
Item No: 079	Sample No: AC000096

Location: Ground Floor, External, corrugated sheets	
Material type: Cement	Asbestos Type: Chrysotile

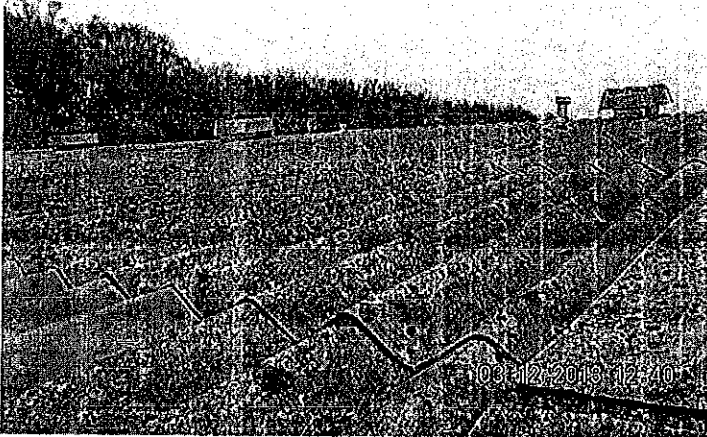
Item No: 080	Sample No: AC000097

Location: Ground Floor, External, profiled sheet	
Material type: Cement	Asbestos Type: Chrysotile

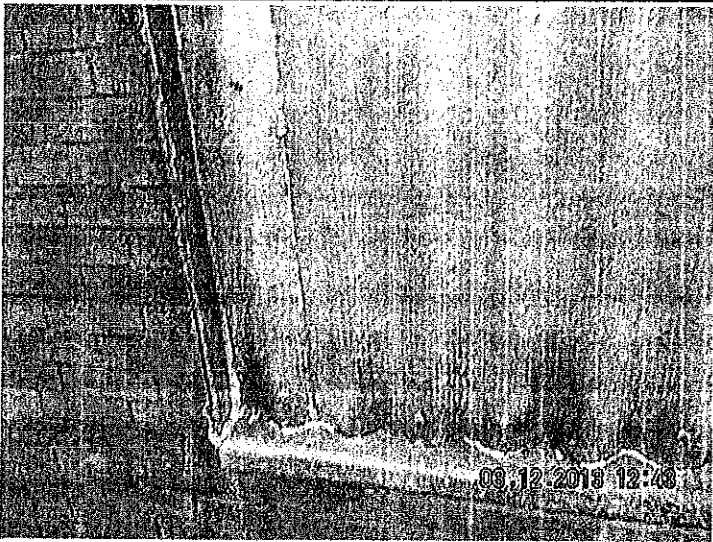
Item No: 081	Sample No: AC000098

Location: Ground Floor, External, sealant	
Material type: Putty	Asbestos Type: Chrysotile

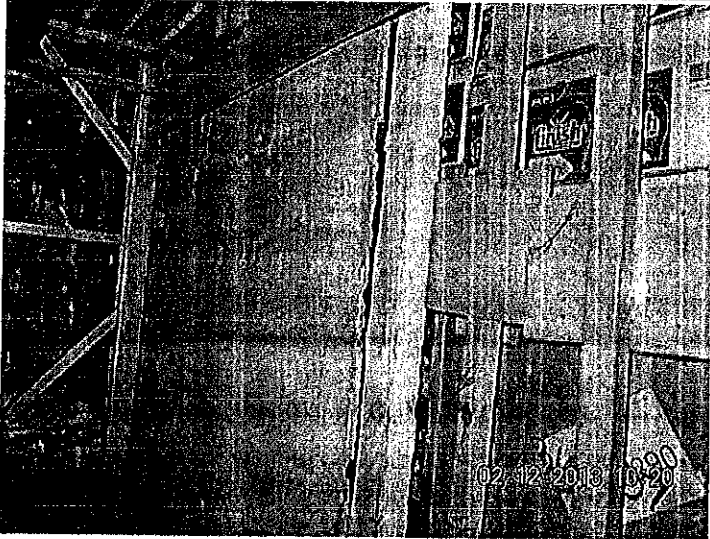
Item No: 004	Sample No: AC000069

Location: Ground Floor, Storage 2, damp proof membrane	
Material type: Bitumen	Asbestos Type: No asbestos detected

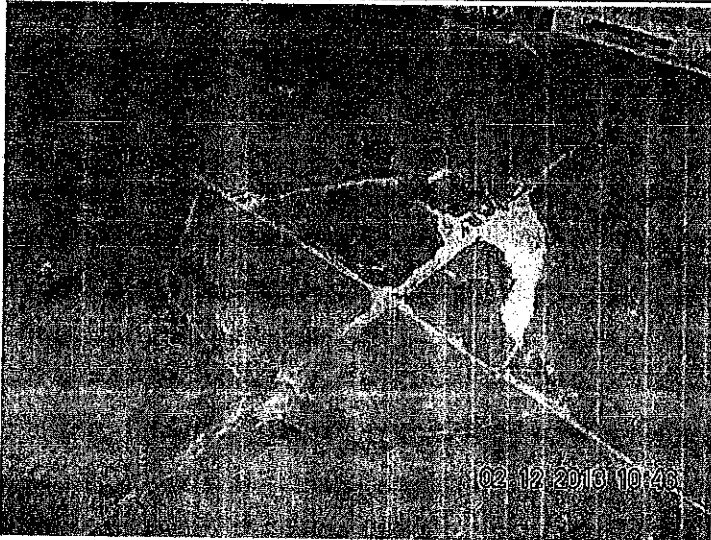
Item No: 007	Sample No: AC000070

Location: Ground Floor, Main storage area, adhesive residue	
Material type: Bitumen	Asbestos Type: No asbestos detected

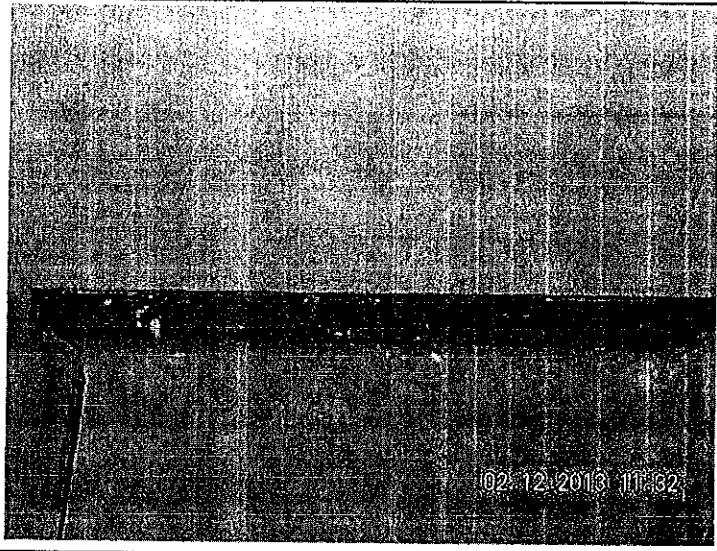
<b>Item No:</b> 016	<b>Sample No:</b> AC000072 Strongly Presumed As AC000072

<b>Location:</b> Ground Floor, Dispatch bay, damp proof course	
<b>Material type:</b> Bitumen	<b>Asbestos Type:</b> No asbestos detected

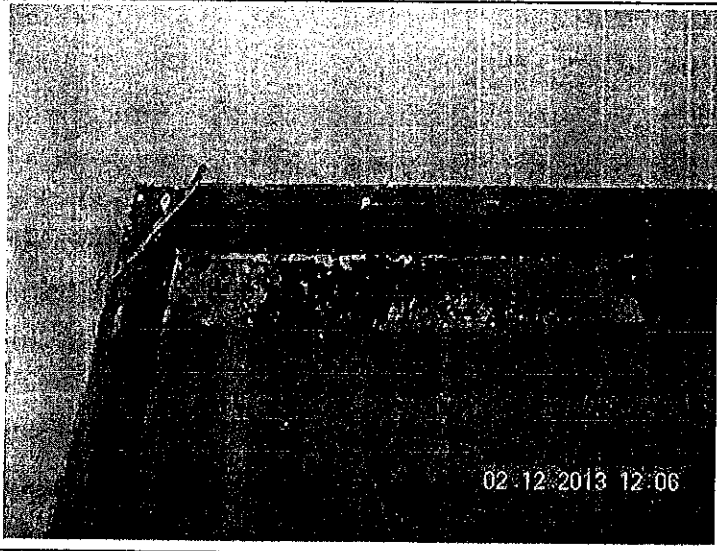
<b>Item No:</b> 021	<b>Sample No:</b> AC000074

<b>Location:</b> Ground Floor, Office 1, adhesive	
<b>Material type:</b> Bitumen	<b>Asbestos Type:</b> No asbestos detected

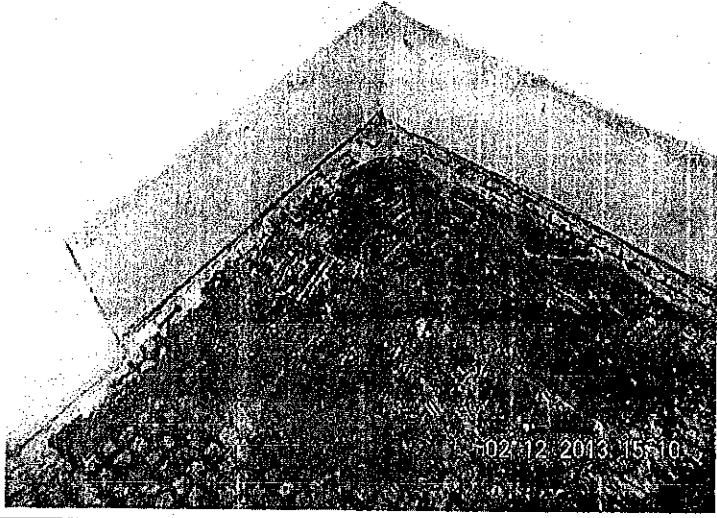
Item No: 041	Sample No: AC000074 Strongly Presumed As AC000074

Location: Ground Floor, Lobby, adhesive	
Material type: Bitumen	Asbestos Type: No asbestos detected

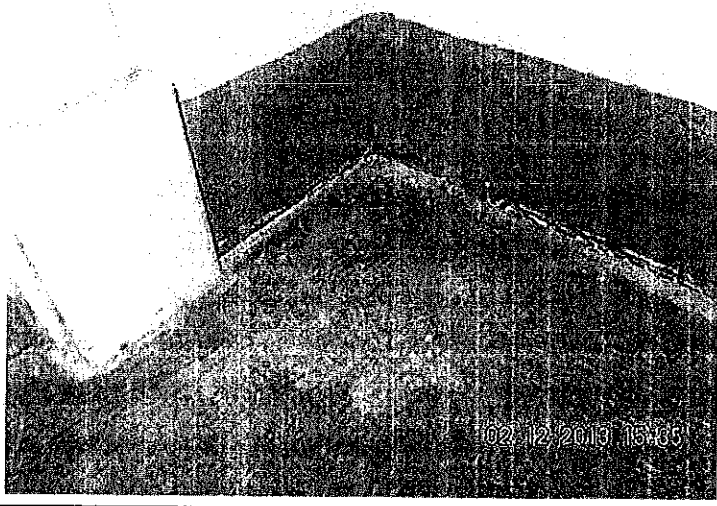
Item No: 043	Sample No: AC000074 Strongly Presumed As AC000074

Location: Ground Floor, Store 3, adhesive	
Material type: Bitumen	Asbestos Type: No asbestos detected

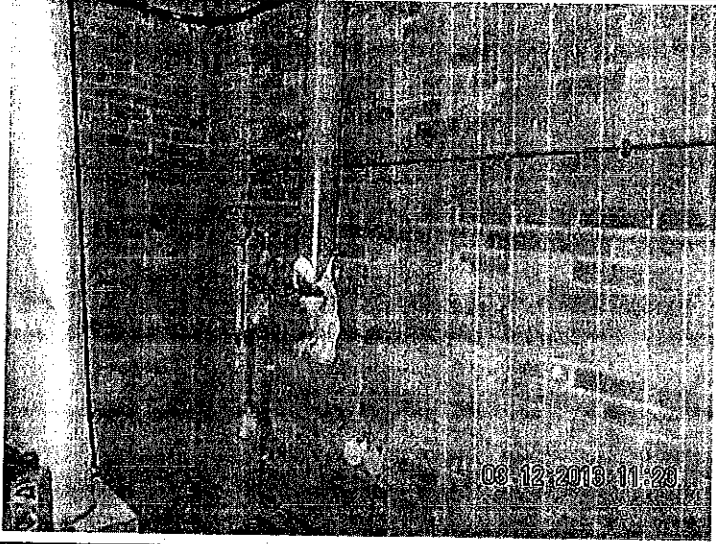
Item No: 065	Sample No: AC000083

Location: Ground Floor, Boiler room, gaskets	
Material type: Gasket	Asbestos Type: No asbestos detected

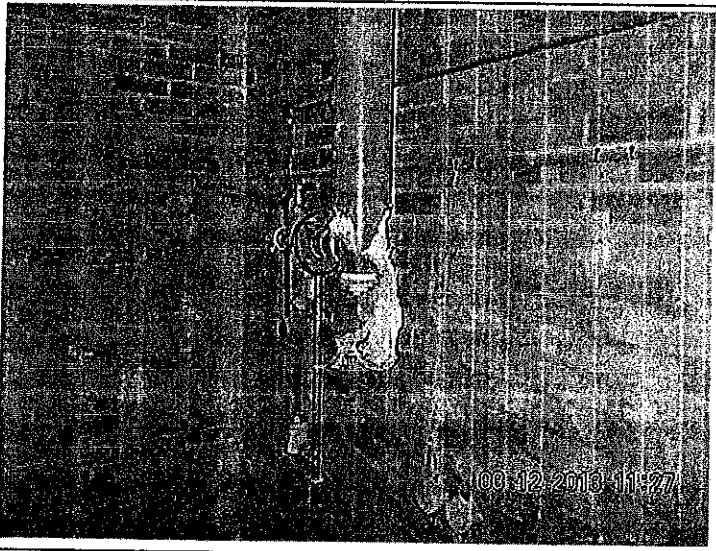
Item No: 066	Sample No: AC000084

Location: Ground Floor, Boiler room, Insulation	
Material type: Friable Insulation	Asbestos Type: No asbestos detected

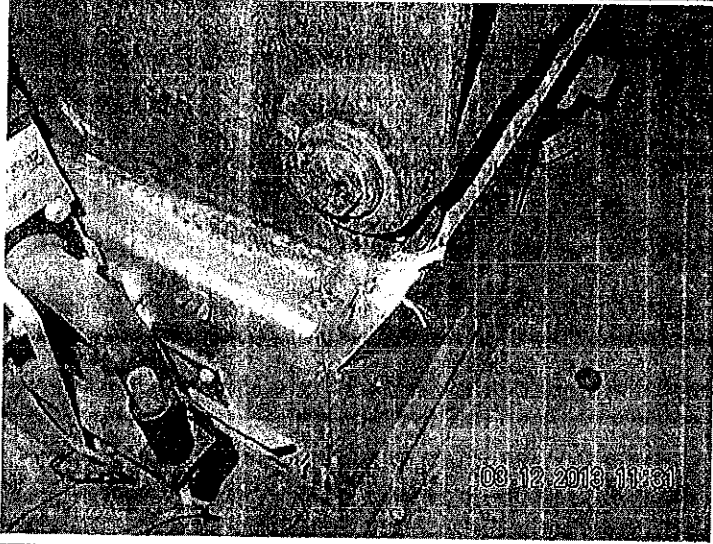
<b>Item No:</b> 067	<b>Sample No:</b> AC000085

<b>Location:</b> Ground Floor, Boiler room, seal	
<b>Material type:</b> Textile	<b>Asbestos Type:</b> No asbestos detected

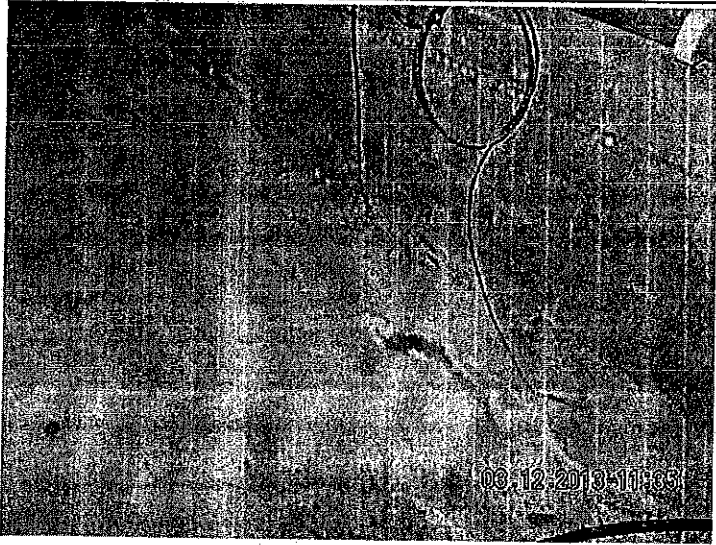
<b>Item No:</b> 068	<b>Sample No:</b> AC000086

<b>Location:</b> Ground Floor, Boiler room, debris	
<b>Material type:</b> Friable Insulation	<b>Asbestos Type:</b> No asbestos detected

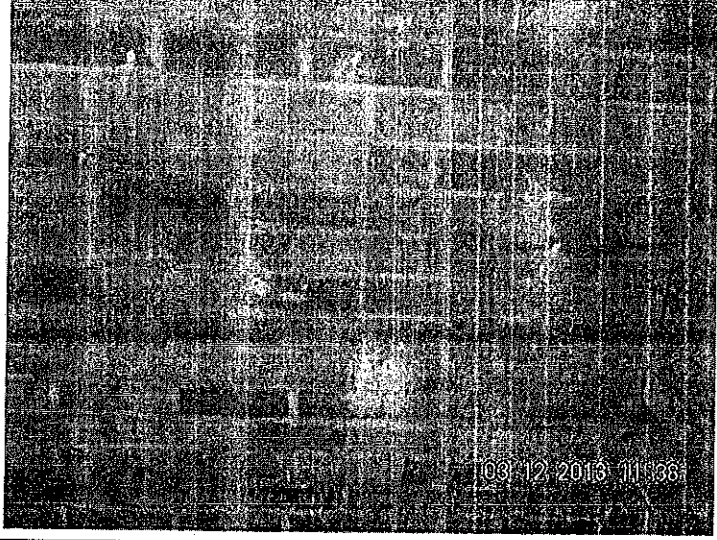
<b>Item No:</b> 069	<b>Sample No:</b> AC000087

<b>Location:</b> Ground Floor, Boiler room, debris	
<b>Material type:</b> Friable Insulation	<b>Asbestos Type:</b> No asbestos detected

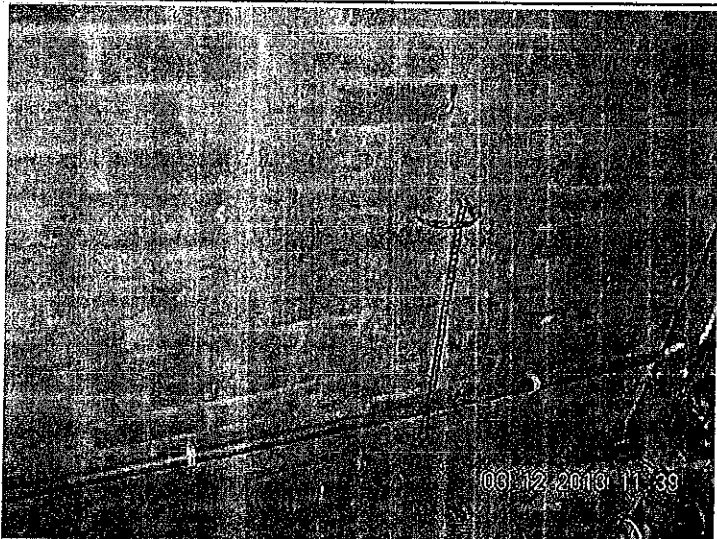
<b>Item No:</b> 070	<b>Sample No:</b> AC000088

<b>Location:</b> Ground Floor, Boiler room, debris	
<b>Material type:</b> Friable Insulation	<b>Asbestos Type:</b> No asbestos detected

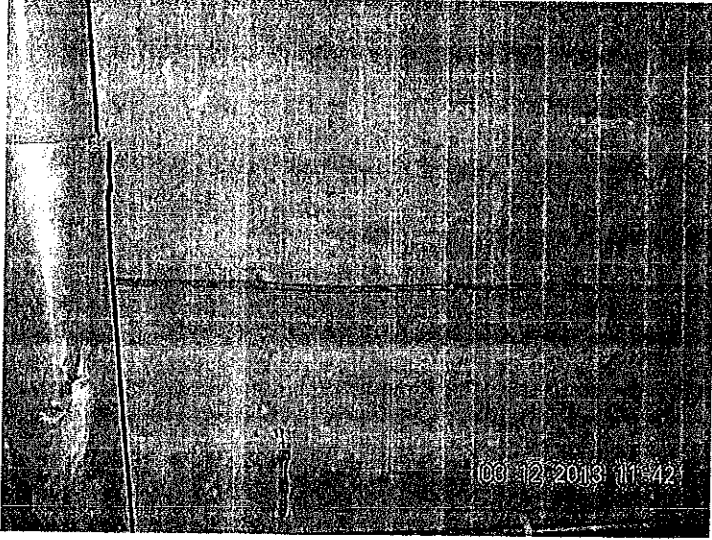
<b>Item No:</b> 071	<b>Sample No:</b> AC000089

<b>Location:</b> Ground Floor, Boiler room, debris	
<b>Material type:</b> Friable Insulation	<b>Asbestos Type:</b> No asbestos detected
