# Asbestos Management Survey Report

Concord International Limited (Cymru)  
Polo Grounds Industrial Estate, New Inn, Pontypool, Torfaen, NP4 0TW

**Site Address:**  
Polo Grounds Industrial Estate, New Inn, Pontypool, Torfaen  
NP4 0TW

**Survey Report Number:**  
J000448

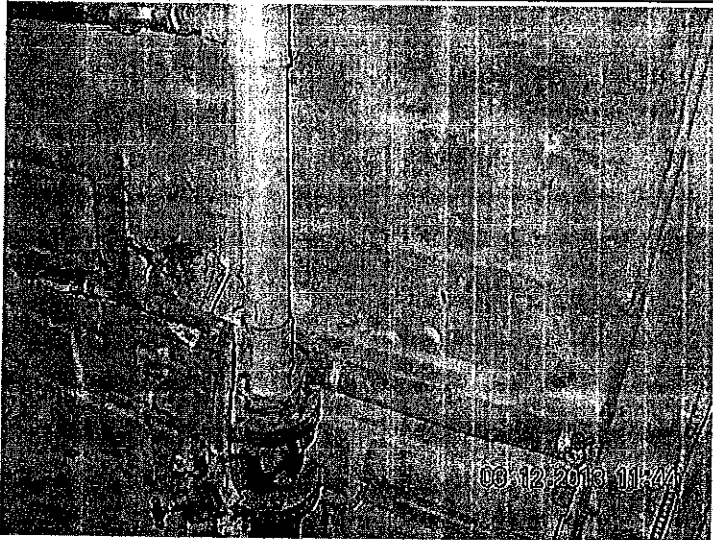
<b>Item No:</b> 072	<b>Sample No:</b> AC000090

<b>Location:</b> Ground Floor, Boiler room, debris	
<b>Material type:</b> Friable Insulation	<b>Asbestos Type:</b> No asbestos detected
