Management survey for asbestos materials
at:

**34/36 High Street
Seaford
East Sussex
BN25 1PL**

DATE: 27/09/21

REFERENCE: 2021 - 249

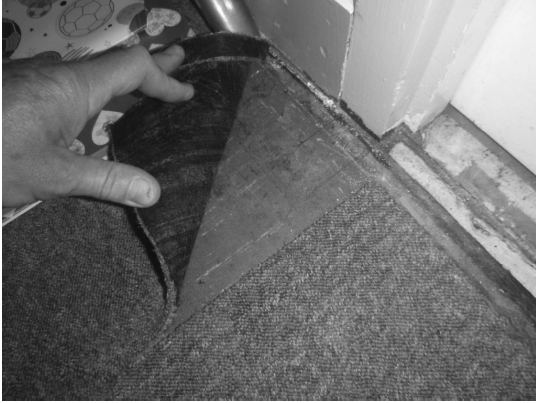
| Floor: Ground floor | Location: Floor (beneath carpet) | Extent: 110 m2 |
| Area: No. 34; Sales floor | Description: Green floor tiles | |

| EOD: | 0. Good condition, no visible damage |

Manage & monitor condition

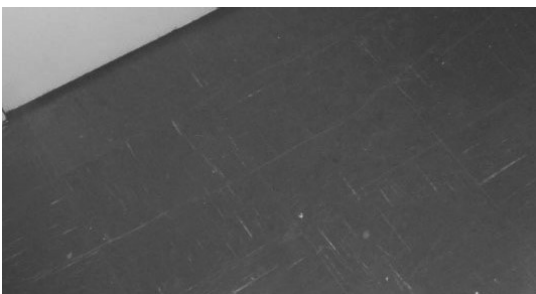
| Floor: Ground floor | Location: Floor | Extent: 25 m2 |
| Area: No. 34; Front stock room | Description: Green floor tiles | |

| EOD: | 0. Good condition, no visible damage |

Manage & monitor condition

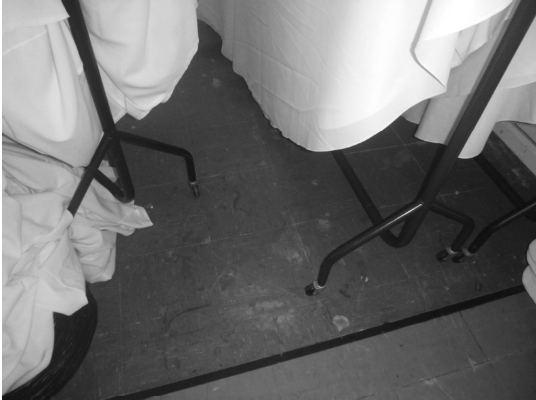
| Floor: Ground floor | Location: Floor | Extent: 15 m2 |
| Area: No. 34; Rear stock room | Description: Green floor tiles | |

| EOD: | 0. Good condition, no visible damage |

Manage & monitor condition

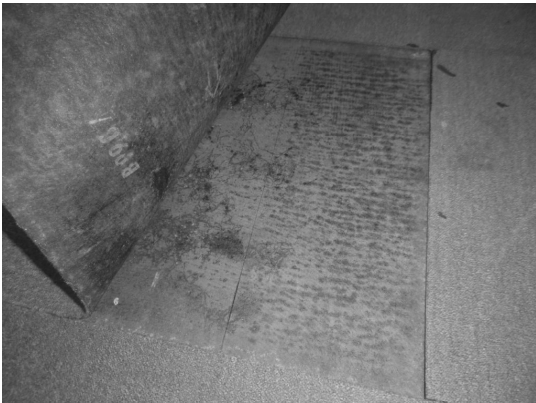
| Floor: Ground floor | Location: Floor (beneath carpet) | Extent: 170 m2 |
| Area: No. 36; Sales floor | Description: Green floor tiles | |

| EOD: | 0. Good condition, no visible damage |

Manage & monitor condition

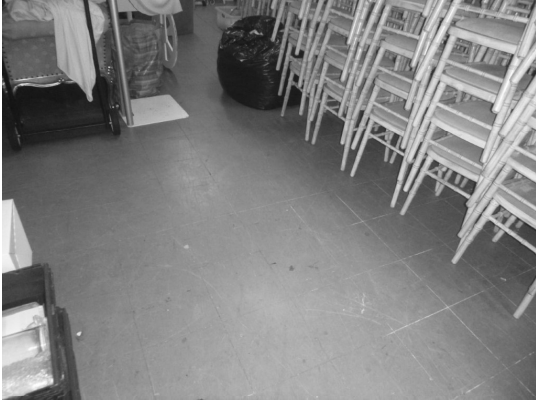
| Floor: | Ground floor | Location: | Floor | Extent: | 60 | m2 |
| Area: | No. 36; Rear stock room | Description: | Brown floor tiles & adhesive | | | |

No asbestos detected

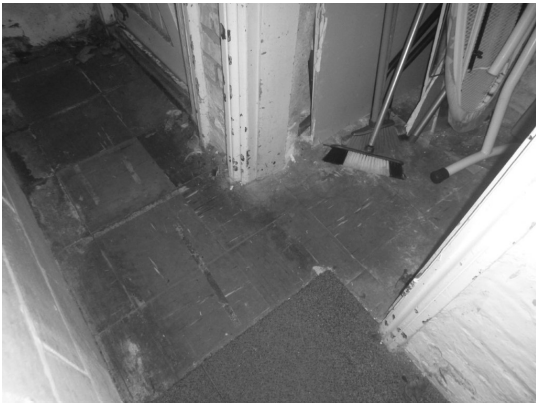
| Floor: | Ground floor | Location: | Floor | Extent: | 10 | m2 |
| Area: | No. 36; toilet & lobby/cpds. | Description: | Grey floor tiles & adhesive | | | |

No asbestos detected

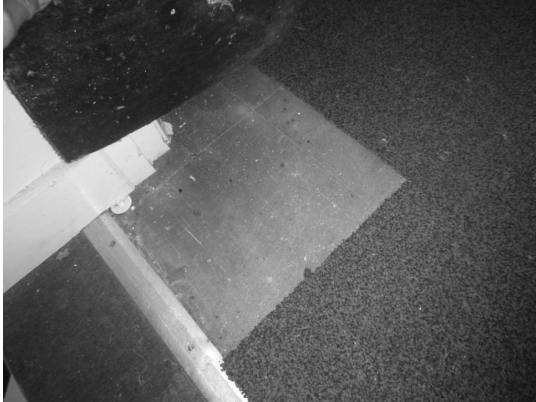
| Floor: Ground floor | Location: Floor (beneath carpet) | Extent: 20 m2 |
| Area: No. 36; kitchen & corridor | Description: Green floor tiles | |

| EOD: | 0. Good condition, no visible damage |

Manage & monitor condition

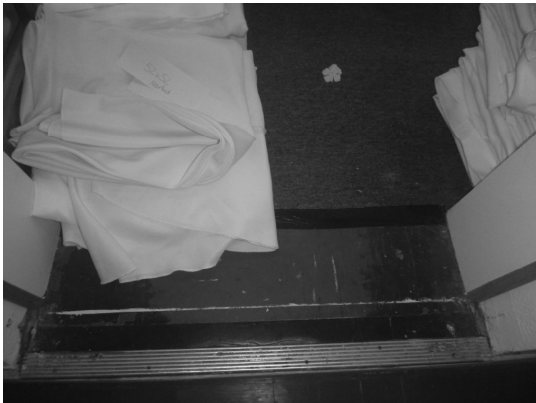
| Floor: Ground floor | Location: Floor (beneath carpet) | Extent: 45 m2 |
| Area: No. 36; stock room (adj. stairs) | Description: Grey floor tiles & adhesive | |

No asbestos detected

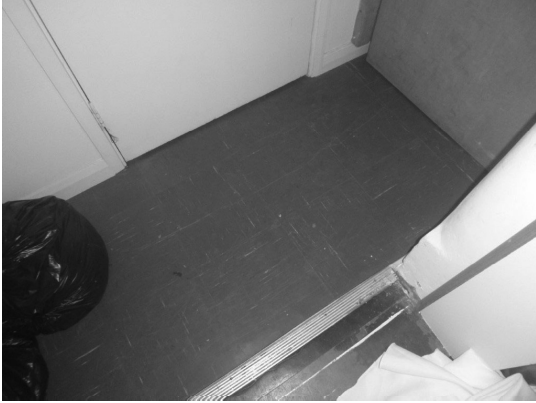
| Area: | No. 36; sales room & lobby to stairs | | | | | |
| Description: | Green floor tiles | | | | | |

| EOD: | 0. Good condition, no visible damage |

Manage & monitor condition
