SWRBD CFRAM Study

Flood Risk Review Report

February 2012
Office of Public Works

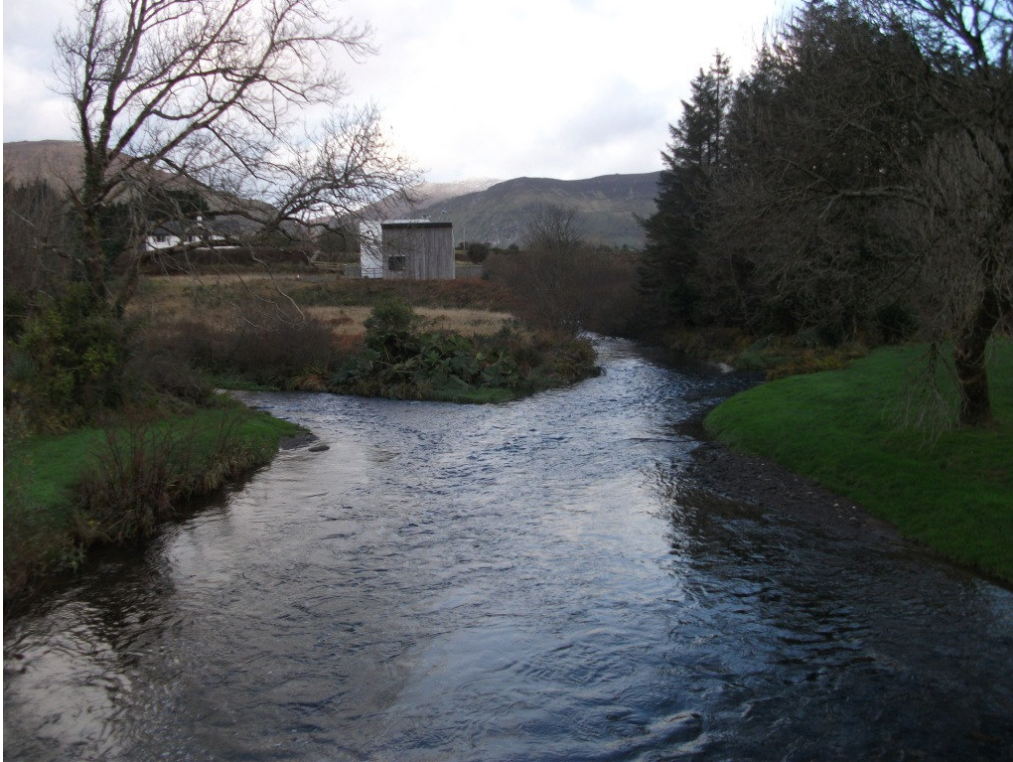
The 10% AEP outline generally matches the 1% and 0.1% AEP outlines used in the PFRA analysis except near the convergence point of the three water courses at the village (north of bridge – see photo below).

Convergence of three water courses upstream of N86 bridge in Anascaul Village

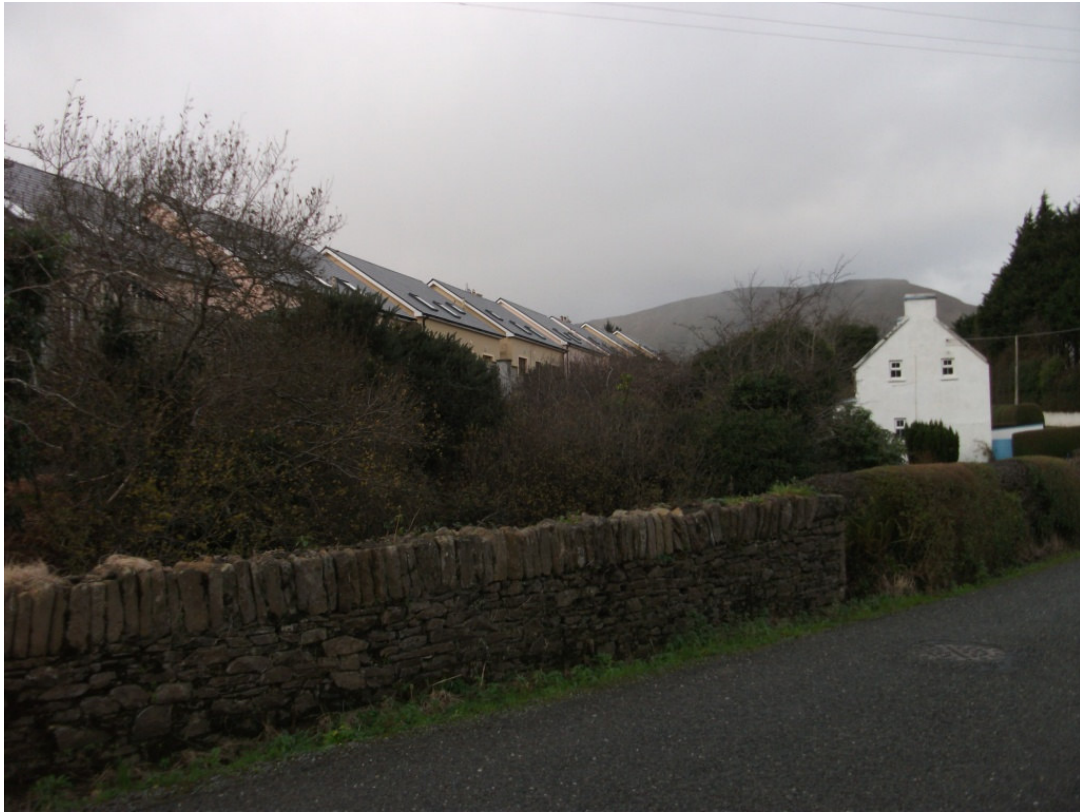
However, from the discussions with locals and the channel cross sections and land levels observed on site, it appears that the PFRA outlines are over estimating the flood risk index. For example, in the photo below, the channel is ~2m below the road level (foreground) yet the new houses (background, higher level) were indicated as a flood risk.

New houses outside predicted flood lines (taken near Annagap Bridge)

Through comparison of the PFRA flood lines with the topography observed on site, the outlines were modified to show a more likely flood extent as indicated on the attached map.

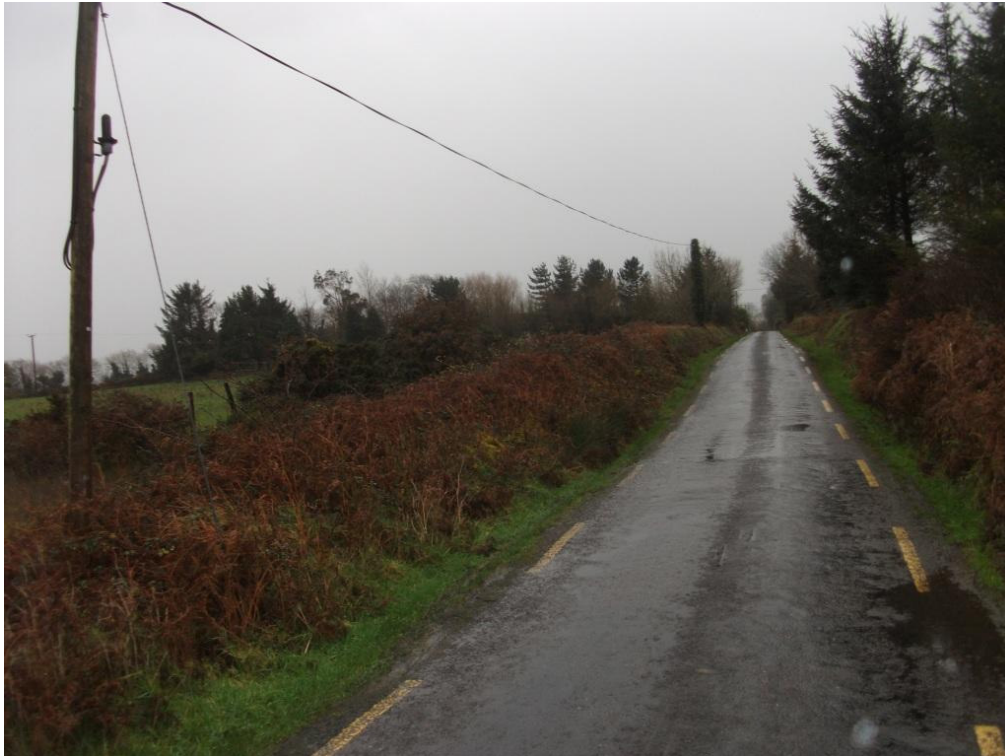
Example of land rising between water course locations indicating inaccurate wedge in model.

Through comparison of the PFRA flood extent outlines lines with the topography observed on site, the outlines were modified to show a more likely flood extent as indicated on the attached map.

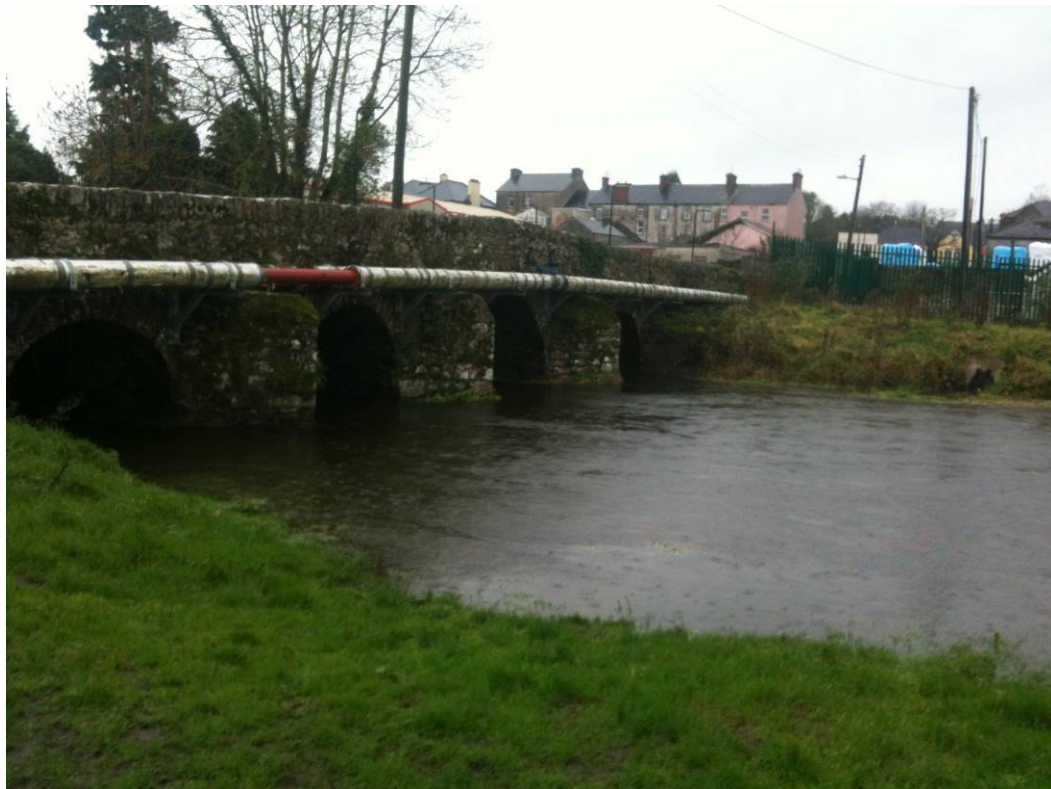
Pipe outlets with non-return flaps were noted at the Buttevant Oldbridge.

Four eyed Buttevant Oldbridge with Non-return outlet flap at east side

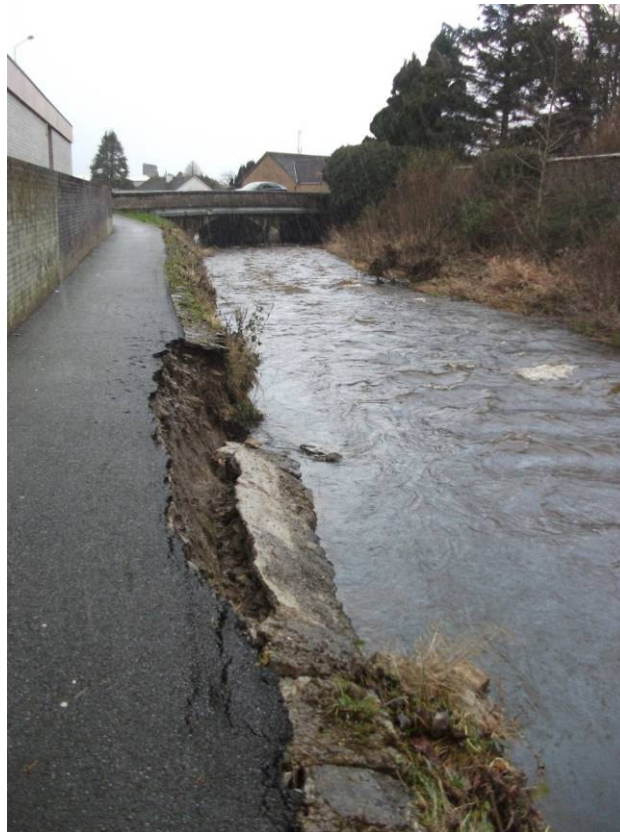
Flows at bank level and slightly above were reported for the channel section near the fire station (this is still below road level on Church Street/R577) and the man was also of the opinion that the nearby schools were not affected. He also advised that recent high flows (a week previous) had cause a section of the river walking path to collapse as shown in the below photograph:

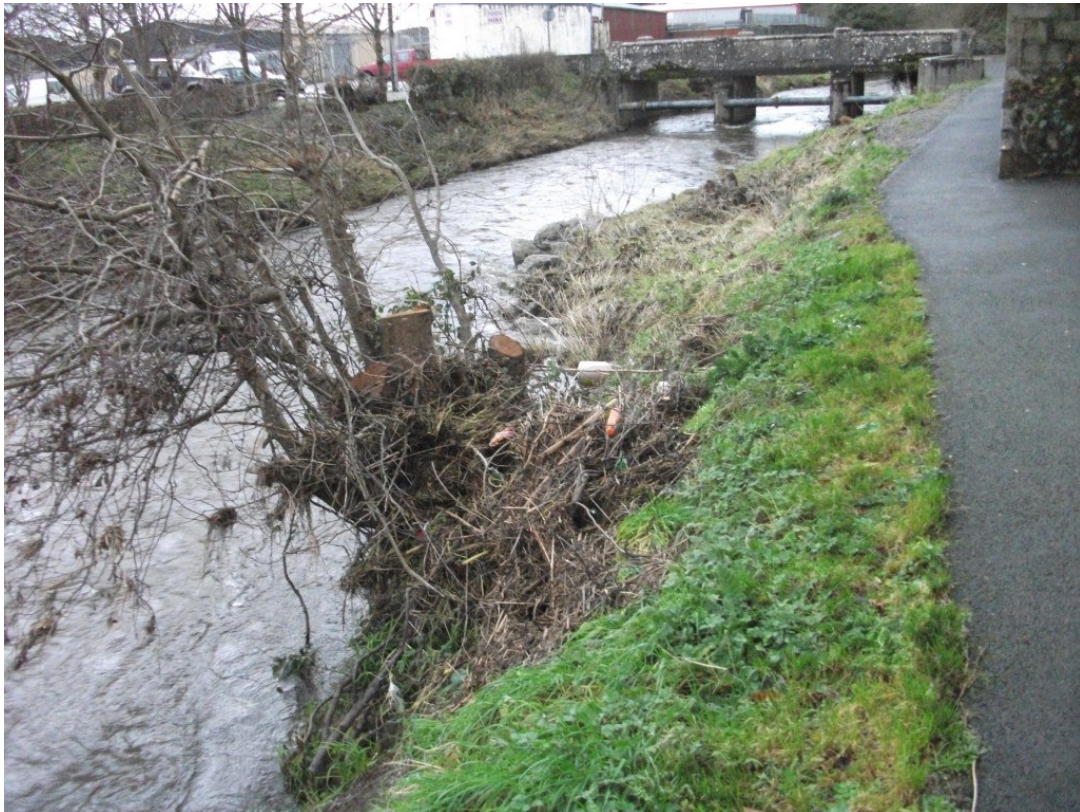
In some locations masonry walls act as flood defences although this may be unintentional.

High water debris on banks of River Maine in town

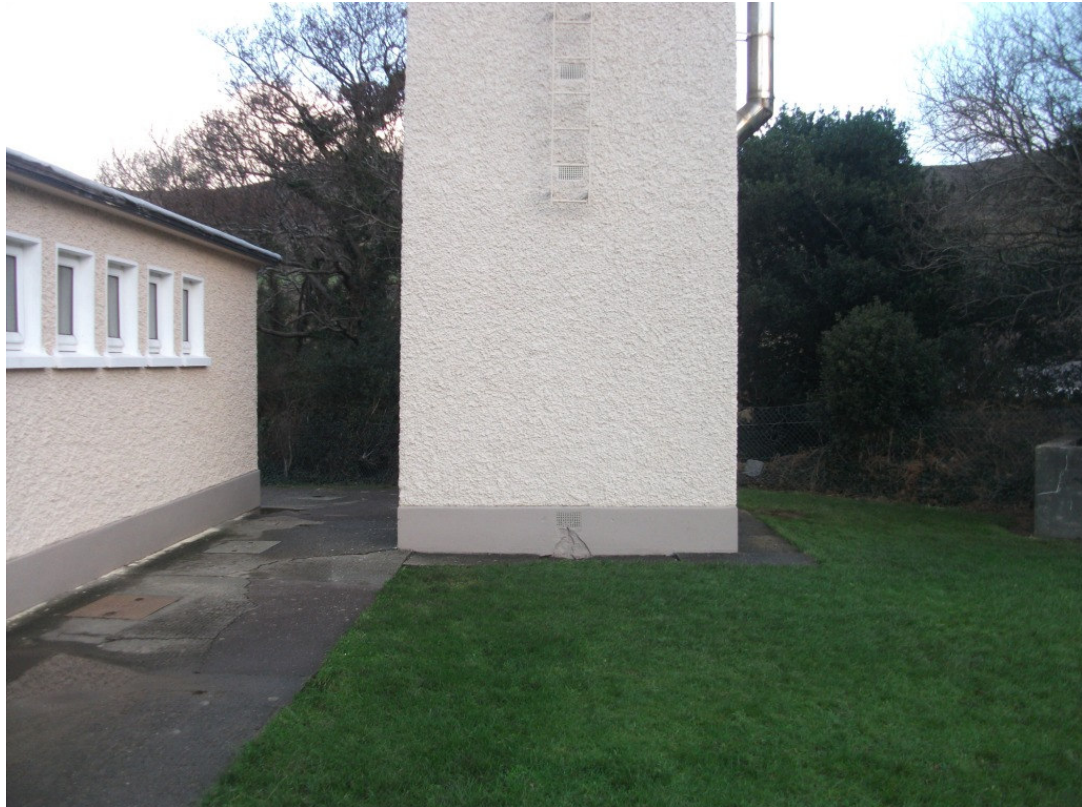
**Location of flow past school buildings
(looking downhill towards main road)**

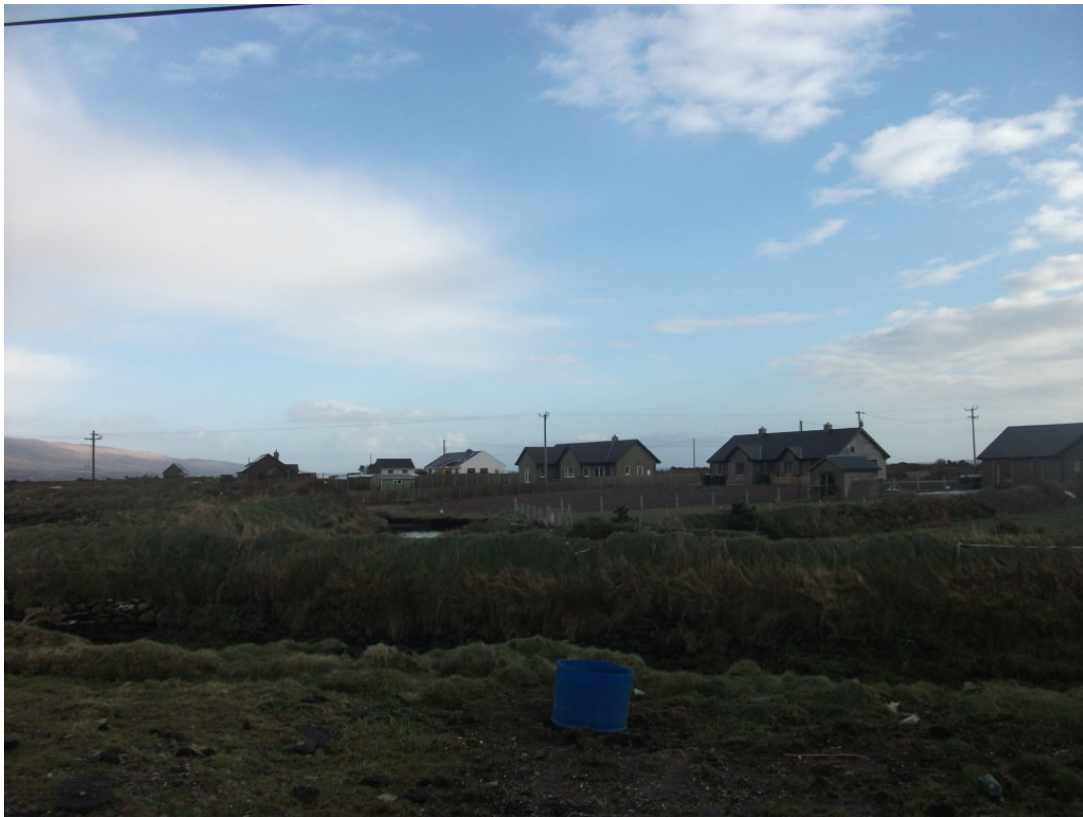
the embankments came close to flooding (water entered garden – see photo below) a number of years ago when a section of embankment collapsed. This section has since been repaired.

Embankments near properties at risk

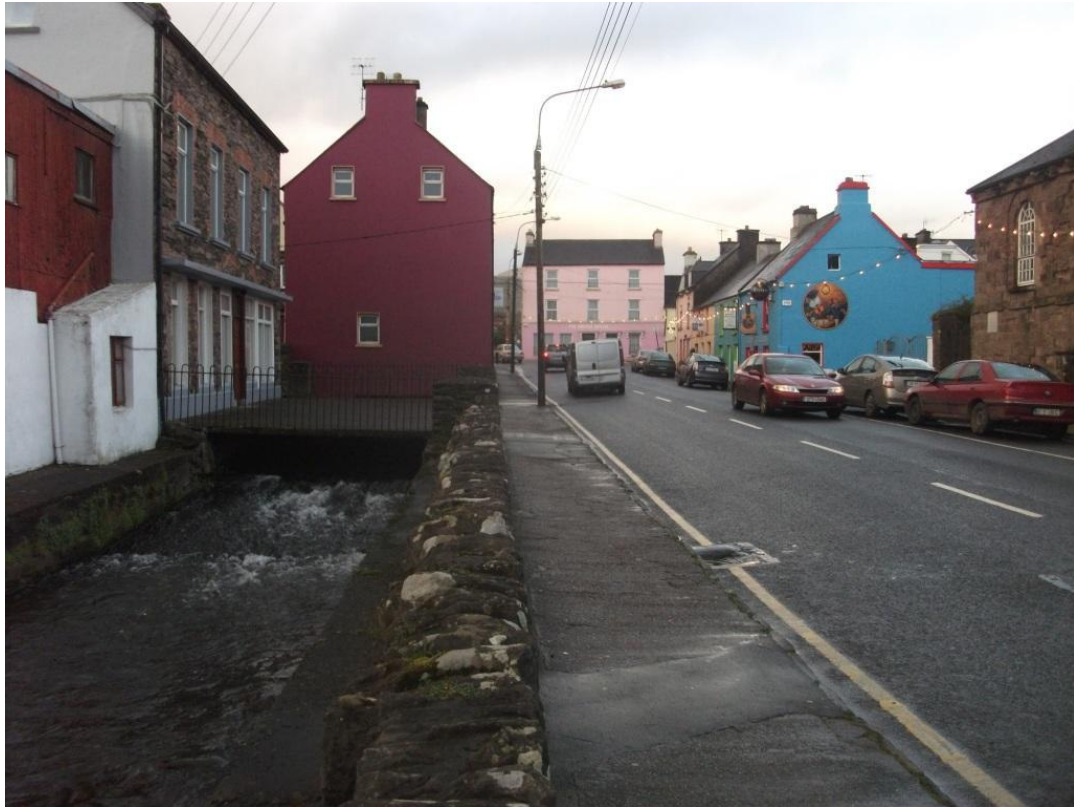
For both sources of flooding it should be noted that the outlines are likely to vary significantly due to aspects not fully accounted for by the PFRA model e.g. gaps in quay defences and walled channels and the likely flow paths through and around these, particularly at The Mall due to the sloped topography.

Building over culverted stream along The Mall in Dingle

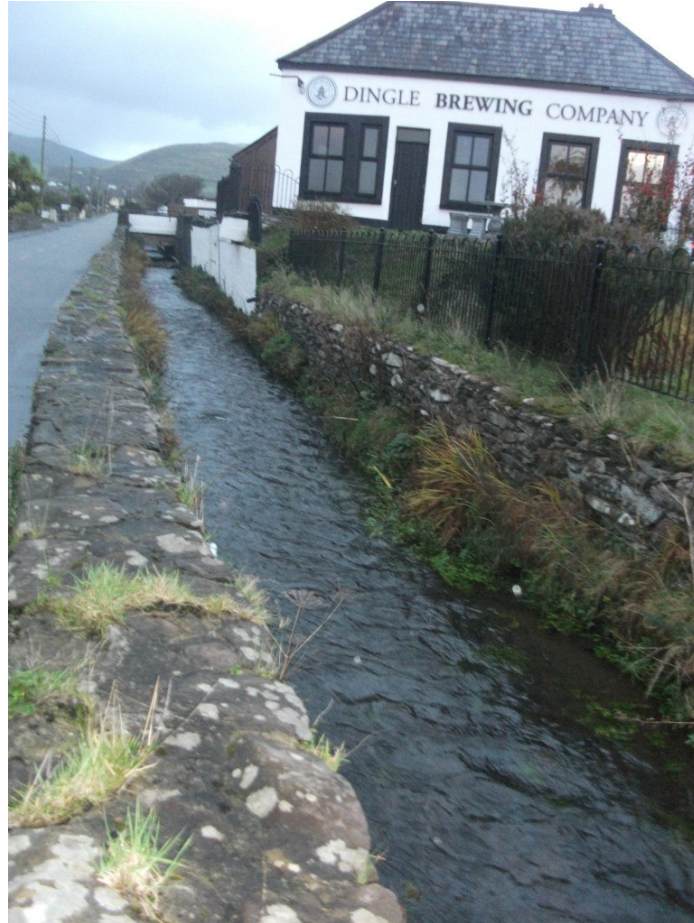
It is estimated that approximately 25 commercial/residential properties could be removed from the FRI score due to the revised 10% AEP fluvial flood extent outline.

Example of building excluded from flood risk boundary due to elevation

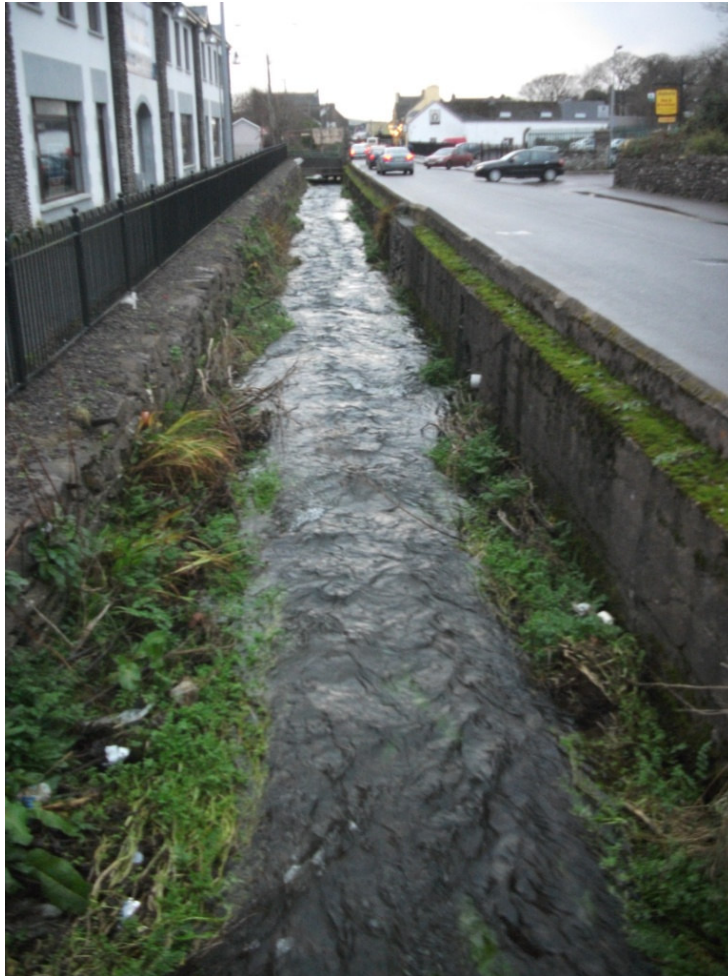
However, there are a number of new commercial and residential properties which may need to be added. Minor differences between mapped buildings and those observed on site mean it is sometimes unclear if all have been accounted for.

Example of new buildings (LHS) adjacent to water course

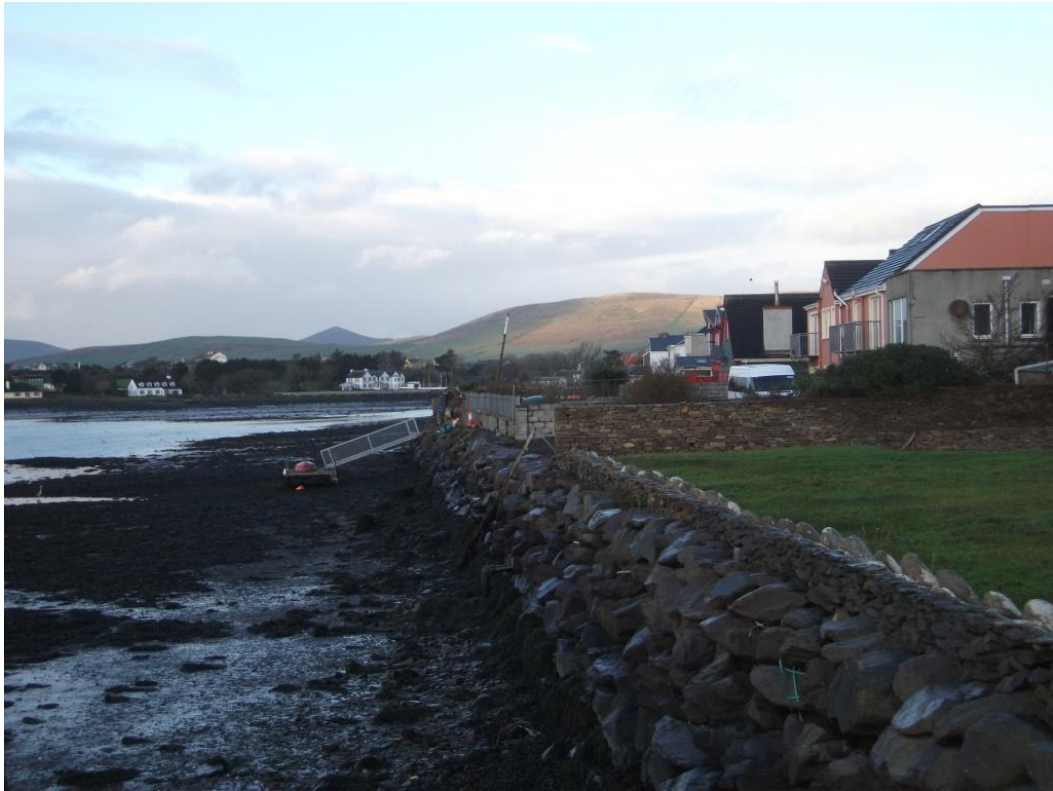
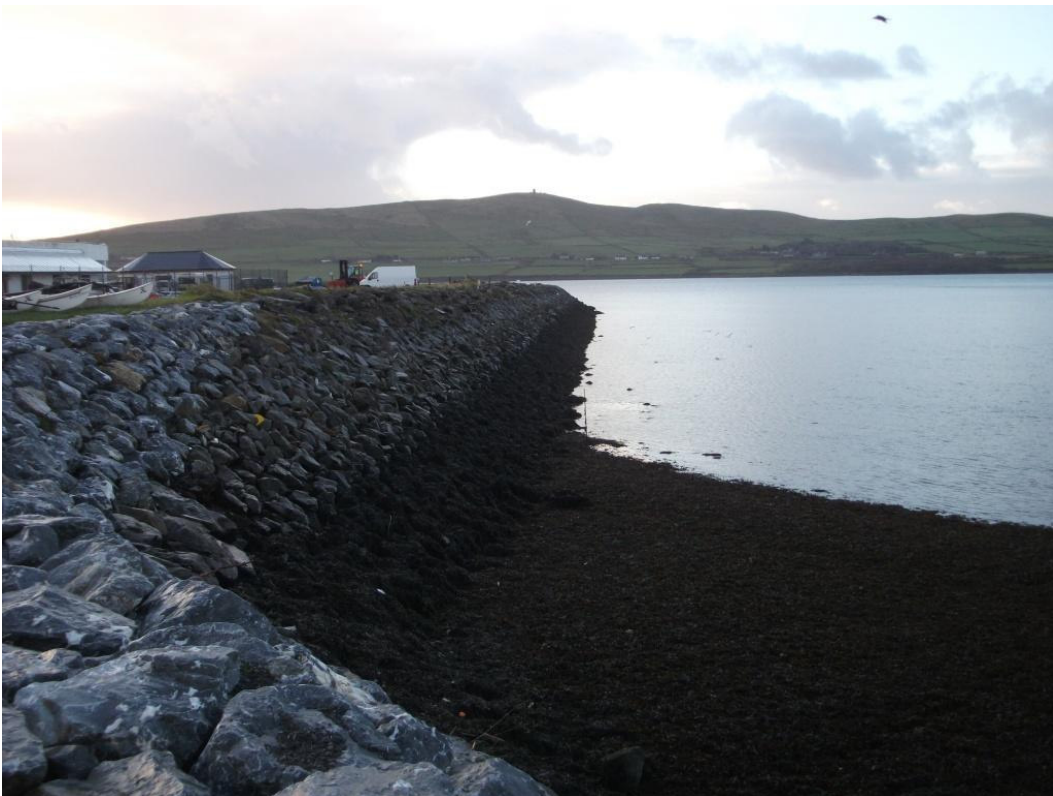
No evidence of flooding noted. High water marks are evident for much of the quay area as shown on the attached photos but these appear to be indicative of normal high tides as opposed to extreme tide events.

High water marks evident near harbour area

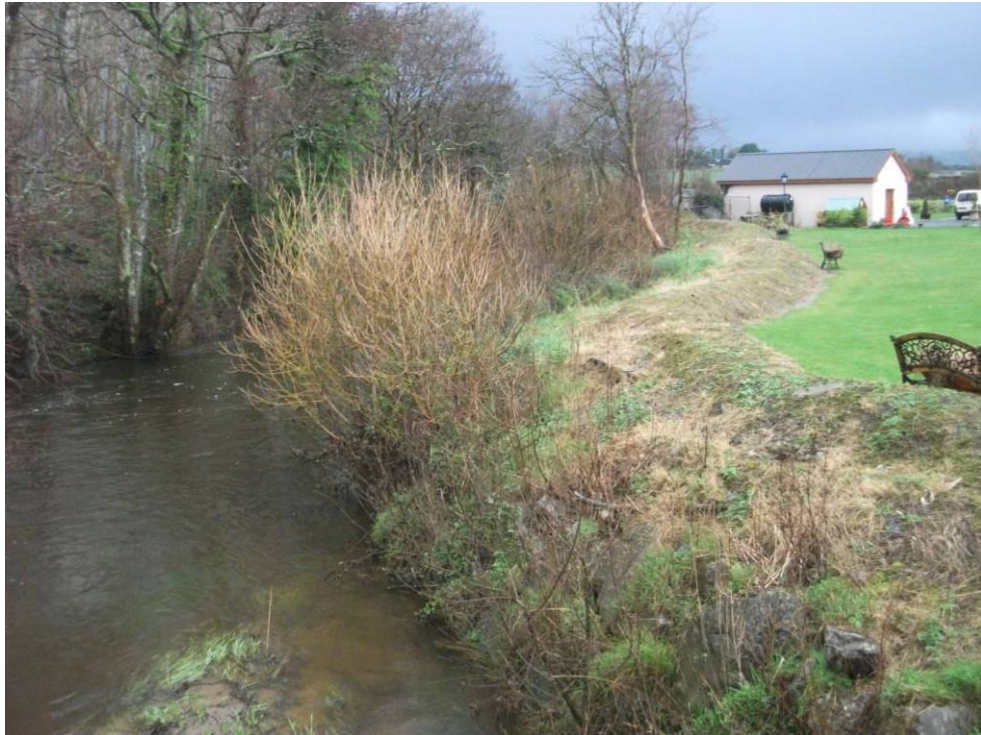
He also mentioned that a neighbour (local farmer whose land also floods) was of the opinion that the problem was due to deposition in the river channel and that that clearance/dredging works were required.

Property affected by flooding at location of meanders in Brown Flesk River

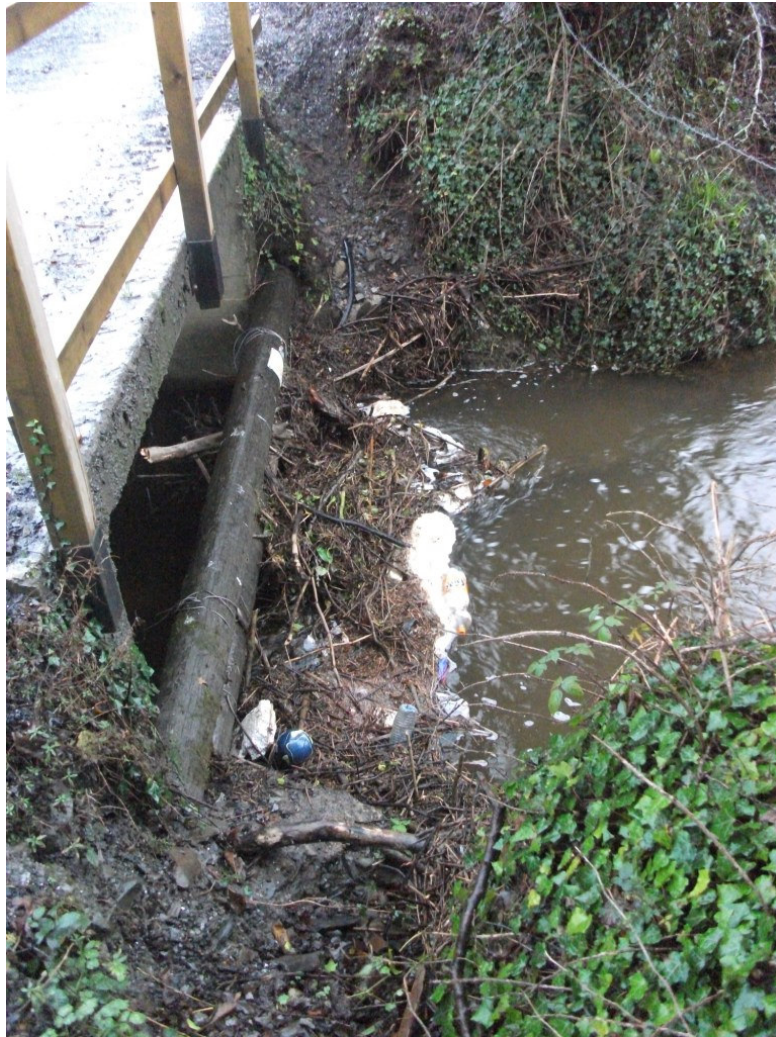
It is worth highlighting that at one location in the western part of the ARR, a blockage was noted at the entrance to residential house (as shown in the photo below). Although flooding is report not to be an issue in this area, it is recommended that maintenance is carried out at this location.

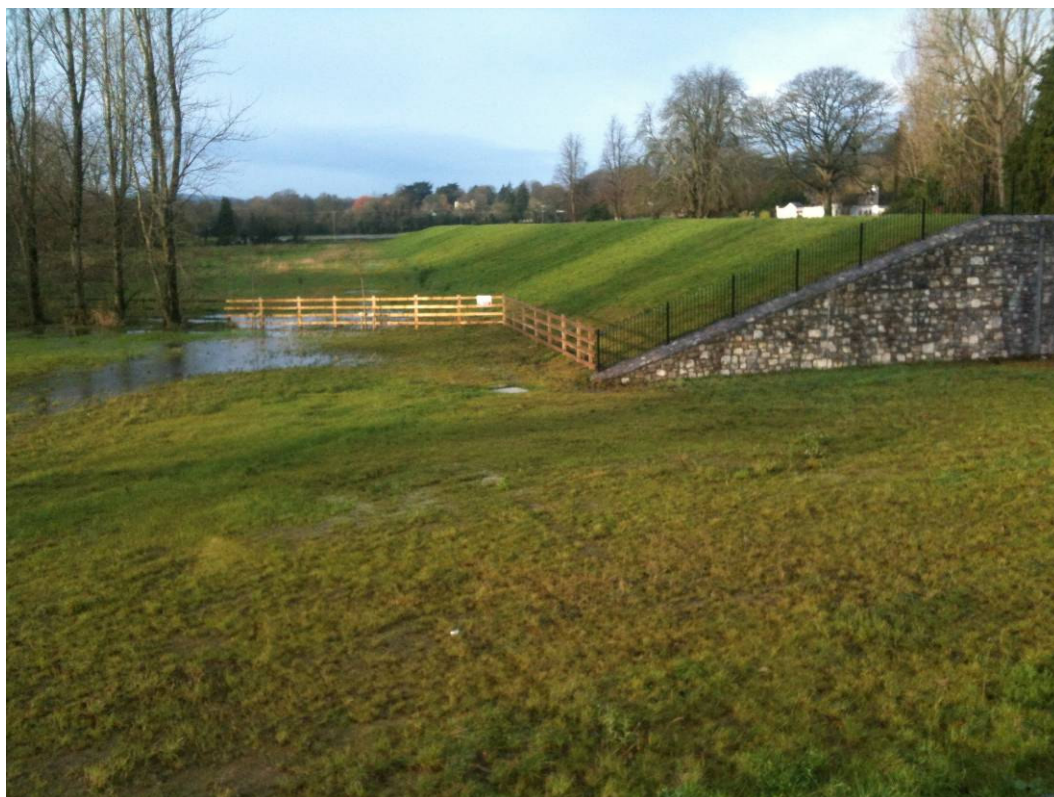
Flood Protection works north of the river west of the bridge

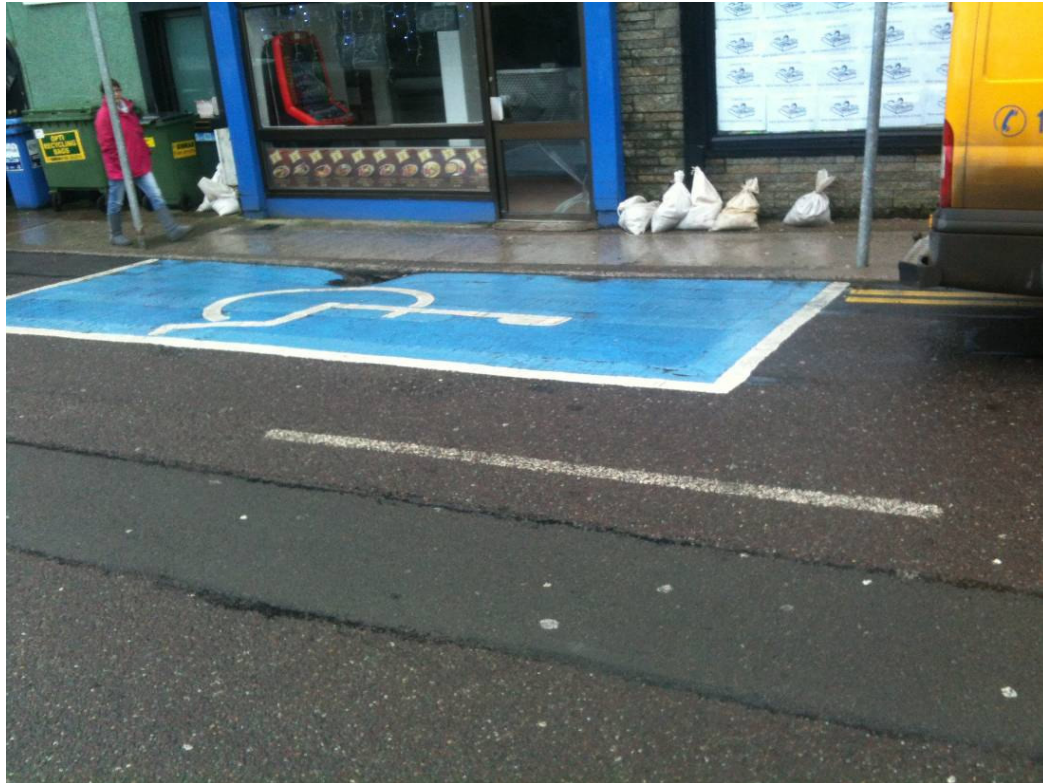
Sand bags were noted outside a commercial property south of the river on O'Neill-Crowley Quay.

Sand bags on O'Neill-Crowley Quay.

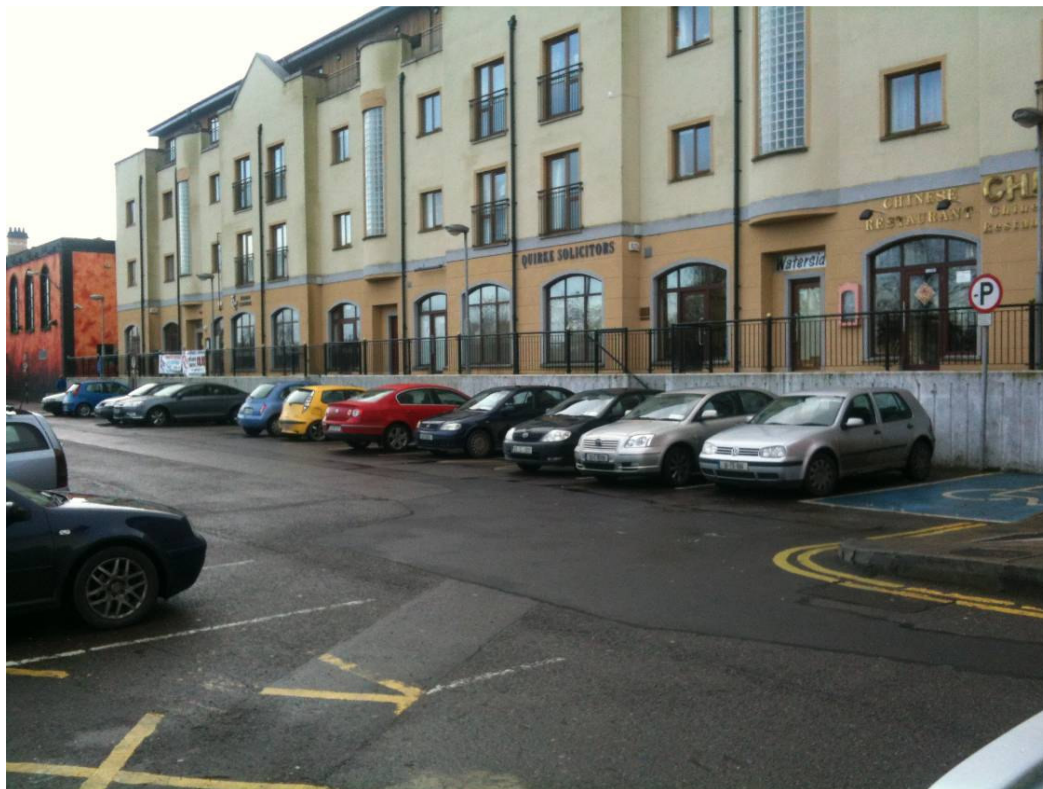
A modern commercial building constructed south of the river on Ashe Quay has raised foundation compared to adjacent buildings.

Raised foundations on Ashe Quay.

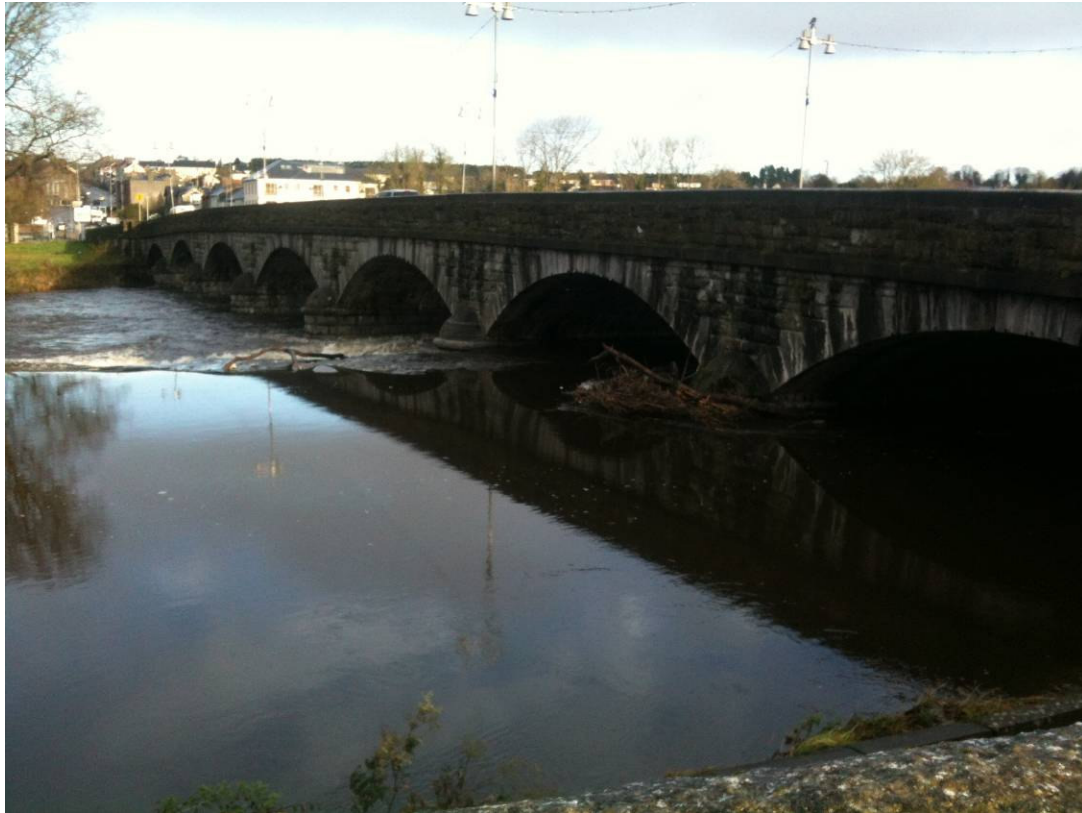
There was debris including a number of tree trunks lodged on the upstream side of the bridge

Debris lodged at the bridge pier

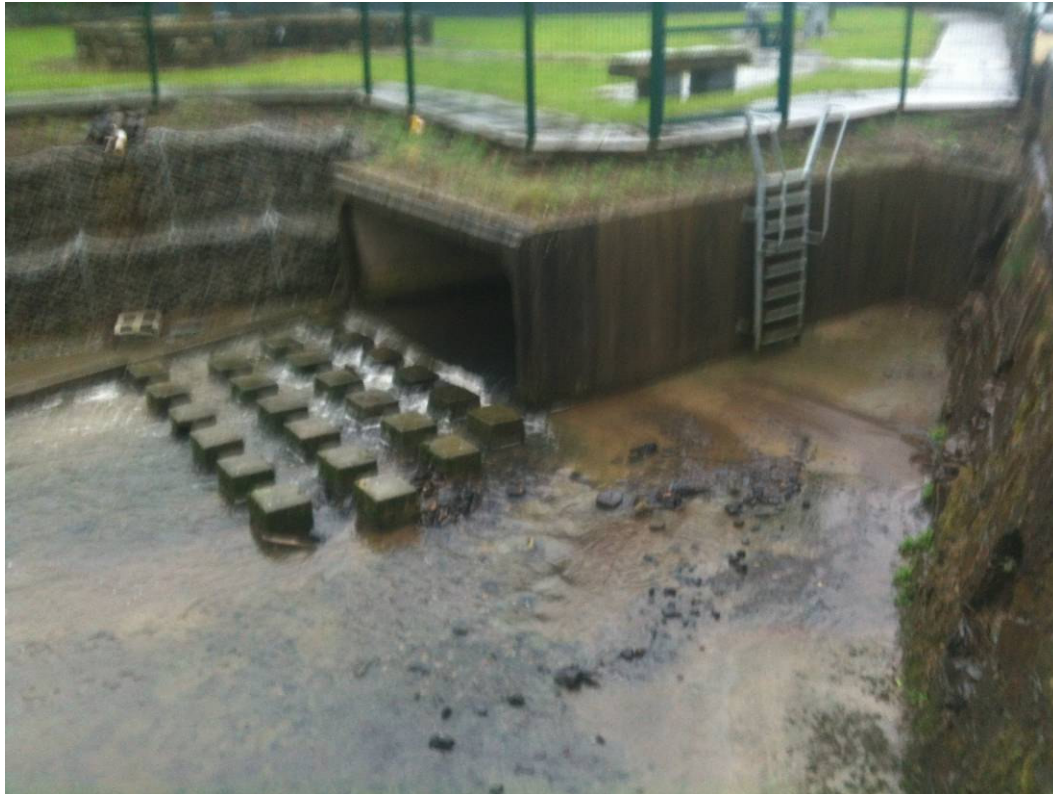
Culverts under the R578 has been replaced and addition capacity has been added to the stream west of the village.

New Culvert under R578 at north side of village. One of the four old culverts is blocked up at the right side

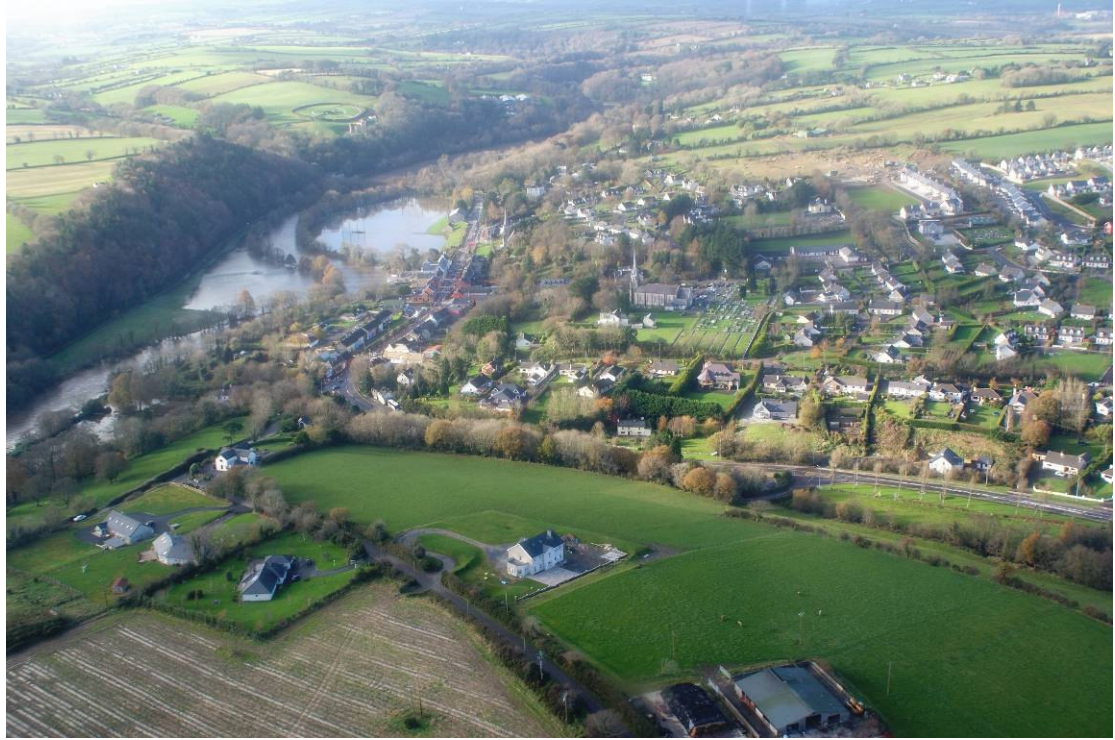
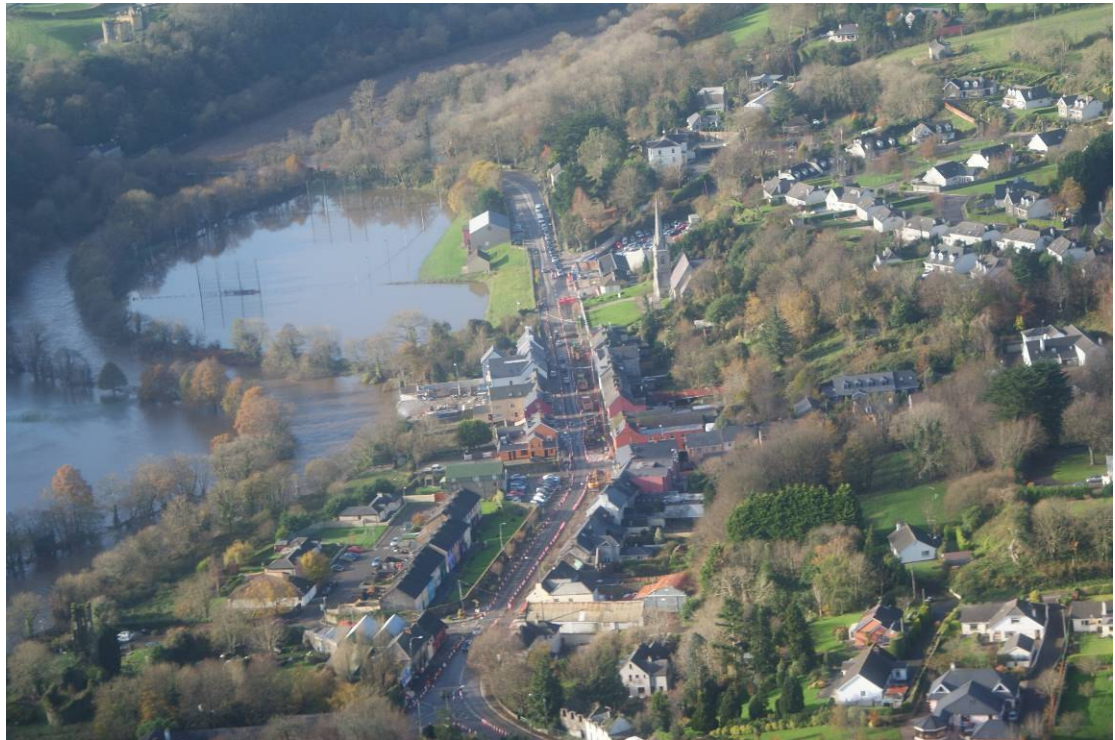
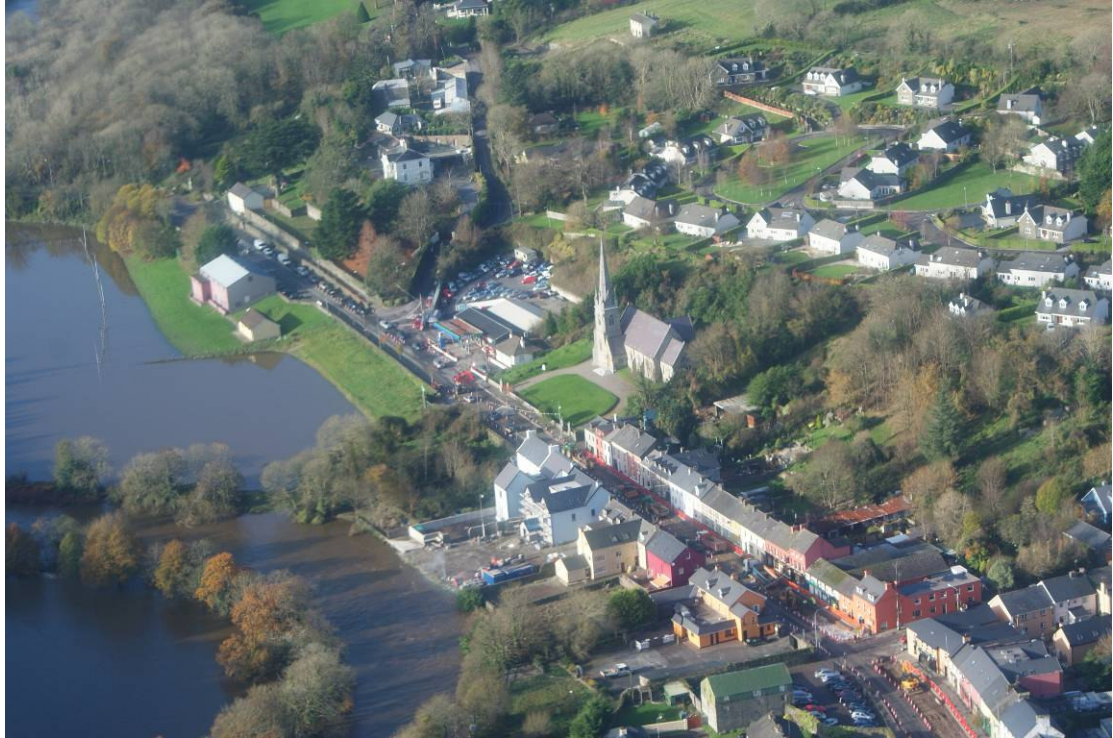
Photographs of flooding in Innishannon during November 2009 provided courtesy of Cork County Council.

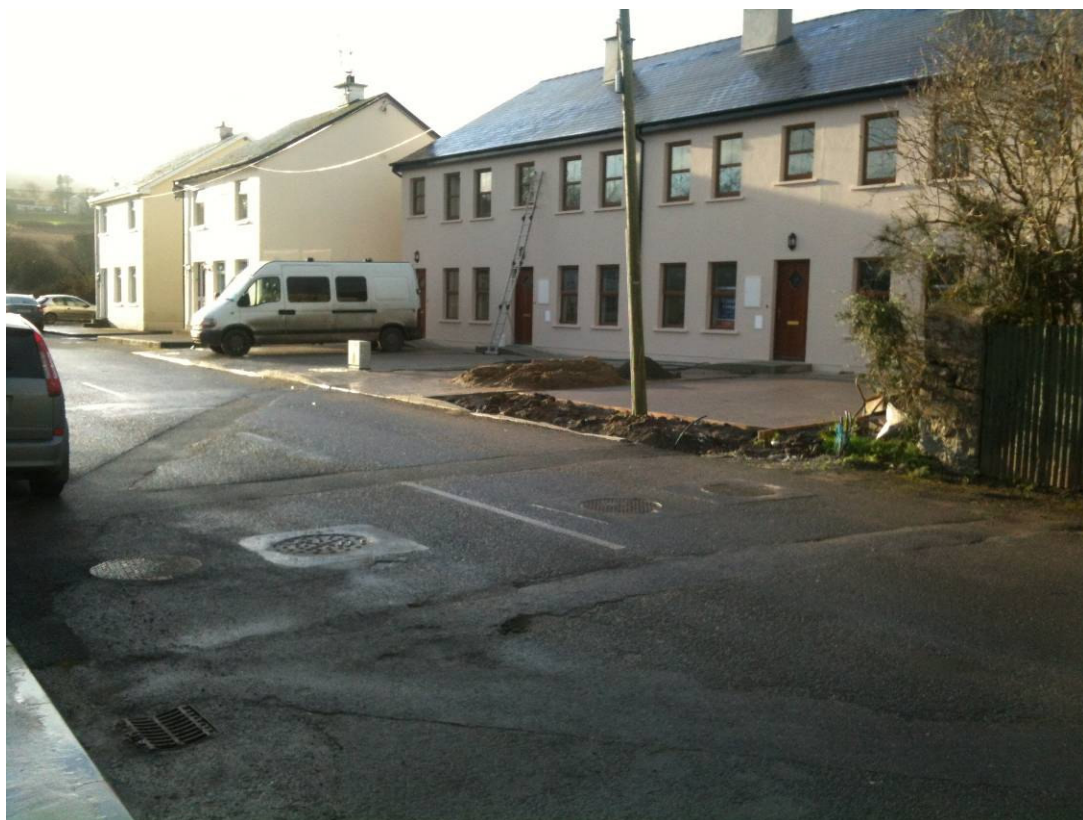
The houses on the lower sections of Ross Street (between Ross Bridge and Main Street) have raised threshold entrances with either 2 steps or ramps lifting the thresholds above footpath level.

Ross Street - four new houses with raised threshold.

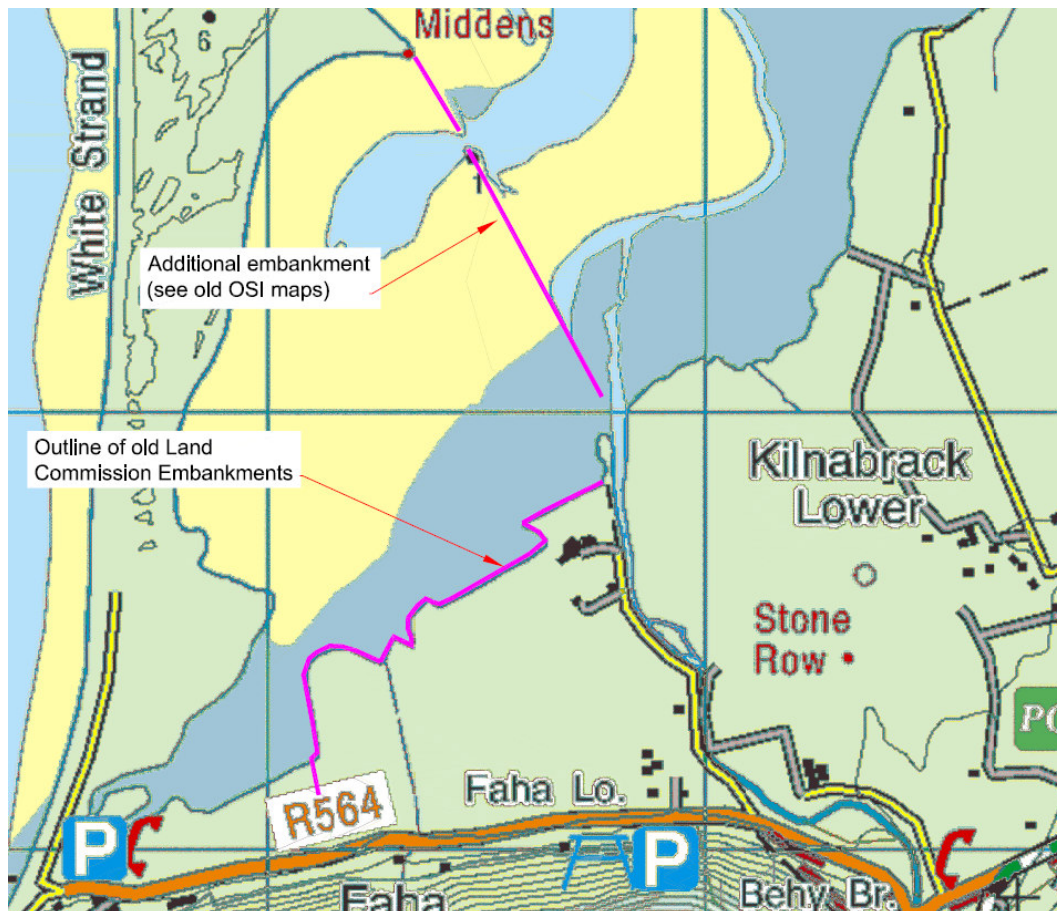
The LA are particularly concerned that the flood defences are no longer anyone's direct responsibility since the Land Commission ceased to operate and as a result, the defences are likely to continue to deteriorate as maintenance is only carried out in a reactive fashion or in some cases, not carried out at all.

Approximate line of Land Commission defence embankment

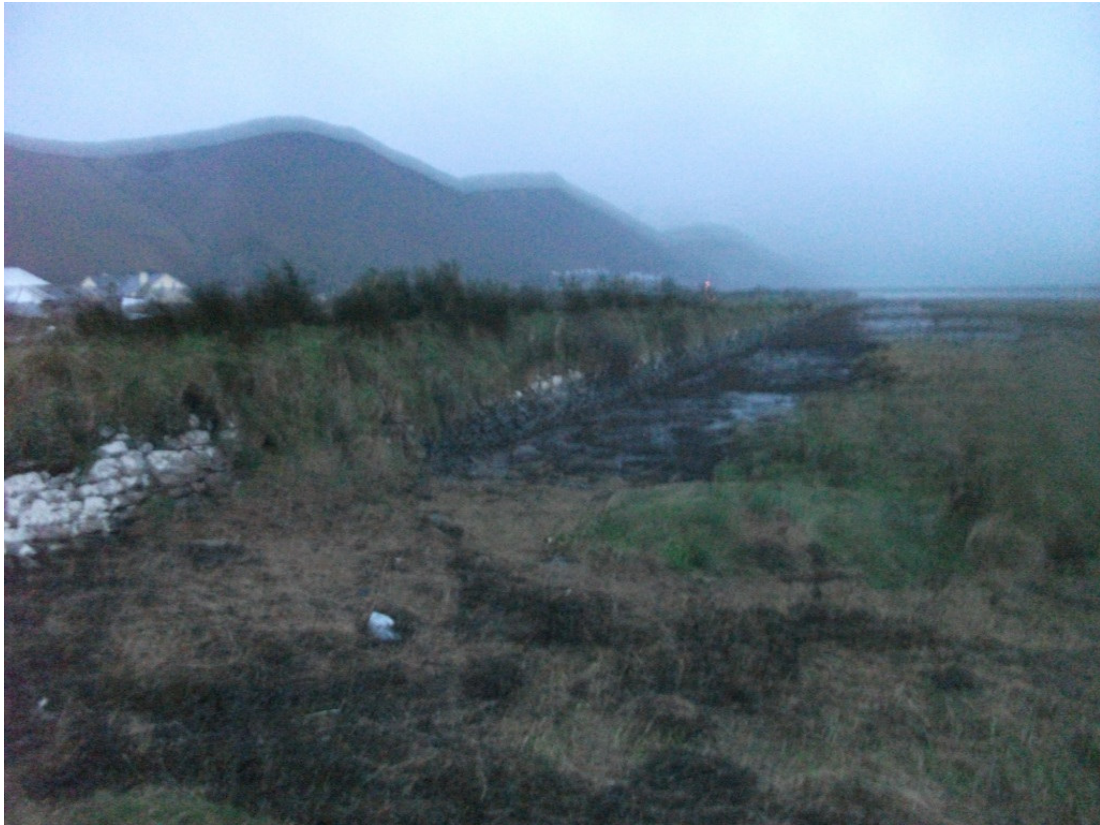
A tidal flood defence embankment near the confluence point of River Behy and the sea was observed and is shown in the photo below:

Land Commission defence embankment (looking south west, towards Faha/Rossbehy from lane adjacent to Behy River)

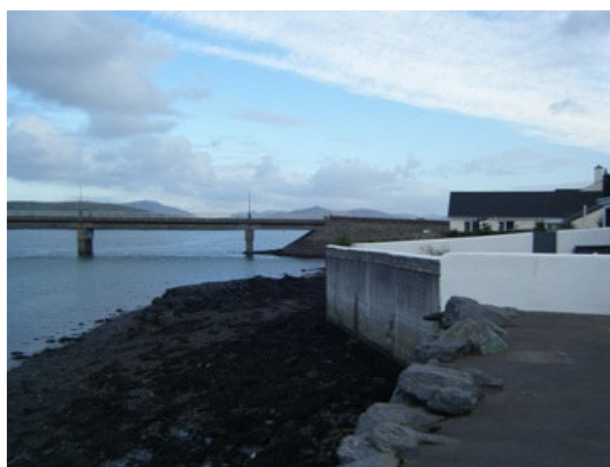
Sea wall back of local shop/post office
