SWRBD CFRAM Study

Flood Risk Review Report

February 2012
Office of Public Works

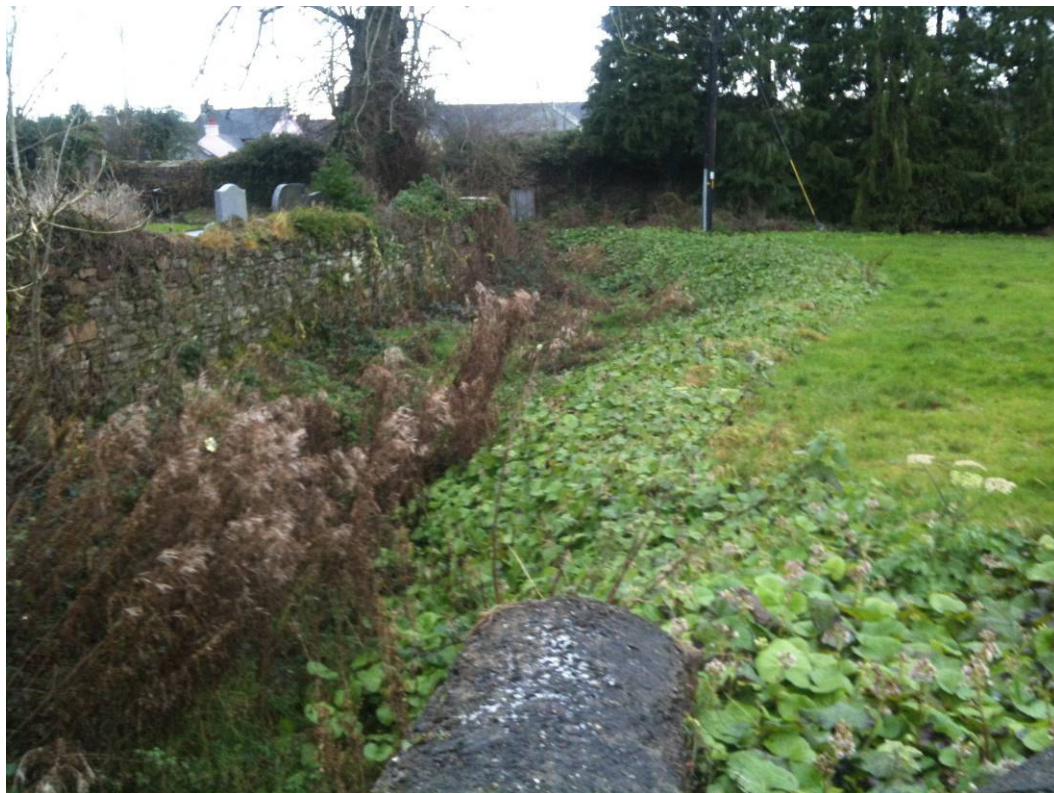
During the site inspection, it was noted that the stream located north side of the Scoil Bhride school appeared to be dry with the main flow diverted south to a stream west of the school. The stream west of the school had a strong flow and appears to be culverted at the Garda Station. The currently dry stream channel north of school passes east through the town in a culvert to the Church of Ireland church, after which it leads to the Shanowen River. Currently the dry stream is choked with vegetation, but may act as an overflow channel. The flood extent outlines have been amended on the maps attached to this Site Inspection Report.

Dry overflow stream channel at Church of Ireland church Rathcormack.
