DAMAGE ASSESSMENT OF CHURCHES IN THE CITY OF CAMERINO AFTER THE 2016 CENTRAL ITALY SEISMIC SEQUENCE

E. Giordano¹, A. Ferrante¹, F. Clementi¹ and S. Lenci¹

¹ Dept. of Civil and Building Engineering, and Architecture, Polytechnic University of Marche, Ancona, Italy
e-mail: {e.giordano,a.ferrante}@pm.univpm.it, {francesco.clementi,lenci}@univpm.it

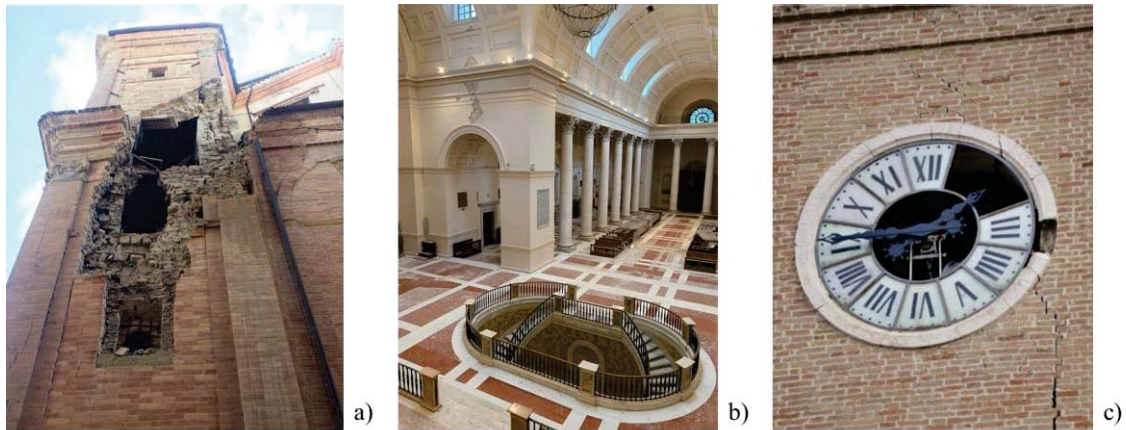
The most damage church is Santa Maria in Via. After the 26th October earthquake, the bell-tower collapsed and a lot of spread cracks appeared, during the 30th October quake the cracks made worst, and partial collapses occurred on the two sides of the façade Figure 5-a. The roof collapse happened after the 18th January 2017 earthquake, provoking the tambour and light vault failure.

The second more damaged church is Santa Maria Annunziata Figure 5-c, it showed significative cracks in both the bell-towers in correspondence of the spiral stairs and near the façade connections. The narthex had cracks on the connection to the façade, probably provoke by a hammering mechanism. On the opposite sides of the presbytery, two symmetric cracks show the activation of its out-of-plane mechanism. The church internally had shear cracks on the pillars and between the change of materials.

San Venanzio, instead, had deep cracks on the light vaults, on the arches and walls Figure 5-b. All of them were declared unsafe after the earthquakes, today the only reopened is the less damage, or rather, San Venanzio.

Figure 5 Some cracks after the Central Italy Earthquake, a) Partial collapse of one façade side of Santa Maria in Via; b) Cracks spread on the walls and the vault of San Venanzio; c) Crack in correspondence of the Clock of one Santissima Annunziata bell-tower

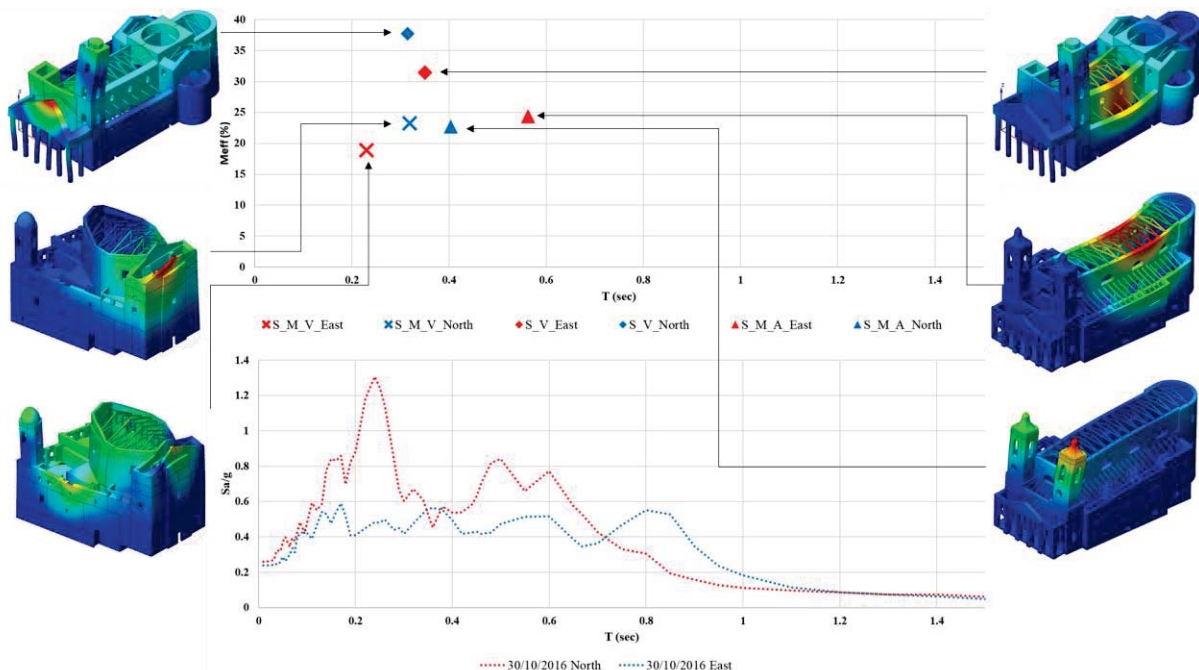
The principal modal shapes periods, for each church, are compared with the spectrums recorded during the strongest quake of the 2016 seismic swarm, the Figure 7 shows that their periods are near the maximum accelerations recorded periods.

In all the models the bell-towers are moved from one of the principal modes, indeed, in all the cases, they showed cracks after the earthquakes. The two long churches, San Venanzio and Santa Maria Annunziata, have as other vulnerable elements the longitudinal walls, instead, the façade is a vulnerable element for the Santa Maria in via church, in effect it has two long cracks on both sides.

Figure 7 Distribution of principal modal shapes in the North and East directions and comparison with the pseudo-acceleration response spectra of the main shock of Central Italy 2016-2017 seismic sequence.

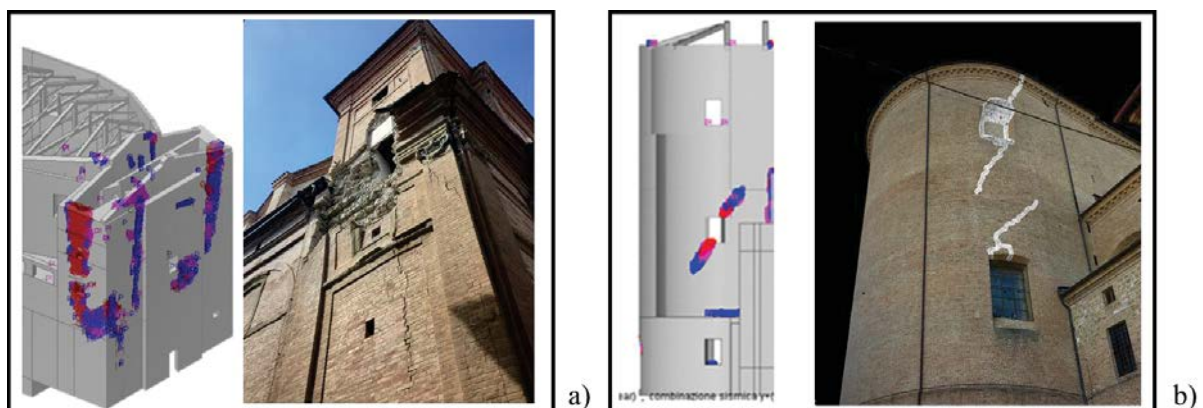
Comparing the numerical cracks with the real damages it is possible to confirm the readability of the numerical models **Figure 9**.

Figure 9 Correspondence between numerical and real cracks for a) Santa Maria in Via; b) Santa Maria Annunziata
