## VALUATION REPORT : RESIDENTIAL

670

REHOBOTH BLOCK A

WAKE ROBIN STREET

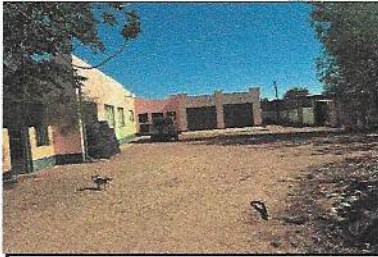
The yard area is unpaved, and the construction standard of the improvements is overly conventional, and finishes are dated in nature, but incompletely functional. Property needs extensive revamping works, particularly with numerous wall cracks, floor cover in some sections, paintworks, damaged/unhinged built-in cupboard doors, doors, inconsistent floor covering throughout, ceiling & roof works, wall tiling, yard rubble, revamping BBQ area and general wear & tear.

Driveway - unpaved

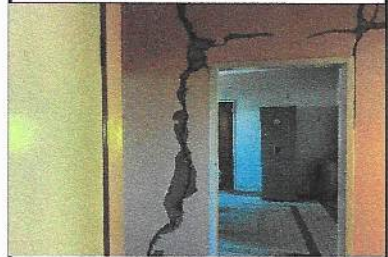
Wall cracks

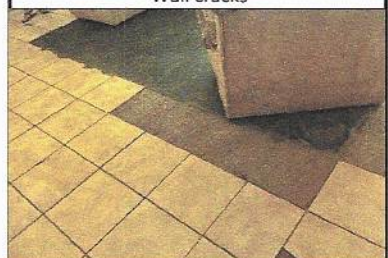
Some missing floor tiles

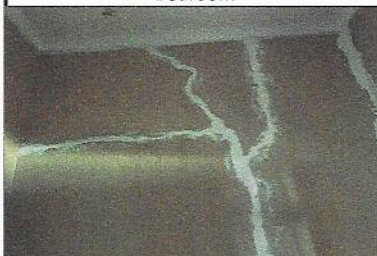
Crack mending
