DC ground fault locating under difficult conditions An AC coupling tale...

CASE STUDY

DC ground fault locating in the presence of unwanted AC coupling

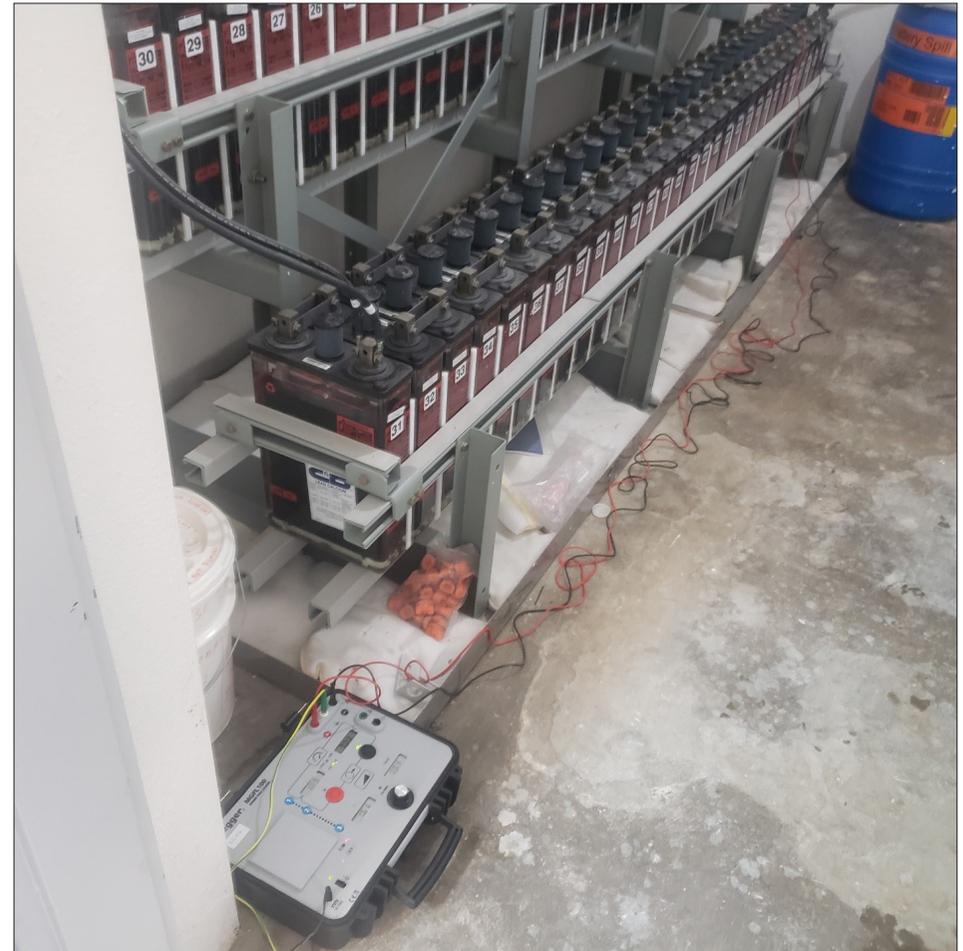
- TVA had used the Megger BGFT and a competitor's unit and traced the fault to the battery charger. They replaced the battery charger, and the fault did not go away.
- Megger assisted with the investigation. We placed a Megger MGFL100 on the string, and it did verify the presence of a negative ground fault (Figure 1).

Figure 1: the Megger MGFL confirming a negative ground fault on the battery string

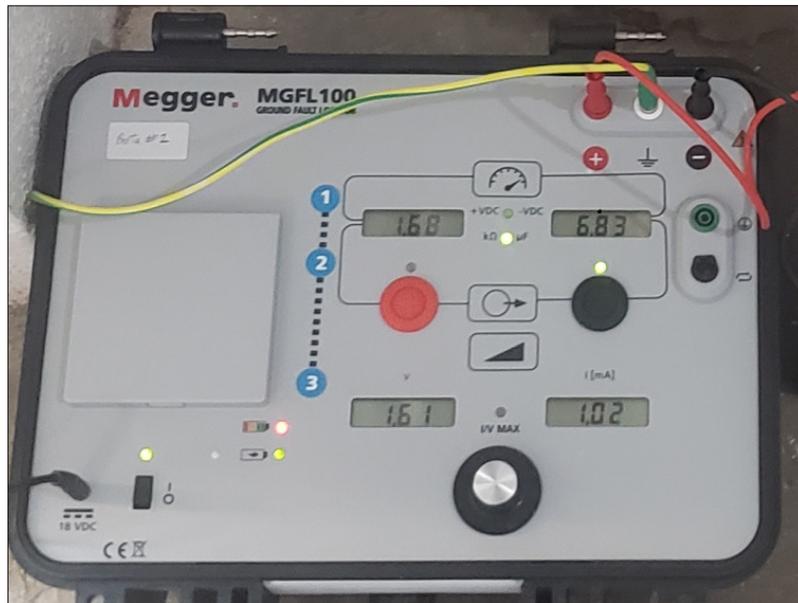
- With the MGFL100, we injected current and found the resistive value of the ground fault to be about 1.7K. The MGFL100 also showed the leakage capacitance to be about 7uF.

Figure 2: the Megger MGFL test results

- Meanwhile, we observed that the current, resistance, and capacitance values were all unstable.
- The fault current was present on the negative battery cable. The investigating team performed tracing and found that there was also current on the positive buss. Once again, none of these readings were stable.
- Knowing the MGFL100 transmitter will output a stable low-frequency AC current, the unstable measurement indicated an alternate low-frequency AC presence in the system.
- After turning off the transmitter, the MGFL100 receiver still measured an AC current on the positive buss. Therefore, there was AC coupling over to the DC.

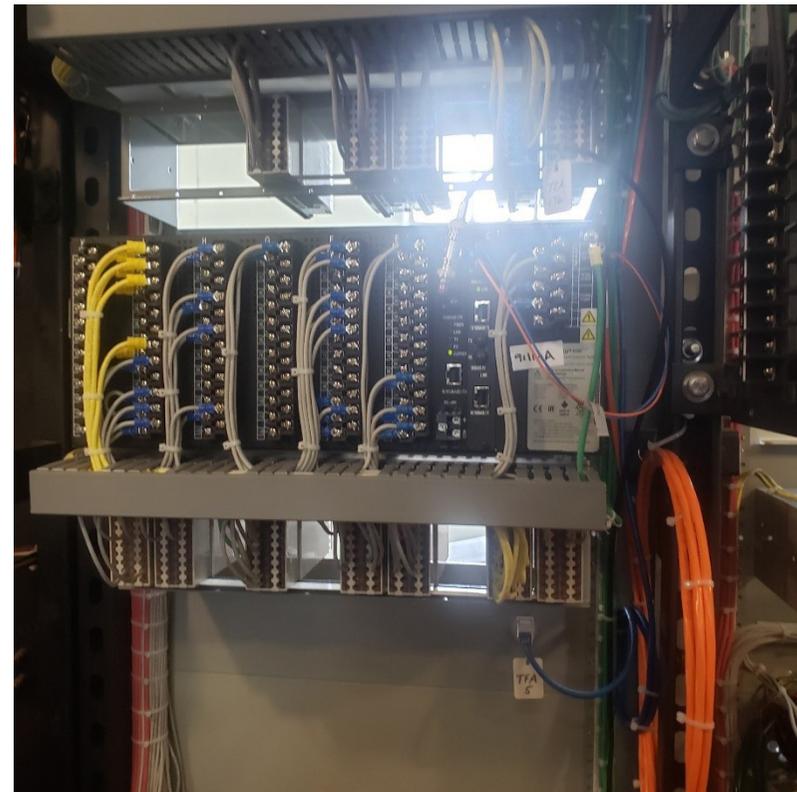
- To locate the source of the AC coupling, the team placed the receiver in its 50/60 Hz AC mode, a unique ability of the MGFL100. We were then able to trace the 60 Hz current to its source, which was the battery charger. This is why the other tracers failed to locate the real fault. The team isolated the battery charger from the system to remove the AC.
- We turned the transmitter back on and could now measure the fault current on the negative buss.
- The receiver was then placed back into the normal low frequency tracing mode, and the real fault was traced to a relay. The team removed the ground lead from the relay, and the ground fault vanished.

- What complicated the ground fault tracing in this case was the presence of an AC current that was coupling over to the DC system.
- The MGFL100 transmitter will fluctuate in the presence of low-frequency AC current. Since an operator can place the MGFL100 receiver in a 50/60Hz mode, it allows the operator to trace stray AC current that may be present on a DC system. So, not only did the operator locate the real ground fault in the relay, but they also discovered a wiring issue in the charger that was coupling AC onto the DC system.
