A87 Dornie Village Junction and Bridge

Examination of Lighting Options

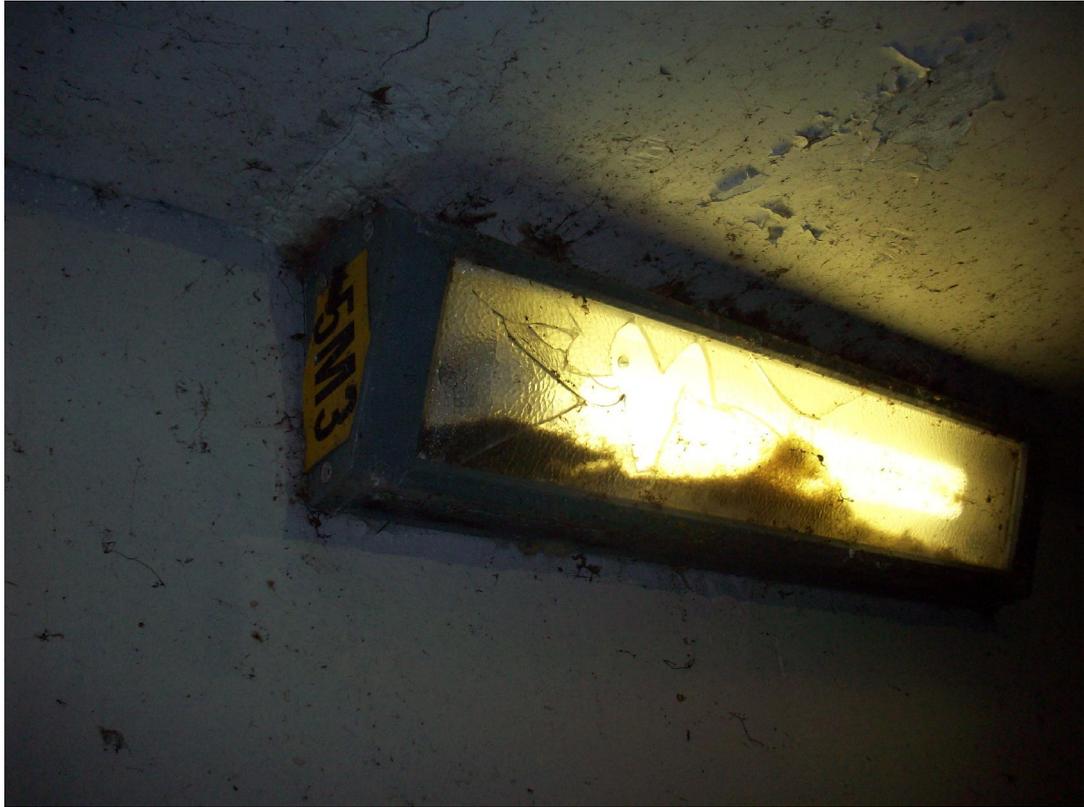
The 14 existing lighting fittings in the underpass are in a poor condition and some are badly damaged (Photograph 1 refers). It is recommended that these fittings are replaced, and that lighting be provided in both of the bus shelters, regardless of which option is chosen for lighting the junction area.

Photograph 1 - Showing the Existing Underpass lighting (Photo 2 omitted)

It is recommended that Option 1 to provide an appropriate, compliant, level of lighting-around the junction conflict area be agreed. This will include appropriate control gear to provide adjustable levels of lighting to different parts of the lit area. An upgrade of the underpass lighting and the provision of lighting at the two bus shelters will be included. The use of aluminium columns and lanterns will provide an extended service life and is anticipated to provide an installation which has a minimal visual impact in this very scenic area. In terms of sustainability the use of lighting columns and the control strategy outlined will reduce power consumption of the installation.
