Grenfell: The Perfect Formula for Tragedy

Christopher J. Wieczorek, Ph.D.

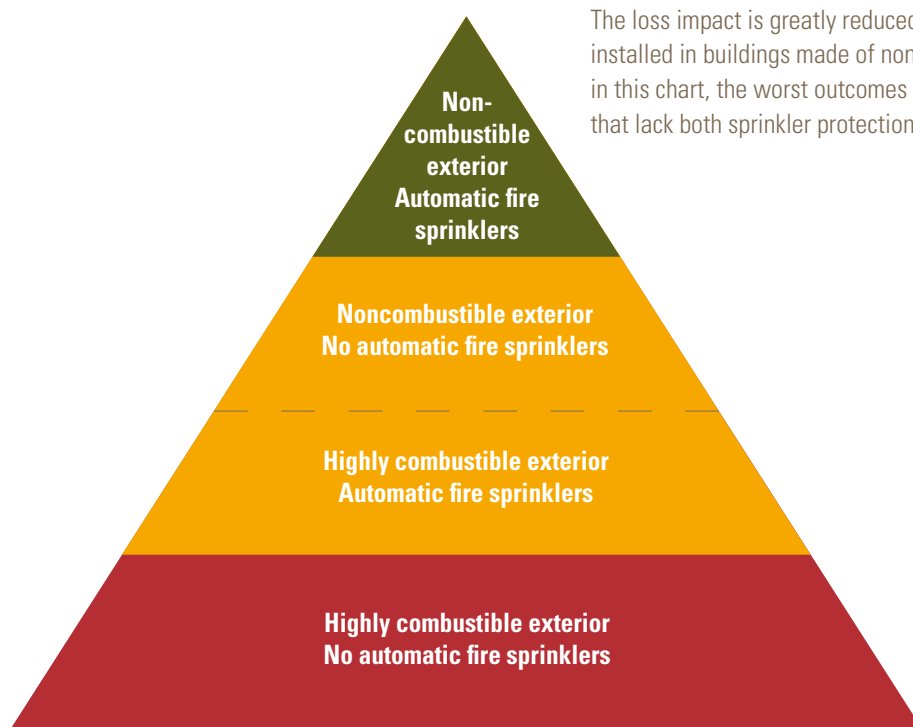
The loss impact is greatly reduced when automatic sprinklers are installed in buildings made of noncombustible construction. As shown in this chart, the worst outcomes are when fires begin in buildings that lack both sprinkler protection and the proper construction.
