FIRE RISK ASSESSMENT

Bree Prenton

34-36]
High Street		
Seaford		
East Sussex	BN25 1PL	Document Reference: 11569

Date: 22 May 2024

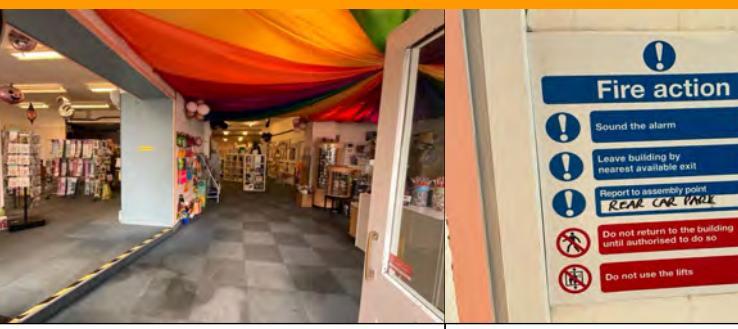
1. Shop frontage.

2. Fire action notice.

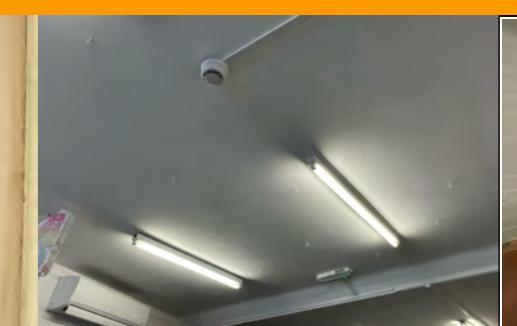
3. Emergency lighting and smoke detector/ 4. Helium filled balloons. sounder.

3	There is a large amount of combustible material present within the premises, this includes for paper, cloth/materials, timber, helium filled balloons and plastics. We would recommend that more fire extinguishers are placed in key points around the premises and that staff are trained in the use. The tenants own fire risk assessment should make note of this issue and advise accordingly.	нідн	3 Months	MEDIUM		
4	There was seen to be combustible material stored against to the electrical substation to rear of the shop. These items would be used to start a fire and should be removed as soon as possible.	HIGH	3 Months	MEDIUM		
5	The mains electrical equipment needs to be enclosed within a 30-minute fire resisting cupboard in order to protect the common way means of escape. All access doors must be ensured to be 30-minute fire resisting and should be rebated onto a door stop. All doors must be KEPT LOCKED SHUT and have suitable notices displayed to this effect along with electrical hazard signage. All gaps and holes made for the passing of cables must be fully fire stopped using a suitable intumescent product. All work to be completed by a competent person.	HIGH	6 Months	MEDIUM	Until all works are completed access to this areas should be restricted and all drapery should be removed immediately.

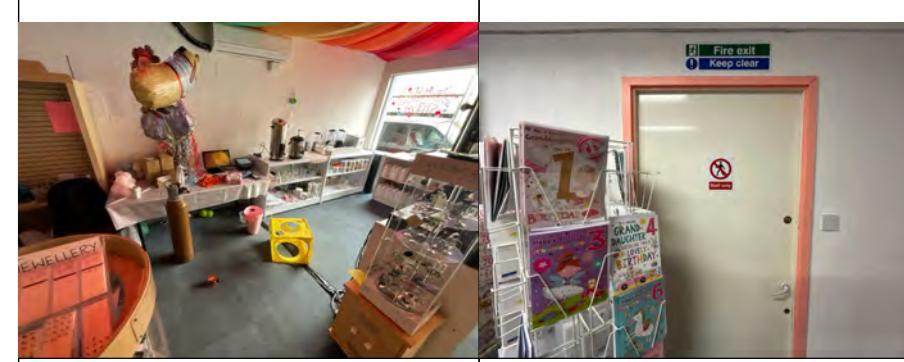
5. Helium canister behind cash desk.

6. Shop fire exit with Yale lock
