VALUATION REPORT : RESIDENTIAL

216

REHOBOTH BLOCK A

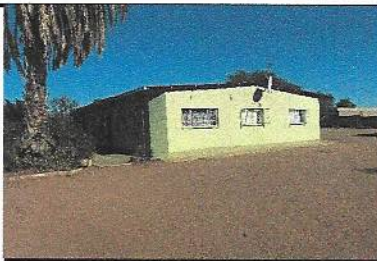
Main dwelling

Construction standard and quality of the structures is overly dated and of average quality, and minimum or no minor improvements observed. The bedrooms in the main dwelling do not have floor covering nor BIC, and defects include worn paint, inconsistent tiling throughout, roof leaks, and general wear & tear.

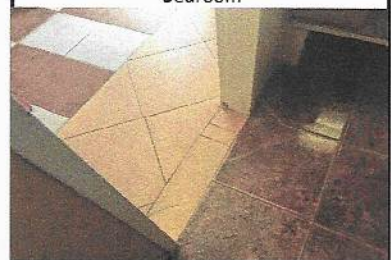
Different floor tiling

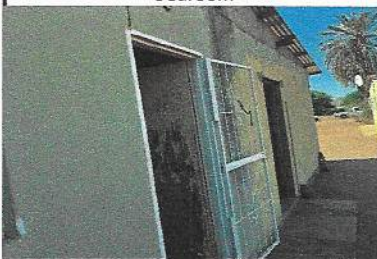
Out-building

The flat is not fitted with sanitary fixtures in the kitchen, floor covering is incomplete, painting is incomplete and only the bathroom has been revamped – external wall surfaces need re-painting.
