Eastern CFRAM Study

Flood Risk Review - Final Report

IBE0600-Rp0001-F02/Dec 2011

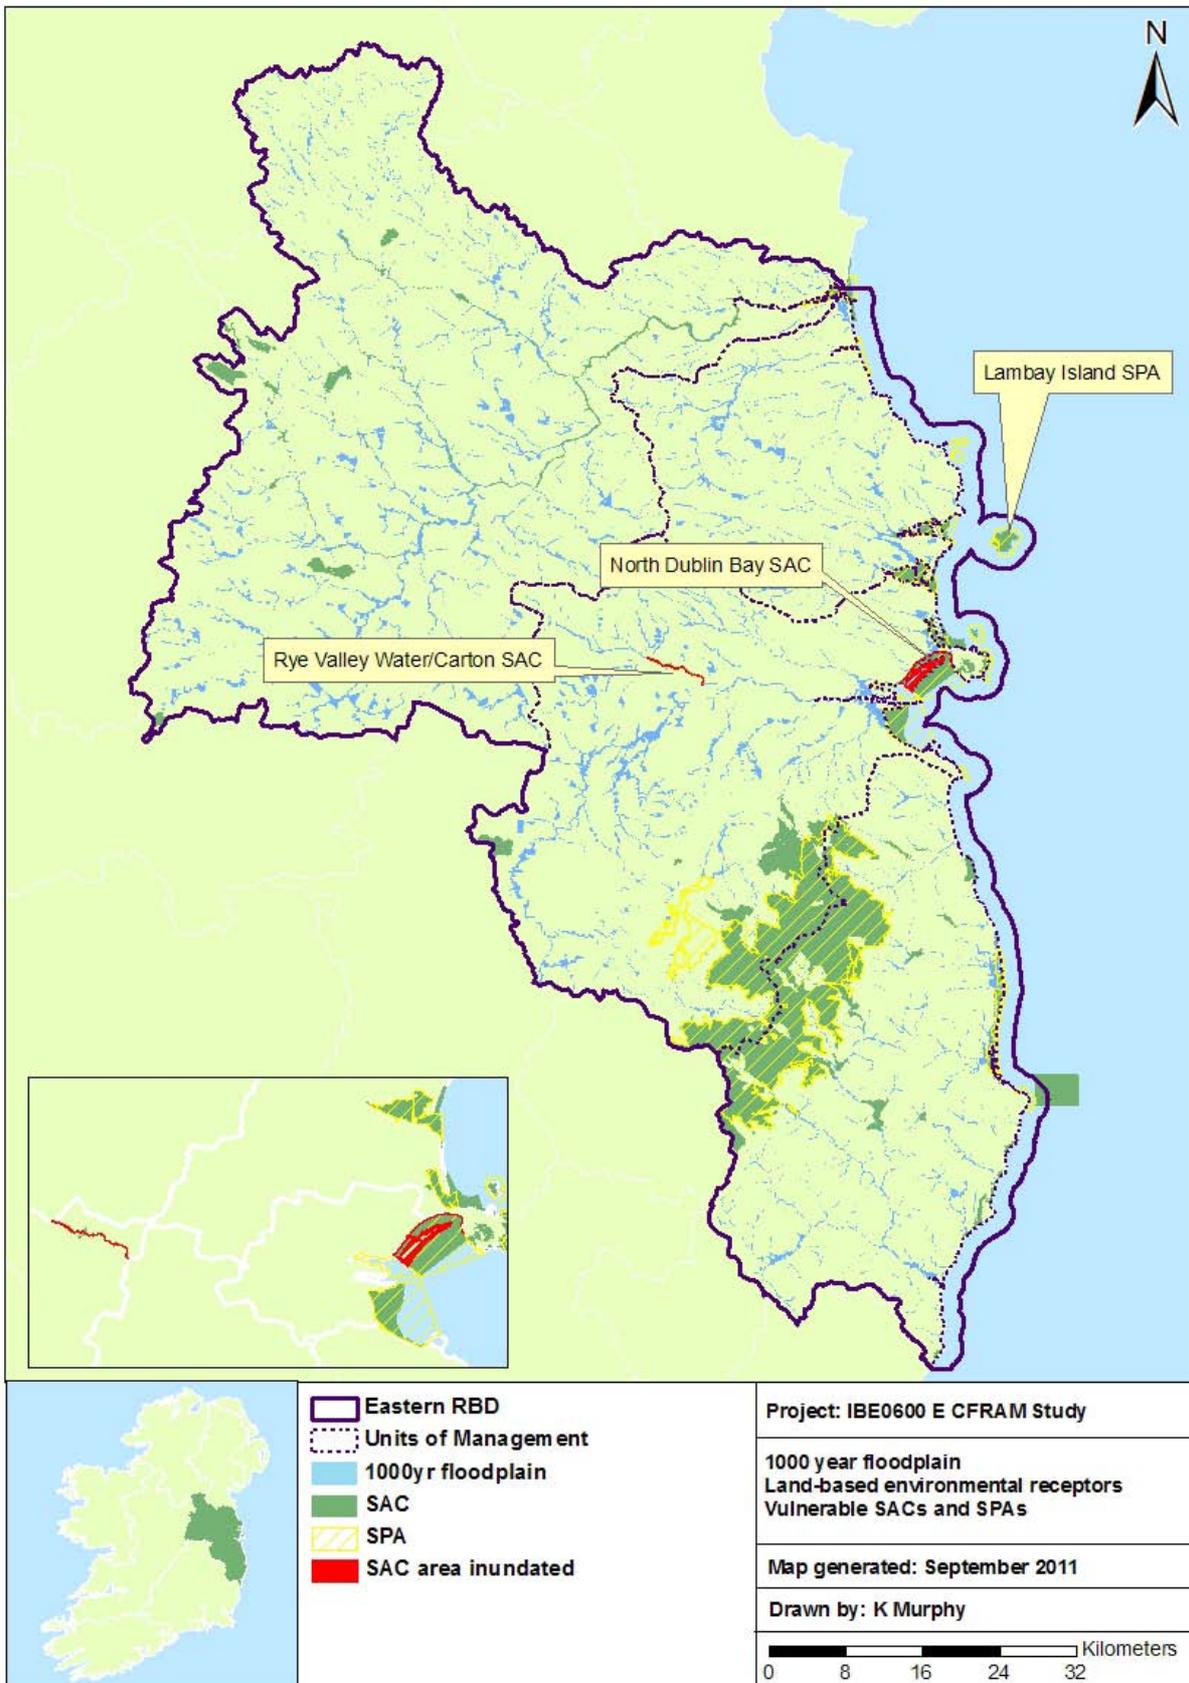
Figure 2.1 Natura 2000 sites qualifying as Probable AFAs within the ECFRAMS area

RPS commenced their assessment of flood risk to environmental receptors by undertaking a GIS exercise to map all environmental assets within the various available PFRA predictive mapping and in the case of large spatial assets the percentage of the asset within the 0.1%AEP flood zone. This provided an indication of the likely significance of fluvial and tidal flooding in terms of environmental receptors within the Eastern CFRAM Study area. A similar exercise was also undertaken by OPW and receptor vulnerability criteria used to score each asset and calculate a corresponding Flood Risk Index. The results of the OPW assessment of the flood hazard to environmental receptors, contained in Appendix D indicate three Natura 2000 sites within the ECFRAMS area to have made the criteria for consideration as Probable AFAs. The sites with an environmental flood risk index (FRI) score of greater than 250 are the Lambay Island SPA, the Rye Water Valley/Carton SAC and the North Dublin Bay SAC the locations of which are shown in Figure 2.1. Two further Natura 2000 sites within the ECFRAMS area were identified as having sufficient FRI scores to be identified as a Possible AFA, the Rogerstown Estuary SAC and the Malahide Estuary SAC, the locations of which are shown in Figure 2.2.

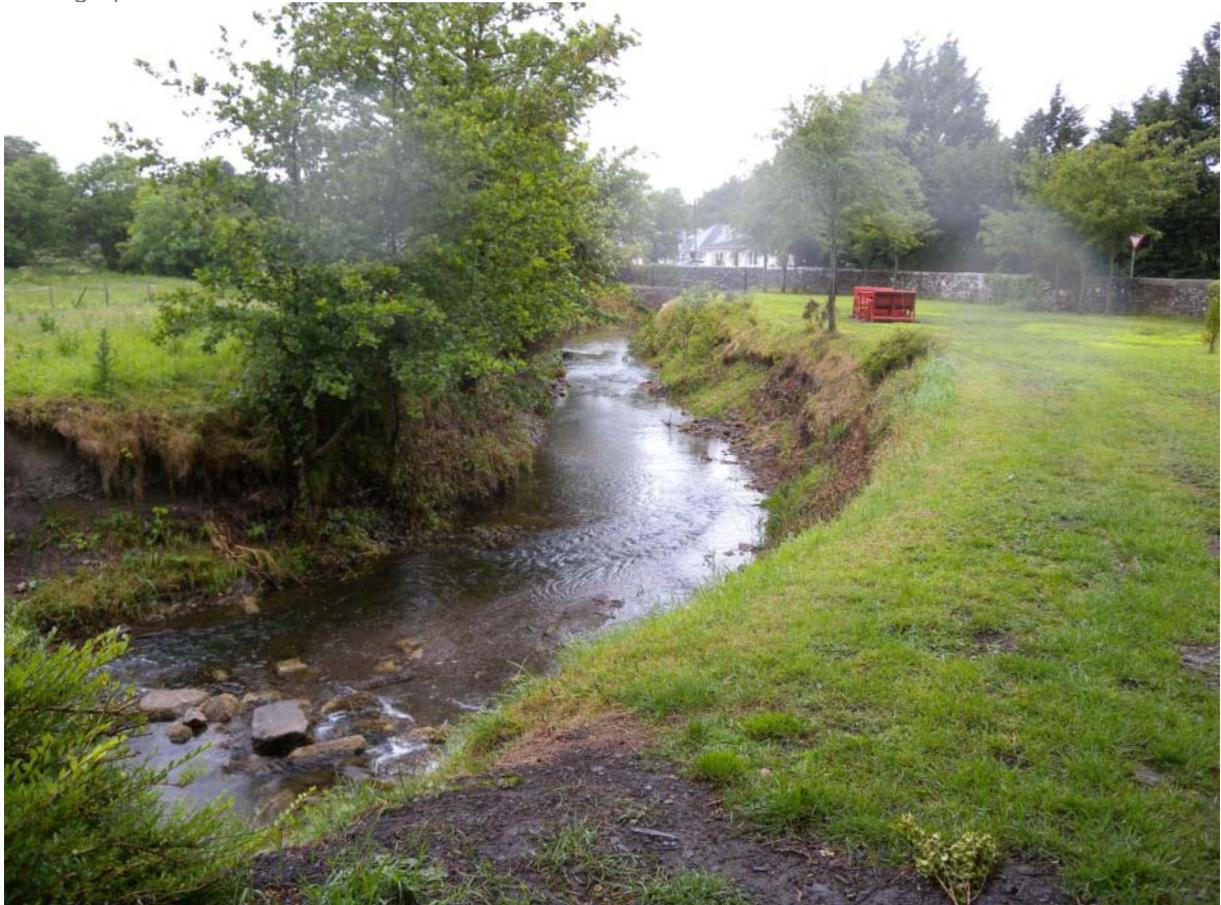
Photographs:

Size of river: 5m (w), 3m (d)		Channel vegetation: Moderate to low	
Channel condition: -		Structures: Stone Bridge – No signs of blockages	
Flood defences: DS of stone bridge, sheet piles located adj to res house, garden raised.		Nature of flow: Moderate to low	
Nature of floodplain: Moderate to wide		Floodplain vegetation: Long grass	
Properties: Single dwelling DS of bridge, adj to wc Bective housing estate, adj to wc		Evidence of flooding: None

Kilmessan was originally listed as a Probable Area for Further Assessment with a FRI score of 405. The site inspection to Kilmessan has found that during the PFRA process a disused millrace had erroneously been taken as the primary channel of the Skane River through Kilmessan to the exclusion of the actual route of the Skane river channel. The millrace has been in-filled in parts and consequently does not represent a continuous flow channel. Inspection of the actual route of the Skane River established that the majority of properties are located on relatively elevated sites and are therefore not considered to be subject to a significant flood hazard. Neither OPW Regional Engineers nor the Local Authority had any knowledge of flooding in the area despite a large event having occurred in 2002 giving confidence in the perceived lack of flood risk. In order to illustrate the likely effect of the reduced flood hazard associated with the correct route of the Skane River the properties located within the 10%AEP flood extent were excluded from the FRI calculation, with the result that the overall FRI was reduced from 405.2 to 58.7. It is therefore recommended that **Kilmessan should not be considered an AFA.**

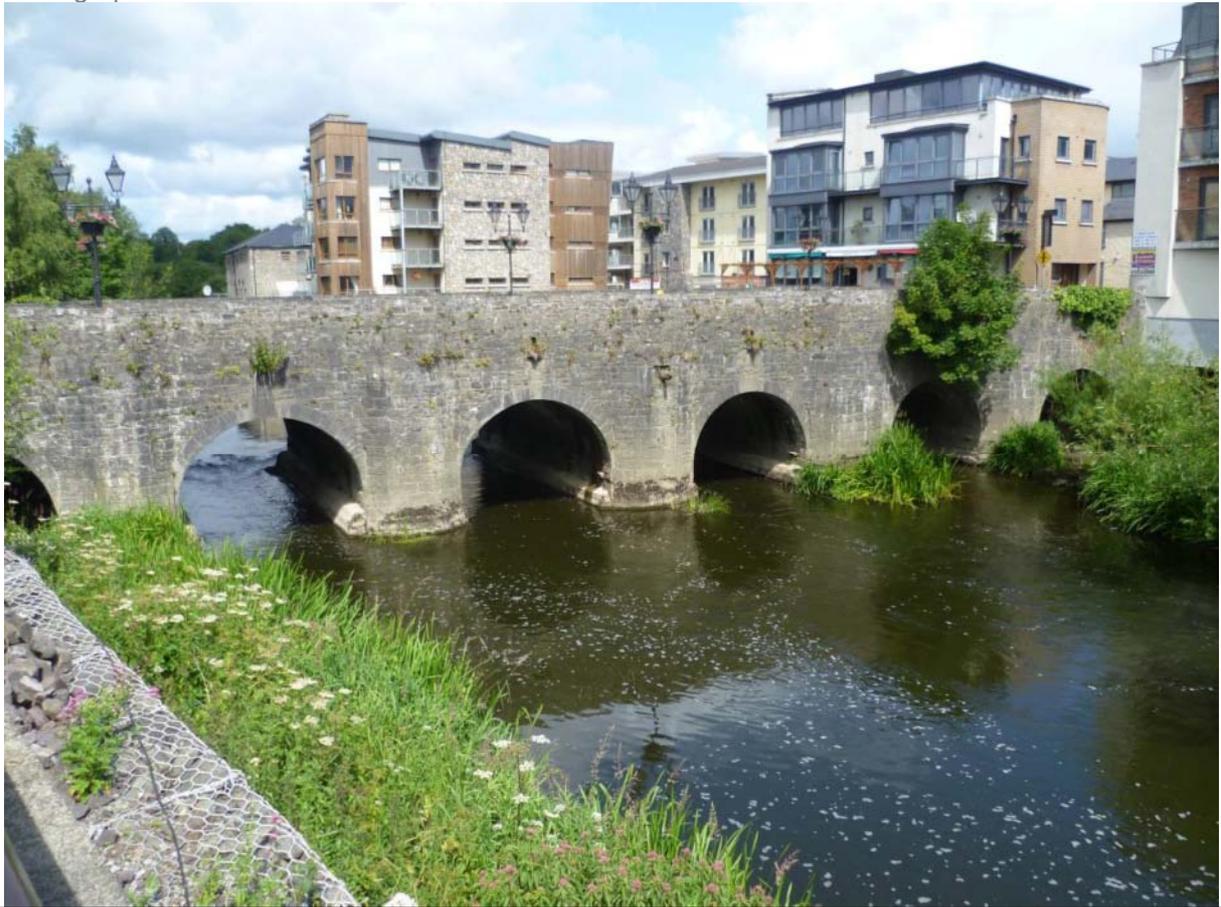
Photographs:

Summary of Site Inspection			
Site inspection observations: 17/06/11			
The Boyne flows through Navan and the River Blackwater joins the Boyne at the centre of Navan. Both watercourse are relatively large and have a history of flooding. The surrounding properties are located very close to the river and the numerous bridges some of which are old stone arch bridges may cause a constriction to flow which may increase the flood risk. If out of bank flooding was to occur a significant number of receptors would be put at risk.			
Size of river: 50m x 7m		Channel vegetation: Low veg	
Channel condition: -		Structures: Road bridges	
Flood defences: -		Nature of flow: Mod to low flow	
Nature of floodplain: -		Floodplain vegetation: Urban	
Properties: Residential and commercial		Evidence of flooding: None

Navan was originally listed as a Probable Area for Further Assessment with a FRI score of 3,670. Predictive and historical data both show Navan to be at risk and this has been confirmed by the Local Authority and OPW Regional Engineering staff. The PFRA predictive mapping for Navan appears reasonable therefore it is unlikely that the FRI score could be reduced to below 250. Consequently it is recommended that **Navan should be considered an AFA.**

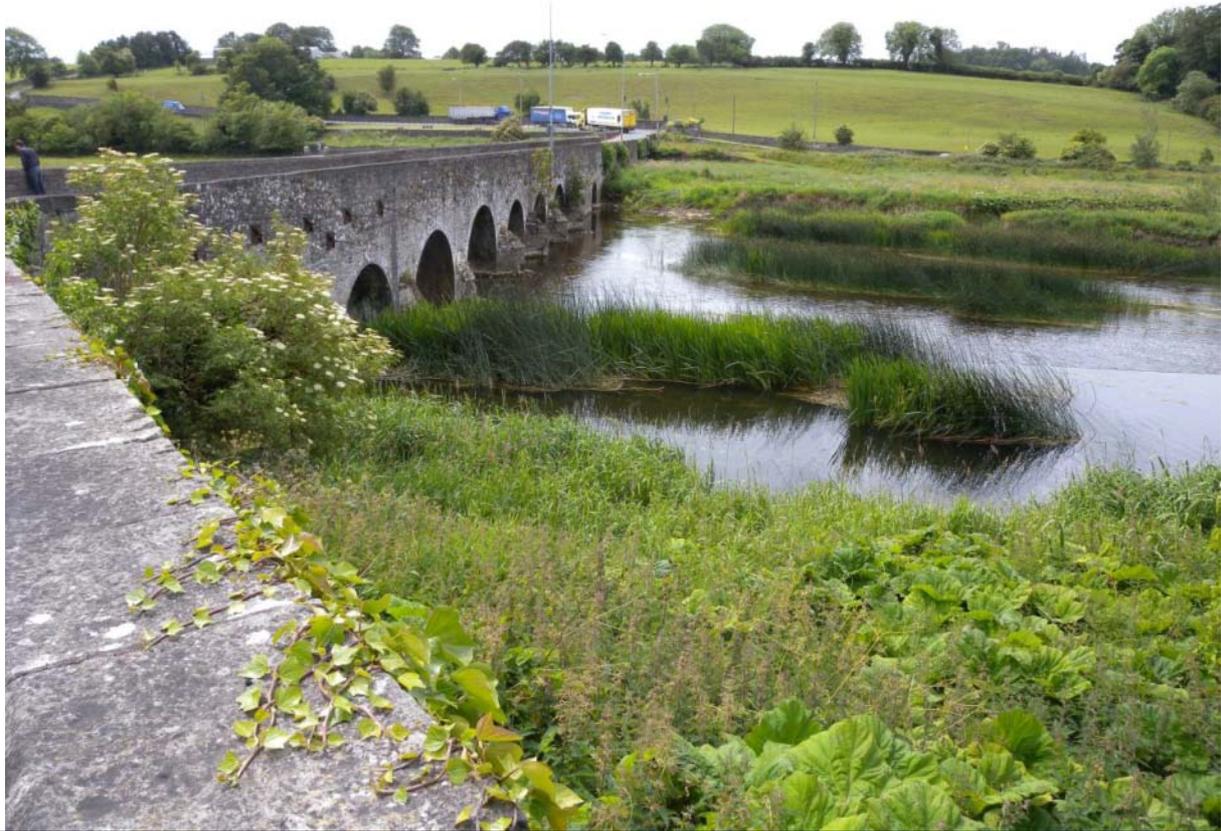
Photographs:

<u>Summary of Site Inspection</u>			
Site inspection observations: 15/06/11			
Slane bridge visited. The Boyne canal starts just upstream from the bridge on the RHB. A weir is located just upstream of the bridge and a millrace is taking flow from the river. There is no strong evidence that the bridge is at risk or that it would be prone to blockages.			
Size of river: 40m (w)		Channel vegetation: Low – mod veg	
Channel condition: -		Structures: Road bridge Canal Weir & Millrace	
Flood defences: -		Nature of flow: Moderate	
Nature of floodplain: Steep V shaped valley		Floodplain vegetation: Grass fields	
Properties: Old mill ds of bridge		Evidence of flooding: None

Slane was originally included as a Possible Area for Further Assessment due to potential flood risk to the N2. No FRI score was available within the PFRA database. The site inspection confirmed the principal flood risk at Slane is to the N2 Road bridge and the old mill downstream of the bridge which is now being used as apartments. These receptors will not generate a FRI score of greater than 250. The Local Authority considers the potential disruption from the road being flooded to be easily manageable given the close proximity of the M1, N51 and M3. It is therefore recommended that **Slane should not be considered an AFA.**

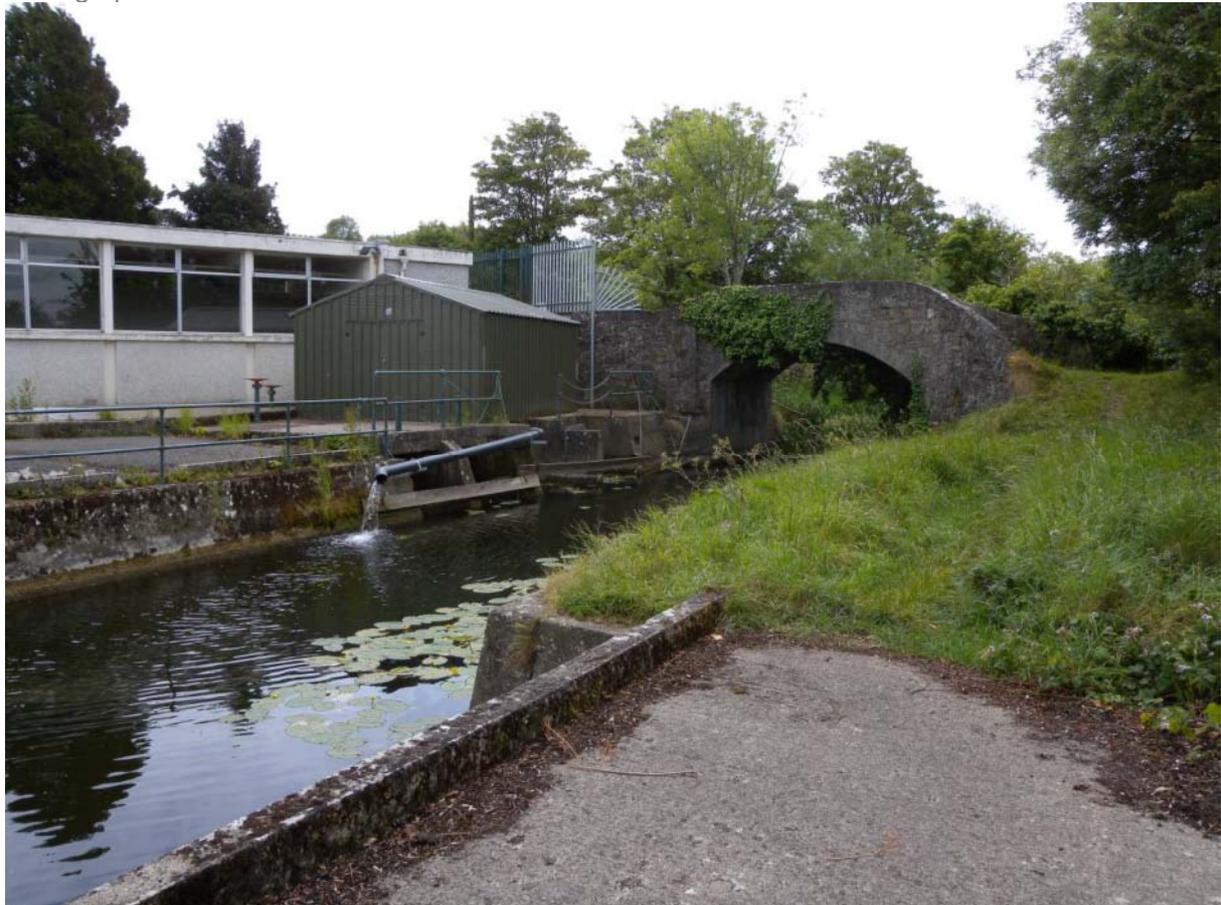
Photographs:

Summary of Site Inspection			
Site inspection observations: 15/06/11			
Water extraction point visited. Extraction taken from canal with an overspill weir to the Boyne. The canal and extraction point are raised above the Boyne and it is unclear if they lie within the Boyne floodplain. There is a potential risk to the water extraction point.			
Size of river: 40m (w)		Channel vegetation: -	
Channel condition: -		Structures: Canal Water extraction point	
Flood defences: -		Nature of flow: -	
Nature of floodplain: Steep on LHB, moderately wide on the RHB		Floodplain vegetation: Grass fields	
Properties: Water extraction point		Evidence of flooding: None

Stalleen Water Treatment Works was originally identified as an Individual Risk Receptor for inclusion in the flood risk review. The actual water treatment works at Stalleen is situated on a hill remote from the River Boyne and therefore is not directly at risk of flooding. The only potential flood risk observed is to the water extraction from the River Boyne/Boyne Canal near Dunore. Any flooding to the plant may prevent water being pumped temporarily to the water treatment works although there is likely to be sufficient reserve at the WTW to avoid disruption. The plant is operated by Drogheda Borough Council and discussion with them did not indicate any known loss of supply at this facility due to flooding of the inlet works. It is therefore recommended that **Stalleen Water Treatment Works should not be considered an AFA.**

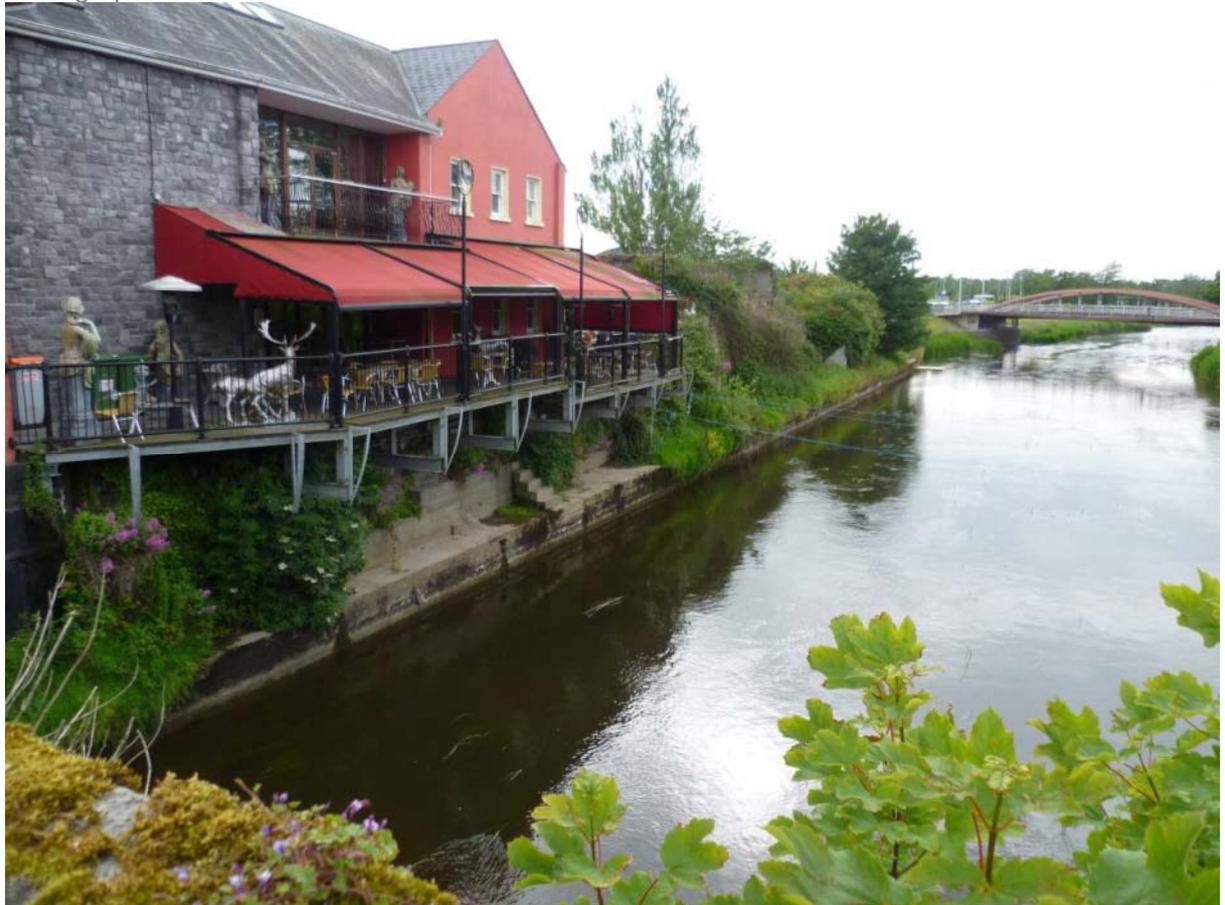
Photographs:

Summary of Site Inspection			
Site inspection observations: 17/06/11			
The River Boyne flows through Trim where two minor watercourses join it. Trim has a history of flooding and the PFRA predictive mapping looks reasonable although some areas form wedges which if corrected may reduce the risk slightly. Nothing was found from the site inspection that would contradict with the predicted flood extent and significantly change the flood risk.			
Size of river: 30m x 5m		Channel vegetation: Some reeds in bed, grass on banks	
Channel condition: -		Structures: Multiple bridges	
Flood defences: -		Nature of flow: Mod flow	
Nature of floodplain: Relatively constricted		Floodplain vegetation: Urban and agricultural fields	
Properties: Multiple houses		Evidence of flooding: None

Trim was originally listed as a Probable Area for Further Assessment with a FRI score of 902. Predictive and historical information both show Trim to be at risk of flooding from the River Boyne. This risk was confirmed by both the Local Authority and OPW Regional Engineering staff, who also indicated that works had been undertaken to alleviate the known flooding problem. The PFRA predictive mapping at Trim does not appear unreasonable, therefore it is unlikely that the FRI score could be reduced to below 250. Consequently it is recommended that **Trim should be considered an AFA.**

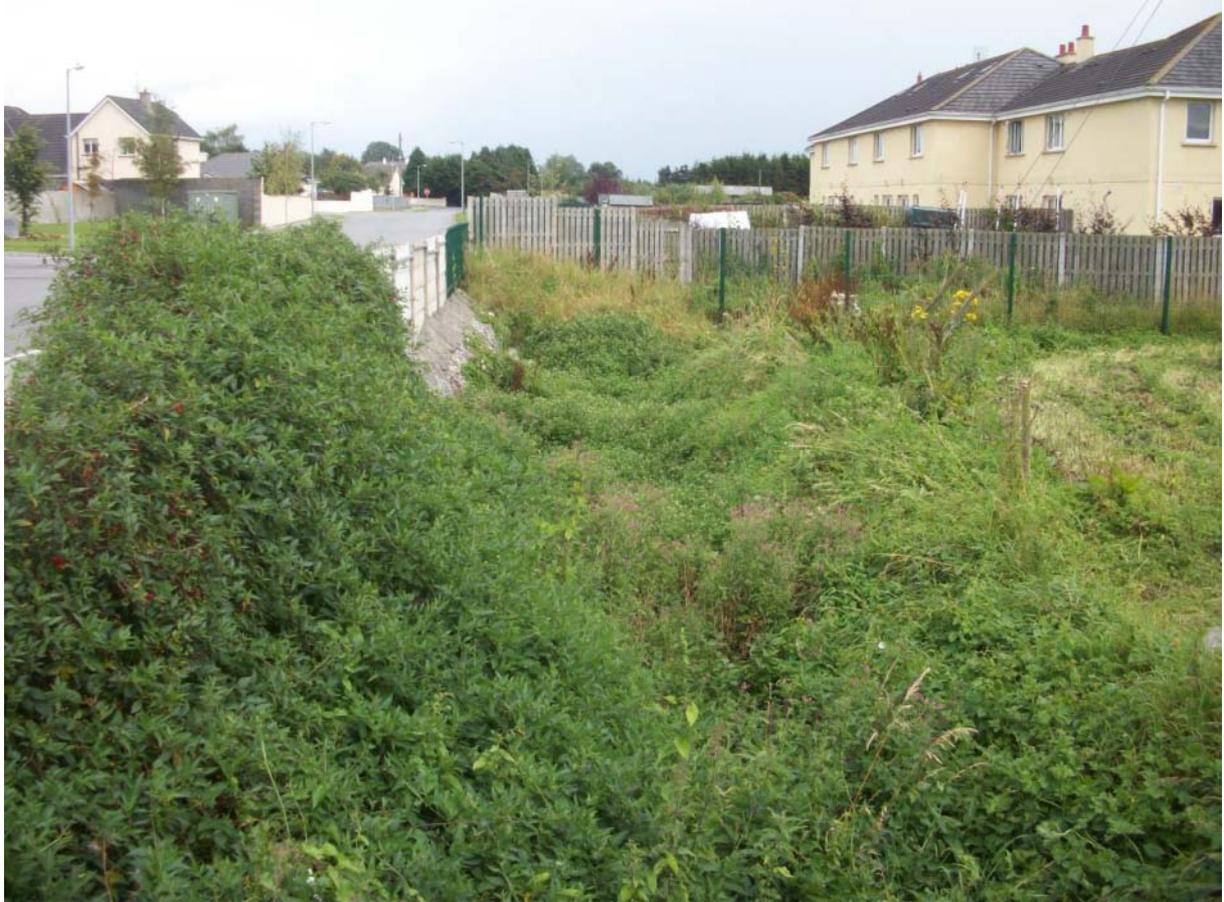
Photographs:

Size of river: 5m x 3m (Boyne) 3m x 2m (Weaver's Drain)		Channel vegetation: Long grass on banks (B) Dense veg (W)	
Channel condition: -		Structures: Road bridges and a weir	
Flood defences: -		Nature of flow: Sluggish (B) Very low flow (W)	
Nature of floodplain: wide		Floodplain vegetation: Long grass	
Properties: Residential and commercial		Evidence of flooding: None

Edenderry was originally listed as a Possible Area for Further Assessment on the basis of concerns raised by the Local Authority and OPW Regional Engineers and the fact that a previous study had been completed. No FRI score was available within the PFRA database as the PFRA predictive mapping shows relatively little flood damage to properties in Edenderry from the River Boyne and this was confirmed by the site inspection as Edenderry is elevated above the River Boyne. OPW Regional Engineers confirmed their concern over flooding from the Weavers Drain which flows through Edenderry to the River Boyne. The Weavers Drain is known to have caused flooding in the past however this watercourse was not modelled as part of the PFRA process and no predicted flood extents are available. The site inspection found no evidence of recent flooding from the Weavers Drain however there are numerous residential houses and commercial building within the vicinity of this watercourse. The level of risk is however difficult to estimate with any certainty and further analysis would be required, consequently **Edenderry should be considered an AFA.**

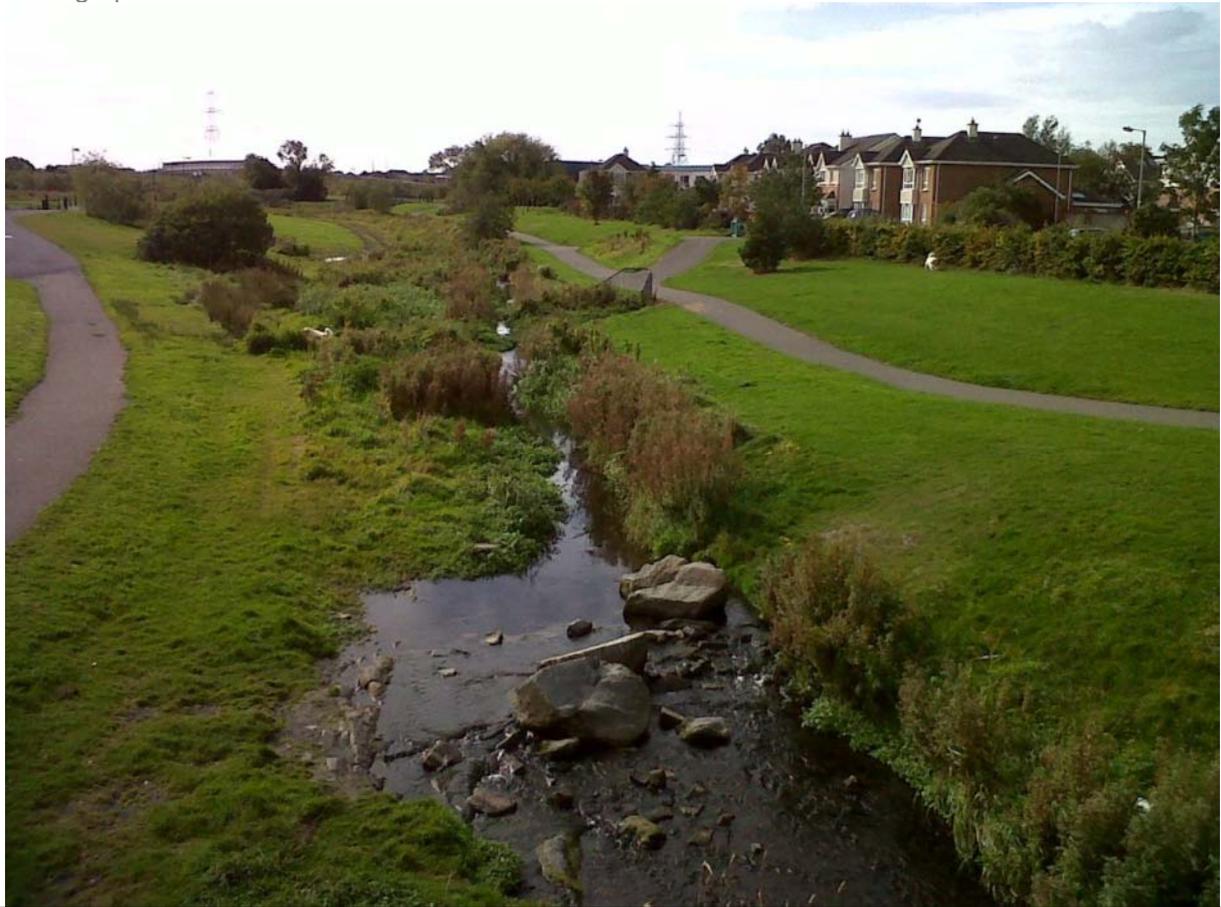
Photographs:

Griffeen River flows through a wide strip of parkland with channel bed circa 3m below floor levels of nearby properties. PFRA flood polygons shown extending into housing area on west bank incorrect, no significant flood risk observed.			
Size of river: 2m x 0.3-0.5m deep		Channel vegetation: Light weed growth	
Channel condition: Some localised armouring		Structures: Bridges, large spans	
Flood defences: None Observed		Nature of flow: Rapid	
Nature of floodplain: Wide, particularly on right bank		Floodplain vegetation: grassland	
Properties: Residential and commercial		Evidence of flooding: Nothing observed

Esker South was originally listed as a Possible Area for Further Assessment as a result of the historic assessment element of the PFRA. No FRI score was available in the PFRA database, however Esker South is potentially affected by the Griffeen River and experienced flooding during the 1954 flood as shown on www.floodmaps.ie. Inspection of the site confirmed that the Griffeen River flows through a linear park and that the bed of the channel is significantly lower than the thresholds of the adjoining properties. It was also considered that the PFRA predictive mapping shown extending into the adjoining housing area is incorrect and that the flood risk to Esker South is very low. Consequently it is recommended that **Esker South should not be considered an AFA**. However this section of the Griffeen River is included in the scope of the survey for the Lucan to Chapelizod Probable AFA and therefore the site inspection observations can be confirmed at a later stage.

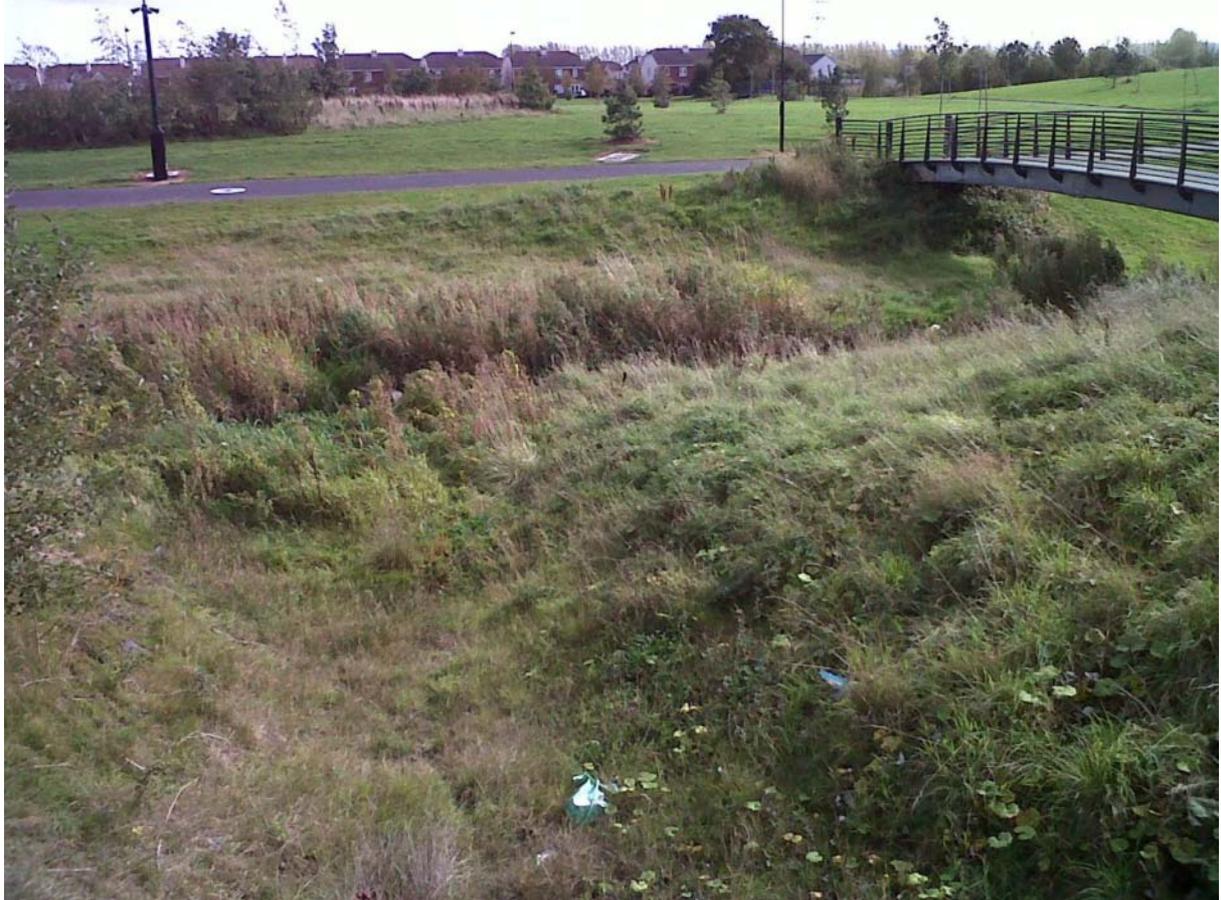
Photographs:

Size of river:		Channel vegetation:	
Channel condition:		Structures:	
Flood defences: None Observed		Nature of flow: None	
Nature of floodplain:		Floodplain vegetation:	
Properties: Residential		Evidence of flooding: Nothing observed

Finnstown was originally listed as a Possible Area for Further Assessment as a result of the historic assessment element of the PFRA. No FRI score was available in the PFRA database despite the PFRA predictive mapping showing properties to be at risk in this area. Evidence suggests that Finnstown has experienced flooding in the past, the historical flood extent from the Dec 1954 flood is presented on www.floodmaps.ie. Finnstown appears to be potentially affected by a tributary of the Griffeen River however this watercourse was found to be totally dry and discontinuous during the site inspection. Consequently it would appear that the PFRA predictive mapping is inaccurate in this area and hence it is recommended that **Finnstown should not be considered an AFA.**

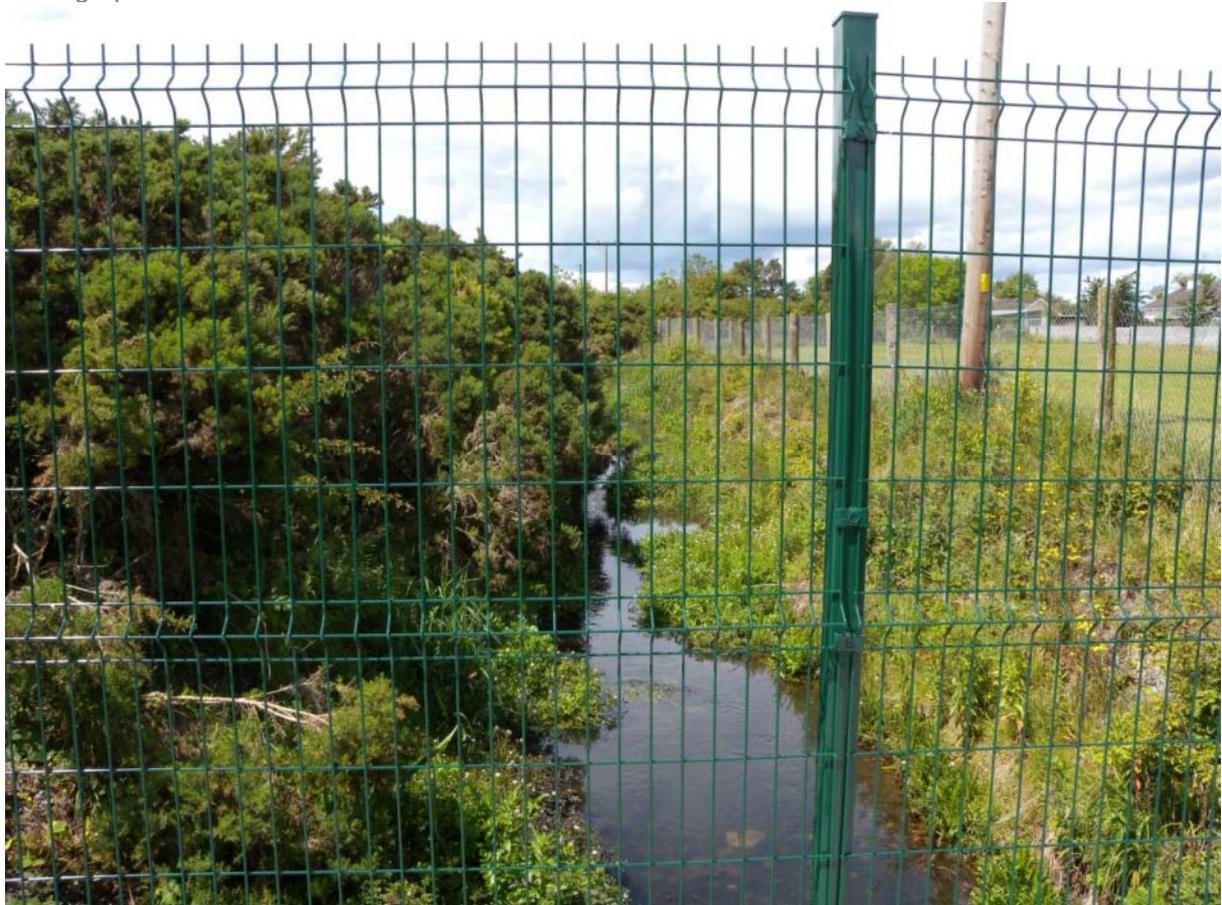
Photographs:

Properties: PS adjacent to WC		Evidence of flooding: None

Milltownpass was originally listed as a Possible Area for Further Assessment with a FRI score of 291, due principally to the predicted flood risk to the primary school. There is no known history of flooding at the Primary School in Milltownpass and the watercourse is maintained by OPW Regional Engineers who confirmed that the channel capacity would almost certainly be greater than Q_{med} . A channel capacity check was carried out and it was found that the channel has a capacity of greater than the 1%AEP flow and while the analysis method employed by RPS is very approximate this does give confidence that the channel could convey the 10%AEP flow. If the FRI for Milltownpass was recalculated with the primary school excluded from the 10%AEP flood risk the FRI score would be reduced to 66.3. The OPW has stated that the effects of flood alleviation works should be ignored in the assessment of potential flood risk and consequently Milltownpass could therefore be considered an AFA. However the vast majority of the FRI score is associated with a single receptor, the local primary school, which could be protected under the OPW minor works programme and therefore it is suggested that **Milltownpass should not be considered an AFA.**

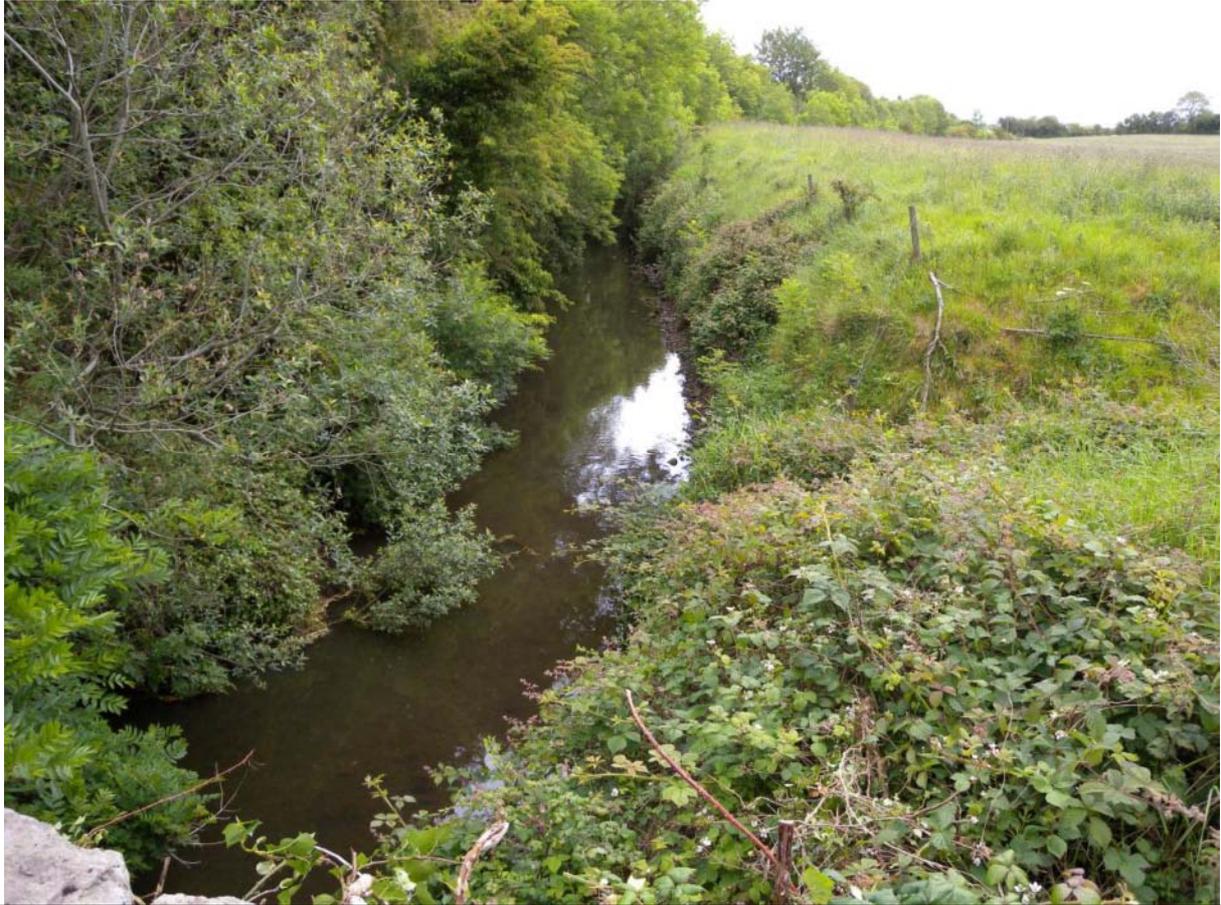
Photographs:

<u>Summary of Site Inspection</u>			
Site inspection observations: 13/06/11			
Visited the Riverstown River. All properties near the watercourse are quite high up and do not look to be at risk. No reason could be found as to why this is a possible AFA site.			
Size of river: 4m (w), 2m (d)		Channel vegetation: Low hanging trees & long grass (LHB), long grass (RHB)	
Channel condition: -		Structures: Stone bridge, no suggestion of blockages	
Flood defences: None		Nature of flow: Moderate flow	
Nature of floodplain: Moderately restricted. Ground rises quickly to Killucan		Floodplain vegetation: Agricultural fields, mainly long grass with trees on LHB.	
Properties: None adjacent. All relatively high		Evidence of flooding: None

Riverstown was originally listed as a Possible Area for Further Assessment although the reason for inclusion is unclear in the PFRA database. No FRI score was available in the PFRA database and neither the predictive mapping nor historical records show any properties flooding. The Local Authority and OPW Regional Engineering staff also had no knowledge of flooding at Riverstown. It is therefore considered likely that Riverstown was brought forward for review in error, consequently it is recommended that **Riverstown should not be considered an AFA.**

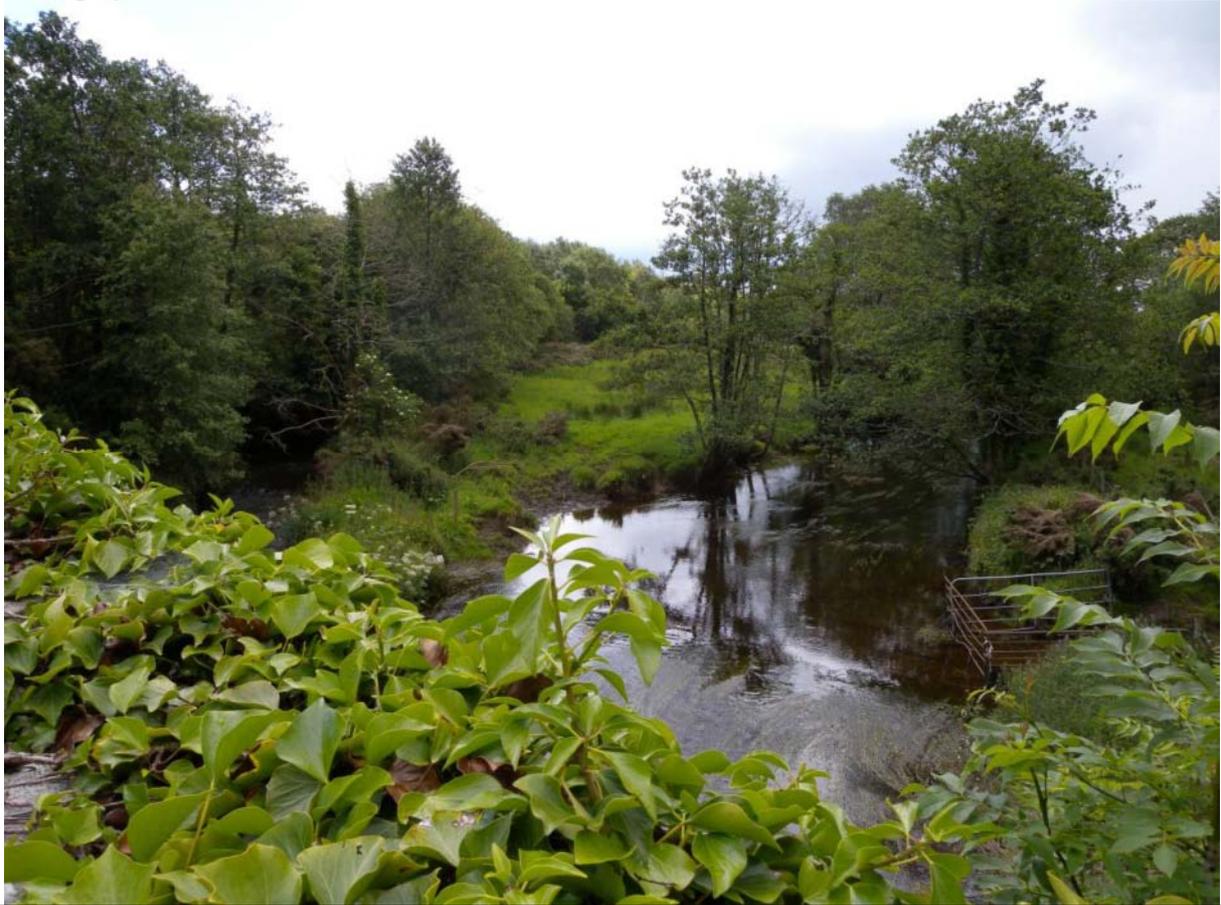
Photographs:

Size of river: 10m x 2m		Channel vegetation: Weedy	
Channel condition: Deposition/gravel		Structures: Single arch bridge	
Flood defences: No		Nature of flow: Rapid	
Nature of floodplain: Semi-constrained		Floodplain vegetation: Trees and open grassland	
Properties: School church pub on left bank well above likely river levels		Evidence of flooding: No

Annacurragh was originally listed as a Possible Area for Further Assessment with a FRI score of 630. The Local Authority has no knowledge of previous flooding in this area affecting property and during the site inspection the nearest properties were observed to be 4-5m above the river level. Thus **Annacurragh should not be an AFA.**

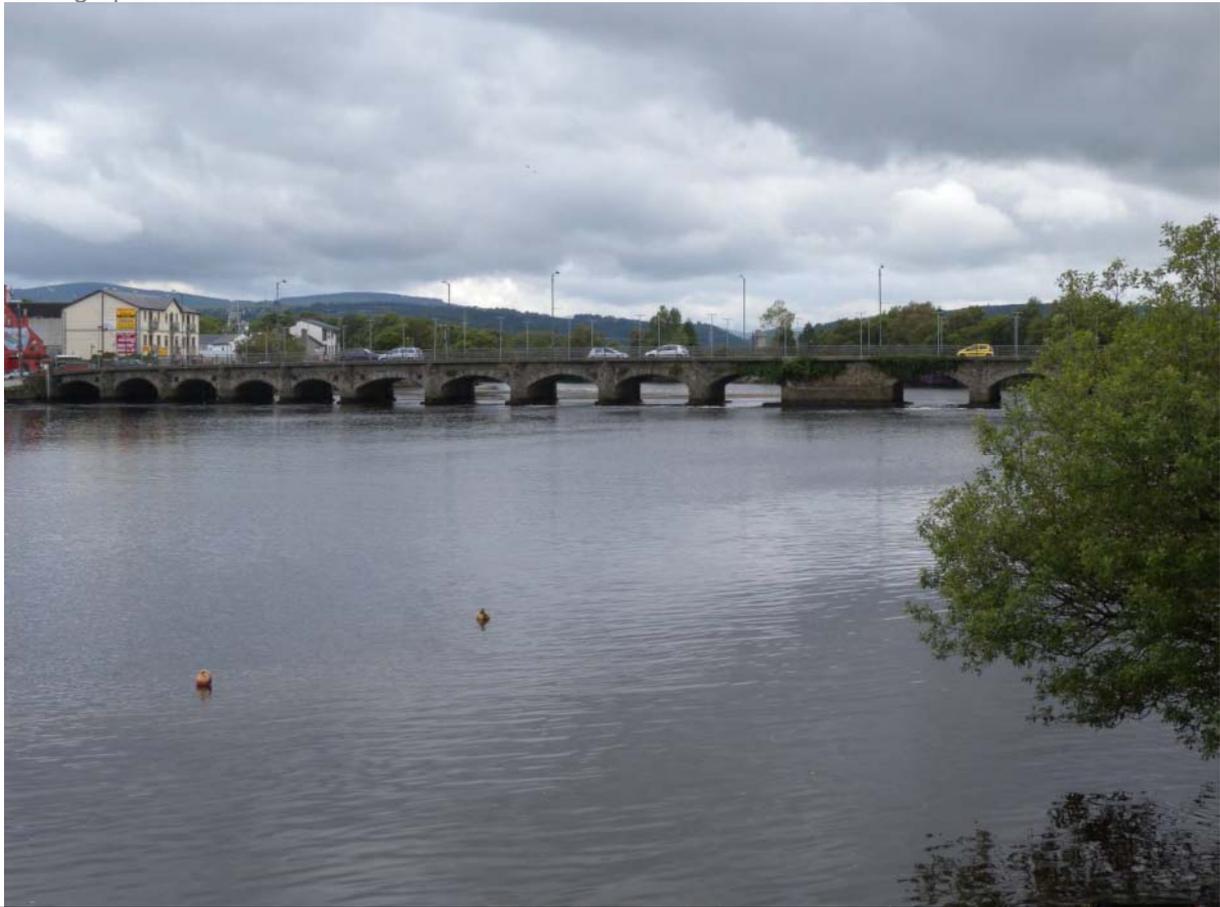
Photographs:

Definite flood risk, some minor works completed recently, evidence of individual property protection, some gaps in low flood wall along South Quay at slipways, looks like provision for stop logs but none observed.			
Definitely an AFA			
Size of river: . Varies		Channel vegetation: Variable, clear in lower reaches, more vegetated upstream	
Channel condition:		Structures:	
Flood defences: Low wall along south quay		Nature of flow: Tidal	
Nature of floodplain: Constrained		Floodplain vegetation:	
Properties: Numerous houses and commercial premises around dock area		Evidence of flooding: Flood stop boards fitted to houses on south green.

Arklow was originally listed as a Probable Area for Further Assessment with a FRI score of 2,994. Both the predictive flood mapping and the Local Authority comments confirm the existence of a flood risk in Arklow, particularly to the low lying areas around the harbour. During the site inspection individual property protection measures were observed along the South Quay. Consequently **Arklow should be an AFA.**

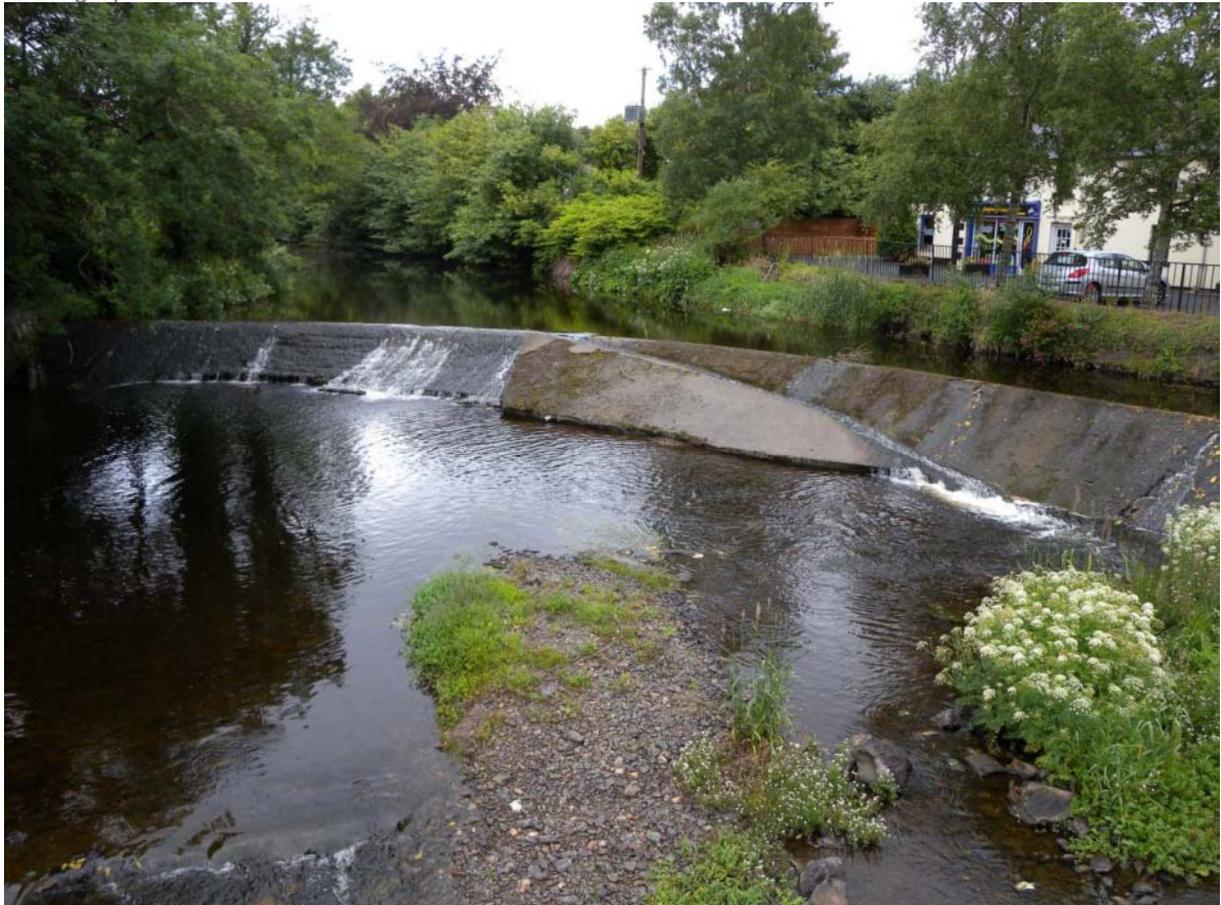
Photographs:

<u>Summary of Site Inspection</u>			
Site inspection observations: 22/06/11			
R763 3 arch bridge, wide flood plain downstream on right bank, steep left bank. Some properties on right bank, no obvious sign of flooding. N11 Ashford – weir immediately upstream, little freeboard to pub, also properties downstream extend right to river bank. Rathnew – river 5-6m wide x 1m deep, properties close by both banks upstream of N11 bridge.			
Size of river: 10m x 2m @ R763,		Channel vegetation: Overhanging trees/scrub	
Channel condition: -		Structures: Various bridges	
Flood defences: -		Nature of flow: -	
Nature of floodplain: Rural upstream, Urbanised lower		Floodplain vegetation: -	
Properties: -		Evidence of flooding: None

Ashford and Rathnew were originally listed as a Probable Area for Further Assessment with a FRI score of 1,442. The site inspection did not identify any reasons to significantly modify the extents of the PFRA predictive mapping, and discussions with the Local Authority confirmed some history of flooding, particularly during Hurricane Charley. Consequently it is recommended that **Ashford/Rathnew should be considered an AFA.**

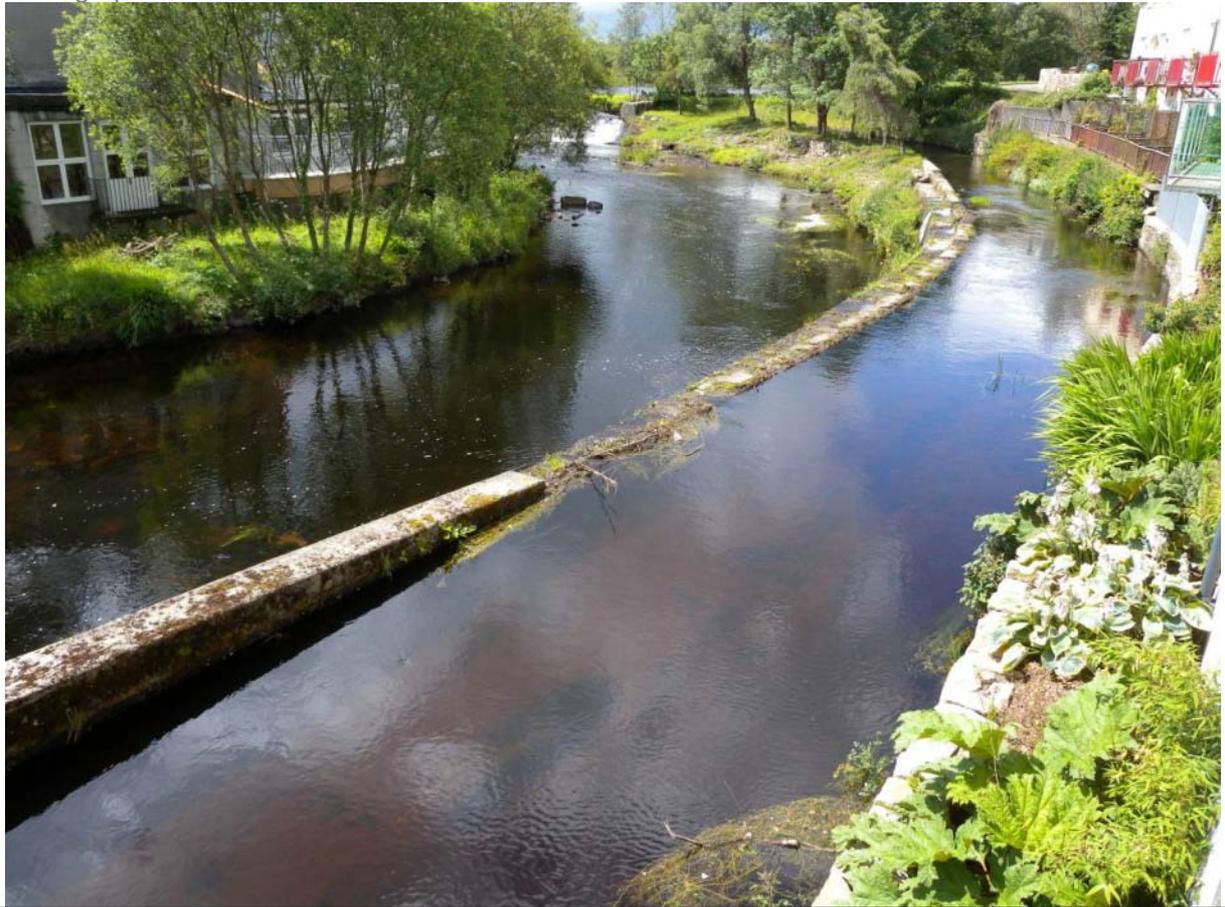
Photographs:

Site inspection observations: 22/06/11 Potential flood risk to low lying properties on right bank downstream of weir and bridge including Lawless hotel and Fogarty terrace.			
Size of river: 15-20m x 2m		Channel vegetation: Clear	
Channel condition: Gravel/armoured		Structures: Weir, bridge and mill race	
Flood defences: None evident		Nature of flow: Fast	
Nature of floodplain: Constrained		Floodplain vegetation: -	
Properties: Houses downstream and hotel?		Evidence of flooding: No

Aughrim was originally listed as a Probable Area for Further Assessment with a FRI score of 466. Historically flooding has been reported at Fogarty Terrace and Meath Terrace and the Local Authority reported having undertaken some remedial works. The site inspection confirmed the potential for flooding to properties such as the Lawless Hotel and the terraces mentioned previously. No reasons were found to significantly alter the PFRA predictive mapping and hence the FRI score consequently it is recommended that **Aughrim should be considered an AFA.**
