Eastern CFRAM Study

Flood Risk Review - Final Report

IBE0600-Rp0001-F02/Dec 2011

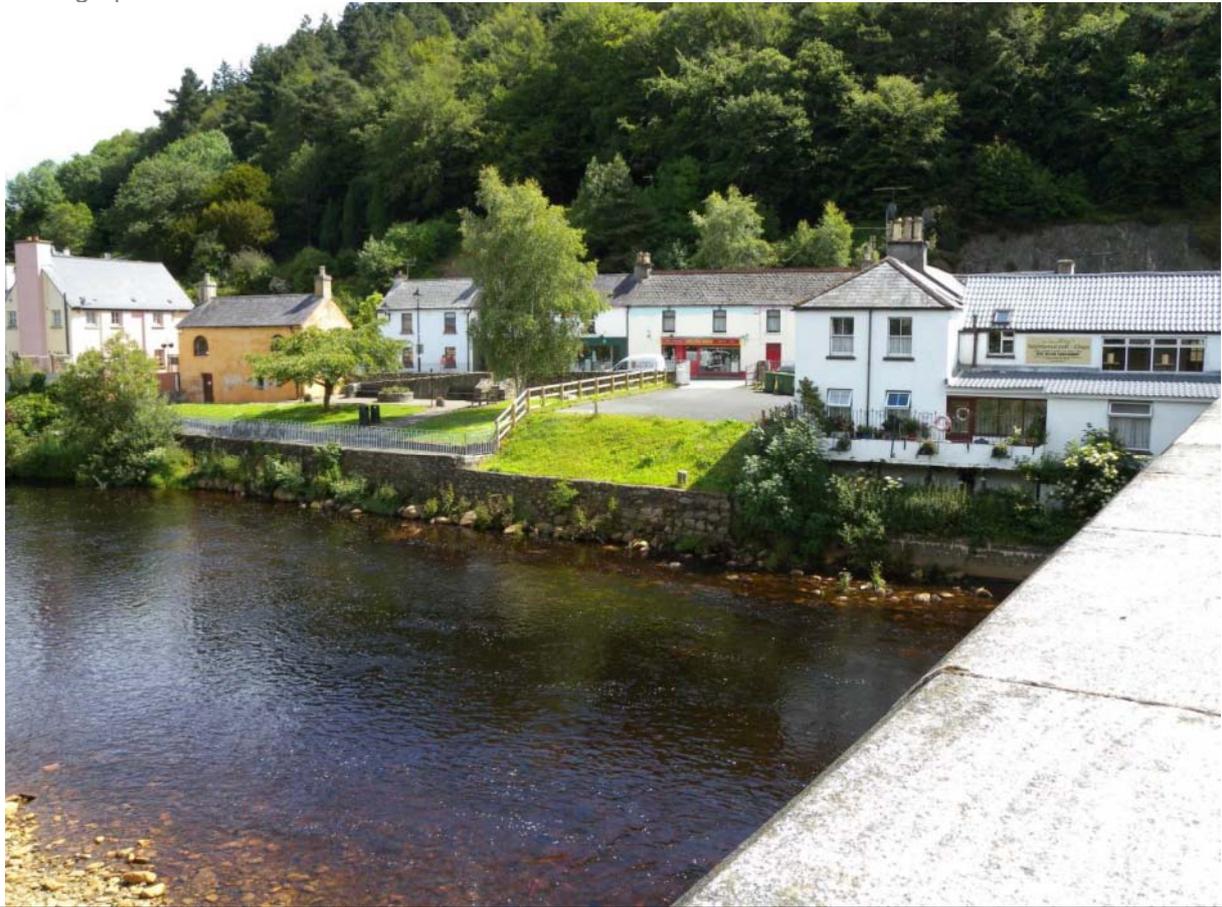
Photographs:

Site inspection observations: 22/06/11			
Flooding at Ballanagh Crescent/Close and Brook Meadow probably due to blockage or lack of capacity in one of many small culverts associated with multiple road crossings. Main bridge cannot have been completed destroyed in Hurricane Charley, as still is use, property located close to both river banks upstream and downstream therefore potential flood risk exists. Unclear how Station Road flooded without also flooding properties on left bank.			
Size of river: 20m x 3-4m		Channel vegetation: Clear – tree lined banks	
Channel condition: Gravel, stable		Structures: 3 arch bridge	
Flood defences: None visible		Nature of flow: Rapid	
Nature of floodplain: constrained		Floodplain vegetation: -	
Properties: Multiple particularly upstream		Evidence of flooding: Abandoned house Ballagh Close?

Avoca was originally listed as a Probable Area for Further Assessment with a FRI score of 413. There are three reports on www.floodmaps.ie relating to flooding in Avoca and the site inspection confirmed the potential flood risk on the minor stream at Brook Meadow. The flood risk from the main river is less certain however there are a number of properties close to the river on both banks and therefore some flood risk exists. Consequently it is recommended that **Avoca should be an AFA**

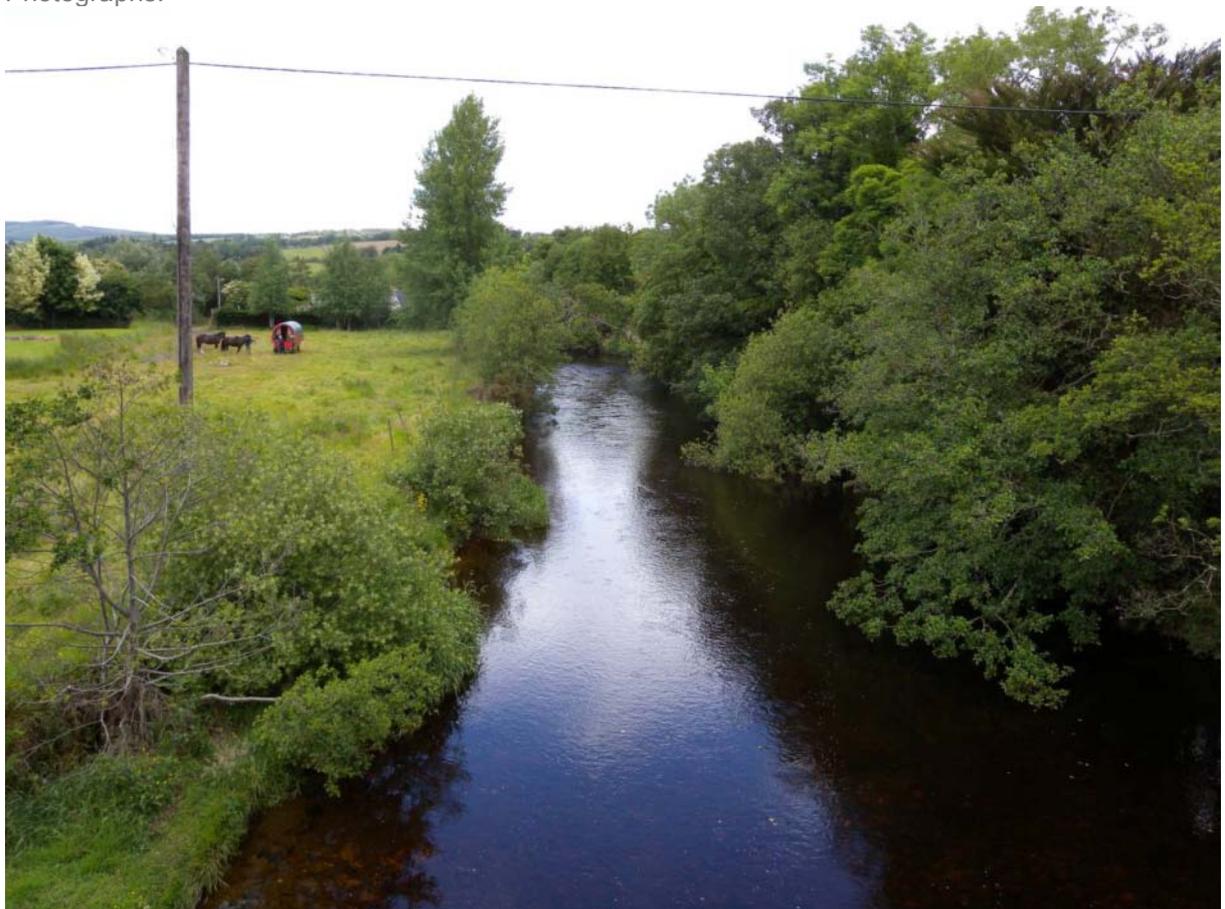
Photographs:

New housing @ Furnace Grove (RB u/s bridge) protected by earth embankment 1.5m to rear of gardens.			
WwTW on flood plain evidence of strand line on fence.			
Potential flood risk to two houses u/s bridge on LB?			
Size of river: 15-20m x 1-2m		Channel vegetation: Overhanging trees	
Channel condition: Gravel, stable?		Structures: 3 arch bridge	
Flood defences: Embankment to rear of houses		Nature of flow: -	
Nature of floodplain: Constrained		Floodplain vegetation: Grass/trees	
Properties: WwTW and 6-7 houses?		Evidence of flooding: Yes @ WwTW

Ballinaclesh was originally listed as a Possible Area for Further Assessment with a FRI score of 161. The only reported history of flooding relates to the WwTW although the site inspection indicated that potentially 8-10 houses may lie within the predicted floodplain (5 of these are protected by a low earth embankment). Evidence of recent flooding (flood wrack caught in fence) was observed at the WwTW however no reason was found to extend the PFRA predictive mapping or bring additional assets into the flood risk zone and hence increase the FRI score. Consequently it is recommended that **Ballinaclesh should not be considered an AFA.**

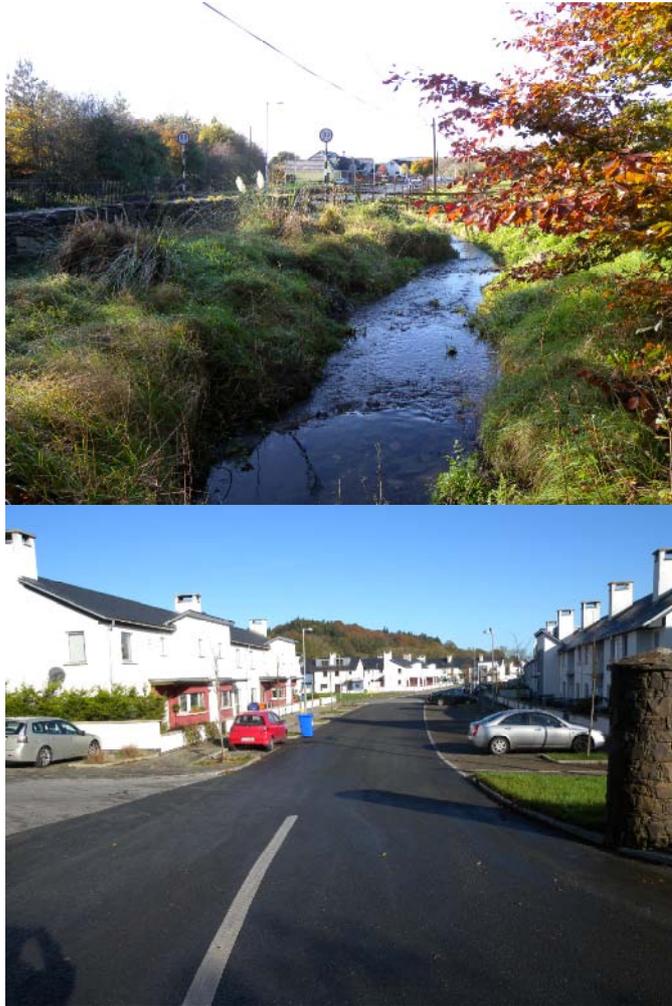
Photographs:

Upstream of Glending Estate, open water course runs "parallel" to R410, to pond one field above Glending Estate. Area of open water in field discharges to 250-300mm dia conc pipe heading towards Glending Estate. Investigations within Glending Estate established incoming pipe carrying watercourse is circa 750mm dia but changes to 450mm dia prior to exiting Estate and flowing along R410 to unknown discharge point. Large drainage channel at green in Glending Estate to intercept overland flow from NE, attempt at provision of flood wall along boundary of Estate has gap, some debris observed in fence. 8-10 houses abandoned in Glending Way due to frequent flooding, sand bags stored at virtually all houses along Glending Way (circa 21 additional properties).			
Housing @ Killmalum Drive/Way/Avenue, site infilled (2-3m) stream culverted through development (circa 1.8m dia), reinforced concrete walls retain fill and provide flood protection, no likely risk to properties. Potential flood risk to three properties further downstream after stream crosses Killmalum Road also new school built adjacent to stream further down Killmalum Road, possible flood risk although property appears to be elevated relative to stream levels.

Size of river: 1-1.5m wide 2+m deep upstream		Channel vegetation: Vegetated	
Channel condition: Modified		Structures: Culverts	
Flood defences: No specific defences		Nature of flow: Steep	
Nature of floodplain: -		Floodplain vegetation: Sub urban and grass fields	
Properties: Apartments u/s R410 Housing development @ Killmalum		Evidence of flooding: No

Blessington was originally listed as a Possible Area for Further Assessment with a FRI score of 1,220. There are numerous small streams that flow through Blessington, and at the time of the site inspections they were all either dry or had low flows. A stream flowing from the north west through the Glending Estate, is shown by the PFRA analysis to represent a significant flood risk in Blessington. However downstream of Glen Ding Way this channel was dry and heavily grassed suggesting that it doesn't convey flow very often. Work has been carried out during the construction of the Glending Estate resulting in the watercourse being re-routed to avoid the housing areas downstream. Consequently the predicted flood extent for this stream downstream of Glending Estate is questionable and it is unlikely that there is a flood risk to the housing at Deerpark. Further downstream after a couple of additional small streams have joined the watercourse is culverted through a major recent housing development at Kilmalum Road, the houses here are elevated and are unlikely to flood. Downstream of Kilmalum Road three houses and a new school are situated adjacent to the stream and consequently may be subject to flood risk. Flood damage has also been assigned to monuments however on inspection no monuments lie within the predicted floodplain. Correcting the FRI calculations for all of the above reduces the overall score to circa 350 due principally to the location of the new school. It is therefore recommended that **Blessington should be considered an AFA.**

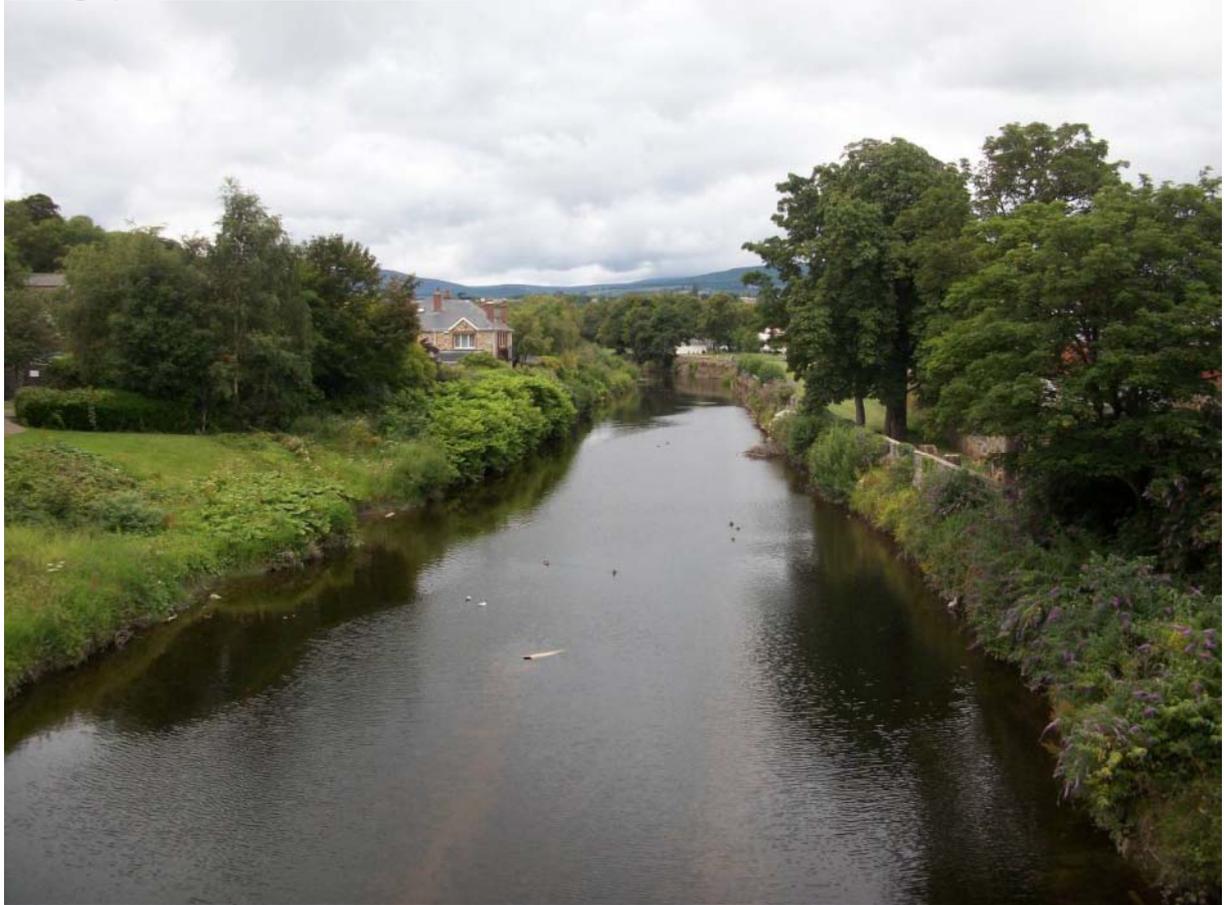
Photographs:

Size of river: 20m x 5m		Channel vegetation: Low veg	
Channel condition: -		Structures: Road bridges	
Flood defences: -		Nature of flow: Mod flow	
Nature of floodplain: -		Floodplain vegetation: Urban and parkland	
Properties: Residential and commercial		Evidence of flooding: None

Bray was originally listed as a Probable Area for Further Assessment with a FRI score of 4,381. Significant flooding is shown by the PFRA predictive mapping for the River Dargle and associated tributaries. Flood reports on www.floodmaps.ie show the historical flood extent from the River Dargle to be larger than the predicted 0.1%AEP flood extent from the PFRA predictive modelling, however there was no evidence on site of the minor watercourse shown in the PFRA predictive modelling to join the Dargle at Bray Bridge. An error in the calculation of the FRI score was identified for Bray and it is more likely that the overall FRI score would be approximately 1860. If the predicted flooding from the minor watercourse that could not be found on site is excluded from the FRI calculation the score would be further reduced to 940. However given that the historical flood extent is larger than the predicted 0.1%AEP flood extent it is likely that the flood extent in Bray has been underestimated and consequently the FRI score should be robustly greater than 250. Therefore it is recommended that **Bray should be considered an AFA.**

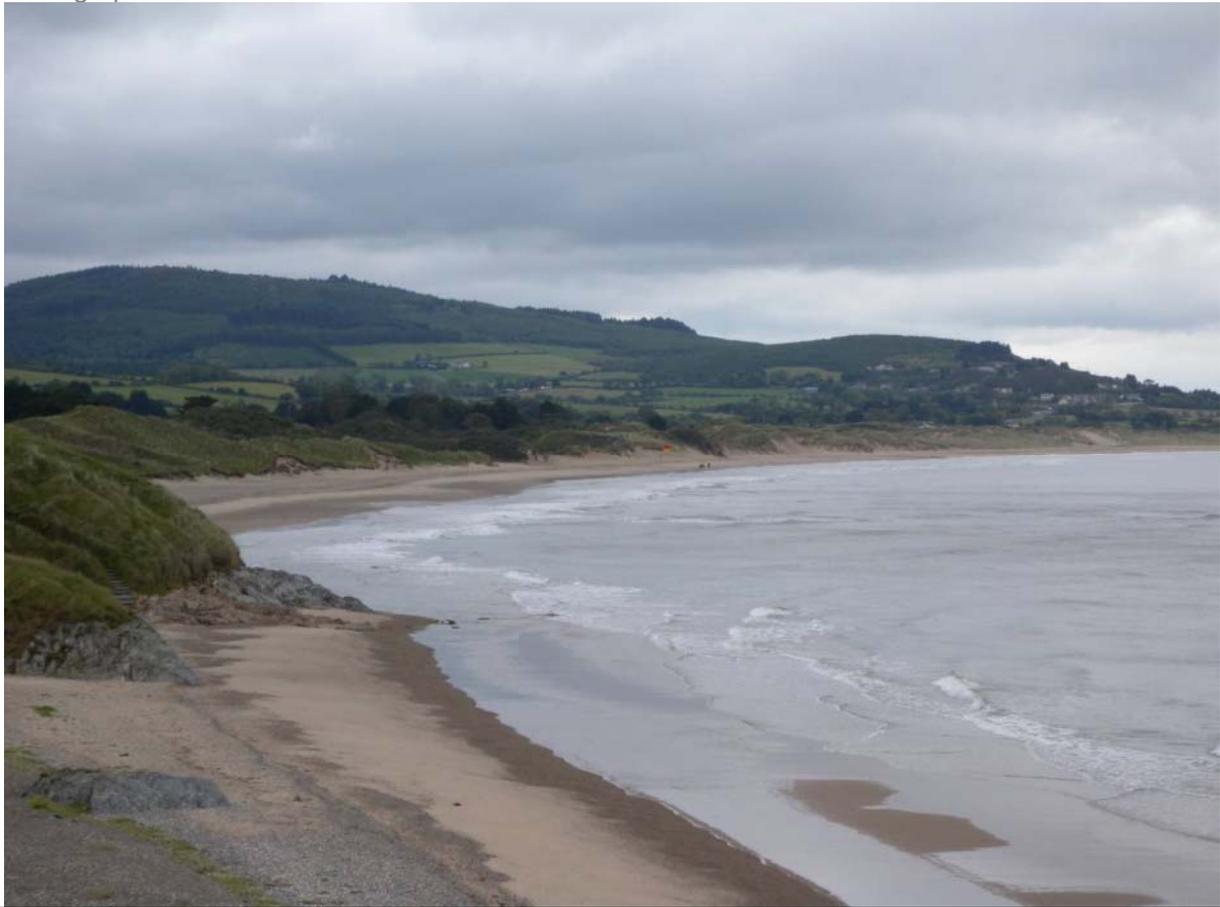
Photographs:

Site inspection observations: 22/06/11 Small watercourse at southern end of beach, unlikely to represent a significant flood risk to any properties. Main risk appears to be associated with erosion of dune which could lead to increased coastal flood risk to low lying properties behind.			
Size of river: 2m x 1-1.5m		Channel vegetation: Heavily vegetated	
Channel condition: N/A		Structures: N/A	
Flood defences: Natural dune system		Nature of flow: Stagnant	
Nature of floodplain: -		Floodplain vegetation: -	
Properties: Low lying housing along road		Evidence of flooding: -

Brittas Bay originally listed as a Possible Area for Further Assessment following receipt of comments from Local Authority on possible flood risk to a number of properties. No FRI score was given in the PFRA database and no records of historic flooding were found on www.floodmaps.ie and this was confirmed during discussions with the Local Authority. The site inspection and discussions with the Local Authority identified the risk at Brittas Bay to be related to coastal erosion and the potential loss of the coastal dune system that presently prevents tidal flooding of the properties behind. As there is presently no actual flood risk at Brittas Bay it is recommended that **Brittas Bay should not be considered an AFA.**

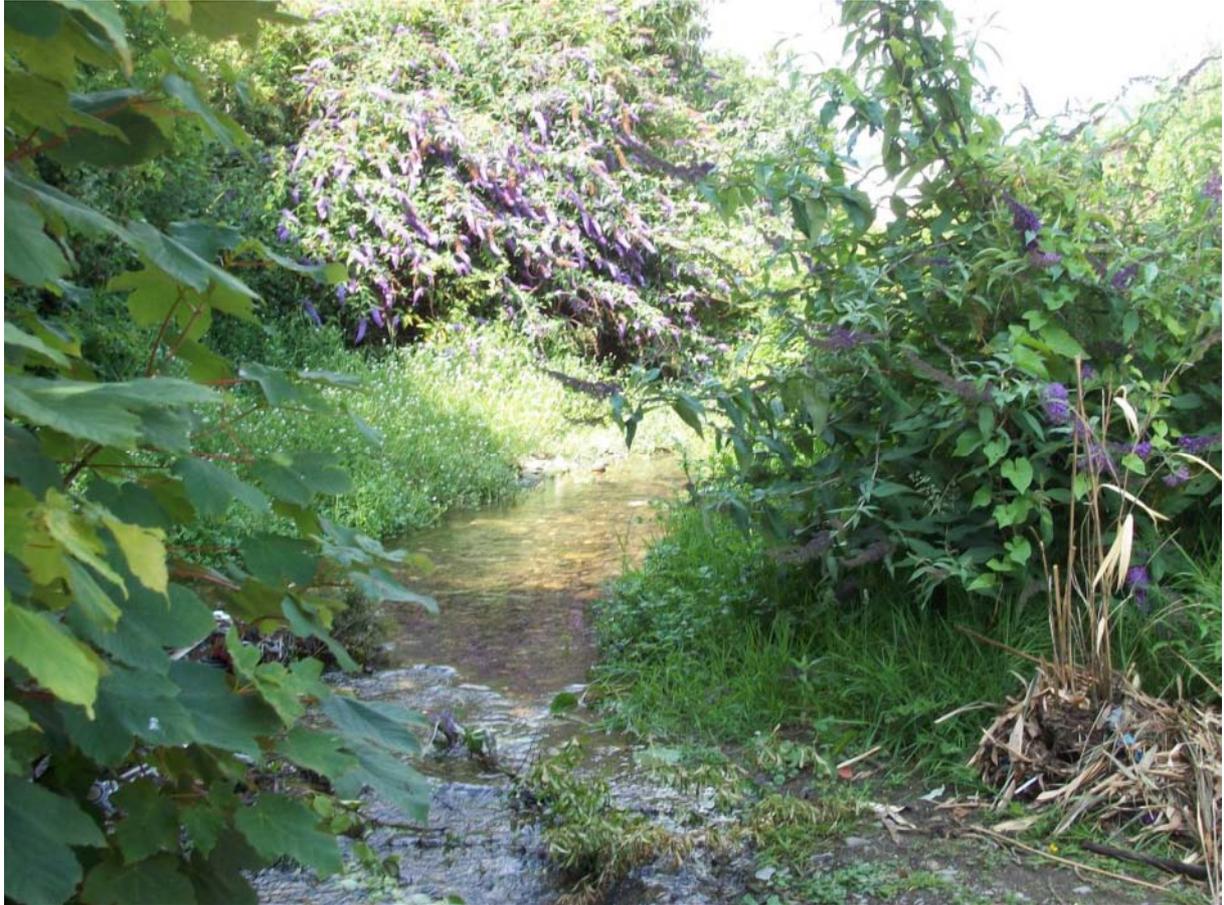
Photographs:

Size of river: 2.5m (w) 1m (d)		Channel vegetation: Mod dense veg	
Channel condition: -		Structures: Kilcoole rd br – low blockage risk Bypass br – low blockage risk	
Flood defences: -		Nature of flow: Slow to moderate	
Nature of floodplain: Widens DS of Kilcoole rd br		Floodplain vegetation: Short grass or urban	
Properties: Residential housing estate		Evidence of flooding: none

Charlesland was originally listed as a Possible Area for Further Assessment with a FRI score of 3,840. Two housing estates are shown to be within the predicted flood extent at Charlesland. The predicted flood extents look to be inaccurate as there are wedges present and the 10%AEP, 1%AEP and 0.1%AEP extents are exactly the same. Historical records on www.floodmaps.ie show that the Burnaby housing estate flooded in November 2003 causing significant damage. The fields upstream of the Burnaby housing estate are low lying beside the river and look to be a natural floodplain. By continuing this estimated floodplain through the housing estate and eliminating the wedges produced in the predictive flood model we can exclude the houses unlikely to flood while keeping the houses likely to have flooded previously. Even with this modification the FRI score within the Burnaby estate alone is still greater than 250. It is therefore recommended that **Charlesland should be considered an AFA**, however there is scope for it to be combined with Greystones Probable AFA.

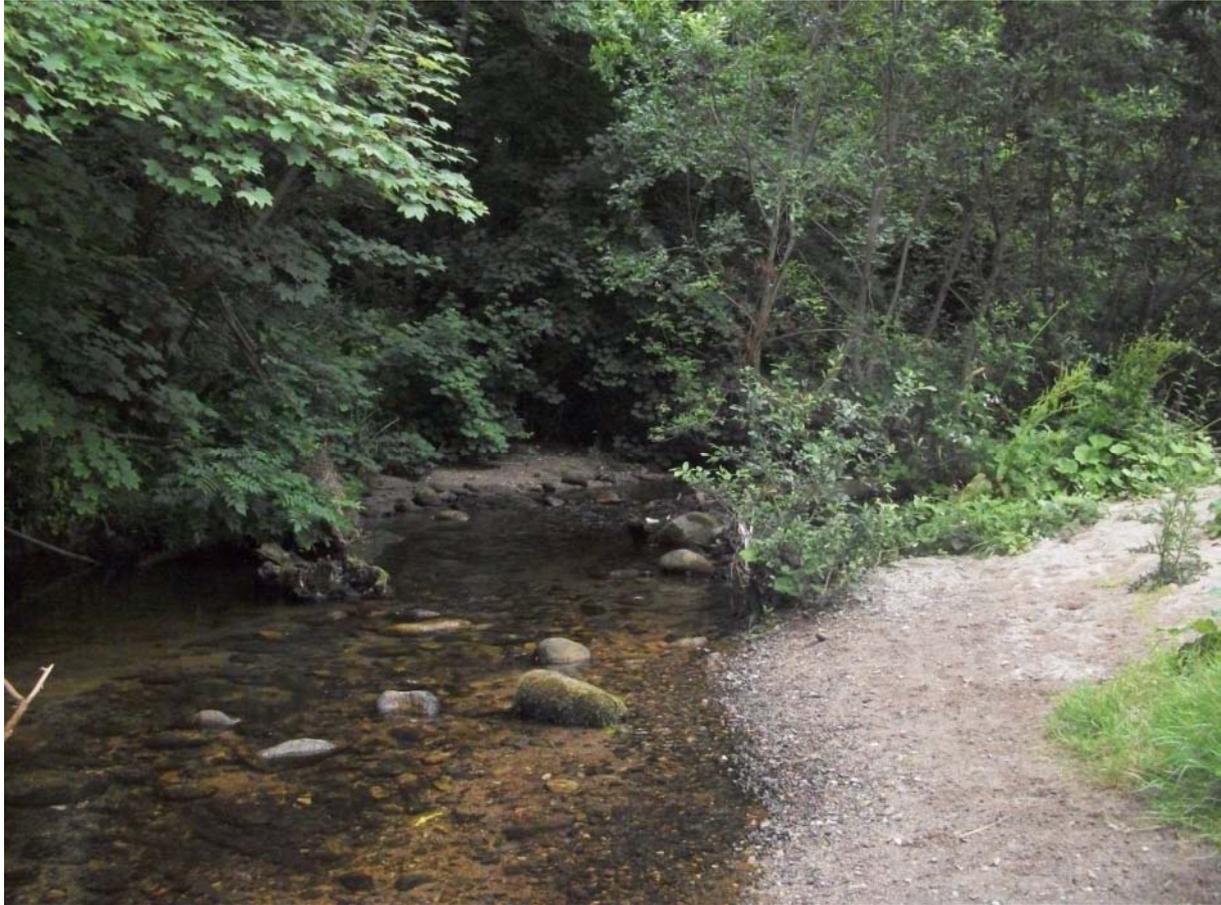
Photographs:

A local resident did highlight a small trib that causes flooding at the Mill Field housing estate. This has not been included in the PFRA predictive mapping.			
Size of river: 8m x 8m		Channel vegetation: Mod veg with trees	
Channel condition: -		Structures: Road bridge	
Flood defences: -		Nature of flow: Low flow	
Nature of floodplain: -		Floodplain vegetation: -	
Properties: Residential and commercial		Evidence of flooding: None

Enniskerry was originally included as a Probable Area for Further Assessment with a FRI score of 380. On review it was noted that the occurrence of out of bank flooding on the Glencullen River through Enniskerry was questionable due to the observed large in-channel capacity. The natural river banks are approximately 8m above the channel bed through Enniskerry. A basic channel capacity assessment indicates that the Glencullen River is likely to be able to convey a flow of in excess of the 0.1%AEP flow through Enniskerry. While the channel capacity assessment is considered very approximate it does give an indication that the channel would be able to convey the 10%AEP flow and that the 10%AEP flood damage should be removed from the FRI score. This reduces the FRI score from 380 to 74 and it is therefore recommended that **Enniskerry should not be considered an AFA.**

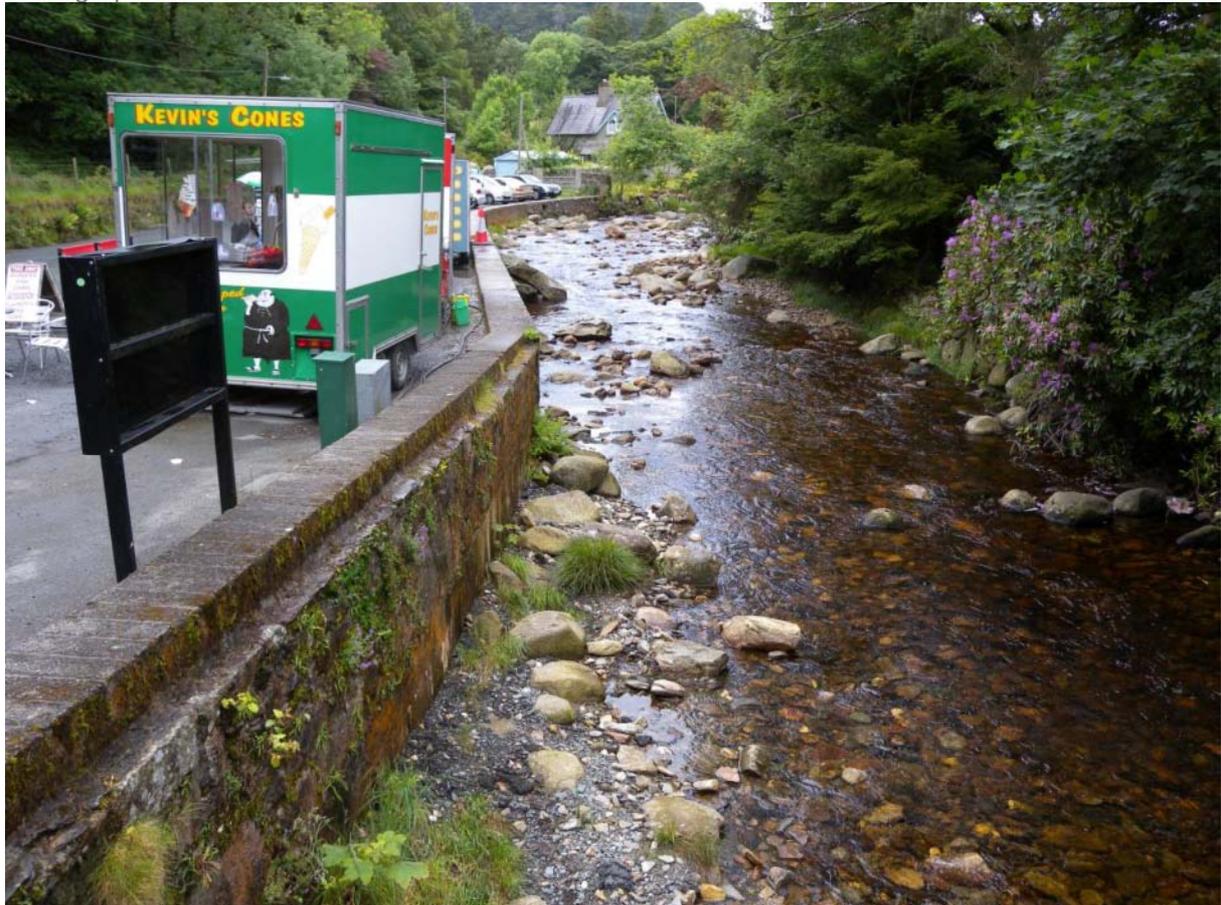
Photographs:

Site inspection observations: 22/06/11			
Hotel & visitor centre situated on natural flood plain, and capacity issue with road bridge upstream of hotel will cause river to flood car park on right bank and potentially cross road to flow across front of Hotel.			
Size of river: 6-8m x 1m		Channel vegetation: None	
Channel condition: Exposed gravel/cobble		Structures: 2 arch bridge	
Flood defences: None		Nature of flow: Rapid	
Nature of floodplain: constrained		Floodplain vegetation: Grass and trees	
Properties: Hotel and visitor facilities		Evidence of flooding: None visible

Glendalough was originally listed as a Possible Area for Further Assessment with a FRI score of 753. Discussions with the Local Authority confirmed that the Hotel and OPW interpretative centre had flooded in the past, however this was not considered a significant flooding problem. The site inspection confirmed the potential flood risk to the various tourist amenities, the river actually flows below the entrance to the hotel, however given that the flood risk is primarily associated with risk to historic monuments (two ruined Churches lie within the 0.1%AEP PFRA predictive mapping) and individual receptors **Glendalough is not considered an AFA.**

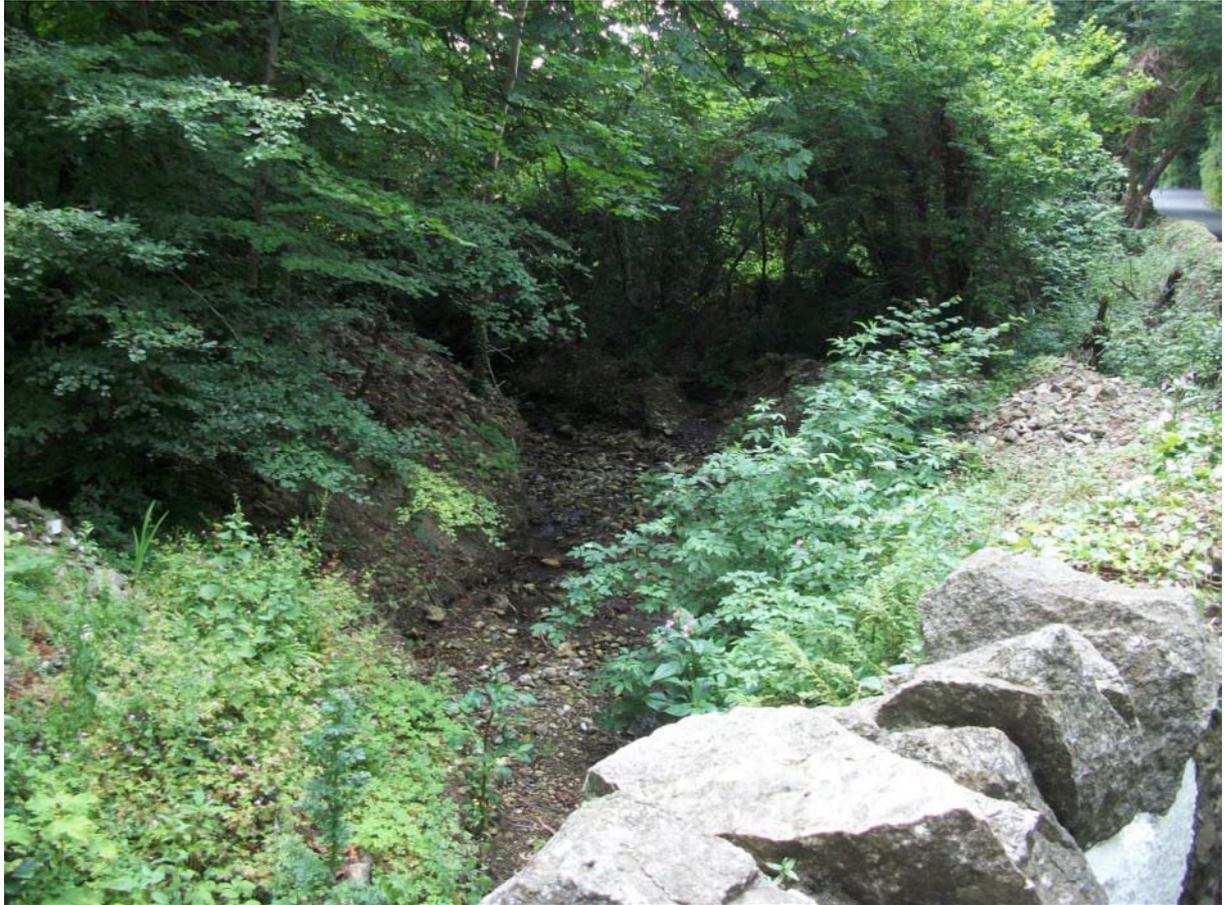
Photographs:

Size of river: 2m (w) 2m (d)		Channel vegetation: Long grass US, dense veg DS	
Channel condition: Erosion in Redford estate		Structures: Numerous culverts	
Flood defences: -		Nature of flow: Mod flow	
Nature of floodplain: Fairly steep and constricted		Floodplain vegetation: Long grass or urban	
Properties: Residential housing		Evidence of flooding: Rebuilt walls

Greystones was originally identified as a Probable Area for Further Assessment with a FRI score of 1,180. There are two sources of flood risk at Greystones tidal and fluvial. Historical flood records confirm that flooding has occurred in the past from both sources, the stream flowing under Redford Bridge has caused flooding in the past which has knocked down garden walls. The stream at Mount Haven looks to be culverted and although the houses are in a hollow it looks unlikely that they will flood. Removing these 30 properties from the FRI score reduces it from 1180 to 880. However it is still recommended that **Greystones should be considered an AFA.**

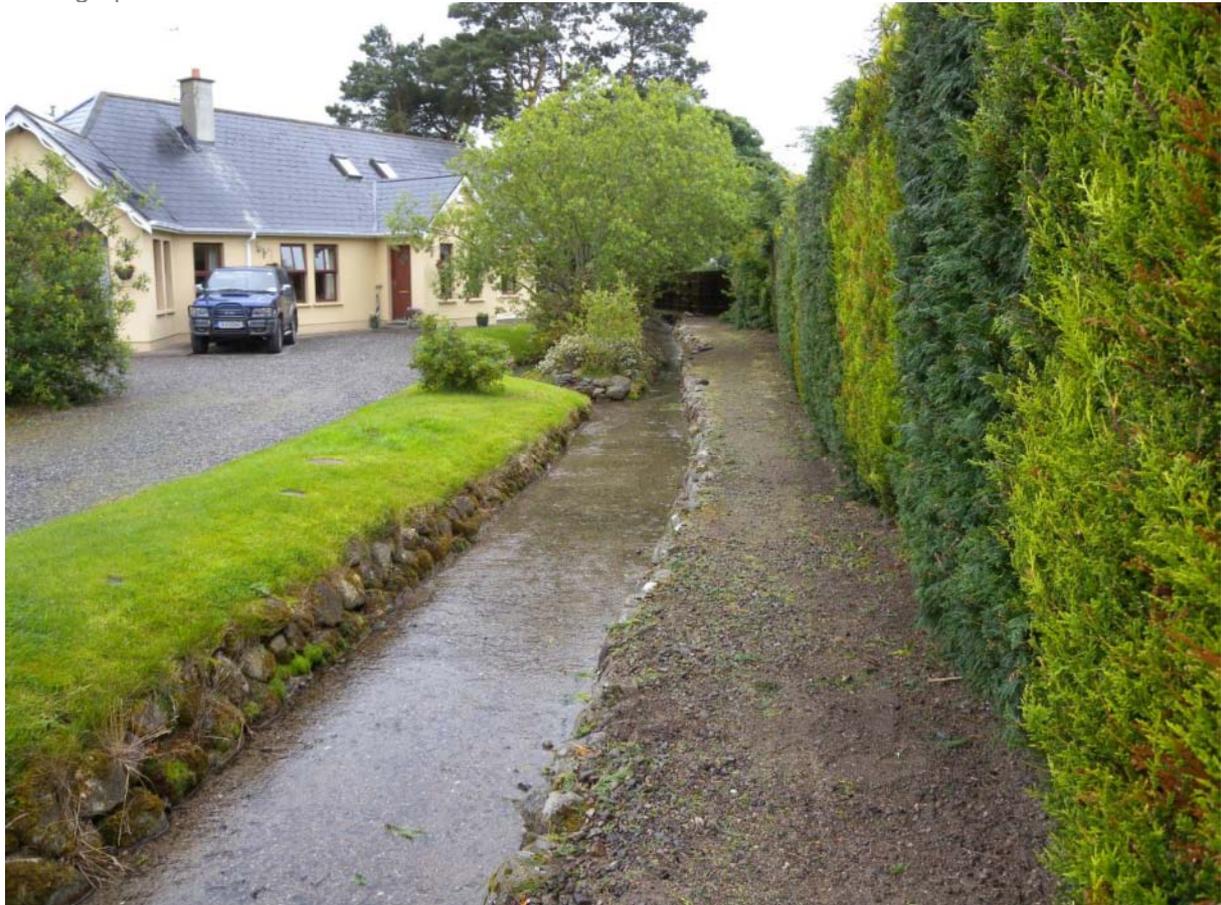
Photographs:

Size of river: 1m x 0.3m		Channel vegetation: None	
Channel condition: Eroding - gravel		Structures: Bridge/culvert	
Flood defences: No		Nature of flow: Rapid	
Nature of floodplain: Constrained RB, wide LB		Floodplain vegetation: Gardens & grass	
Properties: 2-3 houses & pub		Evidence of flooding: No

Hollywood was originally listed as a Possible Area for Further Assessment with a FRI score of 471, due principally to the PFRA predictive mapping including a primary school within the 10%AEP flood outline. Hollywood is affected by a small mountain stream and although it is likely to be flashy it is unlikely to flood any more properties than that shown in the PFRA predictive mapping. The PFRA predictive mapping shows a wedge extending out and including the school, however given the storage available from the field between the stream and the school it is considered unlikely that the school would be at risk during a 10%AEP flood event. Historical flood records show that some roads have experienced flooding in the past but no properties, which strengthens the assumption that the school is not at risk from a 10%AEP flood event. Removing the school from the FRI calculation reduces the Hollywood score to 221. Consequently it is recommended that **Hollywood should not be considered an AFA.**

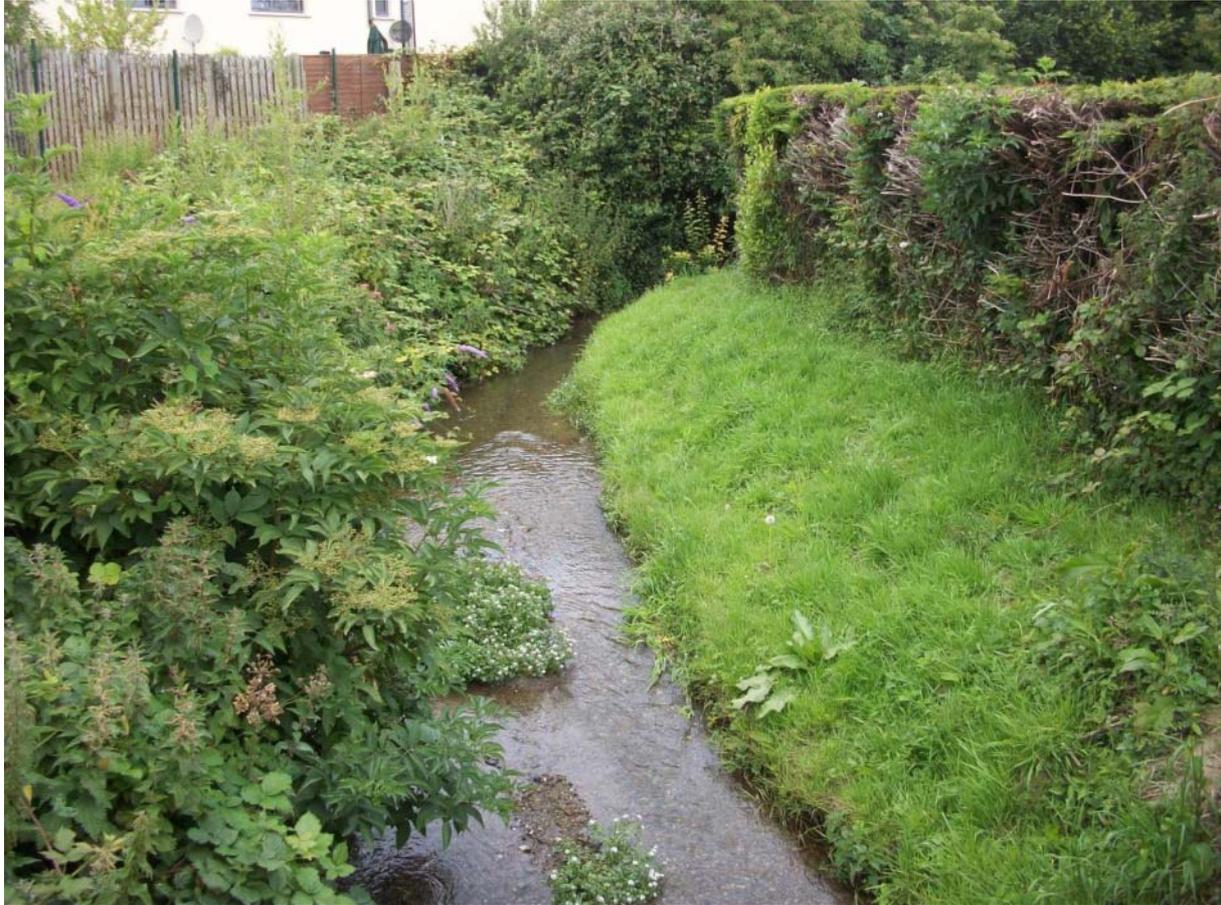
Photographs:

Size of river: 3m x 2m		Channel vegetation: Dense veg	
Channel condition: -		Structures: culverts	
Flood defences: -		Nature of flow: Mod flow	
Nature of floodplain: -		Floodplain vegetation: Urban	
Properties: Residential		Evidence of flooding: None

Kilcoole was originally listed as a Possible Area for Further Assessment with a FRI score of 3,405. Site inspection revealed that the route of the watercourse flowing through Kilcoole and shown in the PFRA predictive mapping is incorrect. This watercourse has been diverted to join another stream which flows through Kilcoole. Consequently the entire predicted flood extent at Kilcoole can be considered inaccurate and the FRI scoring incorrect. The actual route of the watercourse that flows through Kilcoole was not modelled as part of the PFRA hence the flood risk is therefore unknown. www.floodmaps.ie records that properties were affected by flooding in the Beechdale Estate which is adjacent to the actual watercourse through Kilcoole and suggests that a flood hazard exists. On this basis it is recommended that **Kilcoole should be considered an AFA.**

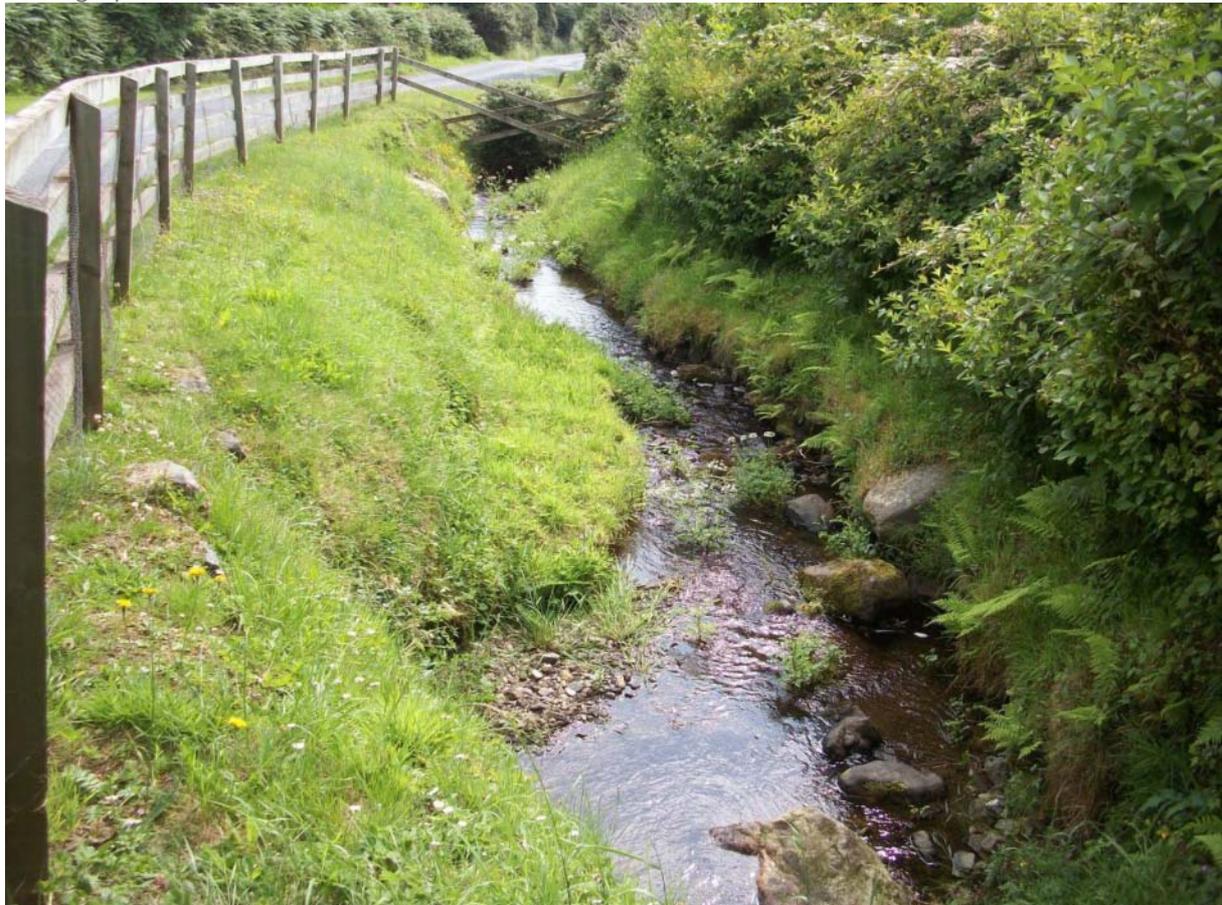
Photographs:

Size of river: 3m x 2m	Channel vegetation: Mod – dense veg
Channel condition: -	Structures: Culverts
Flood defences: -	Nature of flow: Low flow
Nature of floodplain: Steep and restricted	Floodplain vegetation: Grass fields
Properties: Residential	Evidence of flooding: None

Killiskey was originally listed as a Possible Area for Further Assessment with a FRI score of 152. Killiskey is located on the side of a hill and the stream flowing through it is relatively steep and can be expected to be flashy. With this in mind the flood extent shown in the PFRA predictive mapping looks reasonable however a couple of houses look well raised and may not be at risk. The PFRA predictive mapping at this point takes the form of a wedge which may suggest it is inaccurate. The FRI score is not expected to increase from 152 and therefore it is recommended that **Killiskey should not be considered an AFA.**

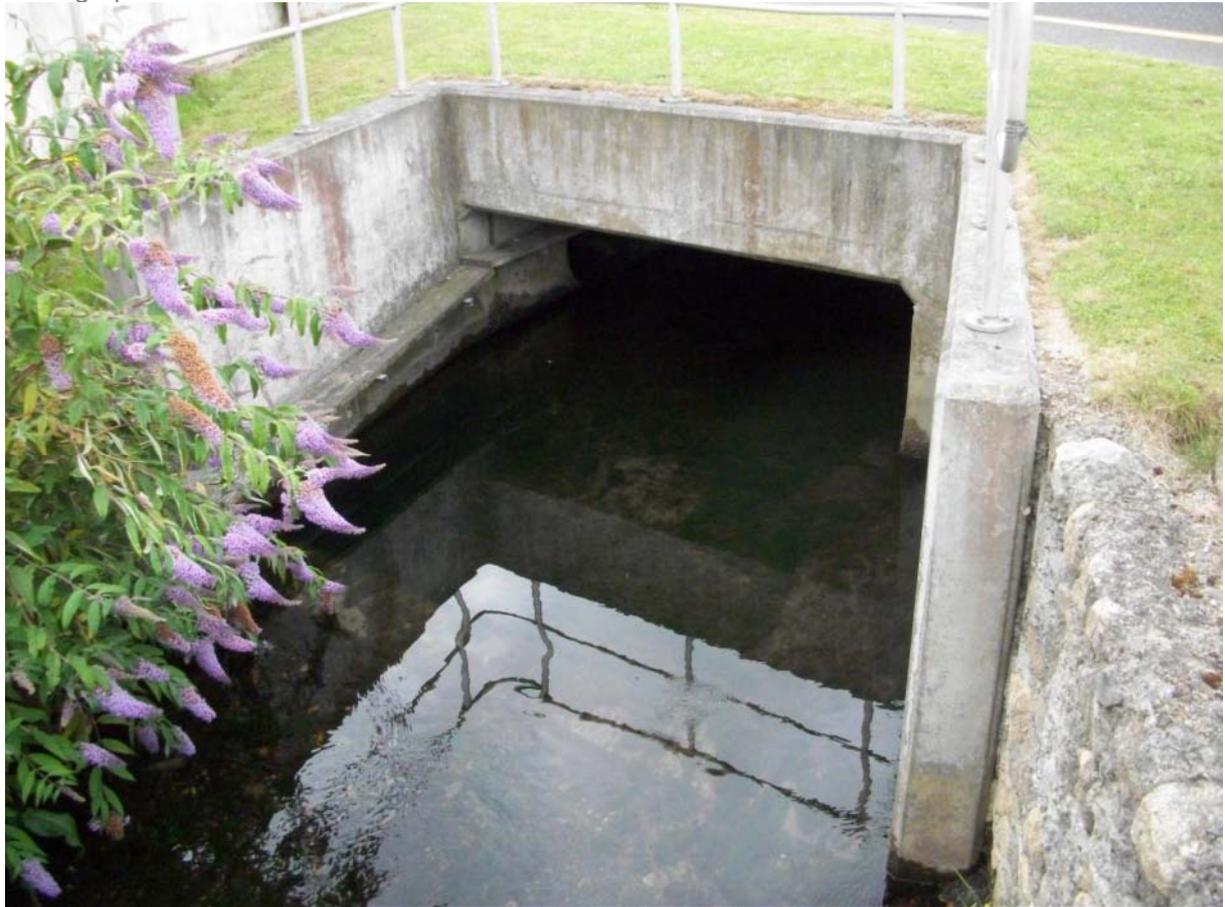
Photographs:

Size of river: 2.5m (w) 2m (d)		Channel vegetation: Dense veg	
Channel condition: -		Structures: Culverts	
Flood defences: Attenuation pond		Nature of flow: Low flow	
Nature of floodplain: Narrow		Floodplain vegetation: Dense veg	
Properties: Residential and commercial		Evidence of flooding: None

Kilmacanoge was originally listed as a Possible Area for Further Assessment with a FRI score of 160. The PFRA predictive mapping shows the stream flowing through Kilmacanoge to affect 13 properties. The predicted flood extent for the 10%AEP, 1%AEP and 0.1%AEP events are exactly the same and which may suggest some instabilities in the model. An attenuation pond is located at the upstream extent of Kilmacanoge and is likely to reduce flows and hence flood risk. Therefore it is likely that the FRI score could be reduced from the currently predicted 160 and consequently **Kilmacanoge should not be considered an AFA.**

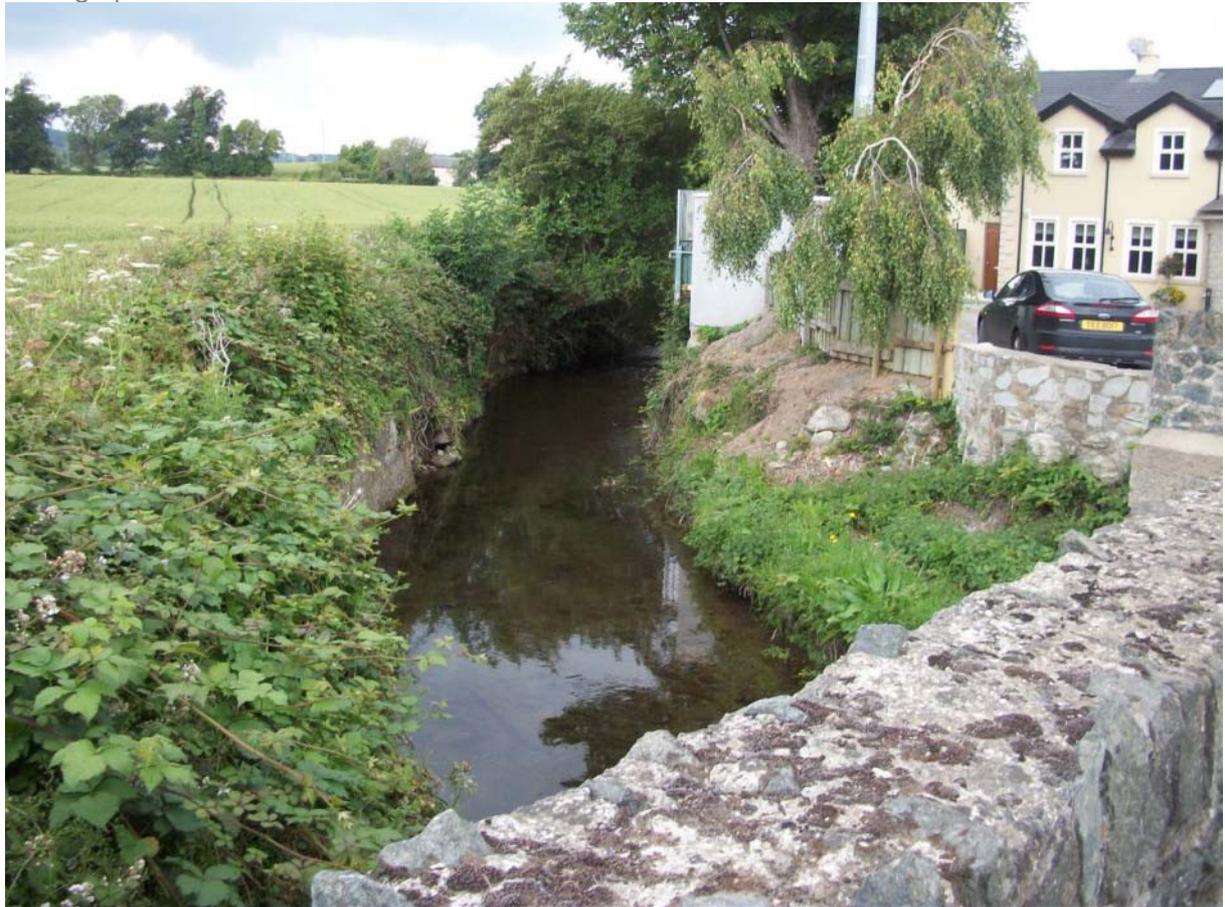
Photographs:

Size of river: 8m x 4m		Channel vegetation: Mod – low veg	
Channel condition: -		Structures: Road bridges	
Flood defences: -		Nature of flow: Low flow	
Nature of floodplain: flat		Floodplain vegetation: Rural fields	
Properties: Residential and commercial		Evidence of flooding: None

Newcastle was originally listed as a Possible Area for Further Assessment with a FRI score of 537. The PFRA predictive mapping at Newcastle look reasonable until 0.5km down the Sea Road when it spreads out over a large area which may not be correct. However the flood damage affecting the FRI score is contained within the part of the flood extent which looks reasonably accurate. The site inspection showed that the actual channel is small and the surrounding land is very flat thus any out of channel flow will spread widely. Historical flood records also confirm that the Sea Road floods regularly, therefore there is no strong evidence for reducing the FRI score of 537.5. Consequently it is recommended that **Newcastle should be considered an AFA.**

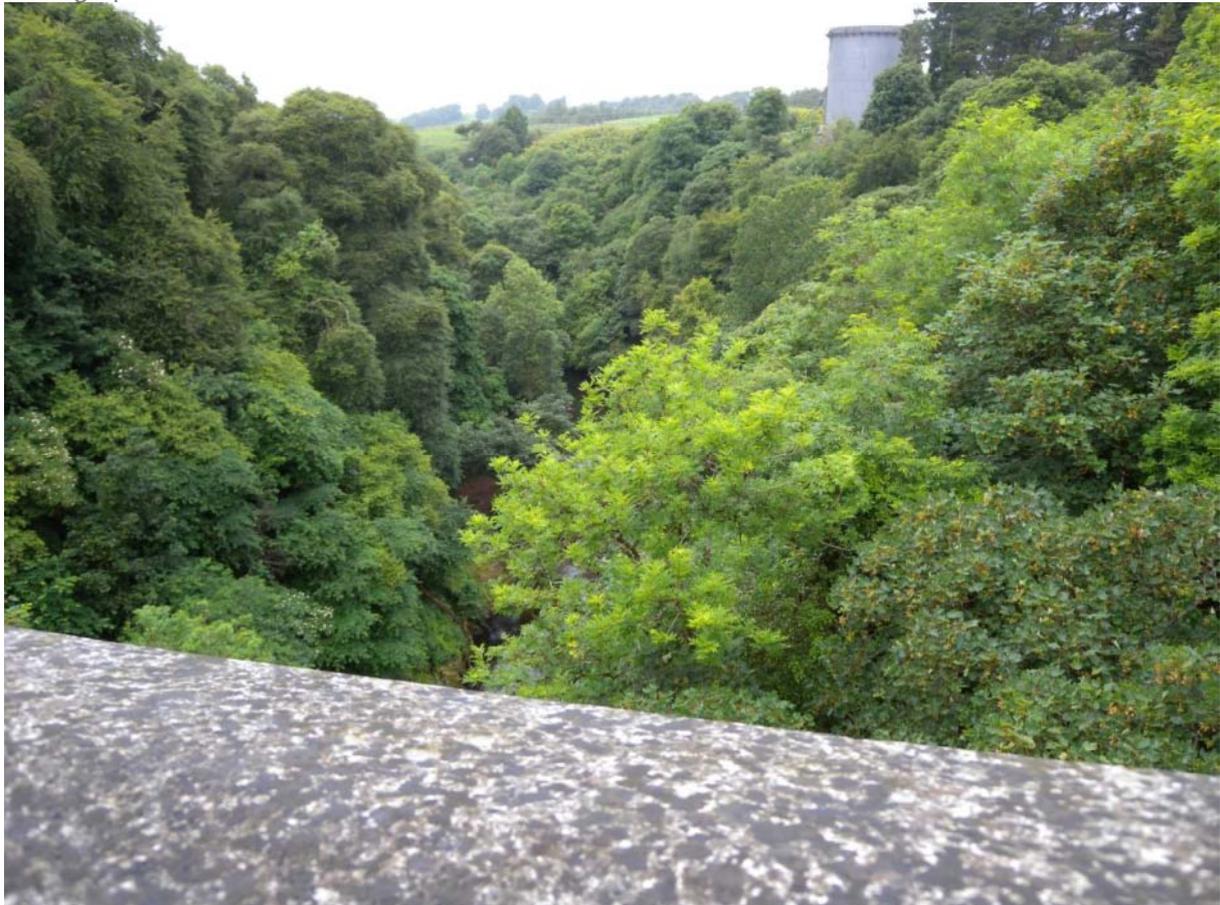
Photographs:

Google indicates power house located in bottom of ravine adjacent to river, potential flood risk if excess water released from dam upstream			
Size of river: Deep gorge difficult to estimate		Channel vegetation: -	
Channel condition: -		Structures: Road bridge	
Flood defences: Dam upstream		Nature of flow: Mod flow	
Nature of floodplain: Gorge		Floodplain vegetation: Forested	
Properties: Power station		Evidence of flooding: None

Pollaphuca is an ESB generating station and was included in the original list of sites as an Individual Risk Receptor with a FRI score of 25,000. The majority of the infrastructure at Pollaphuca station is located at the top of a gorge which the Liffey flows through immediately after Pollaphuca Dam. As the river is controlled by the dam most of the infrastructure appears to be well raised it is recommended that **Pollaphuca should not be considered an AFA.**
