Eastern CFRAM Study

Flood Risk Review - Final Report

IBE0600-Rp0001-F02/Dec 2011

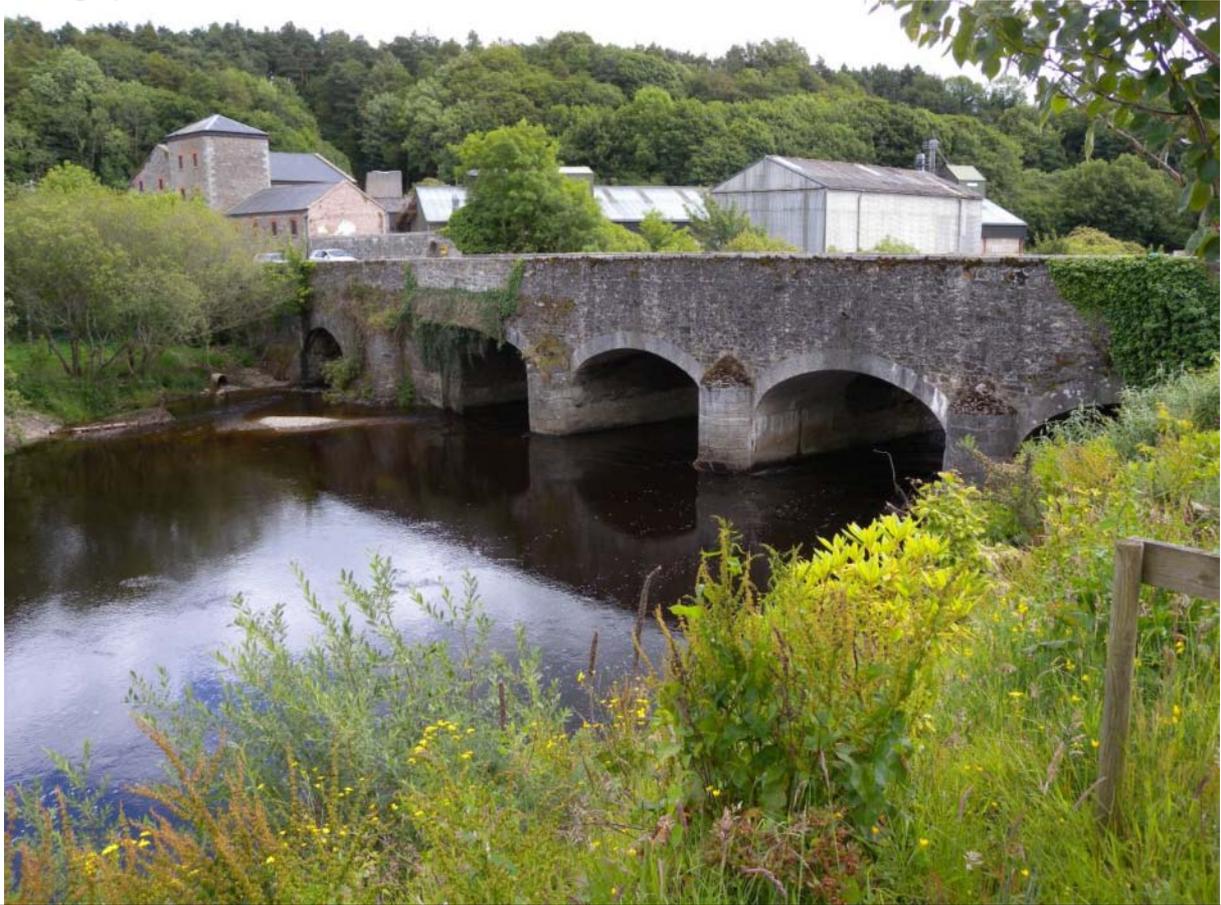
Photographs:

Site inspection observations: 22/06/11			
PRFA flood polygon shown extending toward village incorrect, ground rises steeply from river at this point.			
Wide flood plain on RB immediately d/s of bridge, zoned for development but potentially at flood risk.			
Flood plain u/s of bridge contains caravan site, holiday chalets and public amenity site all potentially at flood risk, also possibly Glanbia facility on LB d/s and new retail/apartment units on RB.			
Size of river: 30m x 1m		Channel vegetation: Little	
Channel condition: LB eroding		Structures: Multi arch bridge	
Flood defences: None obvious		Nature of flow: rapid	
Nature of floodplain: Constrained at bridge, wide u/s and d/s		Floodplain vegetation: Grass and trees	
Properties: Caravans and chalets		Evidence of flooding: No

Rathdrum was originally listed as a Possible Area for Further Assessment with a FRI score of 197. Rathdrum bridge is known to have caused flow on the Avonmore River to have backed up during high flow events e.g. Hurricane Charley. The PFRA predictive mapping incorrectly shows a wedge of flooding extending towards the village which is actually located on top of a hill therefore if anything the FRI score may be over-estimated. Consequently it is recommended that **Rathdrum should not be considered an AFA.**

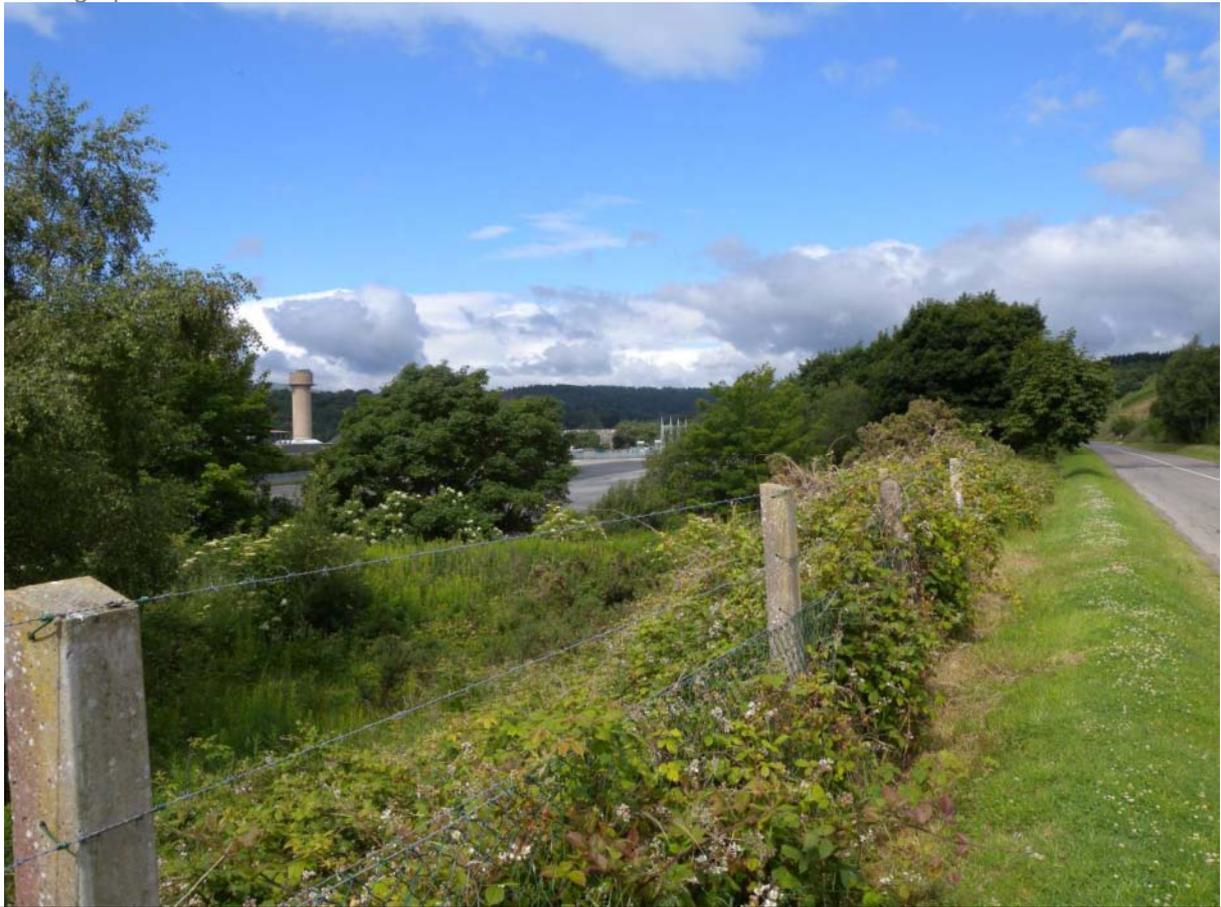
Photographs:

Name: ESB Shelton Abbey	County: Wicklow	Unique ID: 100106	PFRA Status: IRR
<u>PFRA Review</u>			
Reason for inclusion in OPW database: Predictive			
<u>Historical Analysis</u>			
Historical Risk (0-4): 0		Historical Hazard (0-4): 0	
Number of flood report locations on floodmaps.ie: None		Closest searchable town on floodmaps.ie: Arklow	
LA comments confirm flood risk?: No			
<u>Predictive Analysis</u>			
Predictive mapping indicates flooding?: Yes		Flood Risk Index: 2587	
<u>Historical Validation of Predictive Analysis</u>			
Historical Validation Risk (0-4): 0		Historical Validation Hazard (0-4): 0	
<u>Summary of LA Meeting</u>			
Has there been a history of flooding?: None known			
Has any works been undertaken?:			
Are there any maintained defences?:			
LA comments: Wicklow Co Co did not report any knowledge of flood risk to this site			
<u>Summary of Site Inspection</u>			
Site inspection observations: 22/06/11 ESB sub station located adjacent to large industrial site, Avoca River Park. Potentially on flood plain, site appears to be protected by embankments.

Size of river: Wide		Channel vegetation:	
Channel condition:		Structures:	
Flood defences: Possible flood embankment		Nature of flow:	
Nature of floodplain: Wide		Floodplain vegetation: Grass, trees, hard standing	
Properties: ESB sub-station and industrial site		Evidence of flooding: No

The ESB sub-station at Shelton Abbey was originally listed as an Individual Risk Receptor with a FRI score of 2,587. While the site inspection confirmed that this asset is potentially located on the floodplain of the Avoca River, it appears to be within a larger defended site and as an individual receptor **should not be considered an AFA**.

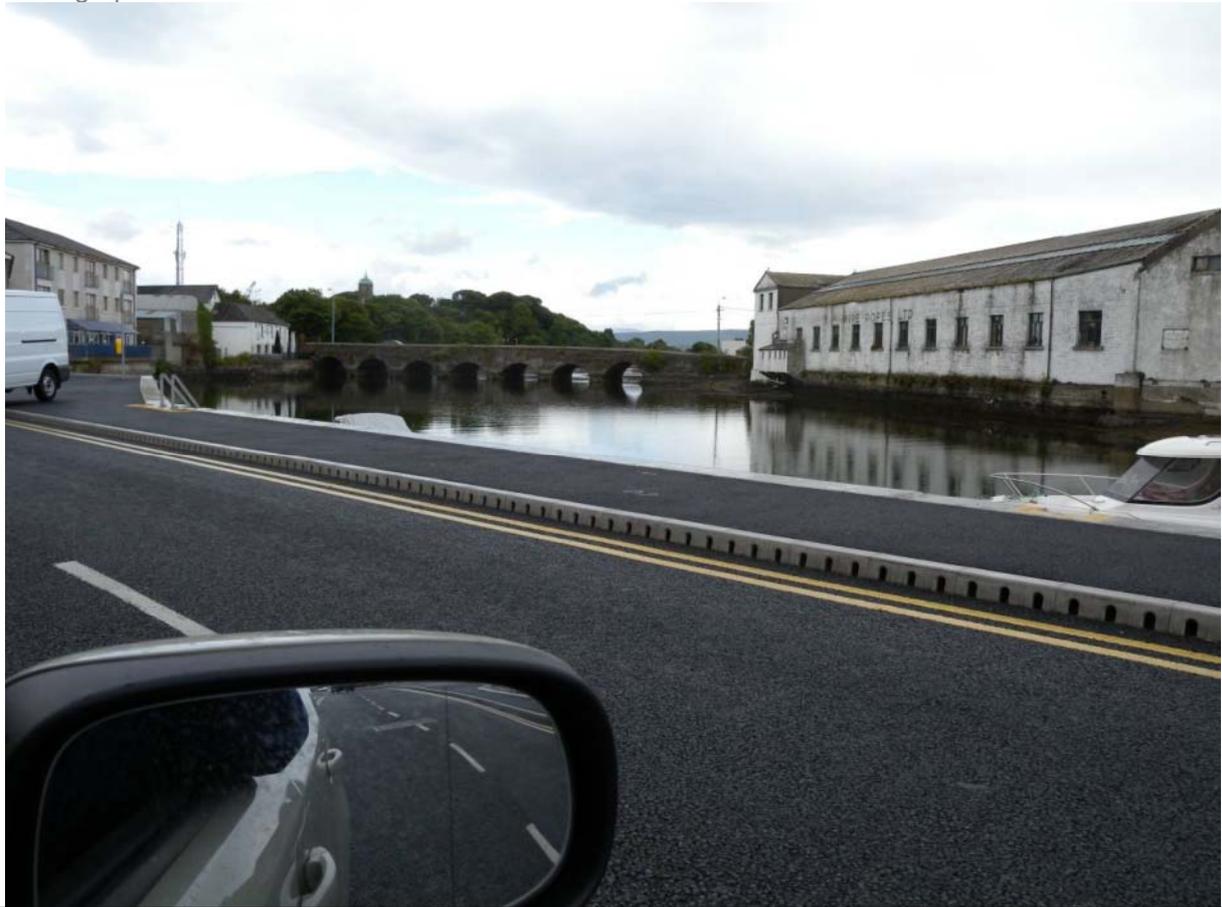
Photographs:

<u>Summary of Site Inspection</u>			
Site inspection observations: 22/06/11			
Masonry multi span bridge represents significant potential for flow restriction, no obvious flood defence structures upstream or downstream of bridge – majority of town rises quickly from river however North Quay/Murrough area and ribbon along river on southern side are potentially at risk from flooding.			
Size of river: Varies		Channel vegetation:	
Channel condition:		Structures: Multi arch bridge	
Flood defences:		Nature of flow:	
Nature of floodplain: Constrained RB/ wide LB		Floodplain vegetation:	
Properties:		Evidence of flooding:

Wicklow was originally listed as a Probable Area for Further Assessment with a FRI score of 690. Wicklow can be affected by flooding from both the sea and the river and the site inspection did not identify any reasons to modify the extent of the PFRA predictive mapping and hence modify the FRI scoring. Consequently **Wicklow should be considered an AFA.**

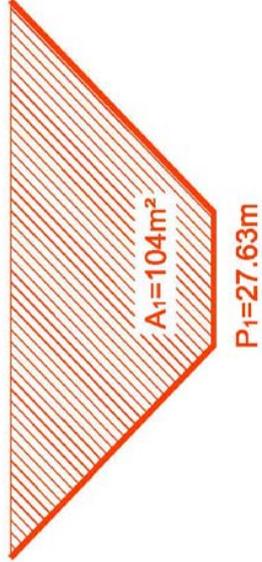
Minimum Channel Profile

Historic Drawing Ref.	Chainage 1		Chainage 2		A1	A2	P1	P2	Chainage A	P	R	R ^{2/3}	S ₂	S ^{1/2}	n ²	Q	PFRA		
	Narrowest Channel	Widest Channel	Q ₁₀	Q _{MED}													Q ₁₀₀		
Kilcullen	N.A.		104	144	27.63m	32.63m	104	27.63	3.764025	2.419738	0.001	0.031623	0.05	159.1592	9.52	13.5	19.64

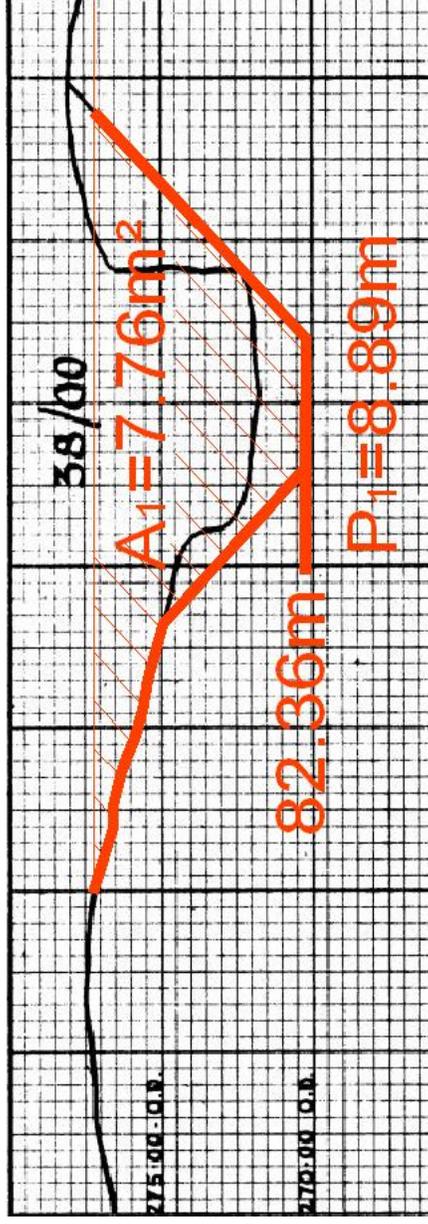
Historic Drawing Ref. 1		Chainage 1	Chainage 2	A1	A2	P1	P2	Chainage Study	A	P	R	R ^{7/3}	S2	S/P	In2	Q	Q _{Med}	Q ₁₀	Q ₁₀₀	PFRA	
Milftownpass	C1/64/1/11	3800 Yds	4800 Yds	7.76	7.76	5.75	8.89	6.54400 Yds	5.75	6.5	0.884615	0.921516	0.0013	0.036056	0.05	3.82096	1.77	2.51	3.65

¹ Cross sectional information received from OPW
