Streamstown Mapping Update Report

Client	OPW					
Project Title	Streamstow	Streamstown Flood Mapping Update				
Document Title	Streamstow	Streamstown Mapping Update Report				
Document No.	IBE1400/Ja	IBE1400/Jan18				
This Document Comprises	DCS	тос	Text	List of Figures	List of Tables	No. of Appendices
Comprises	1	1	27	1	1	3

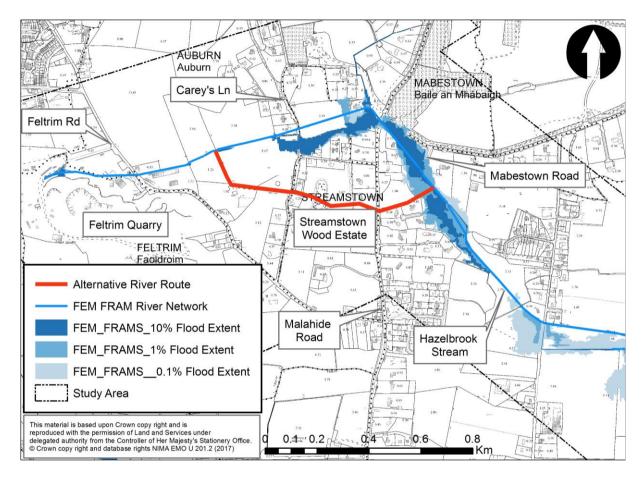
Figure 1.1 Sluice Model Flood Extent Map (SLU/HPW/EXT/CURS/003) showing Streamstown Area

The principal watercourse flowing through Streamstown is the Hazelbrook Stream as shown in Figure 1.1. This watercourse flows along the northern side of the Feltrim Quarry and under the Feltrim Road

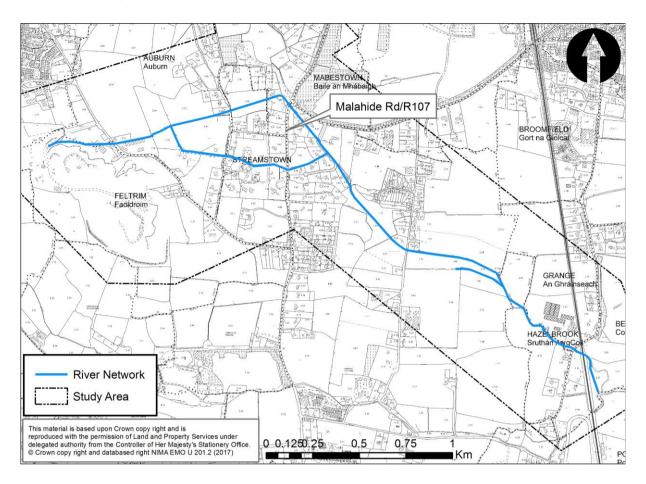
Figure 2.1 Historical Flood Locations

In December 2005, minutes taken from a meeting relating to the OPW Flood Hazard Mapping – Phase One project, report that the area from Dublin to Malahide Road, R107 (location marked on Figure 2.1) at Streamstown is prone to flooding. On this occasion (Flood ID No 1652) one house and a stretch of road was flooded. Remedial works in this area were carried out in 2004.

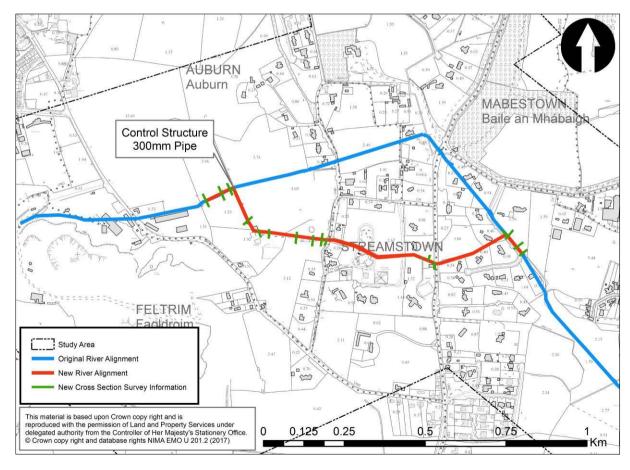
Figure 2.2 New Survey Information

- The new alignment of the watercourse, as discussed in Section 2.4.
- The surrounding area and control structure (as shown in Figure 2.2) which influences how much flow goes down the new watercourse alignment versus the previous watercourse route. It was noted that there is significant vegetation in the area and within the channel.

OPW commissioned Murphy Surveys to carry out a topographical survey of the alternative watercourse route. Figure 2.2 shows the location of the new river alignment compared to the original river alignment and cross sections taken along the new channel route. A total of 19 cross sections, 3 manholes and 7 structures were surveyed in May 2017.

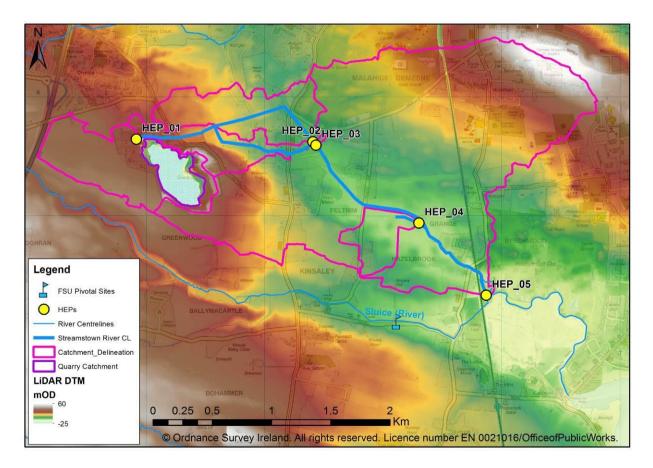
Figure 3.1 HEPs and Catchment Delineation

The first stage in determining the design flows was the identification of Hydrological Estimation Points (HEPs) and the delineation of the catchments to the HEPs. This was undertaken based on a GIS analysis of the LiDAR DTM data along with mapped drainage lines. The HEPs and catchments are shown in Figure 3.1.

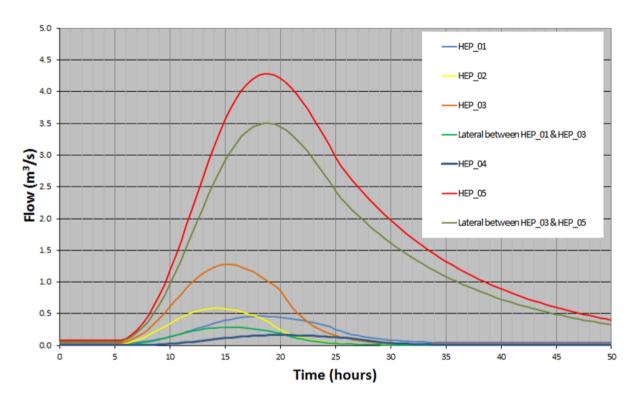
Figure 3.2 1% AEP Design Hydrographs

This resulted in a reduced peak to the flow hydrograph for HEP_01 but an increased base flow. The design hydrographs for the 1% AEP event are shown in Figure 3.2. Hydrographs were generated using the FSU hydrograph shape generation tool (v5) produced by OPW. An initial estimation of shape parameters was derived for each HEP and then an adjustment applied based on a pivotal site. The Sluice gauging station was not considered an appropriate site for hydrograph shape generation due to uncertainty in the observed hydrograph data. Two small catchment pivotal sites remote from Streamstown were used as pivotal sites, 22009 and 26022, as they were deemed to be hydrologically similar. The hydrograph shapes were compared to the available data from the Sluice station and found to be similar in shape albeit the volumes under the hydrograph are much smaller as would be expected in proportion to the relative catchment sizes.

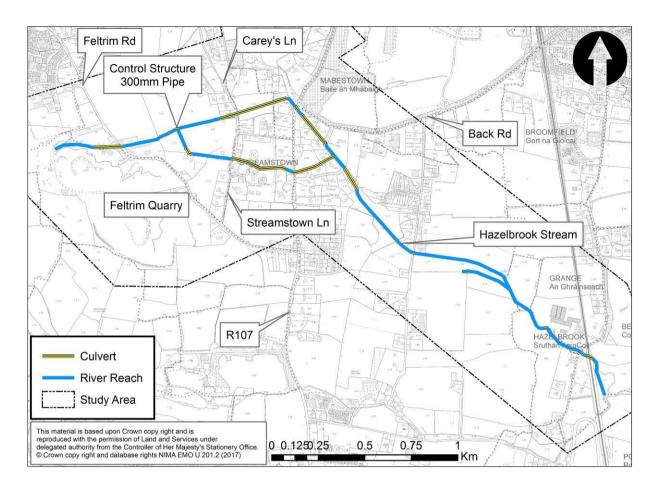
Figure 4.1 Streamstown Model Extents

A review of the existing ISIS Sluice model by RPS concluded that it would be preferable to construct a new 1D-2D coupled InfoWorks ICM 7.5 river model of the Streamstown area (instead of updating the existing model). Cross section information and downstream boundary conditions were extracted from the existing ISIS model. As discussed in Section 2.4, the OPW provided RPS with survey information of the additional watercourse alignment which has been incorporated into the model as per the project scope. Figure 4.1 shows the new model extents.

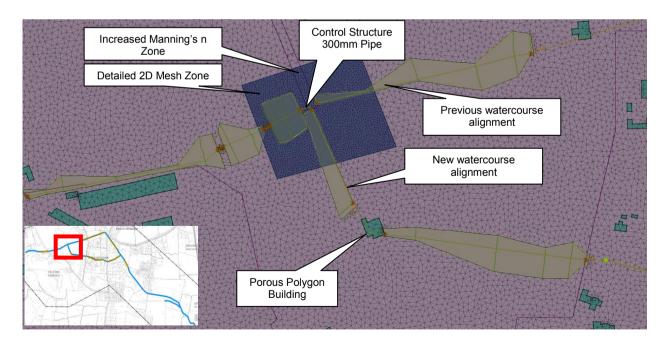
Figure 4.2 Streamstown ICM Network at Structure 01STRE0185

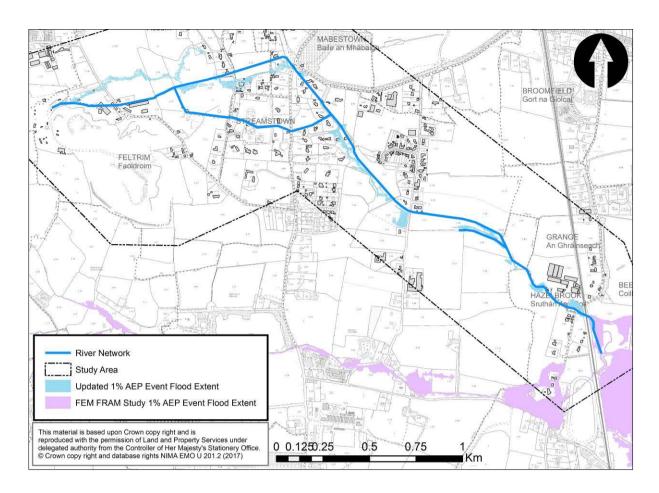
Figure 4.3 Streamstown Mapping Overlap between FEM FRAMs Study Outputs and Updated Outputs for the 1% AEP Event

RPS reproduced the mapping tile SLU/HPW/EXT/CURS/003 (as shown in Appendix A), splitting the extents onto three maps (as shown in Appendix C). Additional pages were required as the previous mapping (produced in August 2010) had been produced at a scale of 1:10,000 however there has since been updated guidance and the new maps were produced to a scale of 1:5,000. Maps were produced using the updated flood extents combined with the previous model outputs using Arc GIS. Figure 4.3 shows the extent of the updated model outputs and where they are combined with the FEM FRAM Study outputs. The updated model outputs cover the Streamstown area and Hazelbrook Stream to the railway bridge.

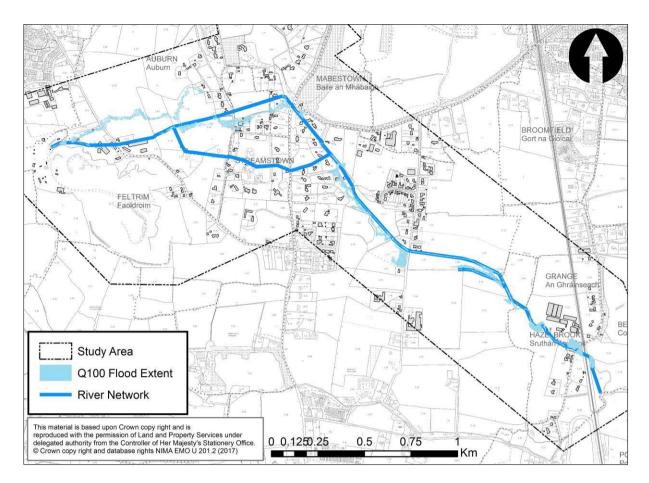
Figure 4.4 Streamstown Flood Risk in 1% AEP Flood Extent

Full results are available in Appendix C, however Figure 4.4 shows the properties in Streamstown which are at risk of flooding during the 1% AEP flood event.

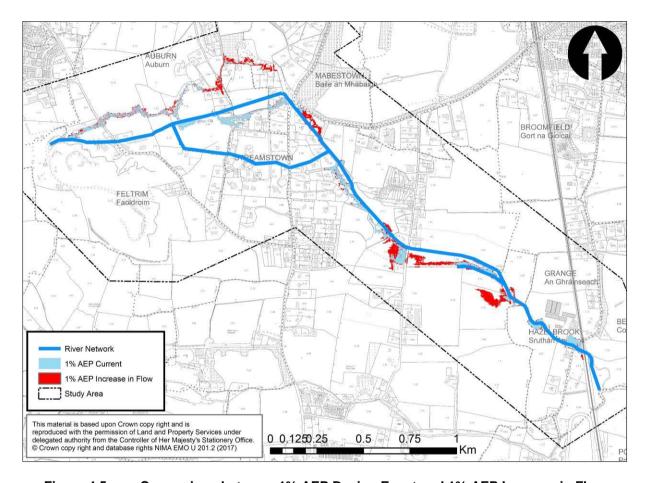
Figure 4.5 Comparison between 1% AEP Design Event and 1% AEP Increase in Flow Sensitivity Event

a) Increase in flow – The 1% AEP event flows were increased by 10%, this resulted in a large increase in flood extents. Fifteen additional receptors are impacted by the changes, these are located in the rural area north of the modelled watercourses (in the vicinity of Auburn Grove) and the Back Road. With 15 additional properties being affected, this accounts for an increase of 100% when compared to the 15 properties which are affected during the 1% AEP design event (located in the vicinity of Streamstown Lane and Mabestown Road). Figure 4.5 illustrates that the model has a high sensitivity to increase in flow.

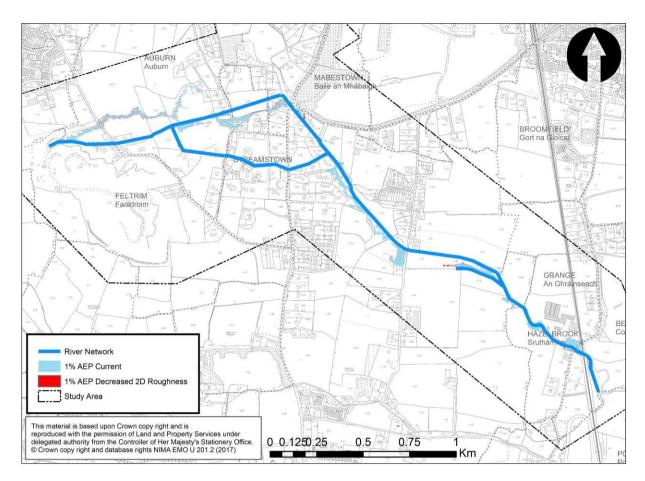
Figure 4.6 Comparison between 1% AEP Design Event and 1% AEP Change in 2D Roughness Parameters Sensitivity Event

b) Floodplain Roughness Decreased – The Manning's n value of the 2D mesh was reduced by 20%. These changes resulted in a small change in flood extents. There is a minimal increase in flood extents within the modelled area, as shown in Figure 4.6. The model is considered to have a low sensitivity to floodplain roughness, one additional receptor is impacted by the increase of flood extents (located on the Back Road).

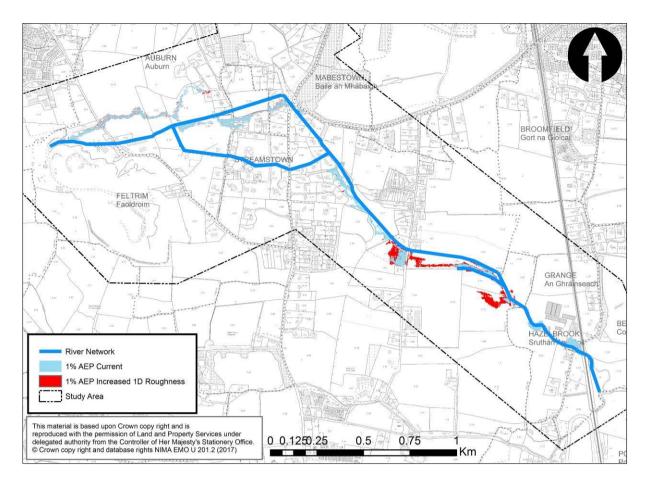
Figure 4.7 Comparison between 1% AEP Design Event and 1% AEP Increased 1D

Roughness Sensitivity Event

c) Channel Roughness Increased – The Manning's n values of cross sections were increased by 20%. These changes resulted in a moderate change in flood extents. An additional 2 receptors (located on Auburn Grove) are impacted by the increase in flood extents, accounting for a change of 13% when compared to the 1% AEP design event. Figure 4.7 illustrates that the model has a moderate sensitivity to 1D roughness edits.

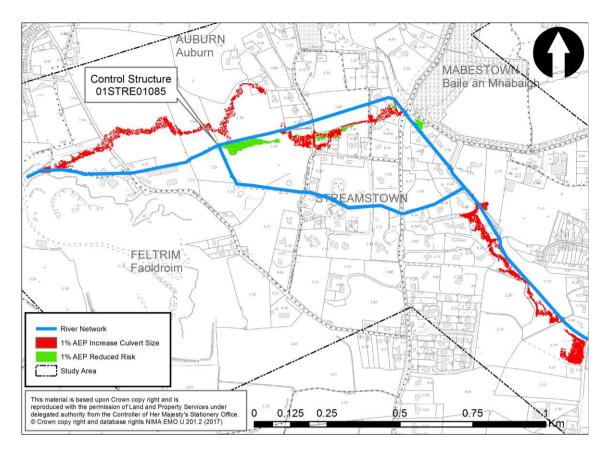
Figure 4.8 Reduced 1% AEP Risk due to Increase in 01STRE01085 Culvert Size Sensitivity

Event

d) Increase 01STRE01085 Culvert Size – The critical structure (01STRE01085) which controls flow going towards the new watercourse alignment and previous watercourse was increased (from 300mm to 600mm) to assess if more flow could be directed down the new watercourse route. The change resulted in a small change in flood extents during the 1% AEP event, as shown in Figure 4.8. There is less flow and therefore out of bank flooding downstream of the culvert with more flow able to follow the new watercourse route. No properties benefited from the reduced flood extents.

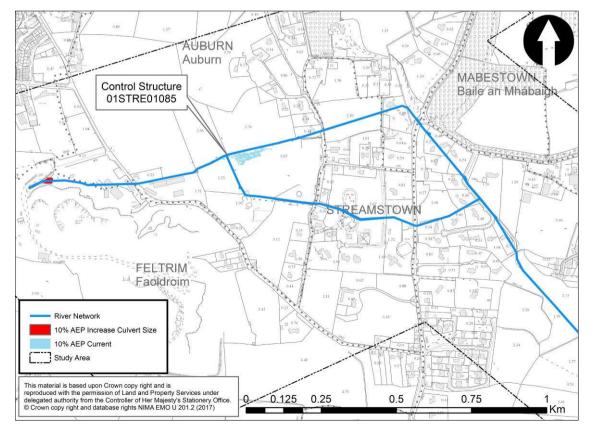
Figure 4.9 Comparison between 10% AEP Design Event and 10% AEP Increase in 01STRE01085 Culvert Size Sensitivity Event

This sensitivity test was also completed for the 10% AEP event. The change resulted in a small change in flood extents during the 10% AEP event, as shown in Figure 4.9. Again there is less flow downstream of the culvert and no out of bank flooding, as more flow is able to follow the new watercourse route. No properties benefited from the reduced flood extents.

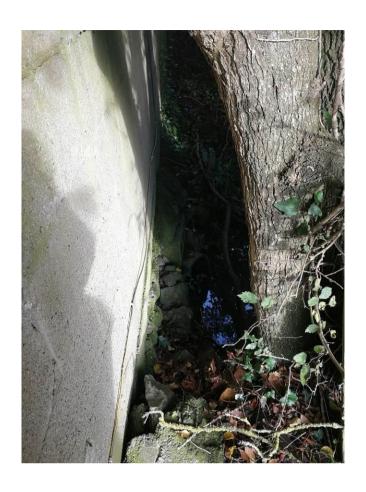
A.1 Outlet of Structure 01STRE00970

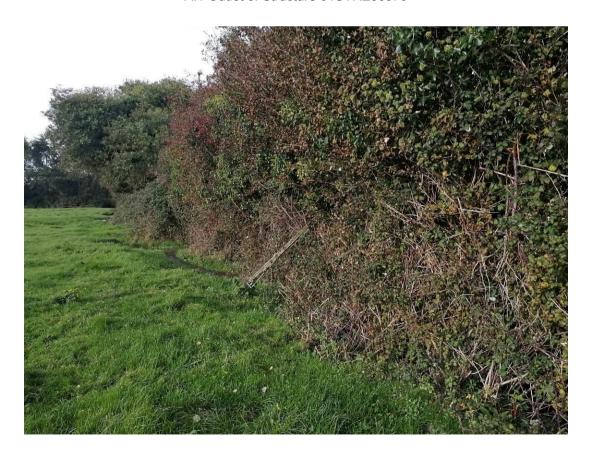
A.2 Watercourse upstream of 01STRE01085

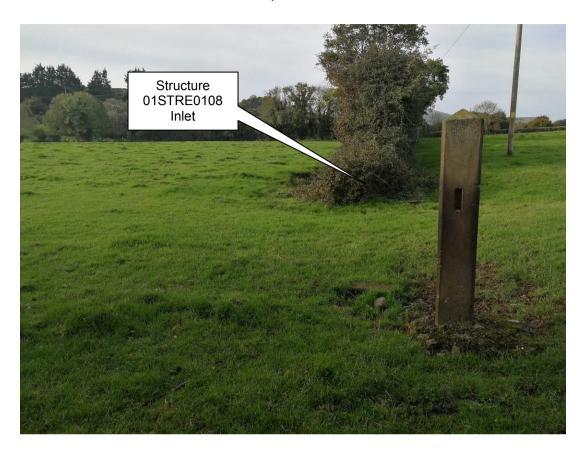
A.3 Looking towards inlet of 01STRE01085

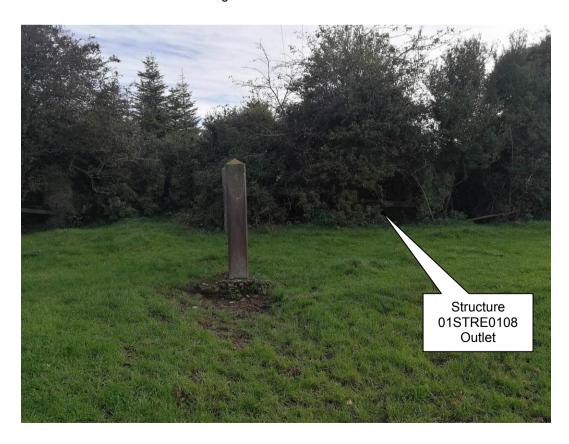
A.4 Looking towards outlet of 01STRE01085

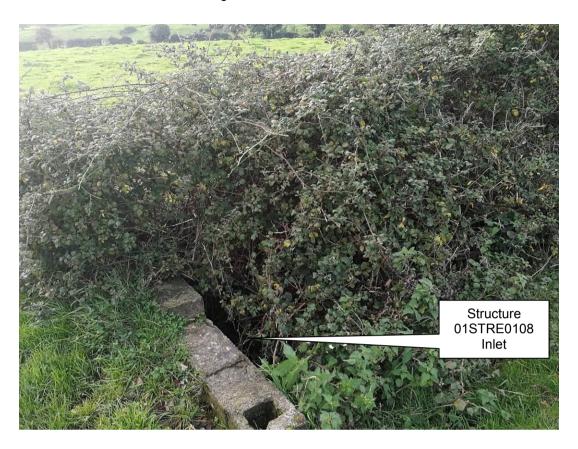
A.5 Inlet of 01STRE01085
