JAPANESE KNOTWEED EXCAVATION REPORT

LOCATION: 8-22 Oakfield Road,
Penge, SE20 8QP

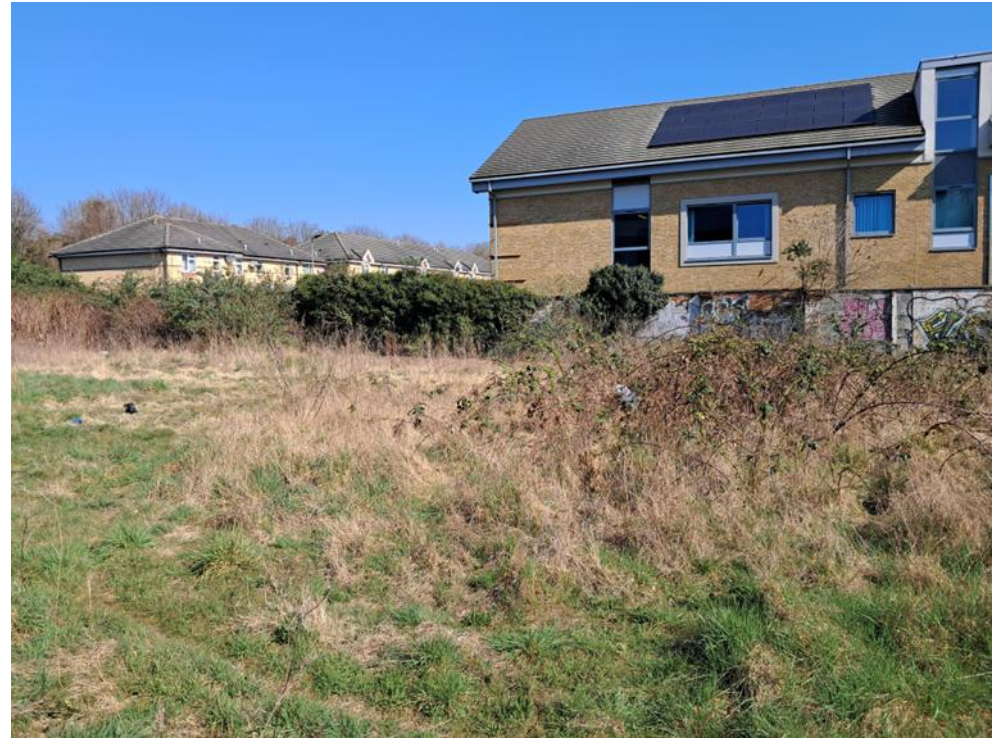
Site prior to excavations

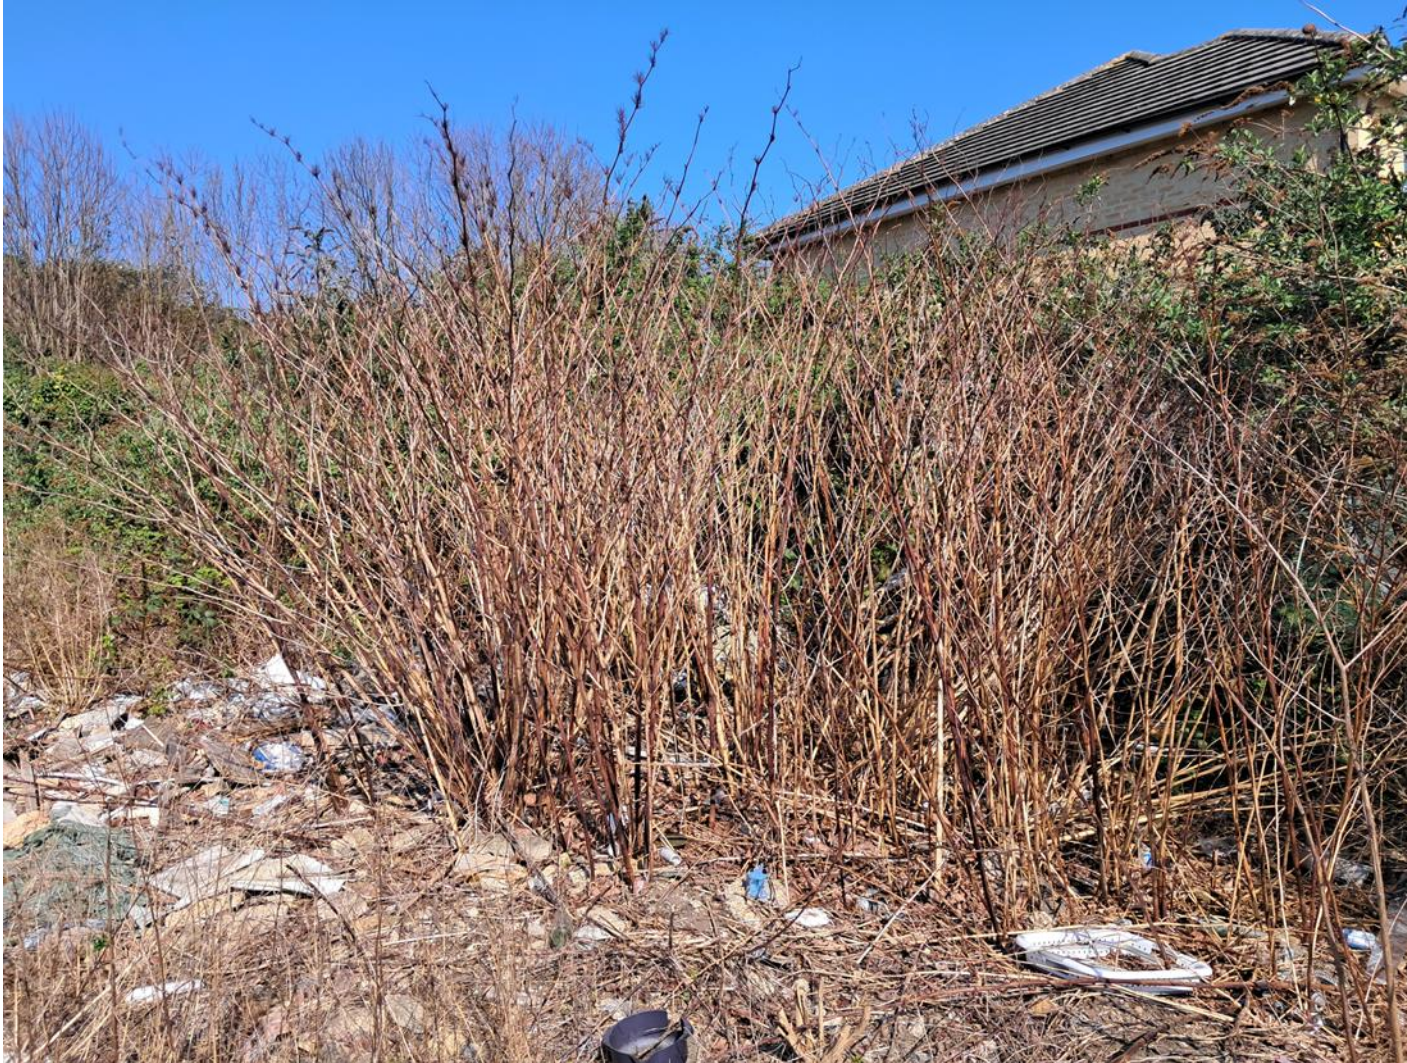
Japanese Knotweed on site has previously been sprayed with herbicide

The material is mixed with many tonnes of fly-tipped rubbish. As the landfill does not accept plastic waste this had to be picked from the organic material by our team

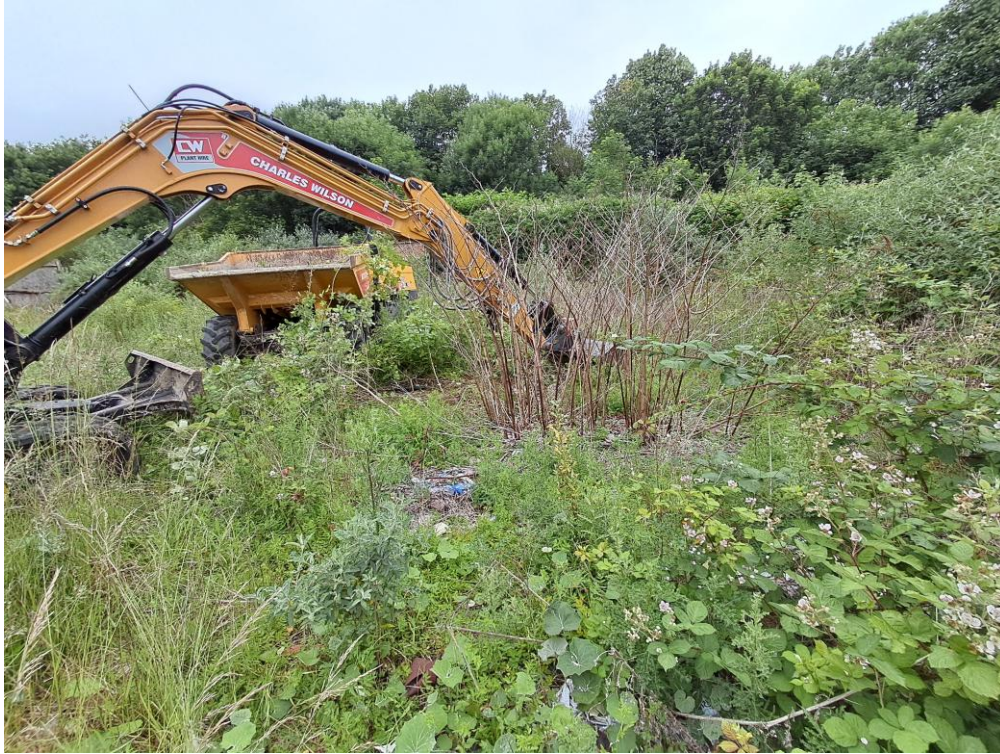
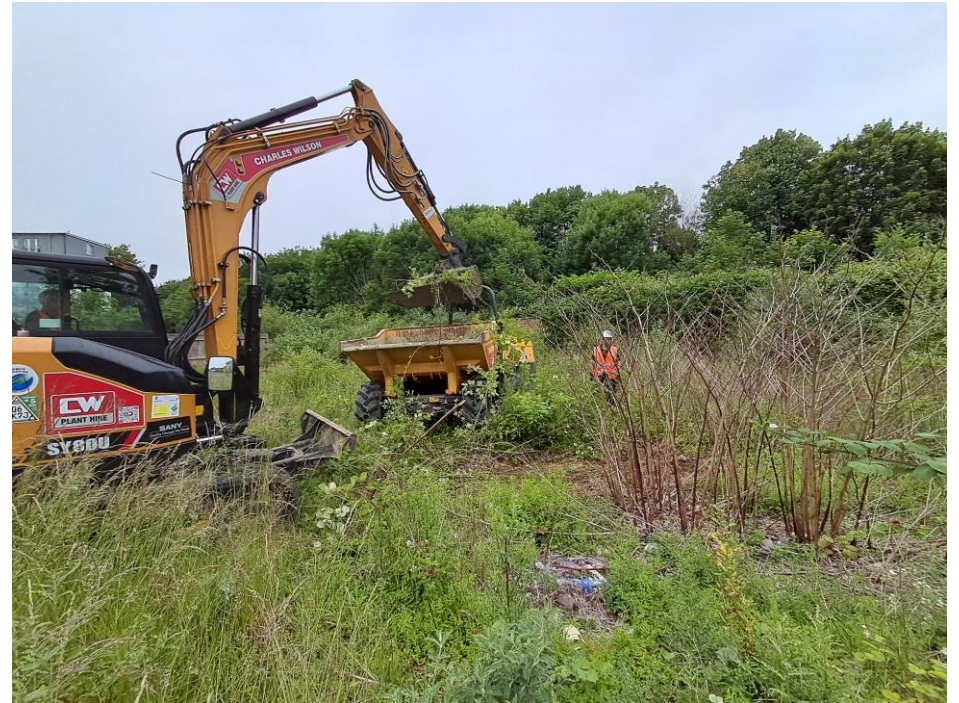
Excavation of JKW was overseen on site operatives using “Rhizome chasing” techniques

The material was loaded into dumpers and transported to an on site stockpile area for collection and disposal

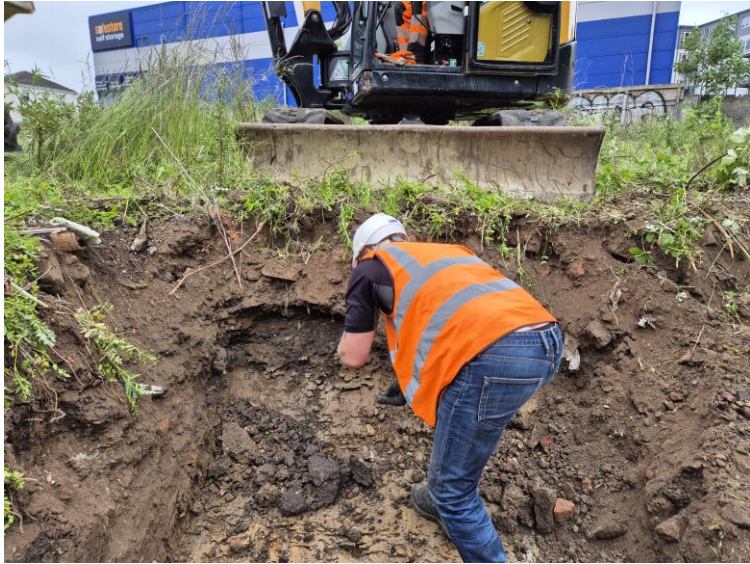
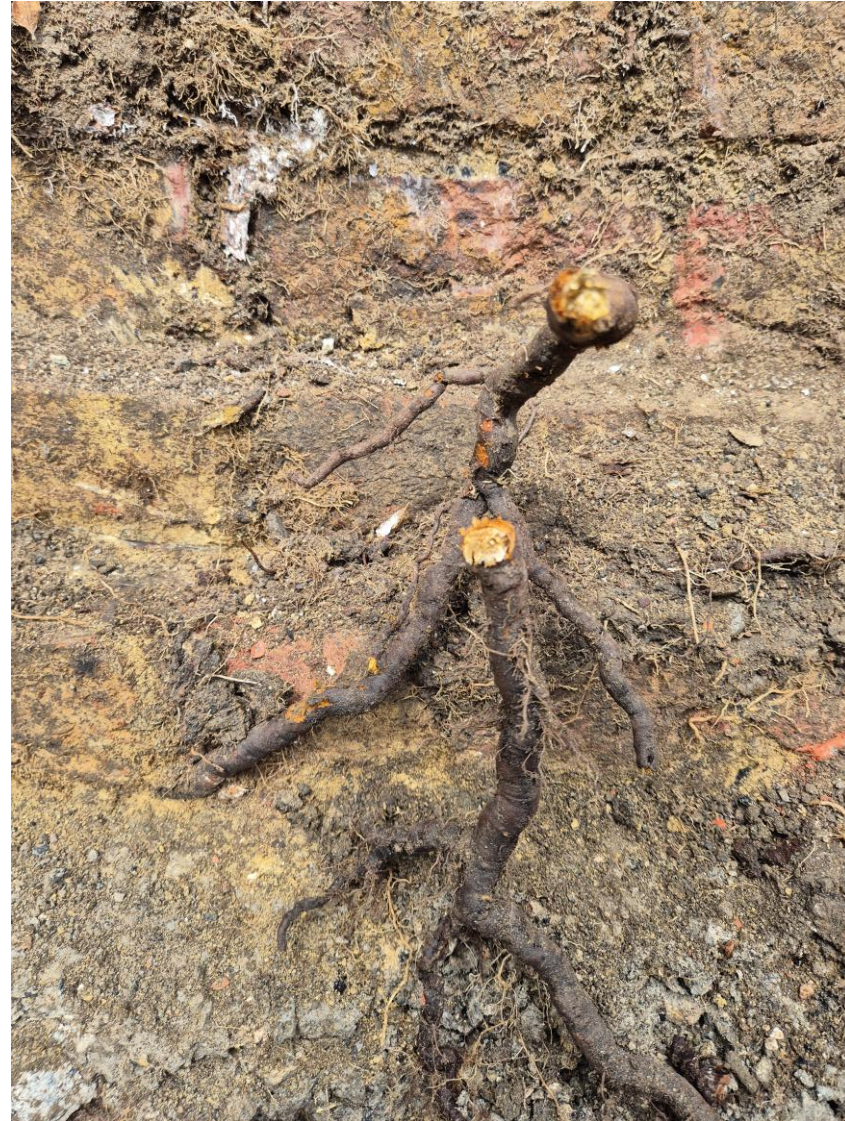
Rhizome investigation and example of JKW rhizome

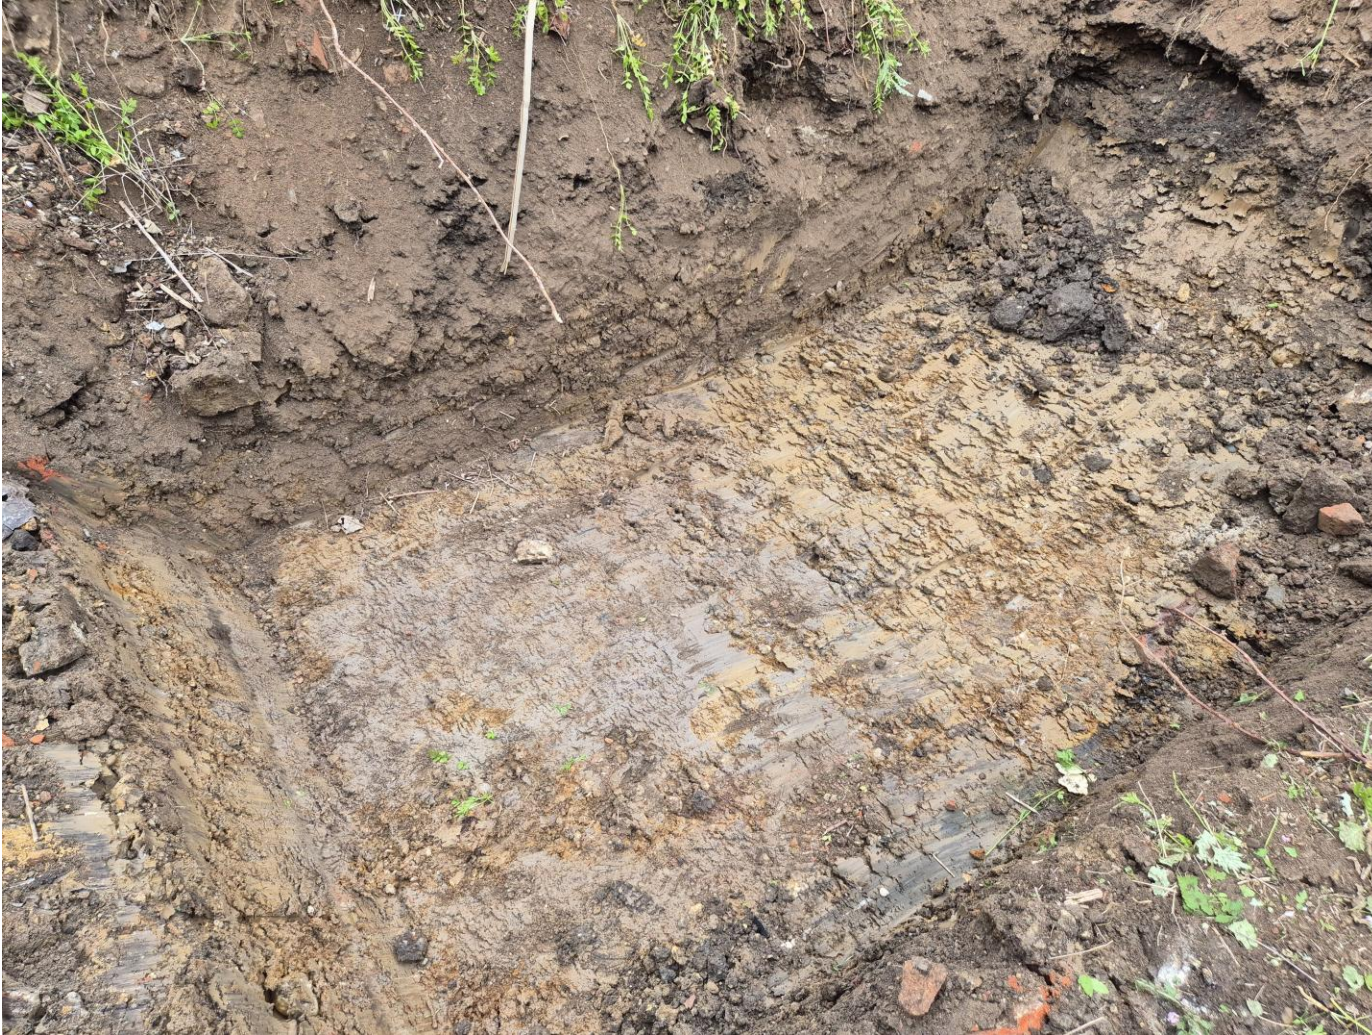
Excavations dug down to clay sub soils. JKW struggles to penetrate clay due to the density of this material

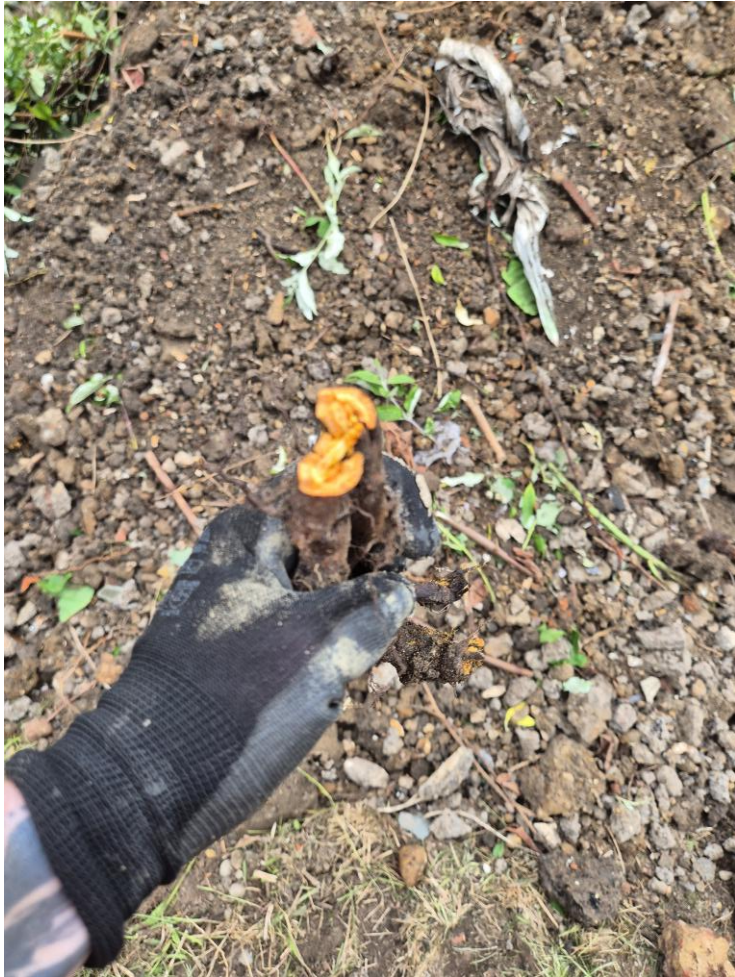
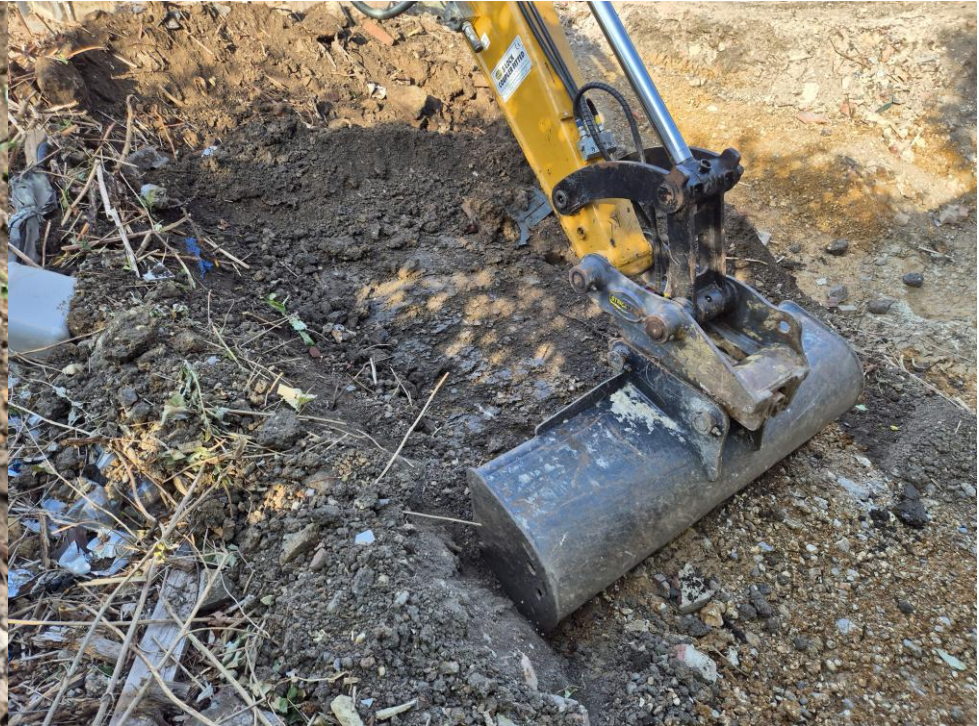
JKW Rhizome (left) showing signs of viability even though it has been treated

These areas were excavated & removed

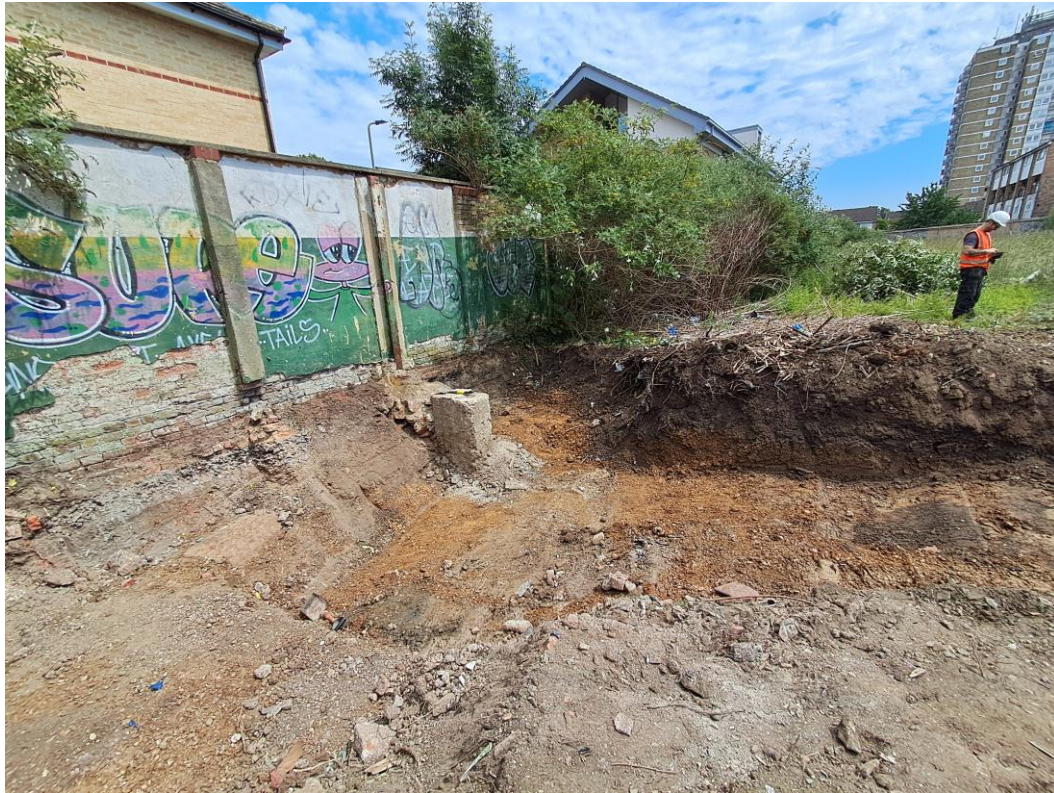
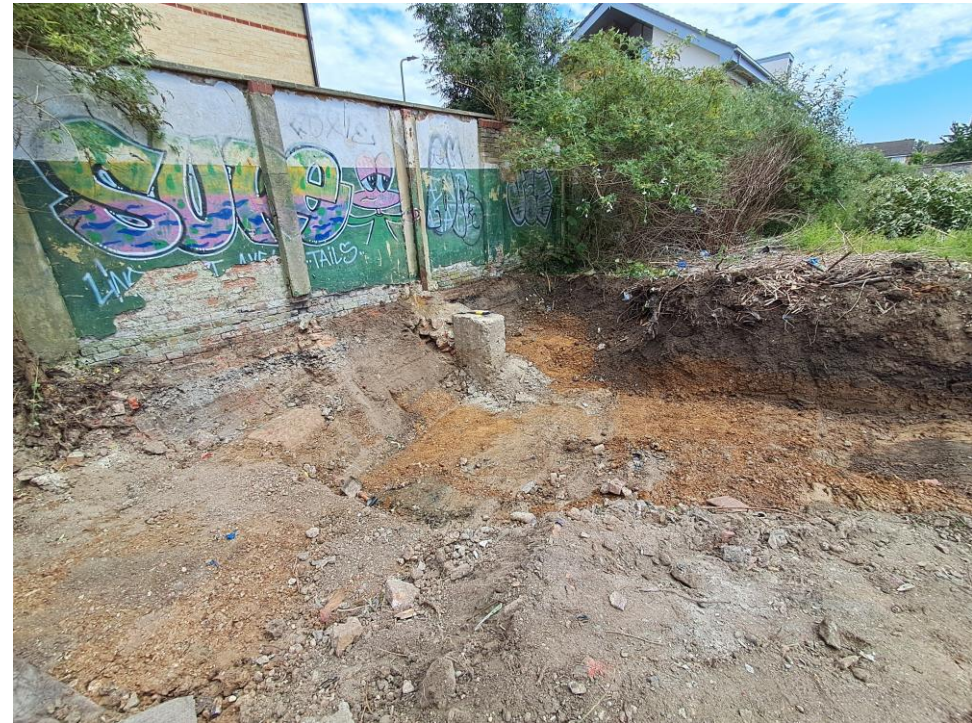
Excavations carried out near the boundary wall. We found JKW rhizome growing into and underneath the wall.

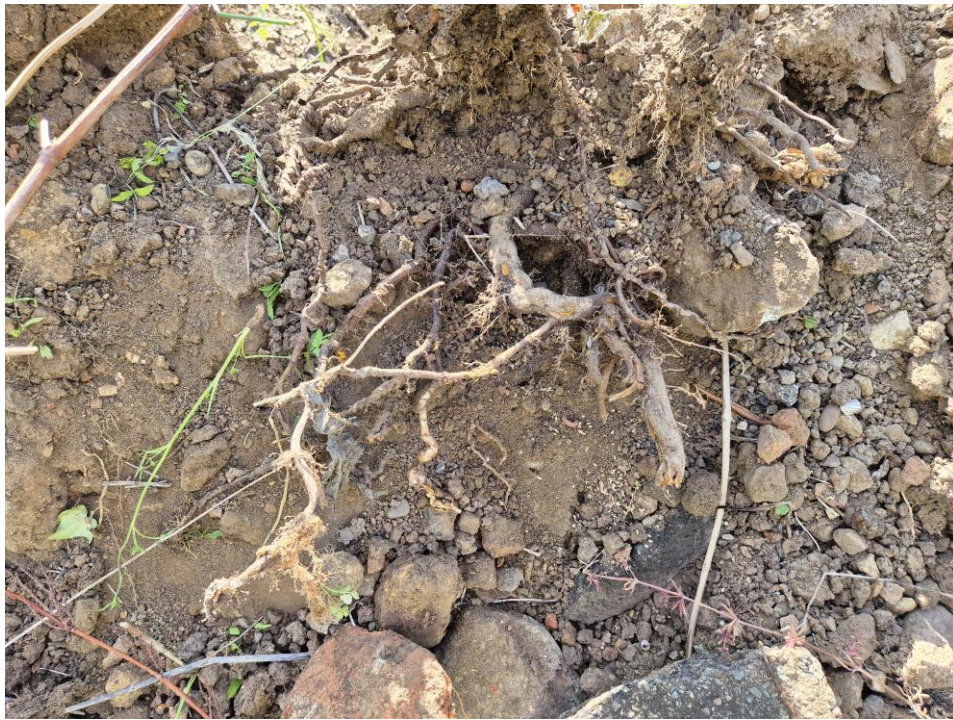
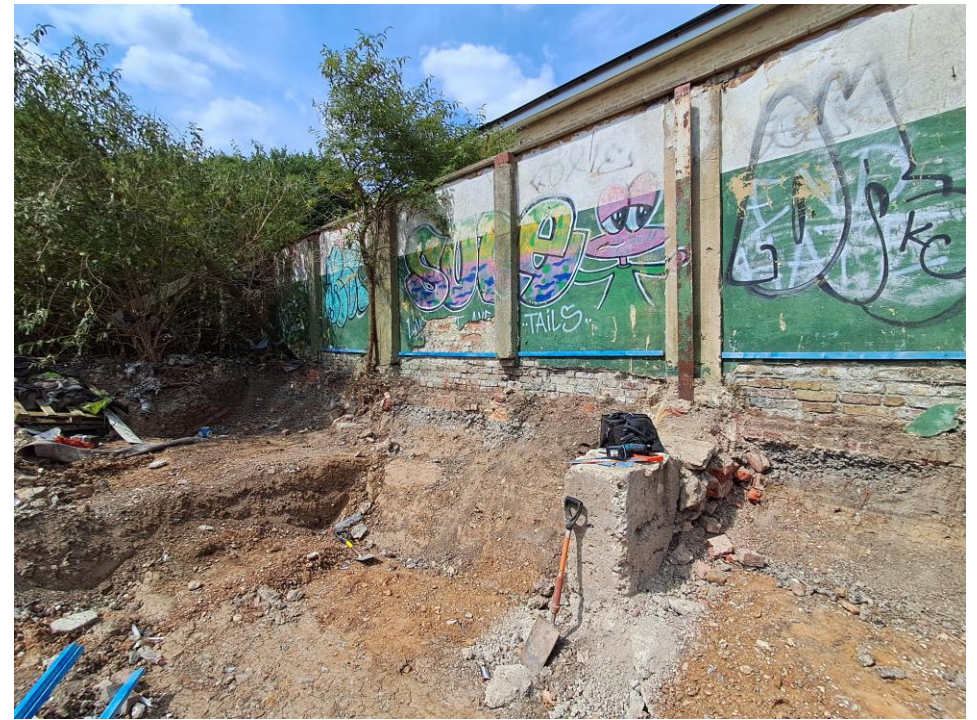
JKW rhizome growing underneath the boundary wall. As cannot dig under the wall and also into the adjoining land UKL (after speaking with the client) proposed installation of a root barrier membrane

This is to protect the clients site from this area of JKW and without having to dismantle the wall and excavate land that is not within the scope of works

Works progressed almost as expected with the exception of requiring to install the root barrier membrane. We found just one area of JKW that was growing through gaps into the wall and as this could not be safely excavated the decision was taken to install the root barrier. This barrier extends for 15m so should be more than sufficient to halt this spread

We also battened the RMB to the wall to help prevent the JKW growing upwards as well as laterally

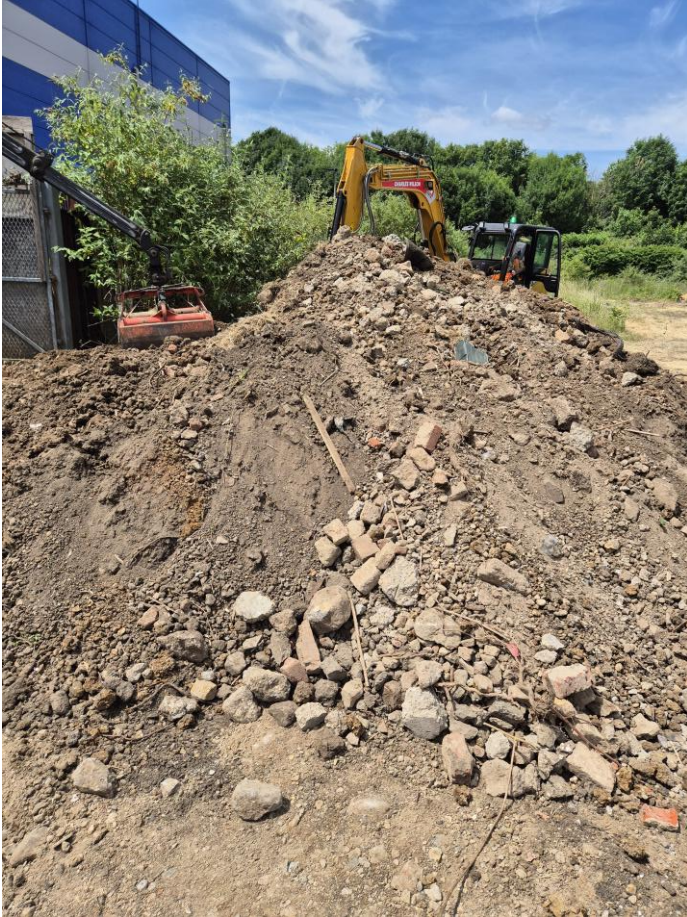
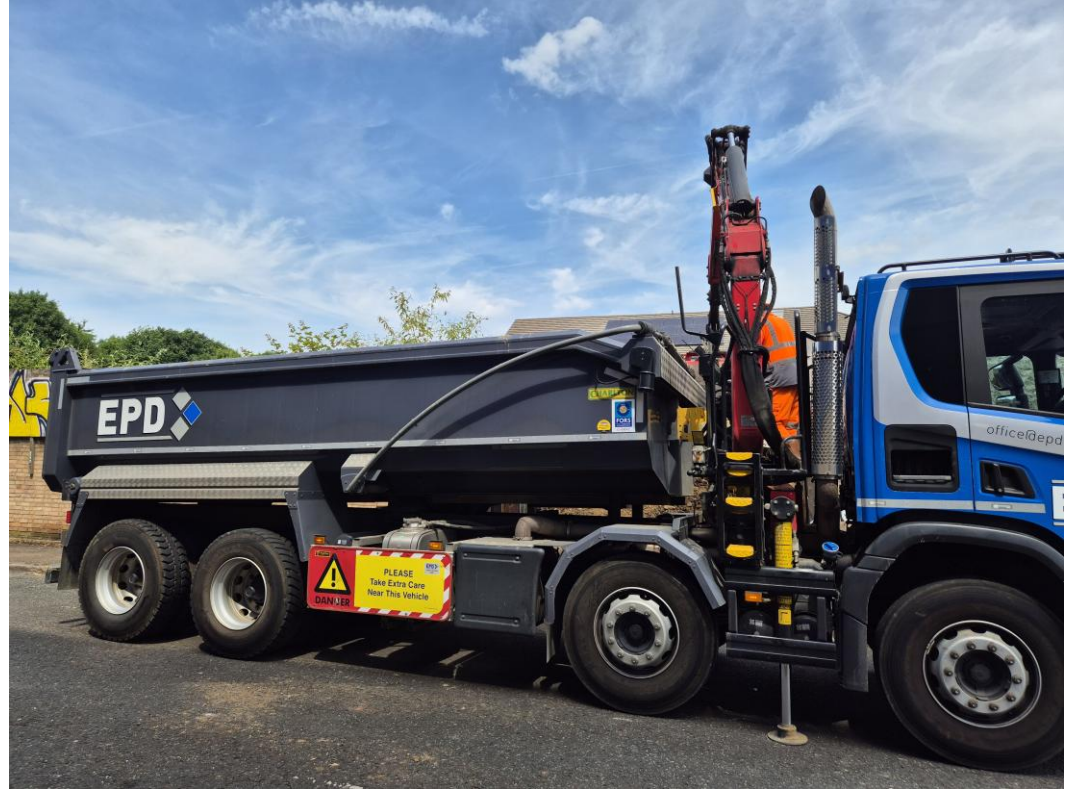
Excavated material stockpile and grab wagons arriving to collect the material

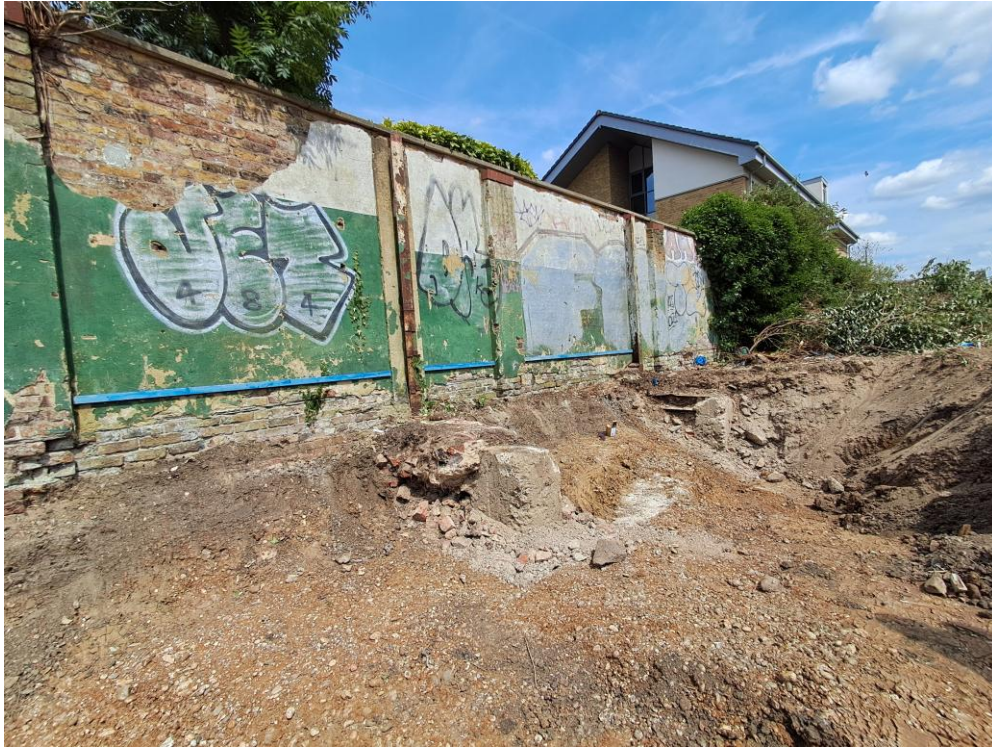
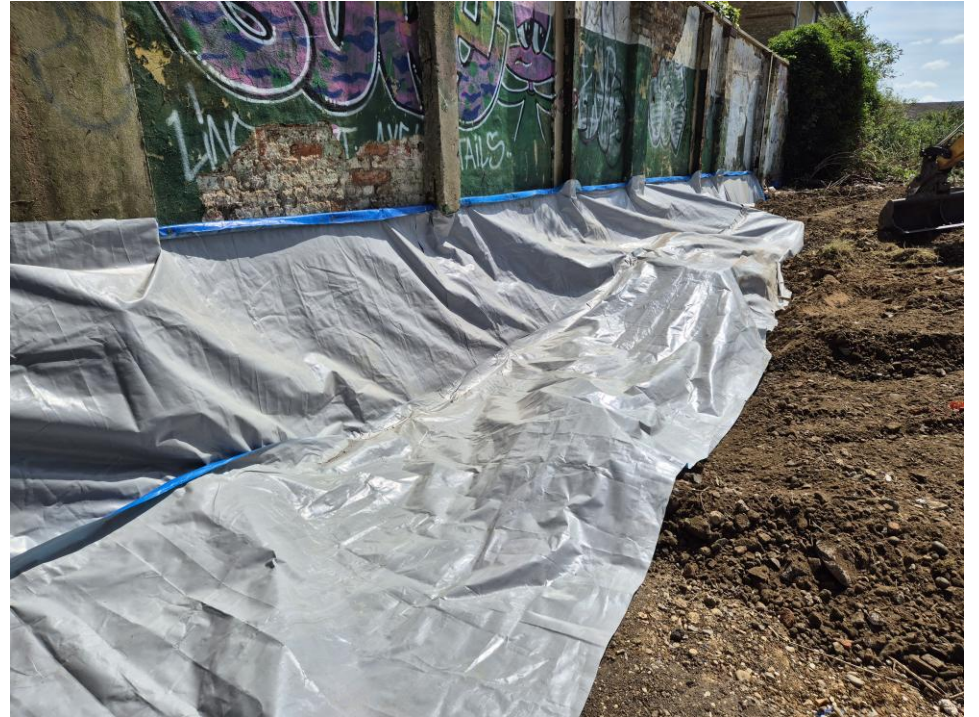
Installation of Root barrier membrane

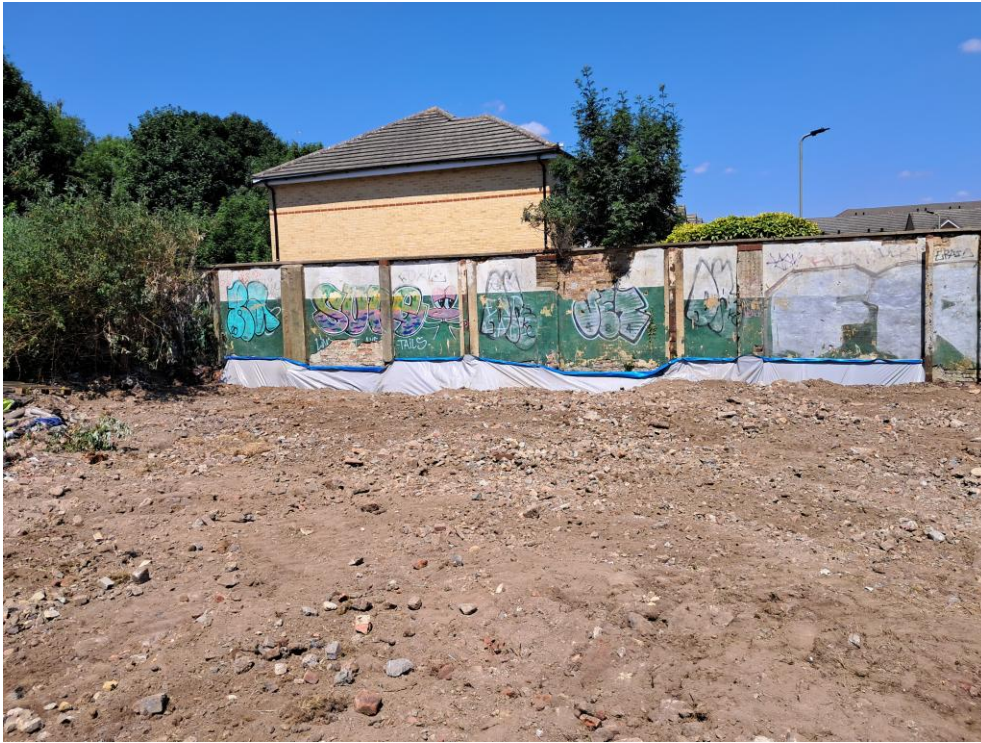
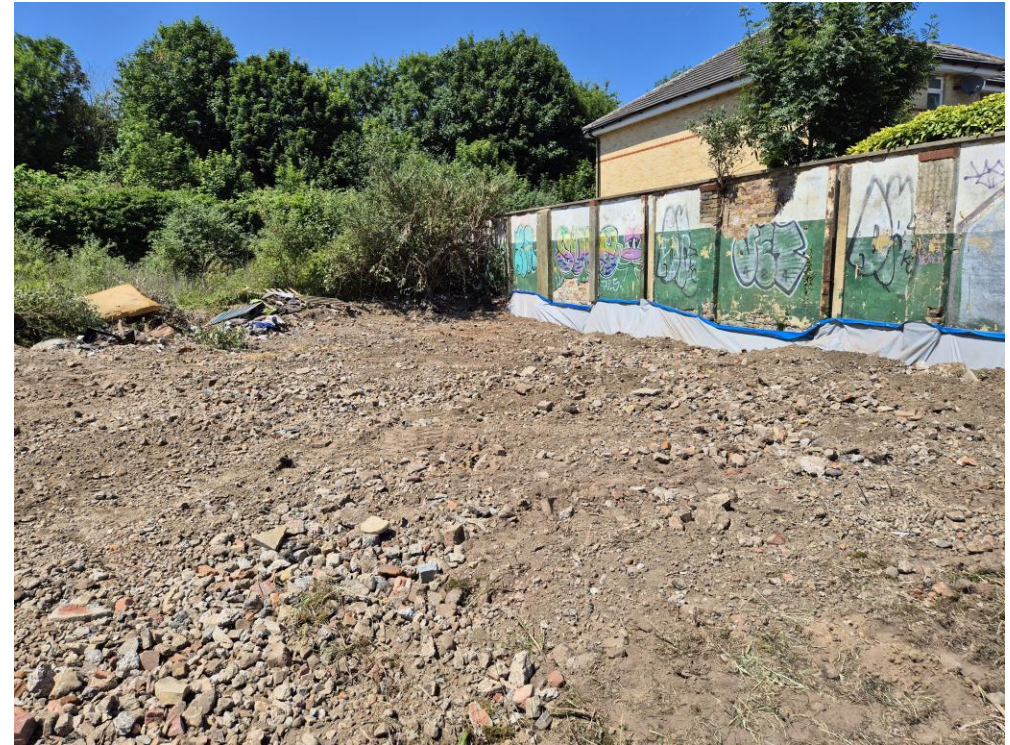
Area was backfilled using clean material with RBM visible to indicate to future workers of the location and as a indicator of not to tamper with

Once the guarantee period is completed this can be cut down to ground level should the client require
