## CASE STUDY

### Delivery Through Collaboration: 16-Day Turnaround for Insert Safety Valve

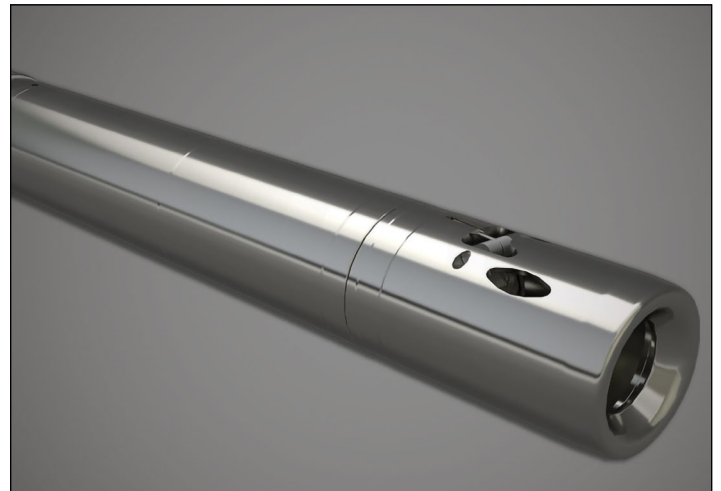
The Oilenco Wireline Retrievable Safety Valve (WRSV) is a self-equalising, flapper type safety valve designed to be installed inside a malfunctioning TRSV to regain wellbore integrity. The valve can be universally adapted to suit any existing TRSV profile with the use of lock mandrels, spacer extensions and seal stacks.

Once the TRSV is locked out and communication to the control line is established, the insert valve assembly can be installed and operated from surface via the existing control line.

Working in close collaboration with our Norwegian partner Archer, Oilenco provided the operator with a complete insert assembly tailored to the 3.813" TRSV profile. In-house machining and engineering capabilities meant Oilenco was able to offer a delivery lead time of just three weeks.

To ensure operational flexibility, Oilenco provided both a primary and a backup solution: two insert assemblies featuring different seal stack configurations, to mitigate the risk of damage or irregularities within the existing TRSV seal bore.
