## CASE STUDY

### Restoring SSSV Integrity Through Targeted Scale Removal

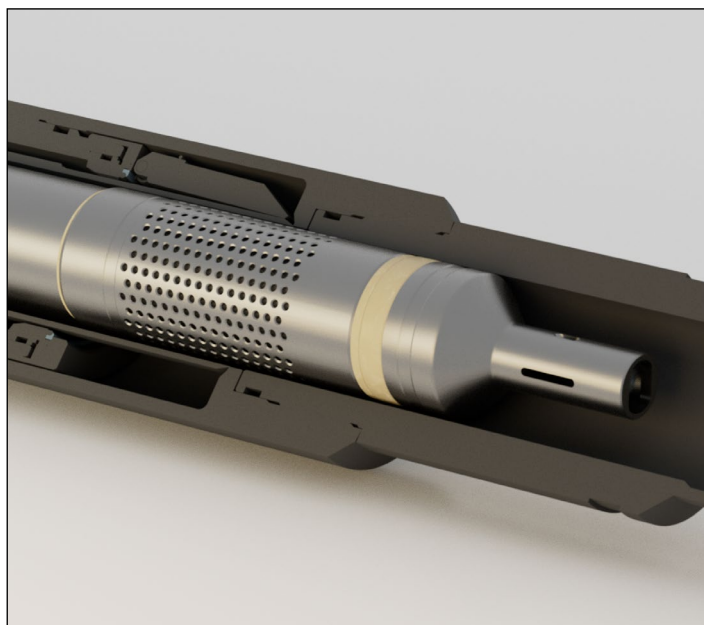
Oilenco mobilised its 4.500" Bullheading Jetting Sleeve, specifically designed to deliver targeted jetting to critical areas of the flow tube recess and flapper area within a Subsurface Safety Valve (SSSV) by bullheading treatment fluid through the tool from surface.

The Bullheading Jetting Sleeve features upper and lower jetting port subs that target specific areas within the safety valve, with fluid distribution determined by the applied pump rate. This ensures that fluid can be directed precisely to the areas most susceptible to scale build-up. To ensure deployment flexibility, the sleeve was supplied with a range of extension configurations, enabling the jetting ports to be accurately positioned within different OEM safety valve designs across the operator's field.

The sleeve was deployed on slickline and landed in the SSSV no-go profile prior to bullheading operations commencing. Once in position, fluid was pumped through the tool, with the jetting ports creating localised turbulence around the critical areas of the safety valve, helping to break down and remove scale deposits affecting valve performance.

Following recovery of the Bullheading Jetting Sleeve from the first well, the SSSV was re-tested and successfully passed the inflow test. Expected control line fluid returns were also observed, confirming that valve functionality had been restored.

Encouraged by these results, the operator deployed the tool in a second well experiencing similar scale-related issues. Following bullheading operations, the sleeve was recovered and the SSSV integrity successfully verified, confirming effective scale removal and successful remediation of the valve.
