## CASE STUDY

### TRSSSV Reinstatement with the Oilenco Scale Remedial Package

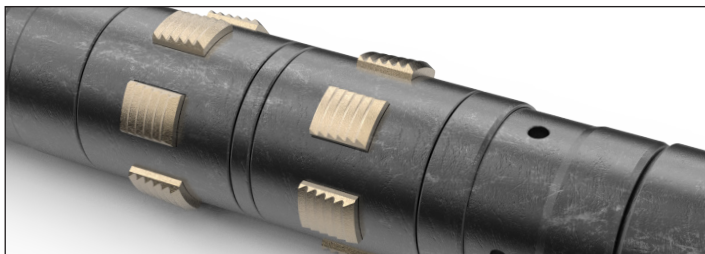
The Oilenco **scraper tool** was run to remove the scale from surface to the TRSSSV. 3 runs of the scraper tool were completed, adjusting the teeth to increase the diameter of the tool with each pass.

Oilenco deployed a **scale remedial package**. This consisted of a scraper tool, soak sleeve and syringe, and wire roller brush.

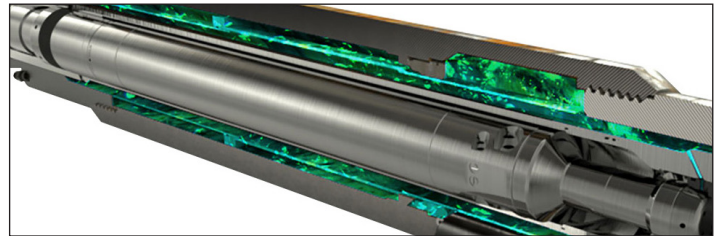
This cleared a pathway to allow the Oilenco **soak sleeve and syringe** to be set across the TRSSSV. The syringe was filled with formic/Cal acid at surface then run in to the soak sleeve where the chemical was dispersed to treat scale within the TRSSSV.

After an initial 3-hour soak, the TRSSSV flow tube was functioned with the soak sleeve in-situ to determine movement and measure flow returns.

The first tests indicated a small increase in returns showing progress. A further 9-hour soak was completed before a final test recorded the correct volume of returns.

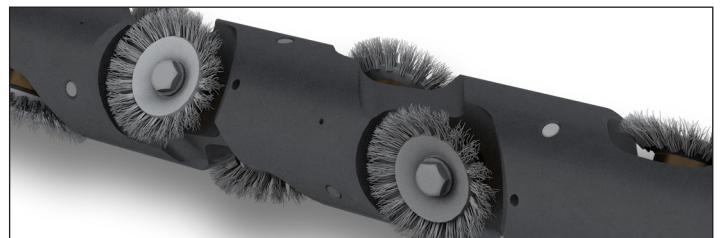
The final phase was to run the Oilenco **wire roller brush** to clear scale around the flow tube recess and brush the safety valve to remove any remaining debris. With all scale remedial work complete, final testing confirmed full reinstatement of the TRSSSV allowing operations to continue.
