# Microbiological investigations of corrosion damages in aircraft

A. Hagenauer\*, R. Hilpert and T. Hack

A joint project of different european aircraft manufacturers involves the investigation of the involvement of microorganisms in corrosion damage in aircraft.

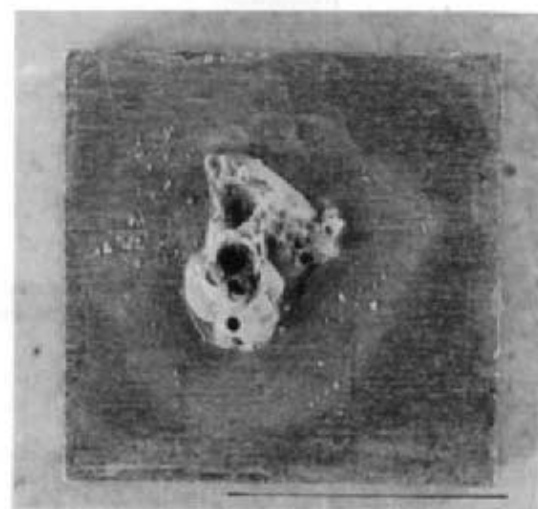
**Fig. 2.** Sample of Al 7075 incubated at 30°C for 28 days in PYG-medium, inoculated with *Enterococcus casseliflavus*. Bar: 1 cm

inspection. Mostly, the corrosion failures were covered by white corrosion products (Fig. 2). After removal of the products the actual corrosion sites appeared (Fig. 3). If incubation was performed with corrosive mycelium forming fungi, no visible corrosion products were formed (Fig. 4, 5).

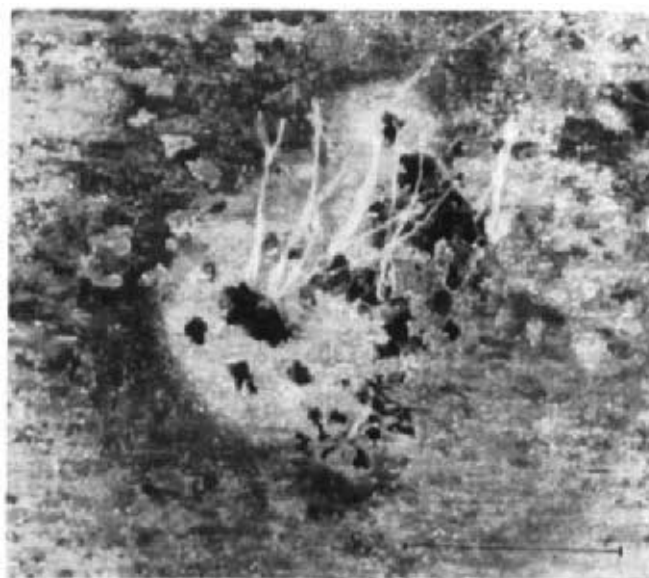
**Fig. 5.** Magnified part of corrosion site of an Al 7075 sample incubated at 30°C for 28 days in PYG-medium, inoculated with *Penicillium* sp. Bar: 1 mm
