The fire resistance performance of two single-leaf, single-acting doorsets, incorporating various items of hardware when tested in accordance with BS EN 1634-1:2014

#### 399805

ICS Security Solutions Ltd. Unit 1, JBJ Business Park, Northampton Road, Blisworth, Northampton, NN7 3DW.

Date: 13th November 2018

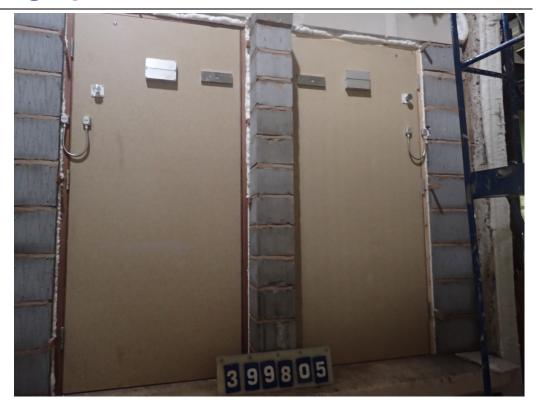
The exposed face of the doorsets prior to testing

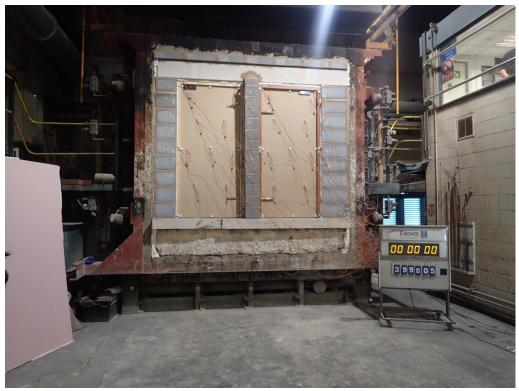
The unexposed face of the doorsets prior to the start of the test

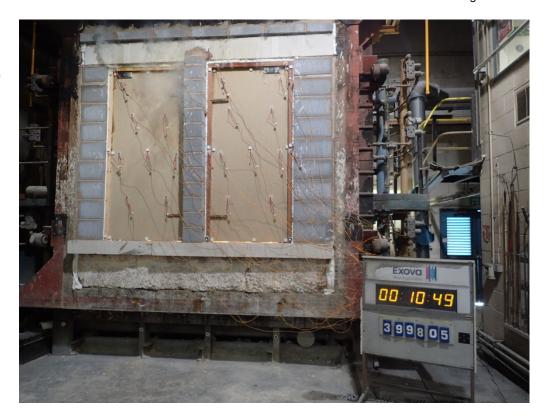
The unexposed face of the doorsets after a test duration of 10 minutes

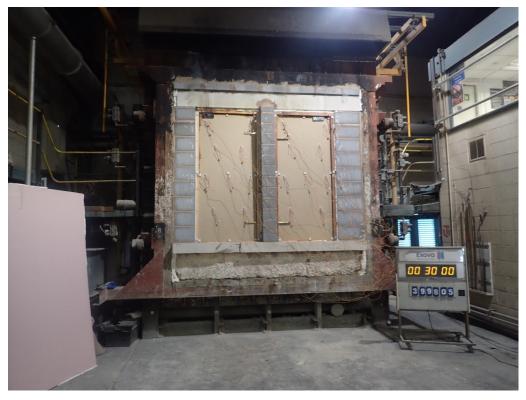
The unexposed face of the doorsets after a test duration of 30 minutes

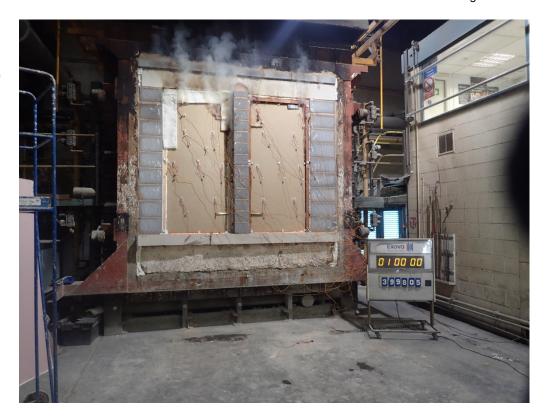
The unexposed face of the Doorsets after a test duration of 60 minutes

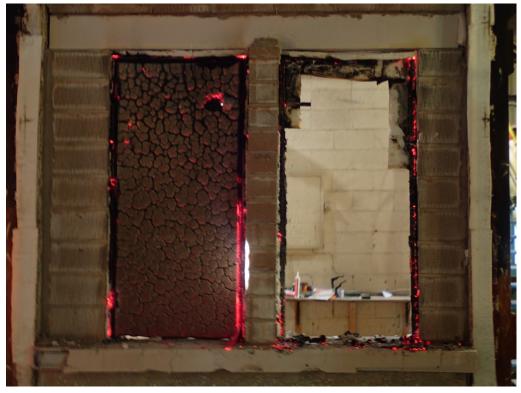
The exposed face of the test assembly immediately after the test
