Flooding on the Whitehorse River, Mountrath, Co. Laois

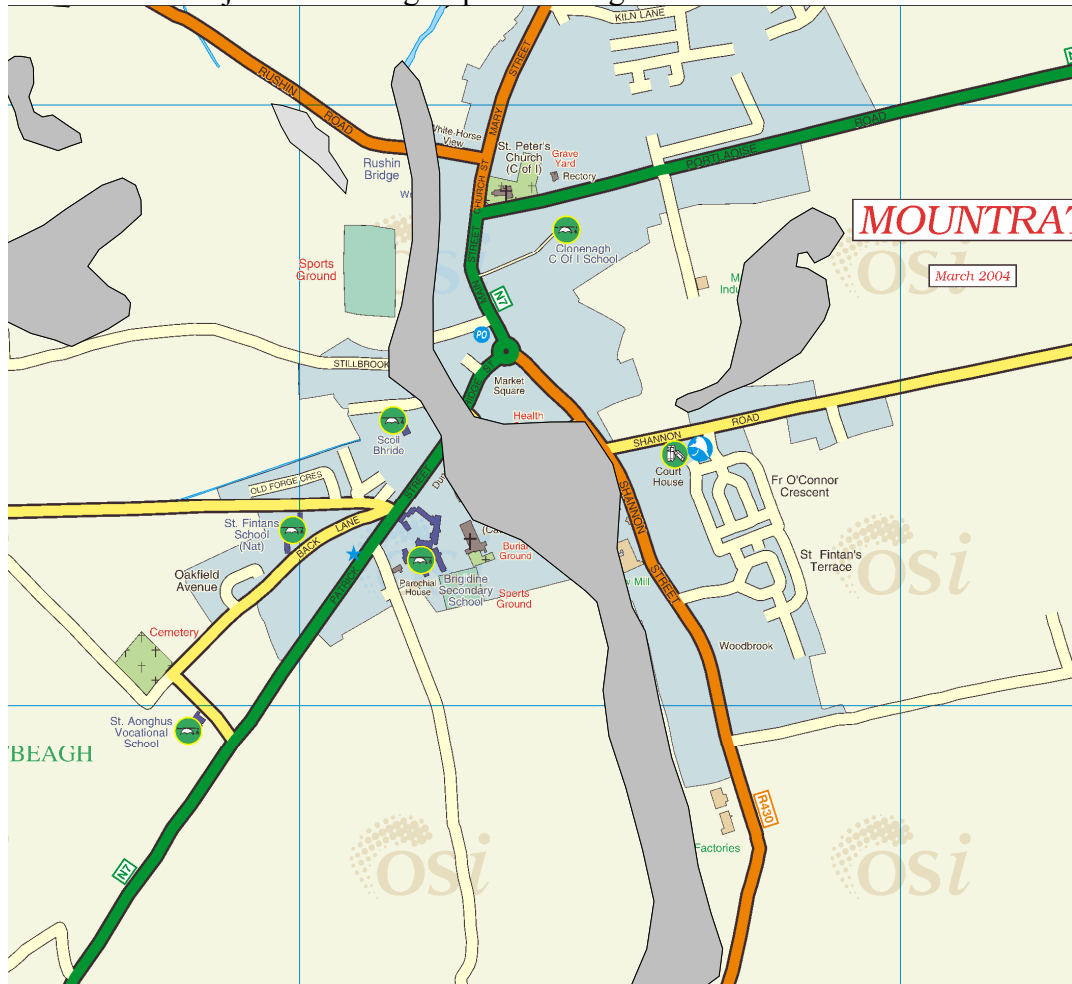
Under More mapped information, the valuation map was cross referenced with the extents of Mountrath. This map forms part of a dataset prepared by the Office of Public Works identifying land that might benefit from the implementation of (Major) Arterial Drainage Schemes (under the Arterial Drainage Act 1945) and indicating areas of land subject to flooding or poor drainage.

Map 2: Benefiting land in Mountrath, from www.floodmaps.ie.

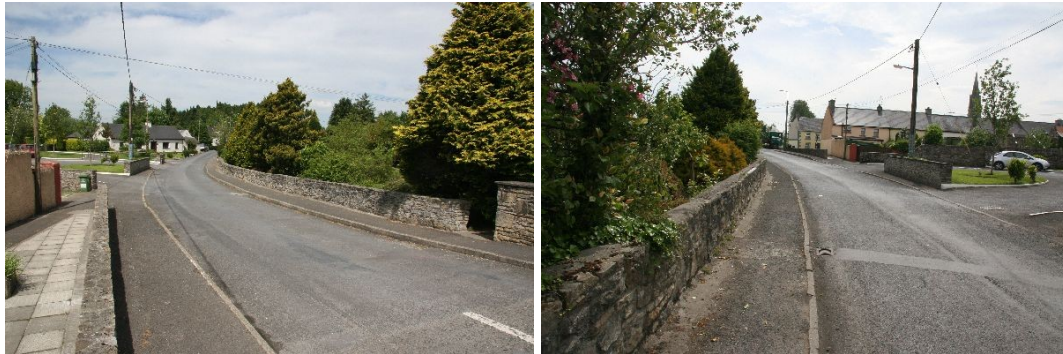
The flooding that occurred on 31st March appears to have been localised to an area on the right bank of the Whitehorse River and between Patrick Street and the GAA grounds.

Figure 1: The area that flooded. The river is behind the stone wall.

The flood event of the 31st March might have been prevented from entering the properties affected by enhancing the conveyance of the existing channel and / or by erecting a flood defence embankment at the entrance to the GAA grounds.

The Patrick Street area might be protected from flooding by increasing the ground level at the points where water can enter at the entrance to the GAA grounds and from the small stream to the rear. A sump could also be installed at a convenient location to facilitate pumping. The small stream that enters the Whitehorse River at the entrance to the GAA could potentially flood into this area, with an increased residual risk. Detailed analysis of the risk of floods from this small stream would be required to fully evaluate this option.

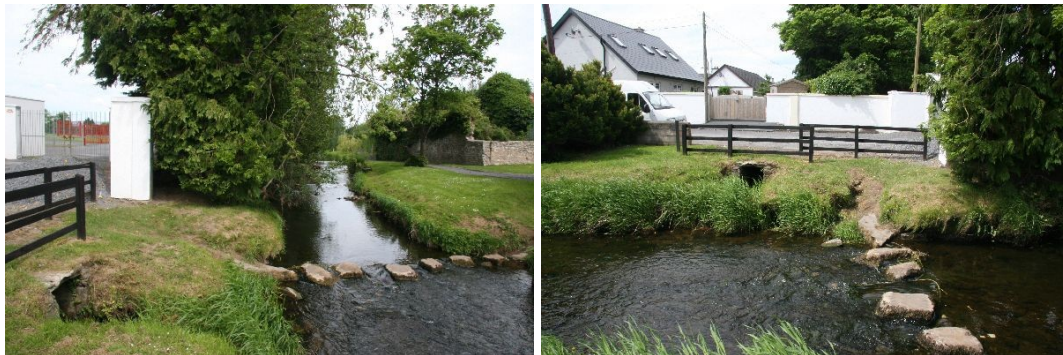
Water level information provided by Laois County Council does not show any major changes in water level, and it appears that the river flowed at or just above bank full. The area where the flood occurred is low lying. There are two possible entry points for flood water to the area, at a fenced section of bank beside some stepping stones, and along the river bank through the GAA grounds. There is also a small stream that enters the Whitehorse River at this point from the west.

Figure 2: Possible entry points for flood water. The stream enters the river in the stone culvert.

There is not enough information available at present to identify whether water followed one or both paths from the Whitehorse River or entered from the small stream.

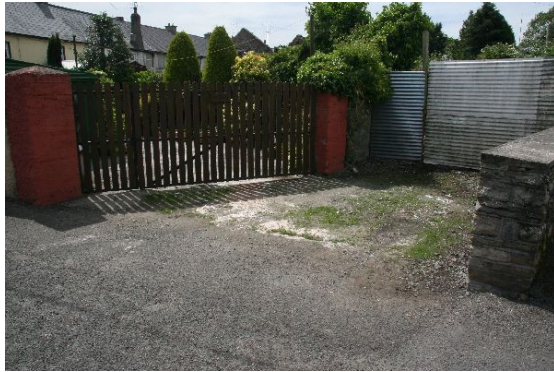
There is no clear exit point from the area that flooded, and it would appear that flood water escaped through the towns surface water system and also back into the river at the points where it entered. The fact that the surface water gullies were well maintained would have reduced the duration of flooding experienced. While the river was high, however, flood levels would have remained high in this area. It would appear that flood water entered the houses on Patrick Street either through the rear gardens or by flowing along a low paved area and onto the footpath. The road appears to be higher than the paths in this area.

Figure 3: Rear of houses on Patrick Street.

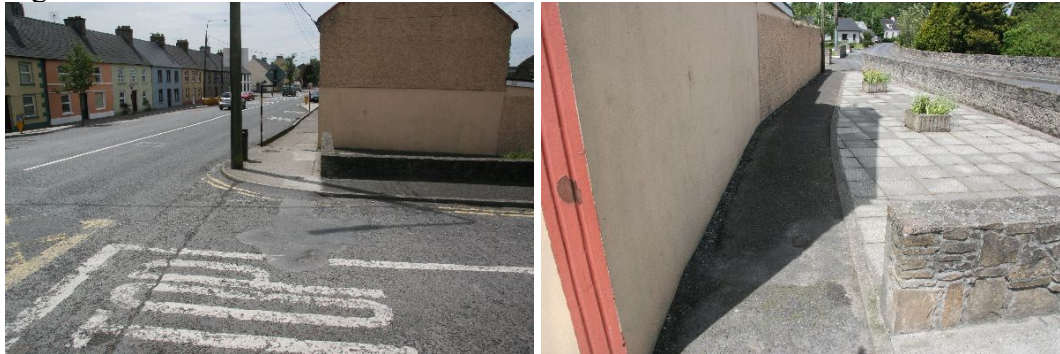
Figure 4: View along Patrick Street and of paved area beside houses.
