## STRUCTURAL REPAIR

## STAIR TOWER I-BEAM &amp; TUBULAR SUPPORTS

MAJOR OPERATOR

NOVEMBER 2019

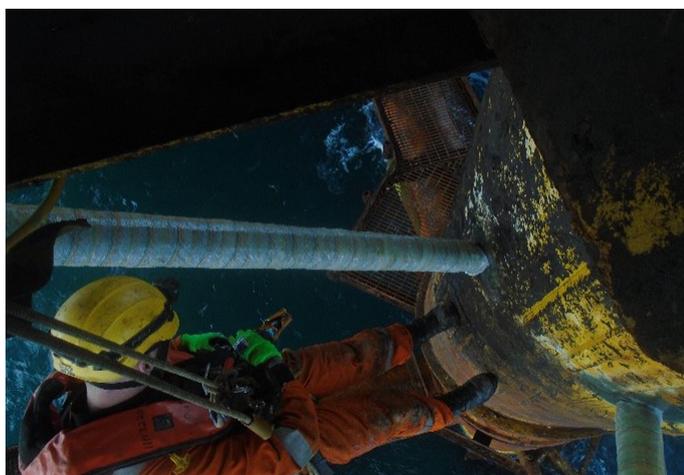
The underside of a deck stair tower onboard a North Sea platform had developed severe corrosion and wall thinning on the stanchion tubular supports, with large, localised perforations on the beam web and flanges. The operator contacted ICR to provide a cost-effective repair solution to reinstate the integrity of the corroded sections. Replacement of the I-Beam and supports on a 'like for like' basis would have been very costly and would involve hot work, which was not acceptable to the client.

The engineered design consisted of 5 layers of Technowrap™ carbon fibre SRS (Structural Rehabilitation System) and LT (Low Temperature) resin. In this application, prefabricated plates were required for all perforated areas consisting of 2 layers of SRS which were bonded using titanium putty and encapsulated with the 5 layers. Further tubular sections were repaired using Technowrap™ 2K. The composite repair has been designed to reinstate corroded sections of universal beams of varying dimensions to their required loading capacity. The main challenge for the application was the complexity of the geometries as well as achieving compression on the corroded beams. Surface preparation was carried out by the ICR technicians and the repair was completed using an ICR rope access team.
