## FAULT FINDING – BELLAVITA BATHLIFT

## **BELLAVITA BATHLIFT DISASSEMBLY GUIDE**

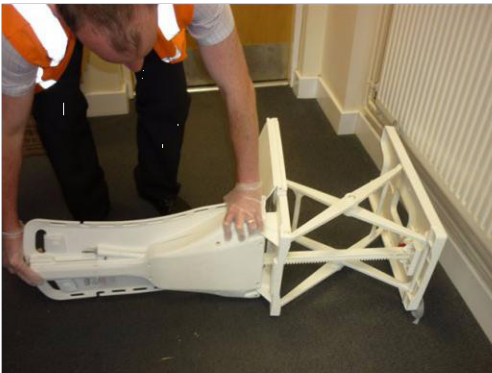
Step 1. Lay the bathlift on its side.

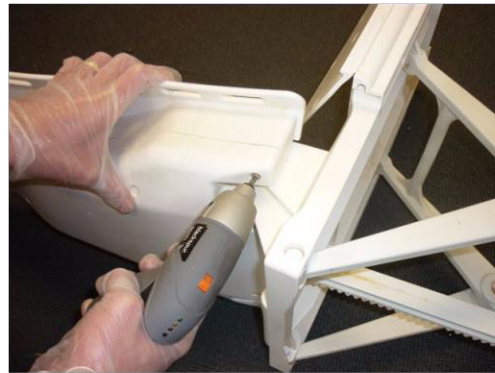
Step 2. Using a T-20 end bit and a screwdriver, remove all the screws on the backrest.  
(T-20 end bits are available from free from Drive Medical on request)

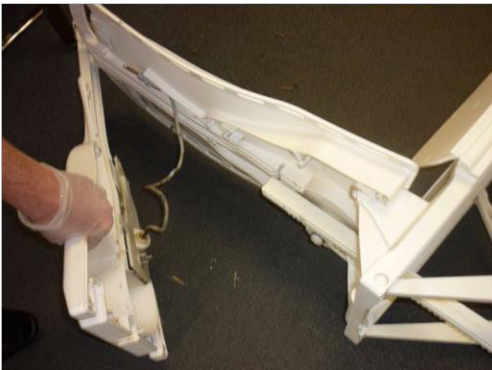
Step 3. Pull the rear of the backrest away from the bathlift.

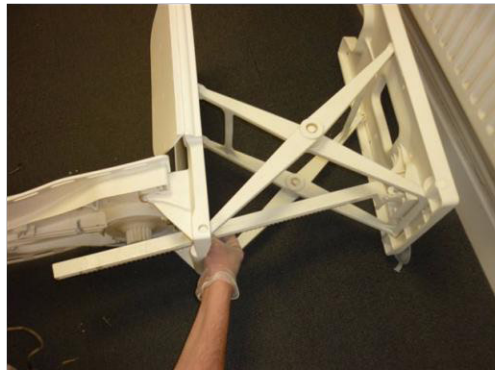
Step 4. Remove the lifting ram and the faulty backrest from the bathlift.  
**Place the faulty backrest in the carton and return to Drive Medical.**
