LEXUS DEALERSHIP UPGRADES SENSORS & ACHIEVES 100% EFFICIENCY RATE

How installation of the OPTEX OAM-Explorer resulted in a safer work environment and smoother daily operations for the Lexus Service Department.

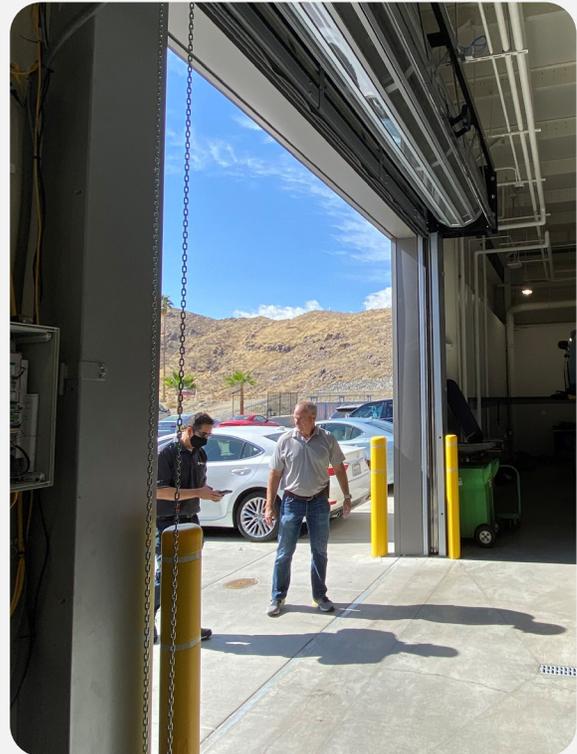
The door was located in the service department at the Shottenkirk Desert Lexus dealership. High speed industrial roll-up doors are used at both ends of their large repair department. This is intentionally designed to facilitate the quick movement of vehicles in and out of the building, while maintaining the building's internal cool temperature.

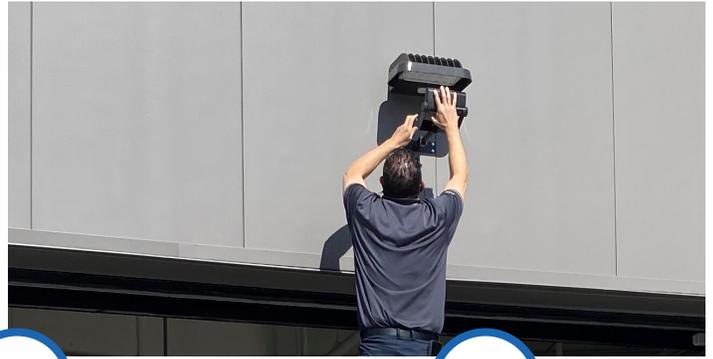
Upon arrival at the site, OPTEX was able to coordinate quickly to remove the Secondary Safety Devices (Wireless Pressure Edges) and replace them with OPTEX OAM-Explorers, Header Mounted Industrial Door sensors. This solution is the best fit for industrial doors of this nature because:

They are not susceptible to interference from wifi or other electromagnetic sources, allowing continued use of their existing technology in the Service department.

The OAM-Explorer is the safest on the market with 3 detection zones. The door will remain open during the presence of cars and humans underneath the threshold.

Additionally, the department can continue to conserve energy as the door will not be triggered to open unnecessarily due to cross traffic.

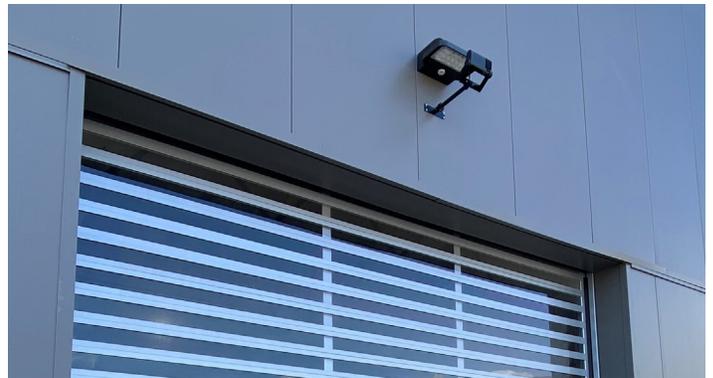
The quick installation required little interruption of daily operations, and the client was pleased that any future configuration could easily be deployed through a smartphone app.

The successful deployment of the OPTEX OAM Explorer resulted in the Lexus service department industrial doors opening and closing as intended, every time. In addition to resolving the door malfunction issue, the installation of our sensor offered Lexus a guaranteed safer work environment for their employees. Unlike the previously used sensor, the OAM-Explorer offered an added layer of human protection through its ability to sense throughout the entire threshold of the door.
