## ***Ozium 1: Safety Notice***

### **This Safety Notice affects All Original Ozium Harnesses (not the new Ozium 2)**

### **Action required: Mandatory Replacement of Reserve Handle**

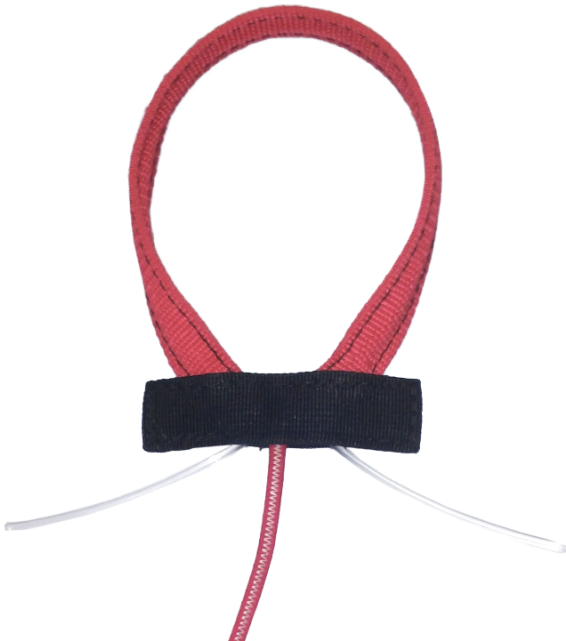
**BAD**

We have had reported a case of failure during a simulated tyrolean deployment. The pins on the reserve deployment handles of all original Ozium harnesses may have been damaged during production. The damage, if present, may result in the pin breaking during deployment causing the reserve compartment to remain closed even if the handle is released. As the breakage is in an area hidden from view we are replacing all reserve handles as a precautionary measure.

The reserve deployment handles on all Original Ozium harnesses should be replaced before next use. Please contact the dealer who sold you your Ozium harness to request a replacement handle. Replacement (GOOD) handles are clearly marked with blue bartacks. If your reserve handle has the blue bartacks, it has been replaced and is ok to fly. If the reserve handle does not, then it must be replaced. Please see photos below.
