TESTIMONIAL

Genie gets a lift from seeing air leaks in action

Application: Compressed air leak detection

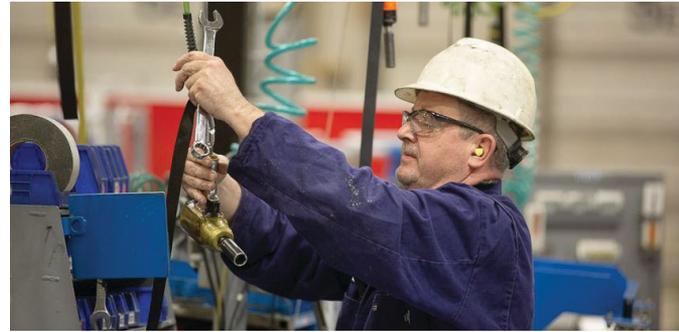
Heavy equipment manufacturer before and after leak inspection

4 air compressors: 2x75 HP + 2x90 HP

Compressor #1	Compressor #2	Compressor #3	Compressor #4	Total
Power/energy log					
Week before	7,954 kWh	2,849 kWh	8,502 kWh	13,818 kWh	33,124 kWh
Week after	10,913 kWh	5,513 kWh	6,779 kWh	1,418 kWh	24,623 kWh
Difference	2,959 kWh	2,664 kWh	(1,772) kWh	(12,400) kWh	(8,501) kWh

After the initial air leak inspections and corrections, Stockert saw a 25.7 % recovery in their compressed air capacity. “We were near the top end of what our compressor system can put out,” he said. “By correcting the leaks found using the ii900, one of our four compressors is nearly idle much of the time.” The reduction in compressor usage translates to an estimated \$48,754 in annual electrical energy savings. However, Stockert believes that there is an additional benefit derived from not having to add more compressor capacity.

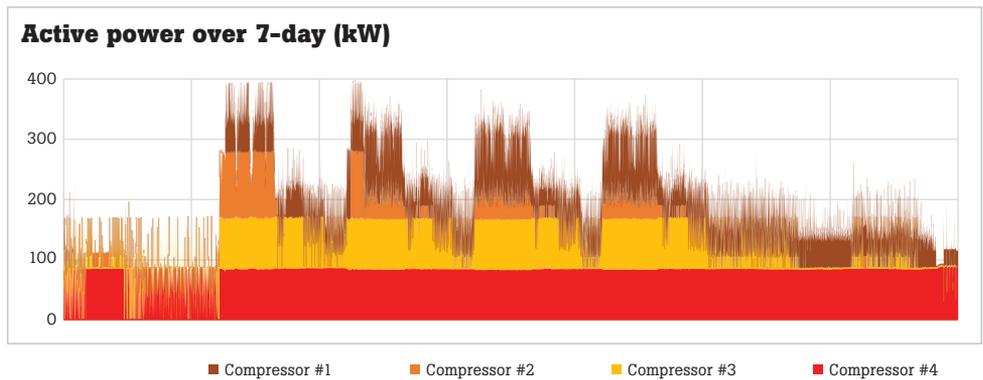
Before

- 90HP compressor #4 working full time (red)
- Air working at max capacity at peak times

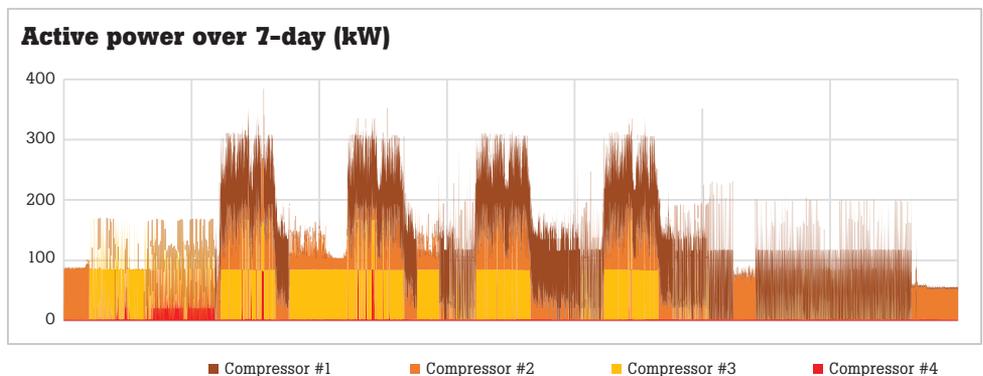
After

- #4 compressor idle
- 25.7 % recovered capacity
- \$48,754 savings

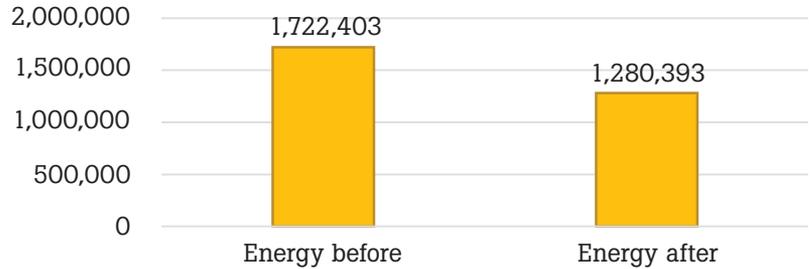
Annualized Consumption (kWh)

Heavy equipment manufacturer before and after leak inspection (continued)

Energy before	1,722,403 kWh
Power bill before	\$189,464
Energy after	1,280,393 kWh
Power bill after	\$140,843
% saved	25.7 %

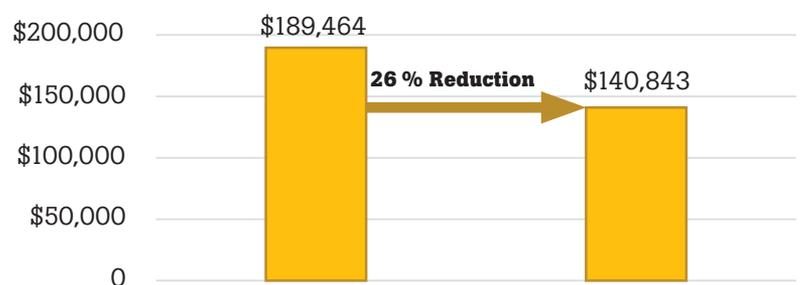
Annualized electricity cost

Energy savings

Per day	1,214 kWh
Per month	36,429 kWh
Per year	443,225 kWh

\$ savings

Per day	\$133
Per month	\$4,007
Per year	\$48,754
