CONTROLLING FLASHOVER BETWEEN ELECTRODE SEGMENTS IN DC POWER CAPACITORS

M.A. Grafton, J.C. Fothergill, L.A. Dissado and J.R.R. Shirley-Elgood

Electrical and Electronic Power Engineering Research Group,
Department of Engineering, University of Leicester

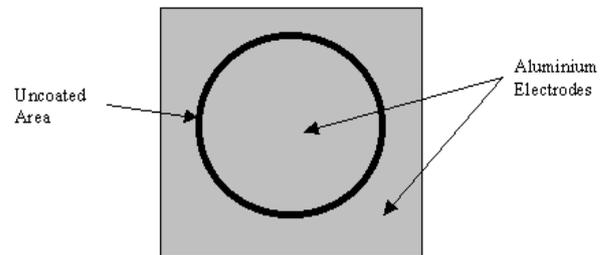
All the results in this paper were derived from specimens comprising a thin film of capacitor grade PP 9 μm thick with a evaporated coating of aluminium on one side. This was 200 \pm 1 nm thick according to the evaporator’s quartz crystal thickness monitor (Edwards FTM 7). However SEM and AFM measurements of cross sections of the specimens set in epoxy showed the coating was very uneven and varied in thickness from 0.5 to 2.0 μm . Flashover took place across an annulus formed in the evaporated aluminium using a circular metal mask. This left a central circular electrode of diameter 47 mm surrounded by a gap, which could be varied from 100 to 1500 μm . This is shown in Figure 1.

Fig 1. Specimen for measuring flashover

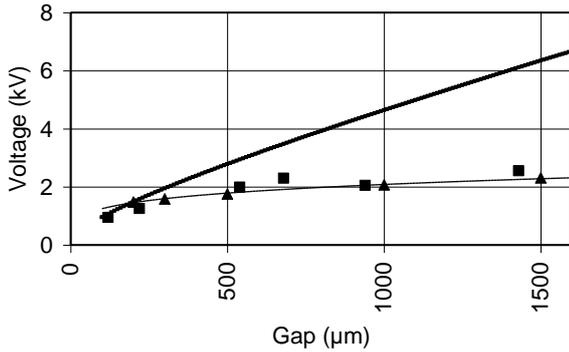
Variation of flashover voltage with annulus gap Fig. 2 shows the flashover voltage for different annuli using a single coated PP layer with the annulus exposed to air as indicated by the square plots. Also shown is the flashover voltage calculated from the Paschen curve, Dissado and Fothergill [2], calculated for a uniform field in the gap as indicated by the top curve.

Figure 2: Flashover voltage as a function of annulus width shown with corresponding Paschen curve

For small gaps the flashover voltage appears to be limited by the breakdown strength of the air. At larger gaps (>~300 μm) the flashover voltage is limited by other factor(s) for example, the field intensification at the electrode edge. This intensification was calculated using finite elements and the “Paschen values” were scaled down accordingly; these are shown as triangular points with an associated trendline. This suggests that for larger gaps the flashover is likely to be controlled by the stress enhancement.

The voltage can deviate from these trendlines by as much as 500V. The flashover voltage tends to increase for the larger gaps since topographic imperfections and asperities cause reduced flashover voltages. These flashover first. These increasing trends tend to be more prominent at larger gaps. From figure 2 this is likely because the narrower gaps’ flashover voltages are determined by the air (or material in the annulus) whereas the specimen geometry is more influential at larger gaps. At present there is some inconsistency in the results, possibly due to variation in humidity or PP surface preparation, which is reflected in the two different sets of results for the 680 μm gap.

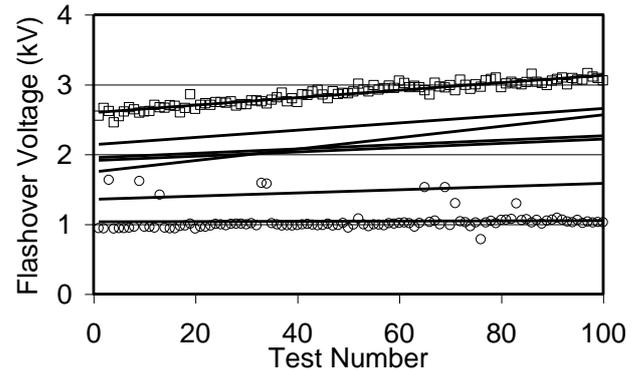
Statistical distribution of flashover voltages The flashover test was repeated 100 times for each sample. This is possible as the aluminum electrode evaporates at the flashover site thereby widening the gap and extinguishing the discharge. Subsequent discharges take place at either other parts of the annulus or adjacent to the previous flashover where the remaining aluminum leaves a distorted shape that gives a local field enhancement. Figure 3 shows results for 6 annuli gaps (with 680 μm repeated). The data is shown for the smallest and largest gaps but only best fitting straight lines are shown for the other cases (for the sake of clarity).

Figure 3: Increase in flashover voltage with successive flashovers. The gap sizes in increasing order of flashover voltage for test 1 were: 120, 220, 540, 680, 940, 680 (repeated) and 1430 μm

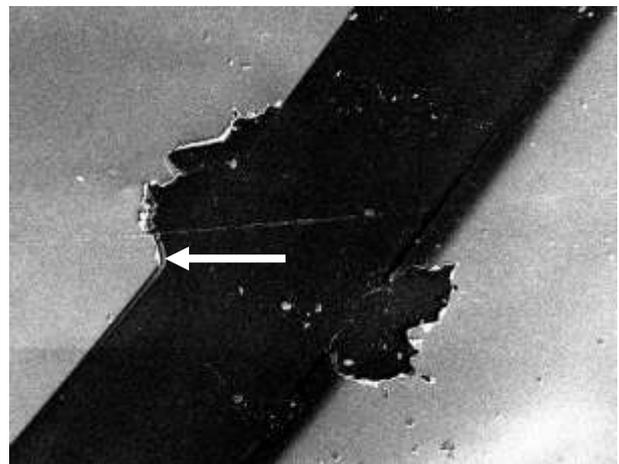
Physical Characterisation Following a flashover the electrode is found to be eroded in a characteristic “butterfly” shape, figure 4.

Fig. 4: Erosion of electrodes due to a flashover across a 830 μm width annulus.

This effect has been observed on a repeatable basis and is not well understood at present. However one would expect that the highest field points are the corners indicated by an arrow in Fig. 4. This would cause preferential erosion at these points and leave a characteristic central protrusion. The surface of the PP is eroded in tracks but these appear to be very clean and not prone to subsequent tracking, Fig. 5.

Surface flashover across narrow gaps ($<300\ \mu\text{m}$) of PP film is controlled by the air or oil in which the gap is immersed. For larger gaps the flashover appears to be controlled by the geometrical stress enhancements. The shape of the erosion of the electrode following a flashover suggests that electrode asperities give rise to a field enhancement that affects the flashover significantly. There may be two different flashover mechanisms. This requires further work but they may be related to whether or not the flashover is triggered by an asperity or other field enhancement point. There appears to be a significant residual charge on the dielectric surface. This is seen in the slowness and magnitude of the charge decay. It may also play some part in forming the shape of the arc.

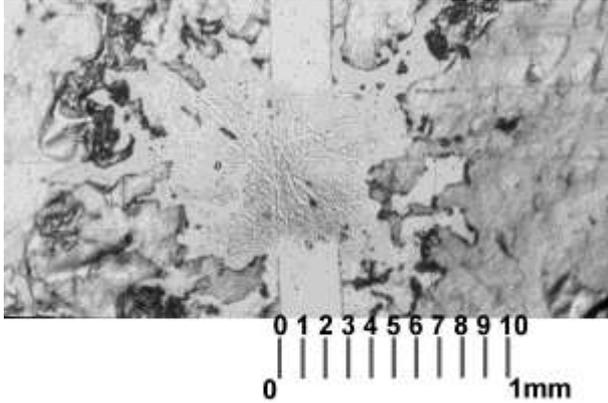
Fig. 5: Surface tracks that appear on polypropylene following a flashover event.

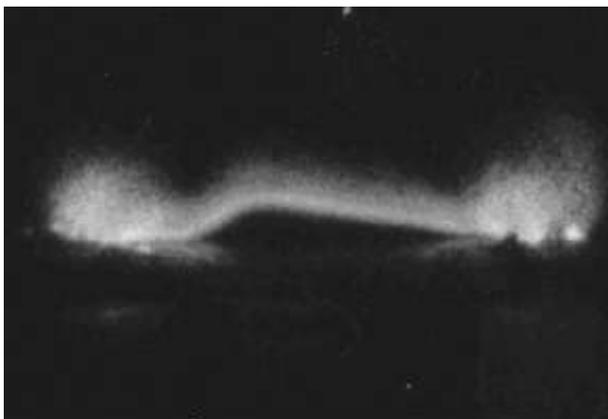
Observation of Arc Fig.6 is a photograph of a typical arc observed during data acquisition. It is evident from the photograph that the arc does not traverse the PP surface but actually 'leapfrogs' across from electrode to electrode. This may be due to convection from the heat of the arcing plasma but may be due to repulsion of the negative head of the discharge from negative charges trapped on the PP surface.

Fig. 6: Photograph of typical flashover in air

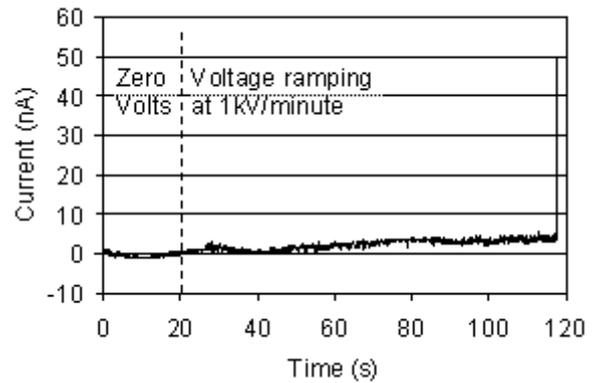
Measurement of Current The current was monitored using a Keithley 617 electrometer and plotted as a function of time. Fig. 7 shows this for a sample with an annulus of 280 μm . A conduction (Ohmic) process would give a current that ramped up with voltage whereas a displacement (capacitive) process would result in a constant current since $i = C \cdot dV/dt$. Any other dominant characteristics one may find would be due to charge injection and accumulation. In spite of

noise generated by the measurement system, one can observe the Ohmic and capacitive characteristics although it was rather difficult to see evidence of charge injection and accumulation on the PP surface.

Fig. 7: Current measured for first flashover

For subsequent flashovers on the same sample, the current plot does not start at zero amps. This is shown in Fig.8 for the fifth flashover subsequent to that in Fig. 7.

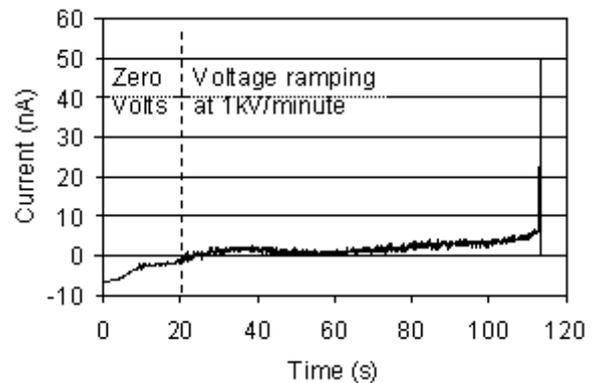
Fig. 8: Current measured for 5th flashover

In fact the current starts at approximately -6nA due to residual charges left in the system from the previous flashover. Using a dielectric spectroscopy it was found that a typical sample of 300 μm annulus had a capacitance between the inner and outer electrodes of $C=6 \text{ pF} \pm 5\%$. Since the first 20 seconds of each test had zero volts applied, the area under this part of the curve represents the remnant charge from the previous test. Using integration it was found that the total charge was approximately 74nC. This cannot be "capacitive" charge for two reasons. Firstly the previous discharge voltage was $V=1.55\text{kV}$ at the time of flashover. The maximum charge stored was therefore $V \cdot C = 9.3 \text{ nC}$. Secondly the charge is only slowly removing – taking about 20s. It seems likely that this charge is trapped on the surface of the PP in the annulus gap.

Another observation seen in some current measurements is the increase in current just prior to flashover. This is also shown in Fig. 8. This effect could be due to corona current of insufficient energy to cause flashover,

or charge injection into the PP surface. Further study of this effect is required.
