Supplementary information files for Macroinvertebrate taxonomic and functional trait compositions within lotic habitats affected by river restoration practices

Supplementary Material

Appendix A.

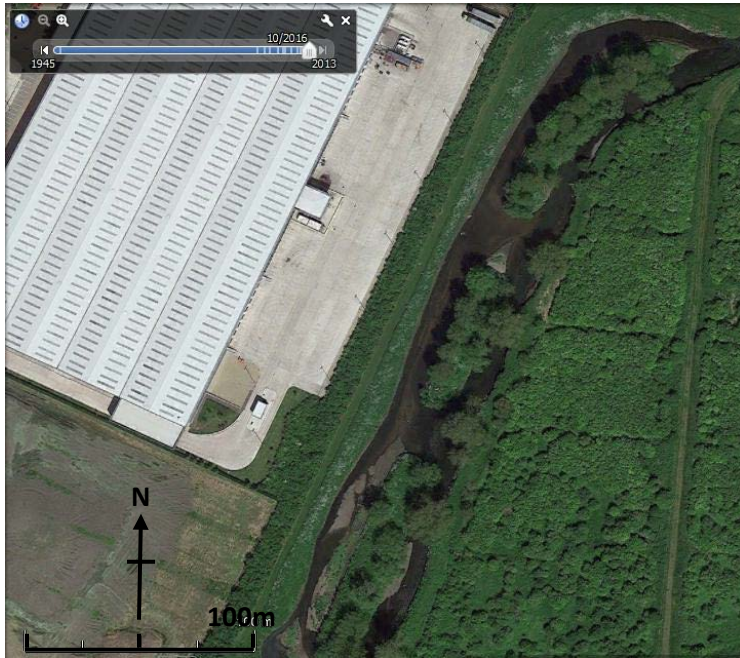
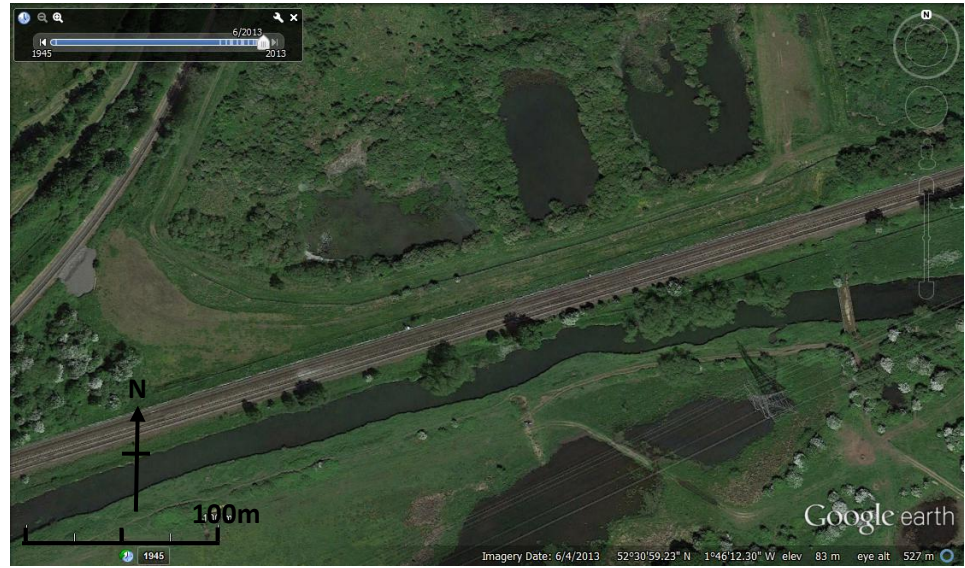
Figure A2. Aerial imagery of the a) restored (source: Google Earth, 2013a) and b) control (source: Google Earth, 2013b) reaches at Minworth.

Restoration works at Minworth were conducted as part of a flood alleviation scheme and project works involved increasing the average channel width from 13 to 41.5 metres. Widening the channel led to the widespread deposition of bare mineralogical substrates – gravel and sand patches (particularly along the west bank - see Figure A2a) relative to the control site (see Figure A2b).

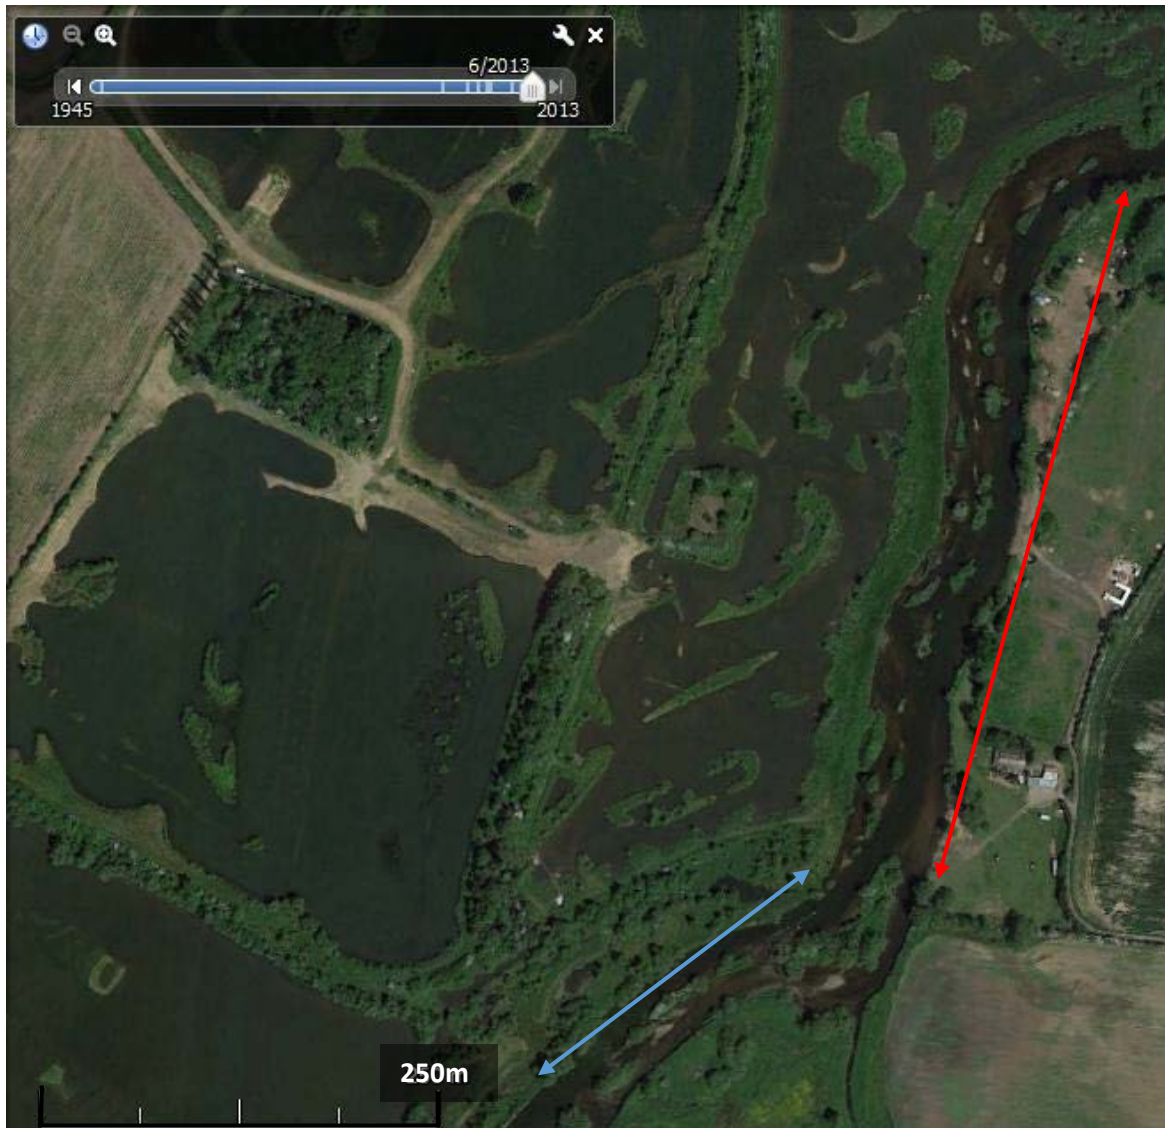
Figure A3. Aerial imagery of the a) restored (source: Google Earth, 2013c) and b) control (source: Google Earth, 2013d) reaches at the Middleton Lakes restoration sites. Red arrow = Middleton Lakes A, blue arrow = Middleton Lakes B.

Both restoration projects at Middleton Lakes were conducted as part of gravel extraction schemes. Works conducted for Middleton Lakes A were carried out in 1998 and the average channel width was increased from 20.5 to 41.5 metres. A number of vegetated islands were maintained in the centre of the channel (in the position of the original eastern bank) and there were evident coverings of bare substrates (particularly along the eastern bank – see Figure A3a) relative to the control sites (see Figure A3b). The restoration project at Middleton Lakes B was conducted eight years later (2006), with the average channel width being increased from 21 to 48.5 metres. However, the design of this restoration project also incorporated fashioning mid-channel bars towards the north-eastern bank which become inundated at higher flows (see Figure A3a). The deposition of bare mineralogical substrates was also evident across large parts of the restored reach.
