Passenger casualties in non-collision incidents on buses and coaches in Great Britain

PASSENGER CASUALTIES IN NON-COLLISION INCIDENTS ON BUSES AND COACHES IN GREAT BRITAIN

Alan Kirk*, Rachel Grant*, Richard Bird**

Paper No. 296

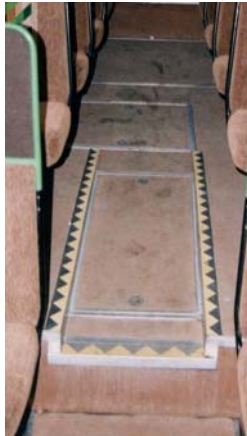
Figure 10.

Uneven floors, especially unpredictable or varying slopes on aisles can present tripping hazards, as they are not expected. New guidelines suggest that floors should not have a greater slope than 3 degrees inside the vehicle (figure 10) and 5 degrees around the door area. Buses with internal steps half way down the aisle can cause falls as passengers are busy trying to find an empty seat rather than looking at the floor (figure 11). The height of any steps within the bus should also be consistent.

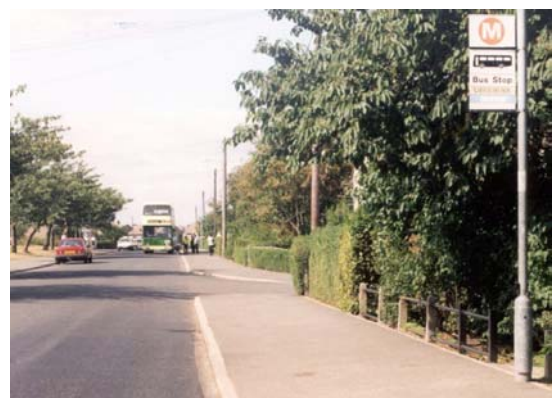
A 52 year old female passenger stood up on the bus intending to alight at the bus stop shown here (figure 18). She had shopping bags in both hands.

Figure 18. Scene of Accident

Before reaching the stop a dog ran across the road causing the driver to brake heavily to a halt. Figure 18 shows the bus in the position at which it came to a stop, so it can be seen that the passenger stood up whilst the bus was a good distance from the bus stop. During the braking action of the bus, the passenger fell forwards and received a fatal head injury from the interior contact shown in figure 19.

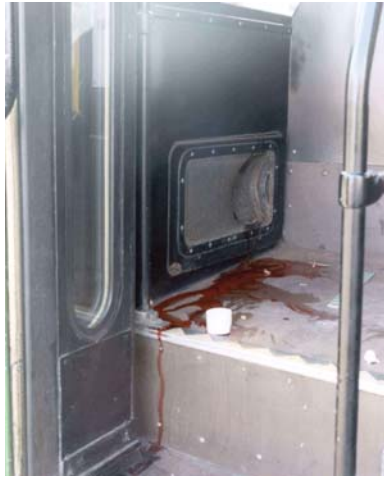
Figure 19. Area of Head Impact

The shape of the head impact can clearly be seen in the grill with the main injury caused by an impact with the rigid metal surround.

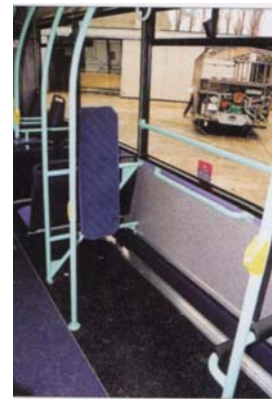
Figure 20.

These new buses have significant advantages on the ease of access for all passengers but especially the less mobile, allowing a wider population to access and use buses, thereby changing the bus user population characteristics. New buses will have low floor access, priority seats and crucially space for wheelchairs and push chairs (figure 20).
