WHY DO PASSENGERS GET HURT WHEN BUSES DON'T CRASH?

Rachel Grant¹, Alan Kirk¹, Richard Bird²

¹Vehicle Safety Research Centre, ²formerly of ICE Ergonomics
Research School in Ergonomics and Human Factors
Loughborough University
Loughborough, Leicestershire, LE11 3UZ. UK

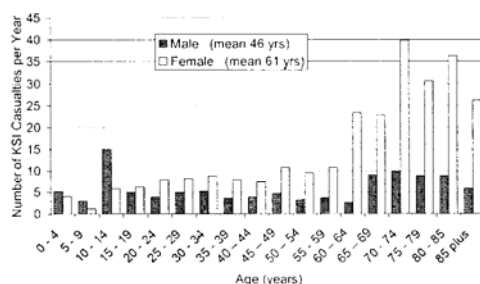
Figure 1. Age and gender distribution

The gender distribution for KSI casualties, injured when no collision takes place, shows that there are over twice as many females (71.6%) as males (28.4%). This is likely to be both a function of greater bus use by females and a lower tolerance to injury. In figure 1 a peak is seen for school age males and there is an obvious increase in numbers amongst elderly females. The mean age for female casualties is 15 years higher than for males.

Overall there is a marked increase in the likelihood of a serious or fatal injury to a female occupant as their age increases. Governmental surveys show that generally women travel more on local buses than men for most types of area and age. This goes some way to explaining why women have a much greater representation as bus or coach casualties than men on the database. Overall it is estimated that in the 16 to 59 years old age group women travel 47% further on local buses than men. Women of all ages also make more local bus journeys than men, whilst travelling further, giving higher exposure to injuries that occur whilst standing, boarding or alighting the vehicle, as they get on and off more often.

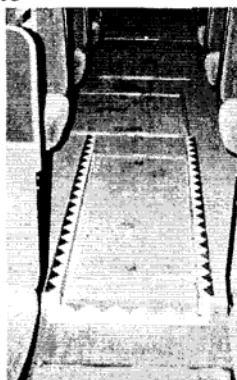
Figure 2

- Slippery floors,
- Weather conditions,
- Uneven floors (fig 2)
- Unexpected or high steps (fig 3),
- Steep slopes,
- Lack of visual cues,
- Physiology in the elderly.
