Construction tools and equipment – their influence on accident causality

Gibb, A.G.F., Hide, S., Haslam, R.A., Gyi, D.E., Atkinson, S. & Duff, R, Construction tools and equipment – their influence on accident causality, Journal of Engineering Design & Technology (JEDT), 2005, Volume 3 Issue 1 pp. 12-23, ISSN 1726-0531

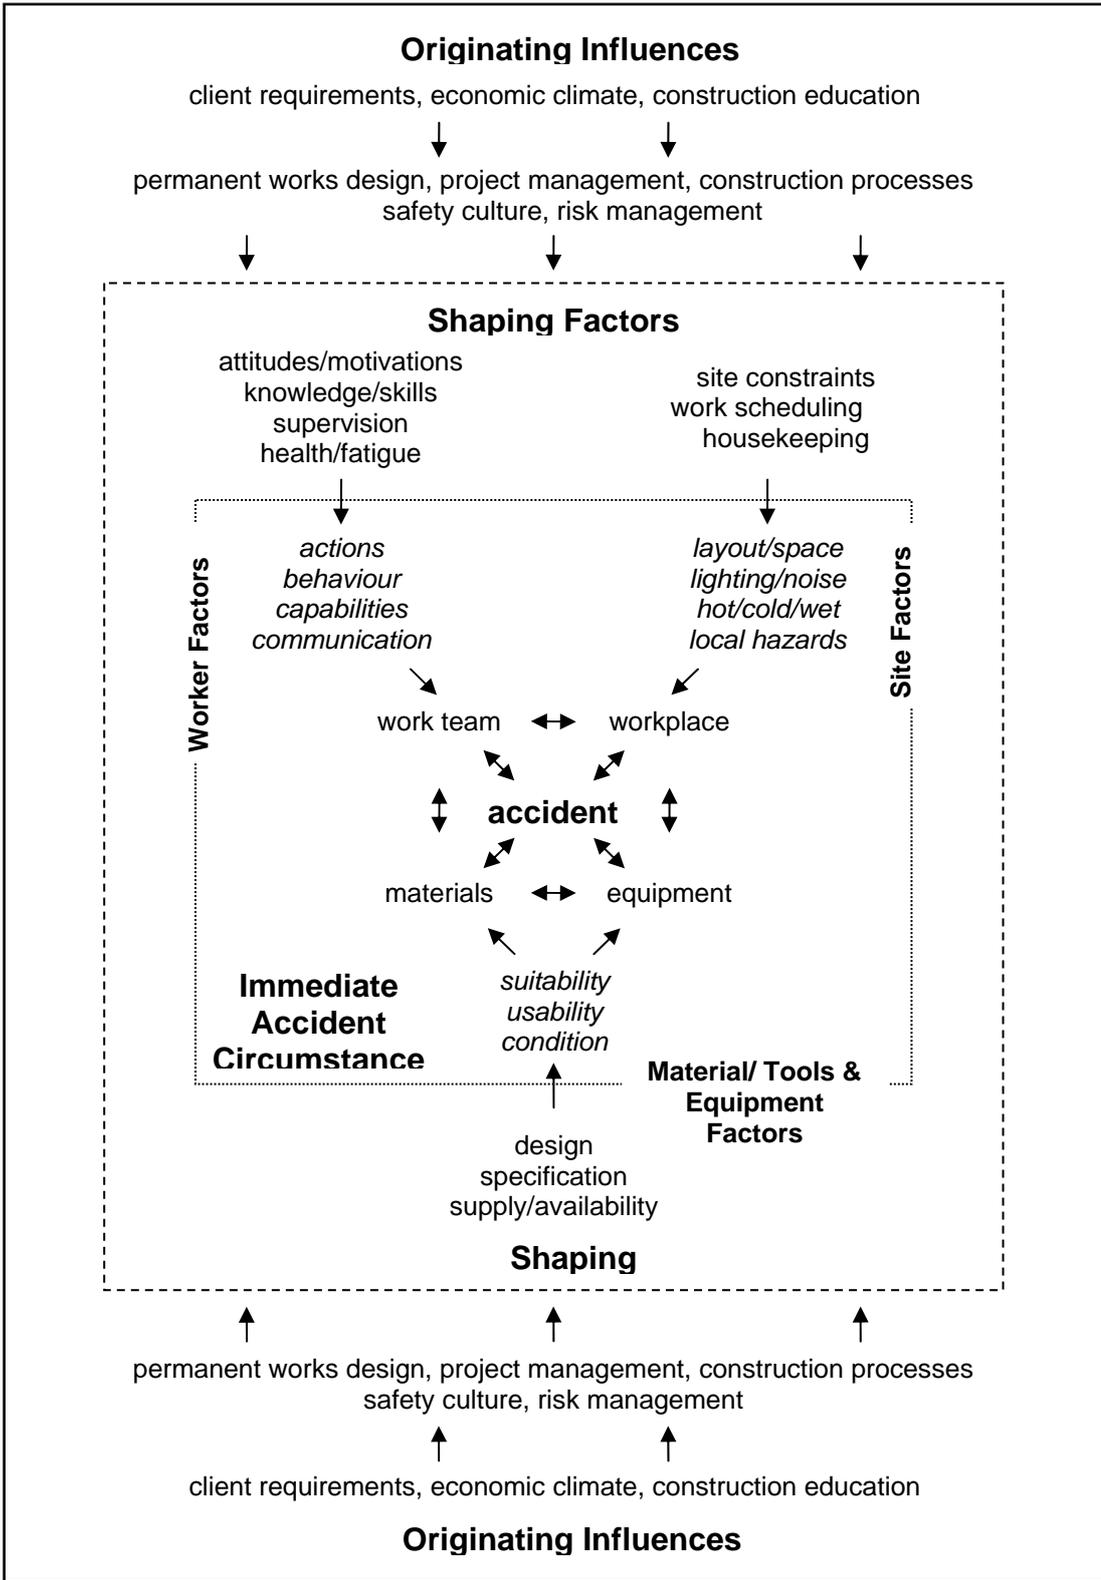
Figure 2 Loughborough's ConCA construction accident causality model (adapted from Haslam et al, 2003)

The ConCA project has produced a causality model (Figure 2), that presents the factors influencing accidents on three planes, namely: immediate accident circumstances, shaping factors and originating influences. These planes can also be viewed in a similar way to Suraji et al’s (2001) proximal and distal causes, in that they move from the more immediate and more easily demonstrable aspects, further along the causal chain where the links become more fuzzy and harder to firmly establish. As explained earlier, the concept of ‘with reasonable confidence’ was used to determine these more distal causes.

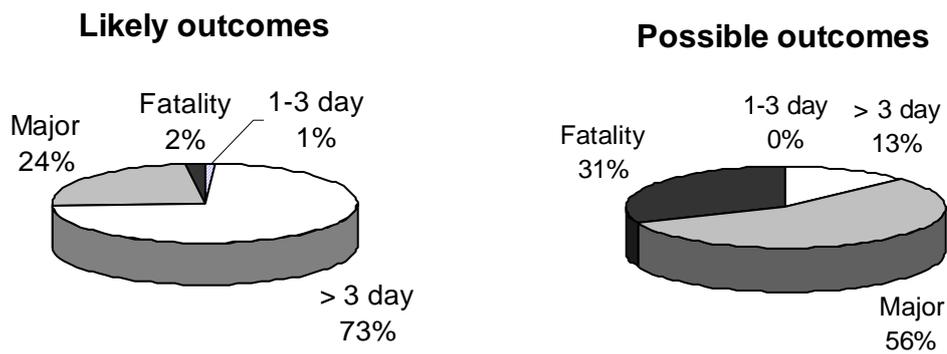
Figure 3 Likely and possible accident outcomes

As mentioned earlier, the limitations on the accident sample meant that most of the accidents studied had outcomes that were not reportable under the UK regulations (RIDDOR⁶). To consider the significance of the research findings an exercise was completed to propose potential outcomes (Figure 3). These were established as ‘likely’ and ‘possible’ based on the RIDDOR classification. This rationale relied on an evaluation of the incident information and evaluation of alternative outcomes if the injured person had been in a slightly different location or if a different part of the body had been involved. Likely outcomes would require only a minor change in circumstances; possible outcomes would require a number of circumstances to change for them to occur. Some of the ‘major’ incidents may have led to permanent disability and hence loss of the individual to the industry. With a modest change in circumstances, it is likely that almost three-quarters of the accidents could have resulted in absences of more than three days and almost a quarter could easily have been major incidents. It is also likely that between 2 and 6 accidents could have resulted in fatalities. With a greater change in circumstances, the almost a third of the accidents could have resulted in fatalities and more than half would have been classified as major.

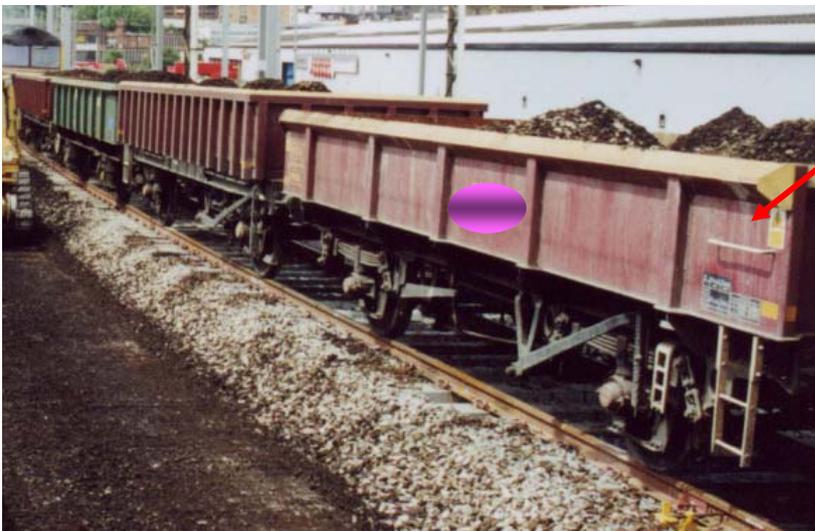
Figure 4 Inadequate ladder access to rail wagon

A related problem occurred in connection with the length of ladder attached to the side of a rail wagon (Figure 4) which was being used to haul excavation spoil from a rail construction project. Elsewhere, use of split or cut down ladders was reported.

Whilst climbing ladder to view rail wagon contents, IP injured hand on top of wagon which had been damaged by a excavator loading spoil material into the wagon

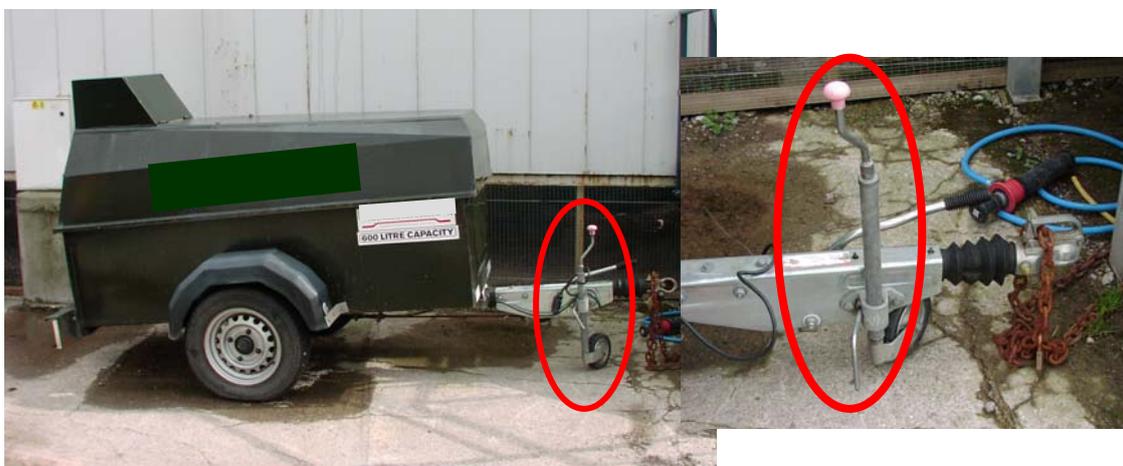
Figure 5 ‘Jockey wheel’ failure on fuel bowser

Problems had also arisen with operations involving manual movement of loads. In one case, load instability existed due to free movement of fuel within a fuel bowser. This situation was exacerbated by the design of the adjustable ‘jockey’ wheel at the front on the bowser (Figure 5). The fuel moved and caused the bowser to topple – the locking mechanism on the jockey wheel did not prevent the instability.

The design did not 'fail-safe' and had not utilised good practice from similar situations in other applications. For example, a very similar situation occurs in the caravan (small mobile homes) market in the UK, but in this case the design of the jockey wheel is much more sophisticated and the vehicle does not fall if the winder mechanism is incorrectly used.

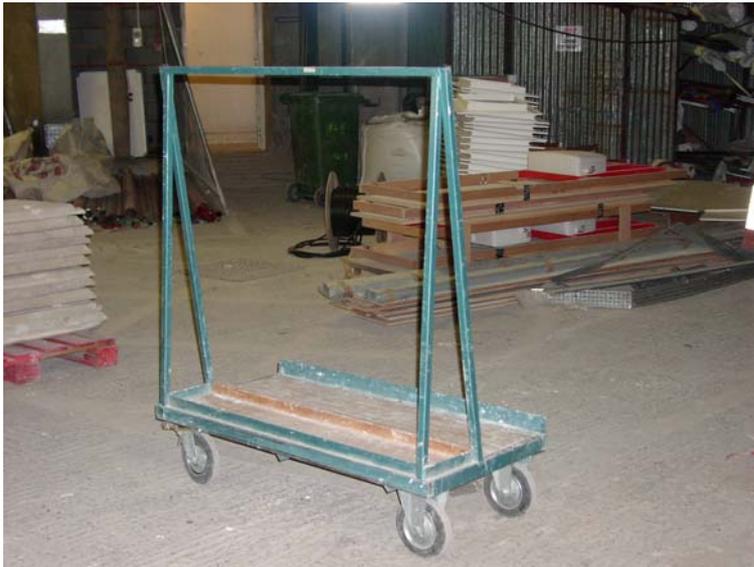
Figure 6 Plasterboard trolley manual handling incident

In another accident, problems occurred manoeuvring a laden plasterboard trolley (Figure 6). The trolley had directional wheels at only one end (the other end having fixed forward facing wheels). While it was not known which end of the trolley was leading, difficulties were to be expected moving a full load with this particular trolley design.

IP's hand was crushed against an adjacent scaffold handrail whilst removing plasterboard sheets from a fully loaded trolley.

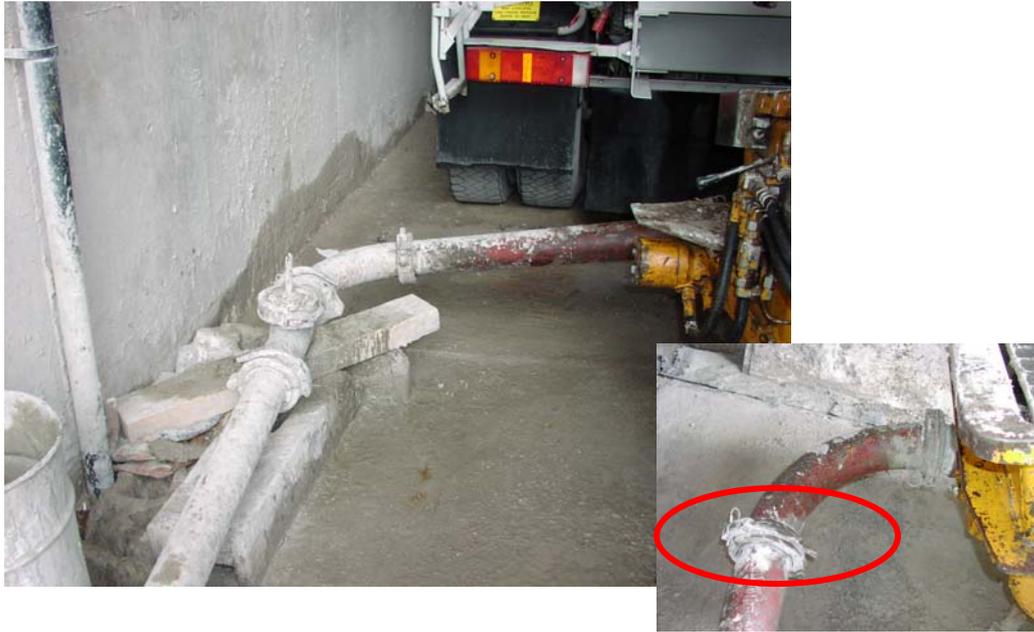
Figure 7 Concrete pump connection problems

Equipment maintenance deficiencies featured in several accidents, especially with respect to steel parts (such as scaffold clips, concrete pipe clamps and extendable steel props). Weathering and concrete spillages on the equipment were reported as the main antagonists. Although 'regular cleaning and maintenance programmes' were in place, overcoming rust and similar problems added to the physical effort required to use equipment. Examples were found where the design of equipment gave little heed to its usability or how the user might detect and monitor different states. Figure 7 shows concrete placement pump and pipeline, where an operative injured his foot attempting to secure a pipe connection clip that had become excessively stiff due to concrete contamination.

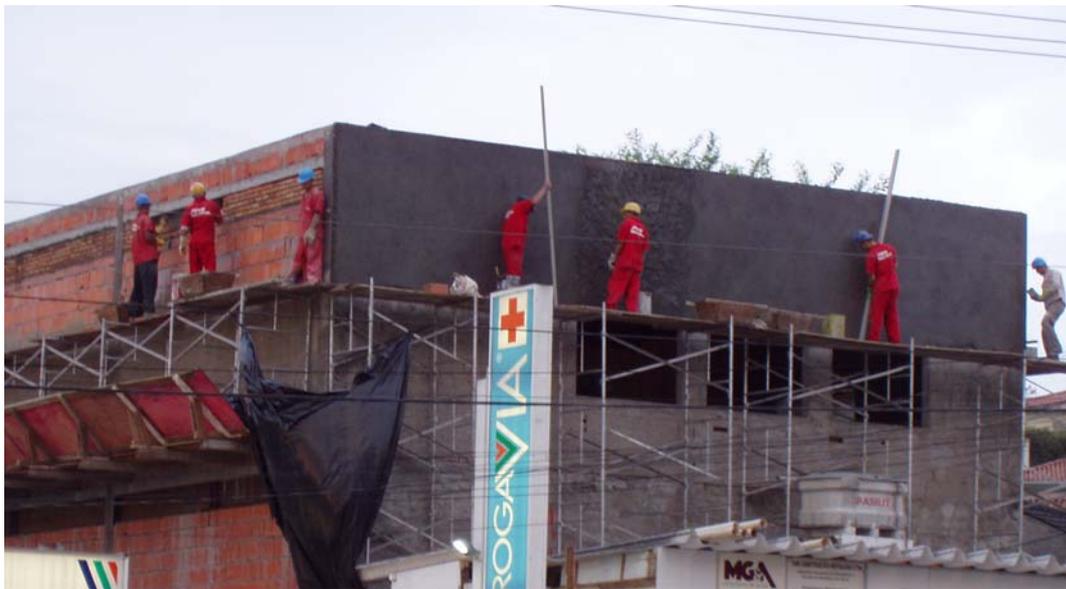
Figure 8 Helmets worn but handrail missing

Many interviewees accepted or were resigned to wearing a safety helmet, seeing them as a 'necessary evil' and in a number of the accidents helmets helped to reduce the extent of the injury. However, it was also said that they are not always needed, with some frustration at the lack of flexibility over when helmets needed to be worn. This seemed to suggest that, on some sites, there was an over-concentration on mandatory wearing of PPE (especially helmets) irrespective of the prevalent risks, whereas other risks were not always addressed. Figure 8 illustrates this point, with operatives rendering the external walls of a building wearing full PPE, including site helmets, although there is very little risk of anything falling on them. Whilst, in contrast, the very real danger of falling from a height of around 20 metres was not addressed in that no handrail is provided to their access scaffold. If they fell from this height their helmet would almost certainly fall off, and even if it did not, it would not prevent them from serious injury or, more likely, death.
