11th conference of the International Sports Engineering Association, ISEA 2016

Artificial Turf Field – A New Build Case Study

Paul Fleming*, Mike Ferrandino, Steph Forrester

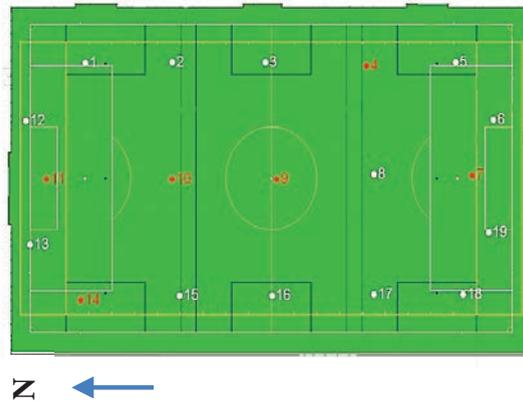
Fig. 1. Testing grid layout, utilized for the monitoring. Pitch length 105 m, width 62.5 m.

The surface system design is based on the play performance requirements of the sport(s). The ‘system’ comprises the shockpad, carpet and infills. In 3G systems infills are comprised of a lower layer of stabilizing sand and an upper layer of ‘performance’ infill commonly a (recycled) rubber particulate. The key play performance parameters for the user are shock absorbency (underfoot and impact comfort) and grip (traction), and ball sports include bounce and roll criteria. The system play performance response is a combination of shockpad type, density and thickness, carpet detail (fiber length, type, and weight/density) and infill types and depths [3]. Maintenance of the field, such as cleaning and brushing, is vital in prolonging good performance [4]. For this project the pitch build programme was from August through November 2014, the weather was unusually warm and dry, an advantage for the earthworks. The new pitch was constructed on the site of an existing natural turf pitch. The general testing position grid utilized is shown in Figure 1, showing the 19 designated points used for system approval testing [2], the lower layer monitoring used this system also for direct comparison albeit not all layers were tested at all positions.

and the range (\pm), for the 19 official test positions (Figure 1) except for ball tests done at 6 positions. Furthermore, the September testing was confined to one sub area of the pitch near the center circle. This pitch is also used for association football (and American Football) and as a result the ball roll behavior is of interest but not a requirement for rugby. In addition the free pile height (FPH) of the fibers was also measured in November 2014 and March 2015 at the 6 positions where ball roll was measured, with both data sets concurring at 19-23 mm. The FPH is useful as it has been shown to correlate strongly with ball roll and can be used to monitor the effectiveness of the brushing maintenance in keeping the fibers upright, previous work [8] suggests a FPH of 20 mm predicts a ball roll distance of approximately 6 m.

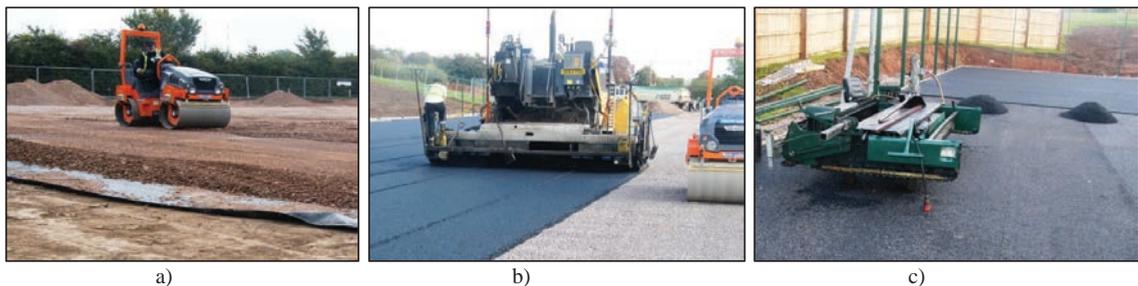
Fig. 2. (a) sub-base compaction, note the geotextile separator (b) asphalt paving machine (c) shockpad paving machine (on blocks).

The aggregate sub-base had low fines to promote good drainage, and a geotextile used as a separator to avoid aggregate and soil mixing (see Figure 2a). The stone was laid using standard plant to a depth of approximately 250 mm, the final 50 mm was laid by a laser level controlled (asphalt) paving machine (Figure 2b) to providing a level surface for the asphalt. The sub-base compaction used a small vibrating drum roller, with repeat passes. The aggregate stability was assessed by three methods, the DCP (CBR %), the 4.5 kg Clegg Impact Hammer (routinely used to assess compacted state), and a portable plate testing technology familiar to the highways construction industry was also trialed. The 'Lightweight Deflectometer' (LWD) plate test utilizes a falling mass and rubber buffer to dynamically load a 300 mm diameter bearing plate to a controlled contact stress (100 kPa) and measures the surface deflection [5]. In the highways industry a minimum of 65 MPa is specified to ensure adequate compaction (of a well graded sub-base) and overall base stiffness. The minimum stiffness value suggested currently for a sport pitch sub-base is 40 MPa, reflecting the lower density and stability achieved with the lower fines. The formation had dried out in exposed areas at the time of placement of much of the sub-base expected to increase the measured stiffness. Samples of the sub-base were taken for further laboratory classification, compaction tests and water content. Pitch edging kerbs, fencing posts and floodlight columns were installed alongside the base construction works.

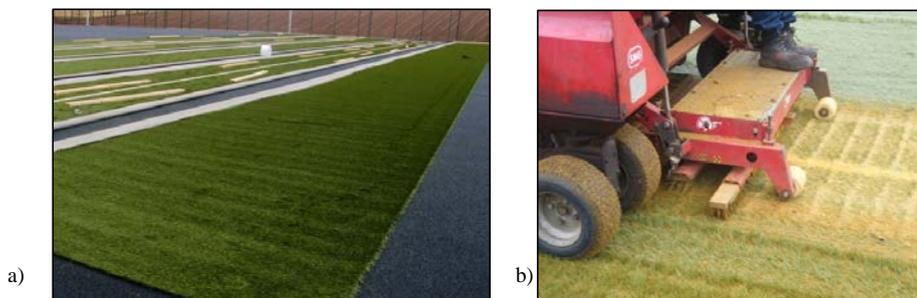
Fig. 3. (a) Artificial Turf carpet rolls laid out to relax prior to seaming; (b) Sand infill layer being applied by mechanized spreader and vibrating brush system.

The carpet installed comprised a 60 mm pile height product, described as ‘3rd generation football turf with sand and rubber crumb infill’. The carpet was laid in 4 m wide rolls, stretched and moved into place (see Figure 3a), and then seamed. Seams were fixed by gluing a 300 mm wide backing strip across the joint. The carpet took 10 days to install including cutting in some of the color line markings. The carpet was vigorously brushed whilst the stabilizing sand infill was applied using a large motorized hopper, to a target coverage rate of 15 kg/m² (see Figure 3b), taking 3 days to complete. A spreader machine was used to install the ‘performance’ infill (rubber granulate/crumb recycled from truck tires) to a target coverage rate of 15 kg/m², also taking 3 days to complete. It should be noted that the particle density of sand is more than two times that of the rubber hence the rubber infill depth (volume) is much greater than sand for the same mass. The field area is approximately 6560 m², and around 160 tonnes each of sand and rubber were applied.

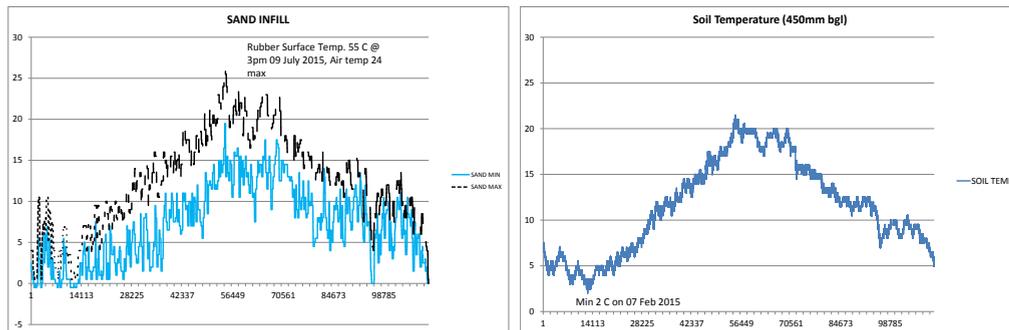
Fig. 4. (a) AGP sand infill temperature; and (b) formation soil temperature over a one year period

Thermocouple transducers were installed at all layers in the pitch construction, in the clay formation layer, sub-base, asphalt, shockpad, carpet backing and the sand infill. It was not practicable to install the steel wire thermocouple into the rubber infill for safety reasons. The aims of this work were twofold: firstly and primarily to provide data for the evaluation and modelling of the heat exchange mechanisms through the pitch layers - it has been observed that on warmer sunny days the rubber infill can reach temperatures well in excess of the ambient air temperature and also that of natural turf surfaces [9, 10]. Secondly, the data help with the debate on frost protection related aspects of pitch base design from evaluation of the insulating effects of the upper pitch layers on the clay formation. Figure 4 provides an overview of the temperature monitoring over the period November 2014 to January 2016 at two depths, within the sand infill (a) and the formation soil (b). The sand data was so 'noisy' that the maximum and minimum daily temperatures are shown for visual clarity. A prolonged period of cold in Jan/Feb 2015 gave the lowest formation soil temperatures to date of 2°C. In July 2015 the temperatures in the sand infill peaked at 26.5°C and the rubber infill peaked at 58°C (measured by a hand held infra-red thermal camera) whereas the peak ambient air temperature was 24°C. The

formation soil temperatures (buried approximately 100 mm into the soil below the sub-base) did not fluctuate as much as the sand, as expected, but showed the same general trend over time. Interestingly the carpet (latex) backing and shockpad (also primarily rubber) displayed higher temperatures than the sand infill during this period. Early work on mathematically modelling the heat transfer has shown good agreement with the experimental data. The ongoing research aims to provide a design tool to predict the expected infill surface temperatures and air temperatures for a range of pitch designs and for a range of global climates. This unique work will then be integrated into studies on the potential for heat stress and player injury risk [10].
