36th WEDC International Conference, Nakuru, Kenya, 2013

**Accessible school latrines in Uganda:
the gap between design and construction**

N. Kasumba & H. Jones, Uganda

BRIEFING PAPER 1798

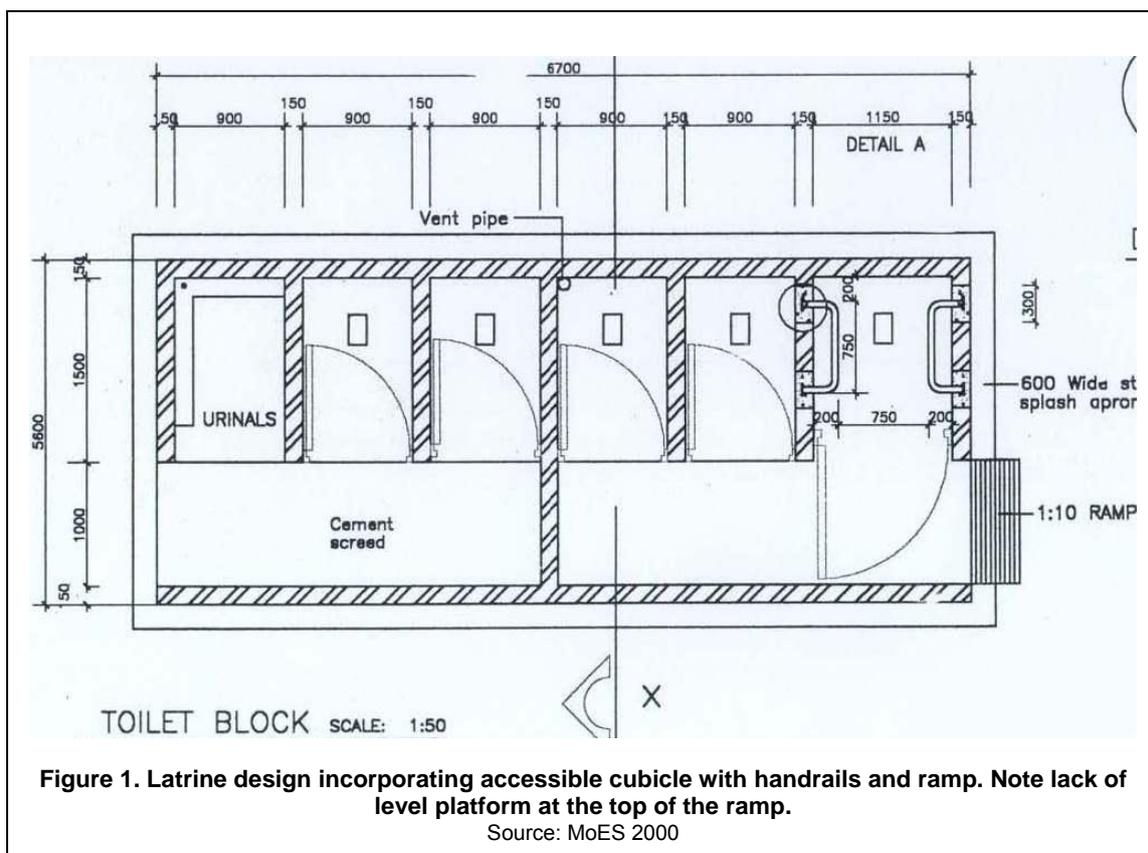
MoES Designs: The MoES has produced three designs, all of which incorporate a spacious cubicle, with ramp access and a wide and outward opening door. Other features include a urinal in the boys' block and a washroom in the girls block. The earliest design (MoES 2000) has a reasonably spacious cubicle (1150 x 1350mm), support rails on both side walls, although they do not span the entire length, and a ramp with gradient of 1:10. There is no level platform at the top of the ramp (Figure 1).

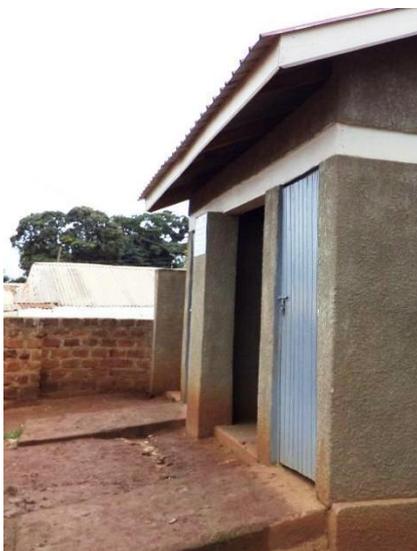
Ramps: Only two facilities complied with the maximum recommended ramp gradient of 1:12. Most of the ramps had very steep slopes making it difficult to provide independent mobility for CWD.

Doors and locks: Five of the six facilities had doors opening outwards, thus allowing for manoeuvrability inside the cubicle by a wheelchair user. One facility had doors opening inwards, which would be suitable for use by visually impaired users (UNICEF et al, 2004), but difficult for wheelchair users and reduce usable space. Door locks in five facilities were too high for children using wheelchairs and small children (Photo 1). Door locks were small and therefore not easy to grip.

Photo 1. Ramps with gradient 1:12. Note lack of platform at top of ramp and high door bolt. This would be inaccessible for a wheelchair user. (Kasumba 2012)

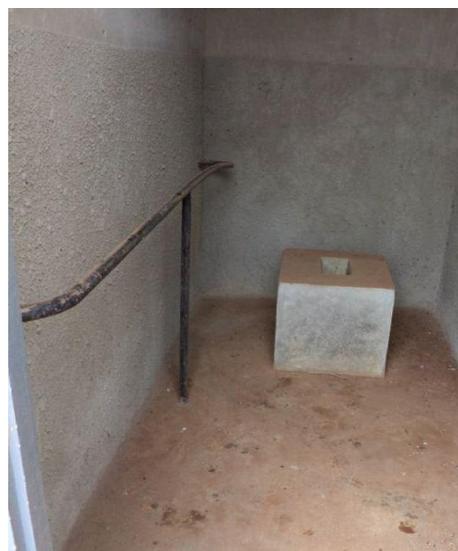
Toilet seats: Two facilities had fixed raised toilet seats (Photos 2 and 3). One facility had a moveable seat placed over the toilet (Photo 4).

Photo 2. Cubicle with raised toilet seat and support rail. The space inside looks adequate, but the inward opening door (see photo 1) reduces the usable space. (Kasumba 2012)

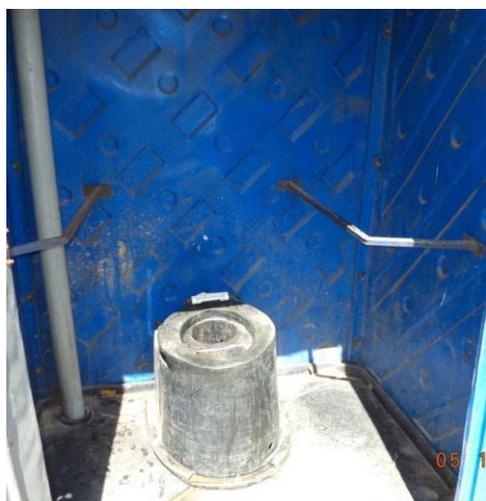
Photo 3. Cubicle with raised seat, support rails on both sides. No room to enter cubicle with a wheelchair. (Kasumba 2012)

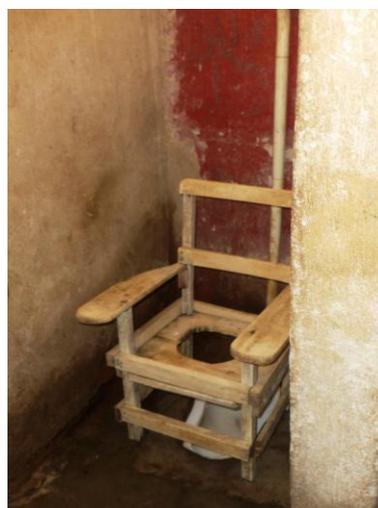
Photo 4. Additional accessible feature – moveable toilet seat. (Kasumba 2012)
