Road Safety Audit experiences related to cycling infrastructure

Keywords: road safety audit, cycling infrastructure, traffic safety.

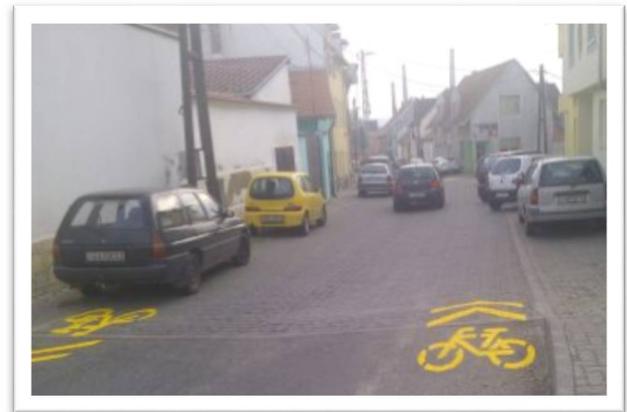
Bicycle chevron markings are applied too frequently and often unnecessarily, even in residential streets with very low traffic volumes (Figure 2). One of the reasons behind this is that these are low-cost measures which can be applied on longer sections, hence receive financial support from EU-funded programs.

Figure 2: Bicycle chevron markings

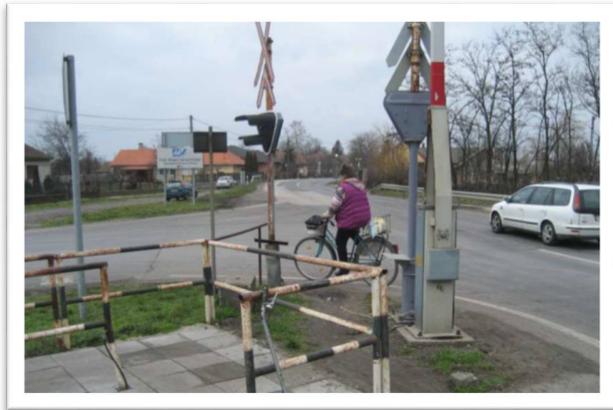
Railway crossings are crucial points in the rail and road network. Cyclist traffic at existing urban railway crossings were also the focus of road safety inspections in the last years [4]. While motorist traffic was controlled by flashing lights and barriers in most of the cases, cyclist infrastructure and control varied over a wide range. One of the typical problems was by-passing the labyrinth fence (Figure 3). Another was waiting between the tracks and the barrier. A third problem is shown on figure 4, where cyclists ride in the opposite direction on a one-way bicycle path. Control devices are provided only for cyclists riding in the correct direction and so violators (both cyclists and pedestrians) cannot see the flashing red signal. Based on the experiences with separated bicycle paths, separated barriers are recommended at railway crossings.

Figure 3: Cyclist is by-passing the labyrinth fence

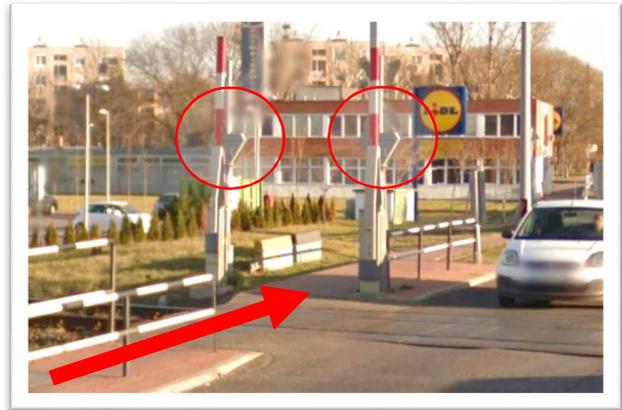
Figure 4: Cyclists usually ride in the opposite direction
