DORNOCH BURN, SCOTTISH HIGHLANDS

Options for reducing flood risk and improving habitats in the lower Dornoch Burn

For
NatureScot

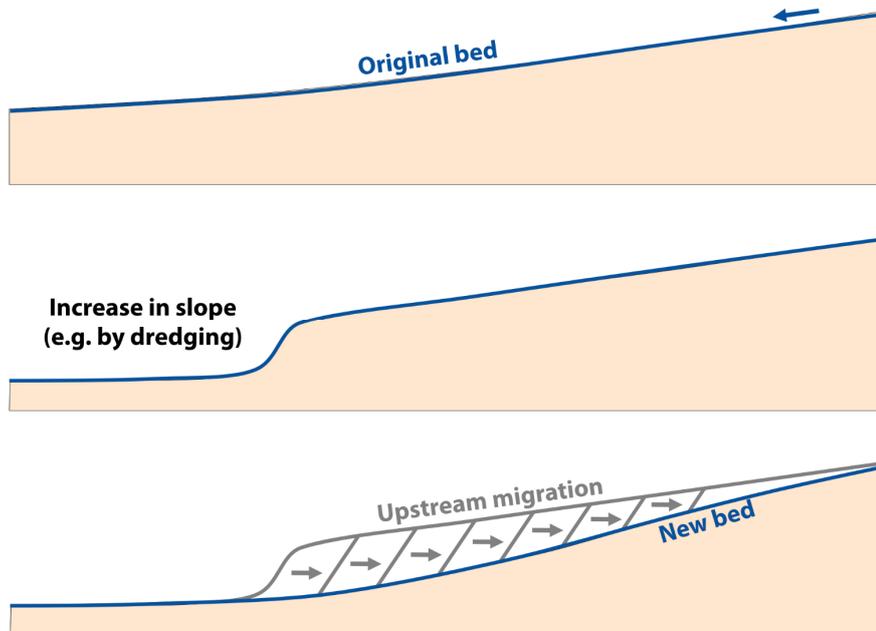
Knick-point erosion

refers to a river's natural response to an increase in the channel slope, usually following the over-deepening of a section of the river. The local increase in slope means the river has more energy and erodes upstream until the slope is lowered back to a more stable gradient. Depending on the level of over-deepening this migration upstream can extend for hundreds of metres.

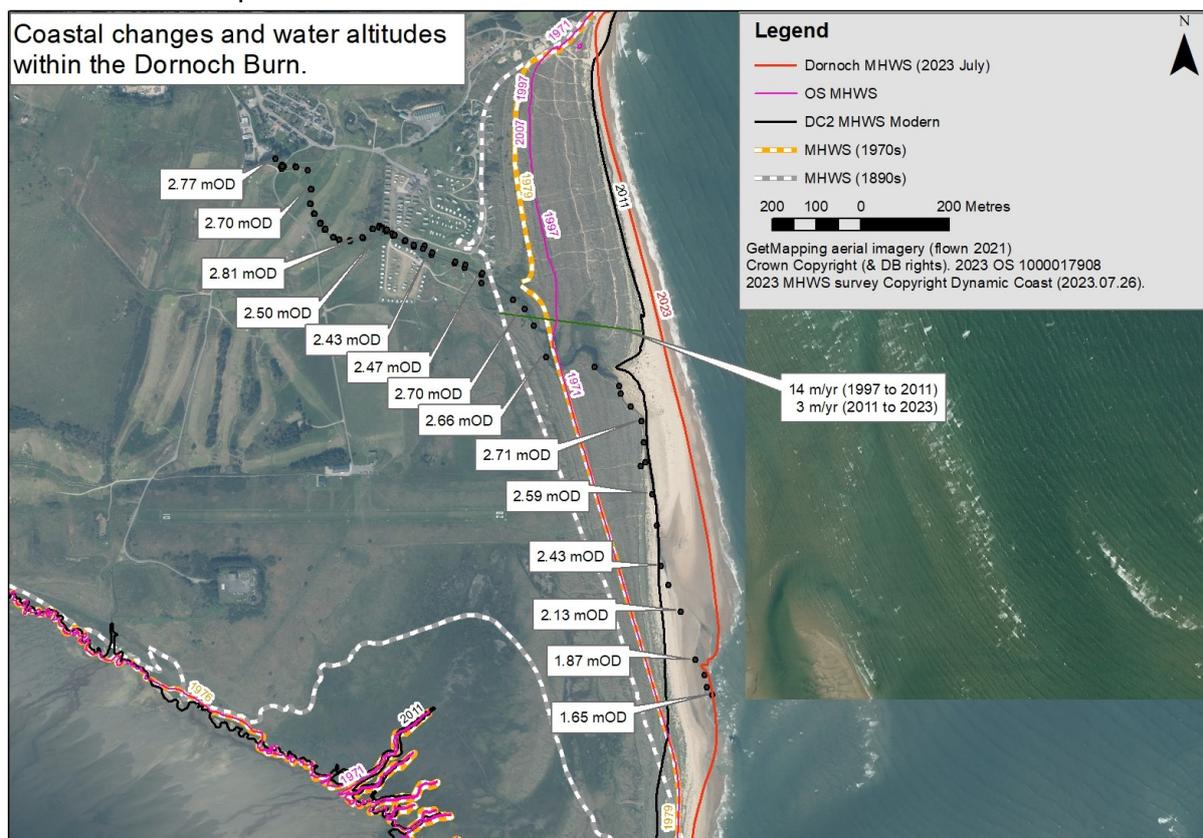
Figure 1 shows the changing position of Mean High Water Springs (MHWS) between 1905, 1979, 1997 and 2011. Such seaward accretion has made the river channel shallower than it was in 1905. Figure 1 also shows the altitude of the water surface within the burn on 8th February 2023. The burn has a very shallow gradient through the golf course, however as it enters the caravan park the water surface elevation actually increases. This may be related to the strong wind during the survey, but the burn's water surface falls very little in the caravan park. South of the wetlands the channel starts to fall, but it isn't until the open beach that the slope increases.

Figure 1: Map showing coastal changes adjacent to the Dornoch Burn, and water surface elevations within the burn.

Dornoch Burn is a small stream in the Scottish Highlands, which enters the sea at Dornoch Firth. Due to relative sea levels falling in this area over much of the last few hundred years, and a large long-shore drift component, the beach has been accreting sand at a rate of 14m per year (www.DynamicCoast.com). This has resulted in substantial changes to the landscape around the lower 500m of the burn before it enters the sea. The foreshore accretion and expanded dunes have blocked the burn, diverting it to the south along the top of the beach and further reduced the previously shallow gradient of the channel. The impounded flow has flooded previously dry dune habitats, creating dune slack and wetland habitats.

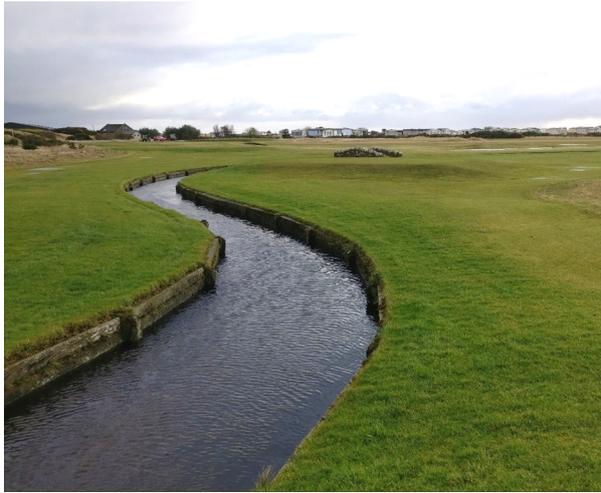
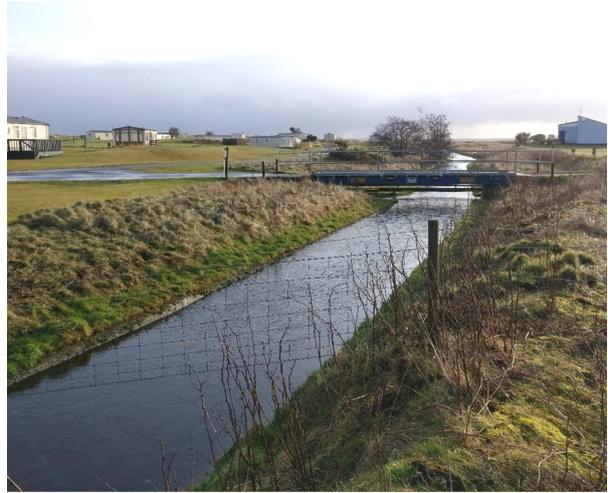
Photos

- At the upstream end, the channel emerges from a culvert under the sewage pumping station.
- The channel is resectioned throughout with uniform channel forms and flow types.
- Toeboards line both banks throughout the golf course.
- The banks are mowed resulting in uniform bank and riparian vegetation structures.
- The golf course is low lying with large areas of standing water present in winter. According to the course manager this is a result of saturated soils rather than river flooding.

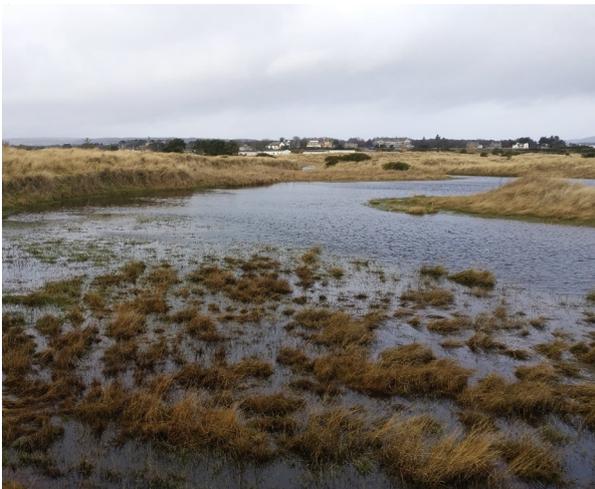
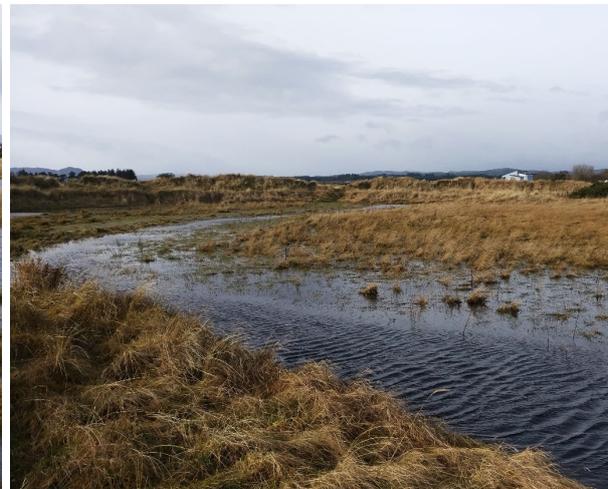
Photos

- Beach accretion has impounded the burn through the dunes and created wet habitats in areas that were previously dry.
- There are high quality habitat features here, including natural berms, islands and cut-off meander loops.
- Immediately downstream of the caravan site, the burn has been dredged and straightened to try and drain water away from the caravan site.

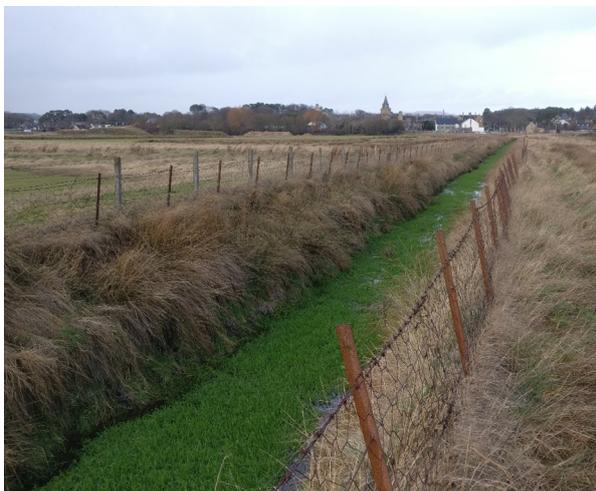
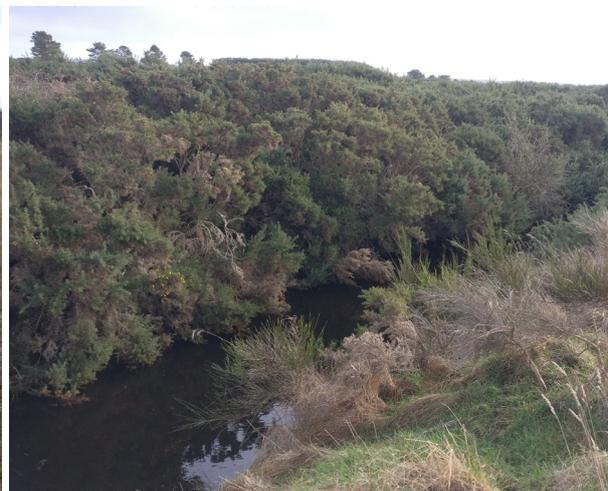
Photos

- The burn has been realigned with an over-deep and uniform channel profile.
- There is pollution coming from one of the upstream culverts, resulting in an ochre coloured sediment for the first 100m
- The channel is choked with vegetation in the upper half of the reach.
- Flow types are slow moving and non-perceptible in places
- Riparian and floodplain vegetation is uniform and the floodplain is completely disconnected as a result of over-deepening and large embankments.
