North Clyde Archaeological Society
Military Project 2015 >
On going report updated as work commences

Murrays (Geilston Farm) Military Installations
Tam Ward. August 2016

GEILSTON FARM SURVEY

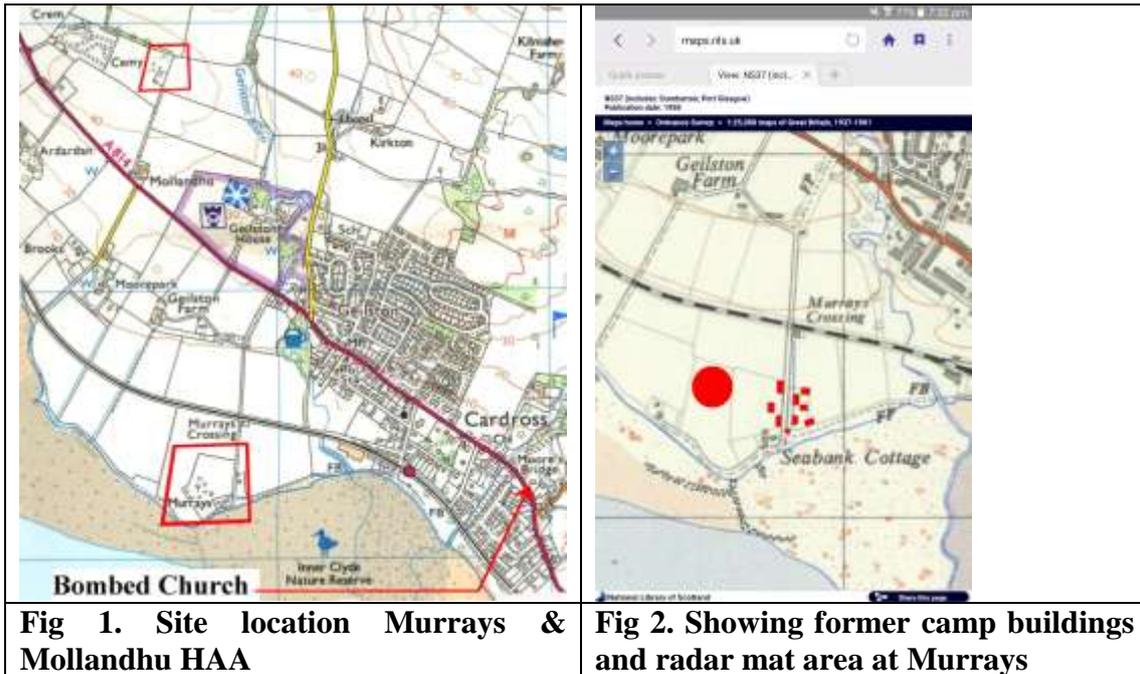
Fig 1. Site location Murrays & Mollandhu HAA

The site lies at the above NGR on the north coast of the Clyde Estuary and immediately SW of the village of Cardross. Located on the raised beach the entire site originally occupied several fields on the south side of Murrays Crossing, being a level crossing of the Helensburgh railway. The OS 1:25.000 map of 1958 shows three roofed buildings on the west side of the access road to the beach and five on the east side, also a single building at the level crossing, none of these buildings survive but apart from the one at the railway, they must all have been part of the camp of the gun emplacements. The OS sheet No 347 (given above) and on Fig 1 shows the site of the guns and two surviving buildings on the east side of the track, and also what may have been the military perimeter fence around the site. The OS 1:25,000 map [NS 37] 1958 (Fig 2) shows three building in the field where the guns remain, and six buildings on the east side of the access road, none of these buildings now exist although the ruinous remains of two lie adjacent the gun field boundary.

Fig 2. Showing former camp buildings and radar mat area at Murrays

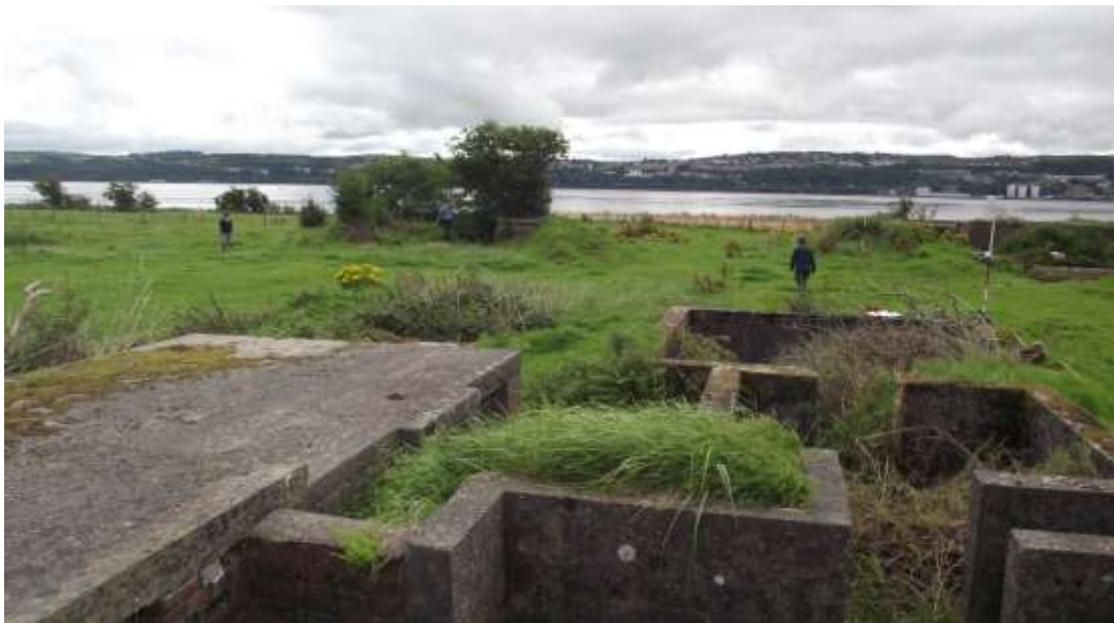
Pl 1. Showing part of the Command Post roof and instrument enclosure, with gun positions beyond.

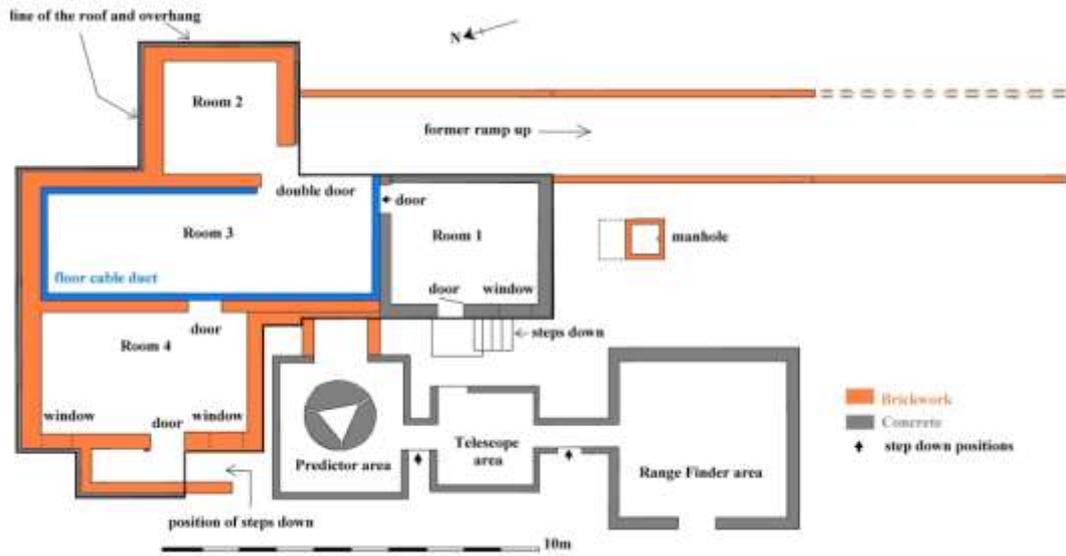
The rectangular rooms all have concrete floors and are described as per the plan (Fig 3):

Fig 3. Command Post and instruments area.

The southerly of the chambers and it is the only one leading directly to the observation areas via a stair way. The room measures 4m by 3.25m, the external door (opening inwards) has been a metal and was hung on two surviving pintle hinges. The internal door steps down 100mm to the floor of the next room (Room No 2), its height

The room measures 3m square and has slightly thicker walls at 0.6m. Presumably it has been a store room with no windows and its doorway leads directly to the former ramp area and is adjacent the larger entrance to Room No 3.

The room is 8.9m long by 3m wide, around the floor is a cable duct measuring 0.2m wide and which has once been covered. Two cable pipes lead through the wall to the Predictor area and a doorway gives access to the next room (No 4). It is likely that this room was the Plotting Room.

The room measures 5.5m by just over 3m wide. It has been furnished with two windows identical to that in Room No 1, the external doorway leads to the area at the bottom of a flight of steps (now buried) and the entrance to a small room of 1.5m by 0.75m.

The higher external areas where the detecting instruments are known to have been used by ATS personnel are perfectly preserved, each has a concrete floor.

The Predictor area is 4.75m by 3.25m and lying on its floor are three concrete slabs 100mm high and forming a circle of 2m in diameter but with an equilateral triangular space in the centre, it has sides measuring 1m long. The structure is presumably a mount for the Predictor instrument, probably to keep a tripod firmly in place when the Predictor was in use.

A short corridor leads to the Telescope Area which is 2.5m square and has an opening leading to the stair down to room No 1.

Finally the Range Finder area is reached via another passage which gives access to outside as does the last compartment itself which is 4.25m square. The Range Finder area walls are slightly thicker than the others being 0.4m while the others are only 0.25m thick.

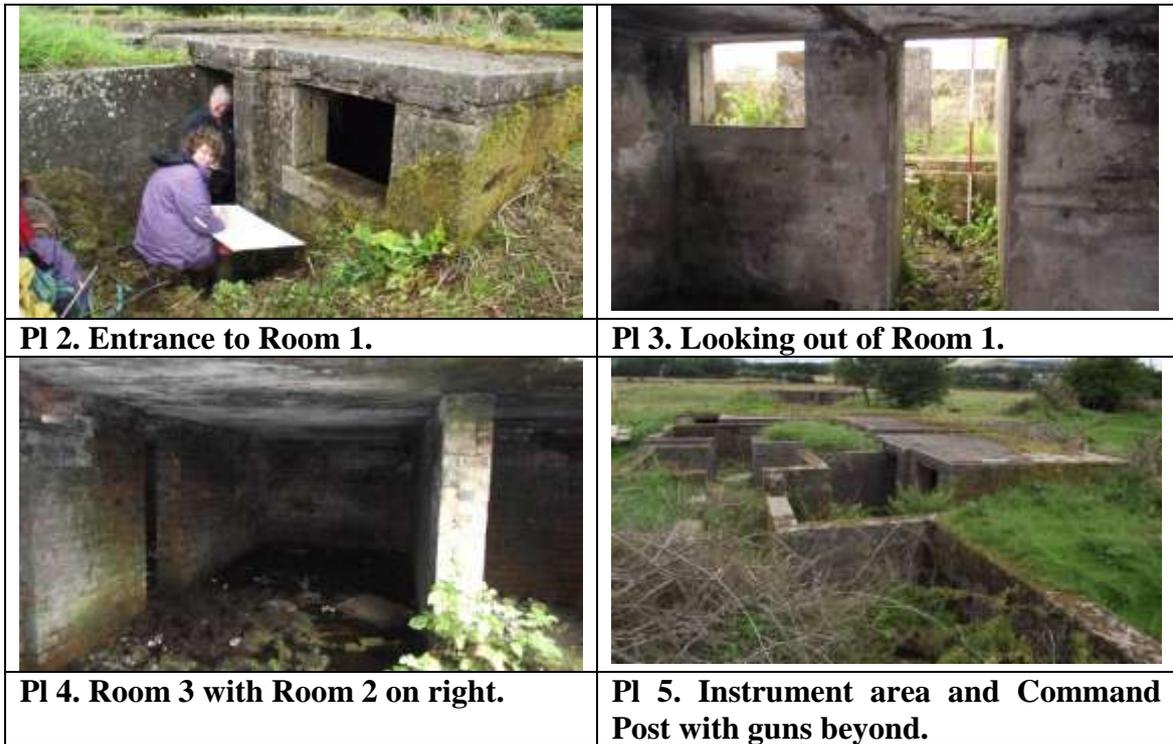
Other features at the Command Post

On the east side of the complex was a 20m long ramp (now filled in), it is bounded on each side by a double brick wall the top of which steps down as the passage progresses up to ground level. The ramp was a very gradual gradient presumably to allow heavy or bulky equipment to be delivered to the wide access at Room No 3.

To the south of Room No 1 is a brick manhole of 0.7m square which was 1.8m deep but obviously partially infilled, the internal chamber widened to the north by a further 0.6m as its roof sloped downwards, three foot rungs were in place. This may have

been a drain manhole, the drain ensuring that water did not flood the sunken internal rooms of the Command Post.

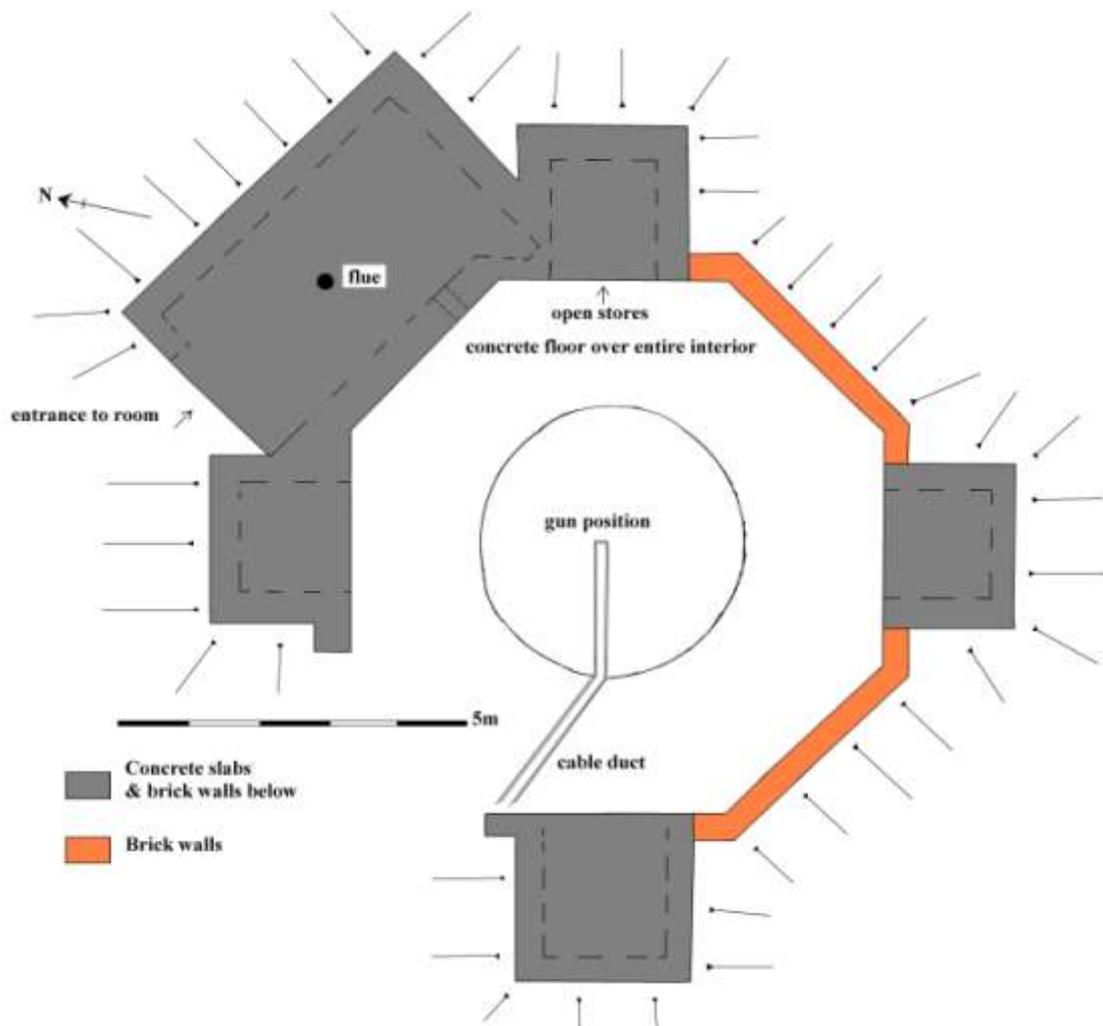
Four gun positions are located to the north and east of the GOR and arranged in a typical arc with each gun site building being open to the central area. Apart from their alignments and two of the small rooms being on a reverse side, they are identical in constructional details and comprise of the following components; four open cubicles diametrically opposed in pairs to one another and facing inwards, a room with a central pipe through the roof and a 'floor' scarcement, and enclosing double brick walls. Fig 4 shows Gun No 3.

Fig 4. Showing typical layout of gun locations. This is Gun No 3.

The central floor is concrete overall, however, a circular patch measuring 4m in diameter appears to be a separate pouring of concrete, and the details of the gun mounts are arranged in a circular form on this and are identical in layout to those of the isolated gun positions to the north and south of the complex (No's 7 & 8). The cable duct runs from the centre of the gun position and towards the side of the entrance, it must have been installed before the walls were built as it runs below them. An identical arrangement may be seen in the gun positions at Mugdock Park in Glasgow, although the shell storage areas at Mugdock are slightly different in layout. See 'Isolated gun positions' below for description of metal work and mounts.

The four cubicles and the small room never had doors and are all covered by a shuttered concrete slabs which have been created over double brick built walls, all the walls are brick. The roofs are all 103mm thick and are flush with the walls. Each

cubicle is 1.5m square internally and 1.4m high, three channels can be observed in some of the concrete floors to indicate a possible sliding arrangement (of shell racks?), the semi circular grooves are 50mm wide and 25mm deep and are equidistantly spaced running from front to back.

The side room measures 4.5m by 2.5m and has a small aperture/window through the brick looking inwards to the gun position. The room is accessed by a 2m gap in the wall. The pipe leading through the roof may have been ventilation (or a heating stove?). Two short wall stumps are on each side of the gun area entrance. None of the cubicles or the small room indicates they have had doors hung on them, but electrical conduit saddles indicate that lighting bulkheads were probably installed around the inside of the enclosure.

Surrounding each gun position is an embankment of earth running out about 3m and coming to within 0.5m of the wall heads.

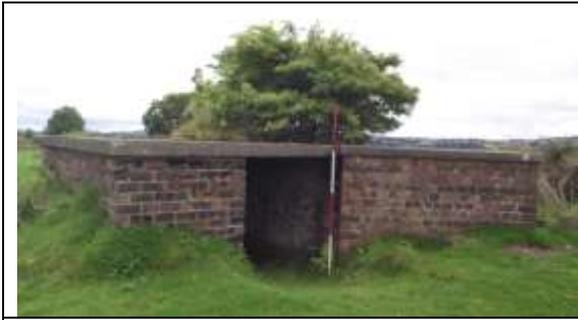
Pl 6. Showing entrance to rest room.

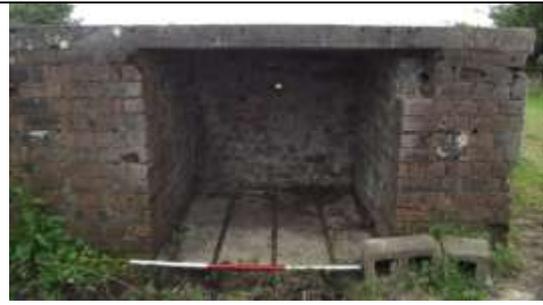
Pl 7. Gun cubicle for ammunition with floor rails

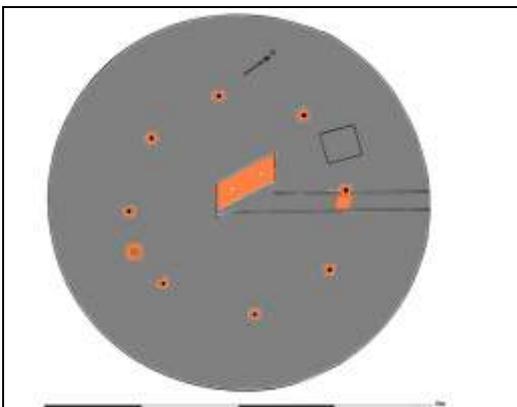
Two circular concrete bases each measuring 4m in diameter are located one to the north and the other to the south of the main complex. The southern example was cleared and surveyed (Fig 5 & Pl 8). Each 0.3m high structure was made with concrete including basalt chips as part of the aggregate. Eight circular steel ‘mounts’ were evenly spaced and located in a circle on the structure; they measured 180mm in diameter with a 100mm central flange within which there was a 70mm hole. Another large steel ‘mount’ measured 200mm in diameter and with a central hole of 100mm lay only slightly outwith the circle of the other ‘mounts’, directly opposing this was a concrete pillar of only 100mm high by 300mm square, it is known that this pillar covers one of the larger ‘mounts’. A cable duct runs from the centre to the edge of the structure, it measures 250mm wide and 450mm deep, it has been covered by a plate, in its base were fragments of field drain pipes, possibly used to contain cables. In the central slightly offset area an angle iron runs in line with two larger ‘mounts’ probably indicating they are fixed to it below the concrete, this plate has two 25mm holes in it, perhaps once used as bolt holes. Also crossing the cable duct at an angle but lining up with two of the smaller mounts is another angle iron plate, it has one of the smaller ‘mounts’ fixed to it suggesting that the plate runs round the structure as a support for all the ‘mounts’.

Fig 5. Gun? No 7 position. Showing steel ‘mounts’ and cable duct.

It is uncertain at this stage in the Project what these structures were used for, but gun positions are strongly suspected.

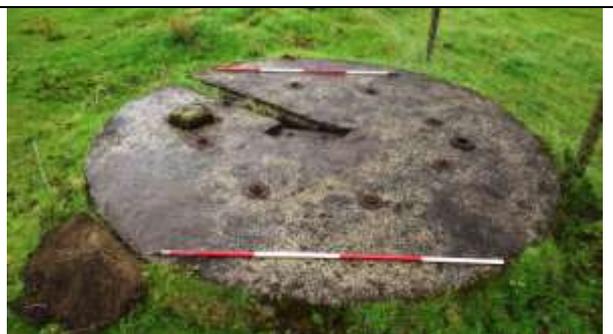
Pl 8. Gun? No 7 concrete base with ‘mounts’ and cable duct.

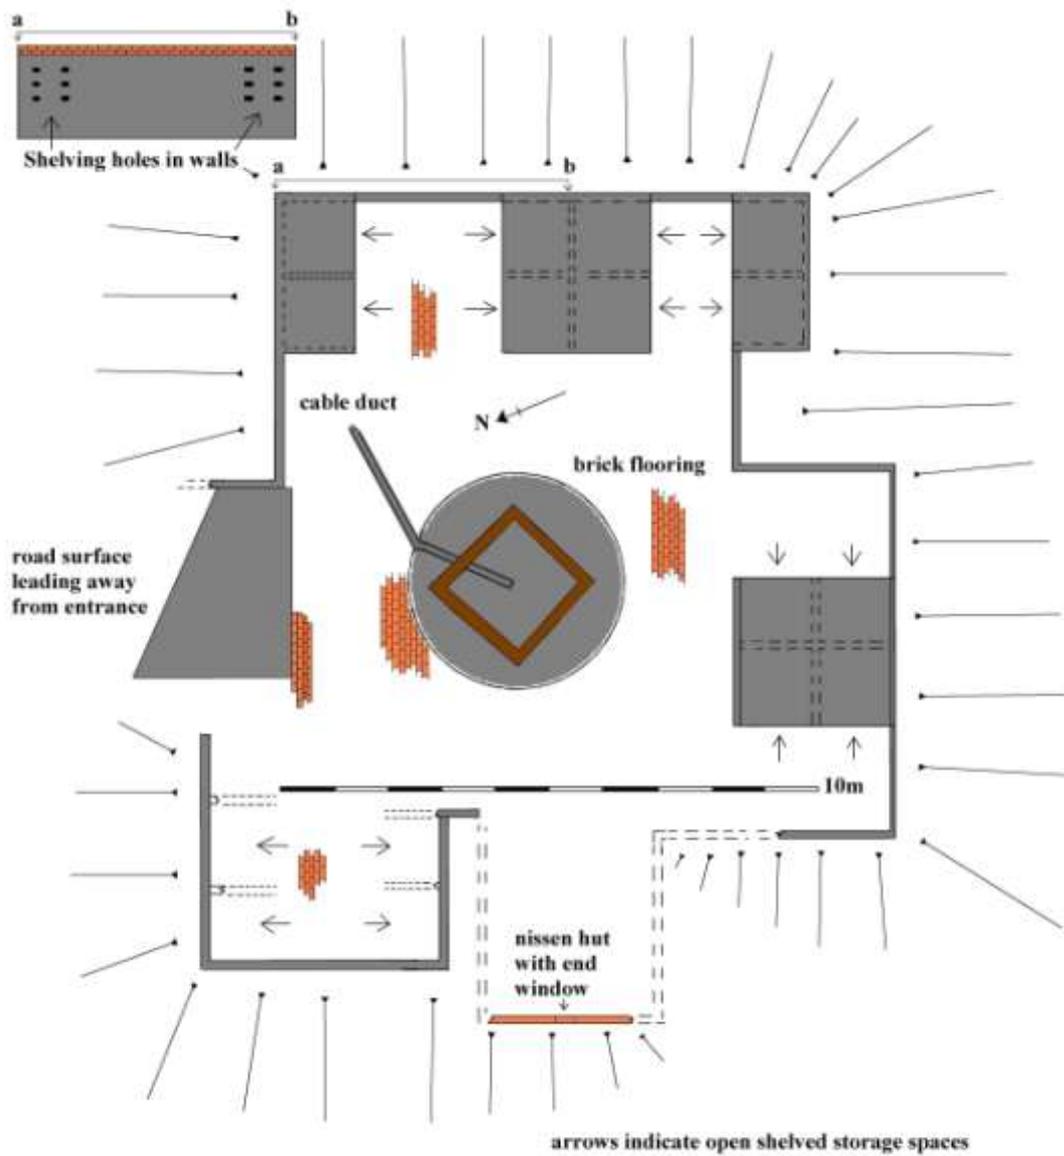
The plan of Gun No 5 shows it to be just over 15m square overall (Fig 6), the entrance walls which would have extended further to the north are missing. A central courtyard of c8m square has a centrally placed circular concrete foundation of 4m in diameter, exactly the same size as those in the other gun locations. However the arrangement of mounts is different from those in as much as a steel angle iron plate forms a 2m square set flush with the upper surface of the concrete (Fig 7, Pl's 9 & 11). The arrangement is identical to that recorded at Woodend HAA installation (Ward 2016), although in this example the concrete pillars over the bolts are all missing, however in the adjoining building (Gun No 6), which is clearly the same in function despite a differing plan and being much more ruinous, some of the concrete pillars survive. The cable duct leads under part of the main building and appears to run towards the GOR. Nearly all of the floor surrounding the concrete circle and within the storage cubicles is made with bricks as far as may be determined; however an area of concrete floor has been laid at the entrance (Fig 6 & Pl 9).

Fig 6. Gun position No 5.

The perimeter walls are all made with 'double hollow' concrete blocks, occasionally with bricks built into the walls, Summerlee, Hurl and Broomhouse bricks were used on the building. On top of the concrete block walls a double line of brick was used to achieve the desired finished height. On top of these bricks four of five concrete roofs survive and which cover open ended chambers of which sixteen would originally have existed. Each chamber is 1.4m square and 1.6m high, there were no doors fitted to them. On each of the side walls of the cubicles are six cut outs which show the position and arrangement of timber shelves, possible 3" x 2" timbers were inserted to form three shelves each time, the lower one being just over 0.5m from the ground and each shelf having 0.25m space height. Thus there were 48 shelves in total in the cubicles of Gun No 5 (Fig 6 & Pl 10).

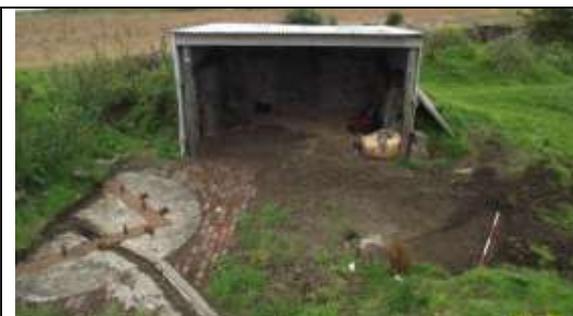
PI 9. Gun No 5 showing partial mount, cable duct and brick flooring.

A modern horse shelter (Pl 9) has been built over part of the west side of the building, incorporating the original structure there.

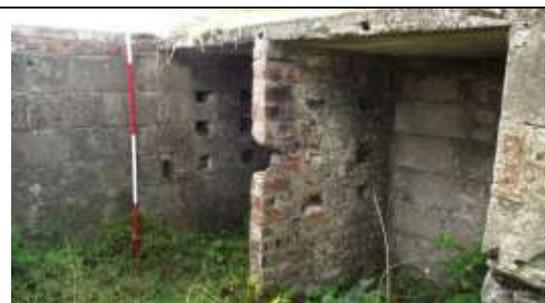
PI 10. Gun No 5 showing cubicles and shelf slots.

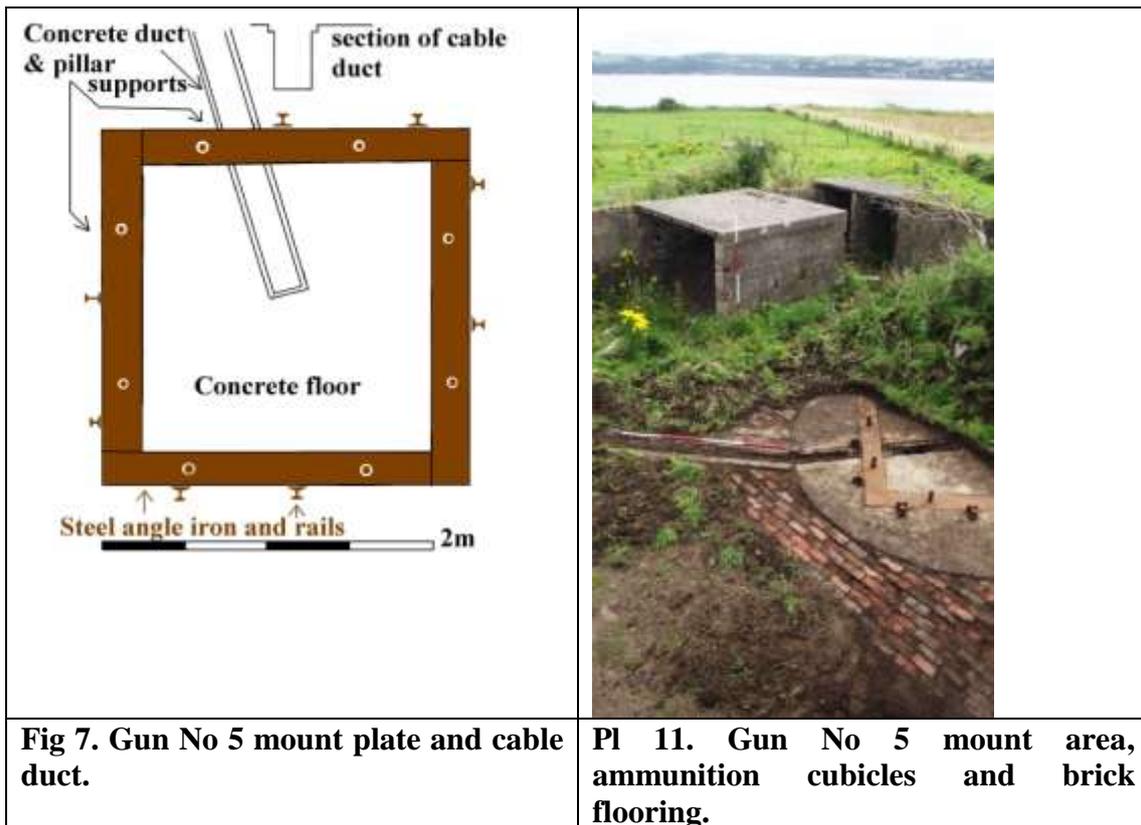
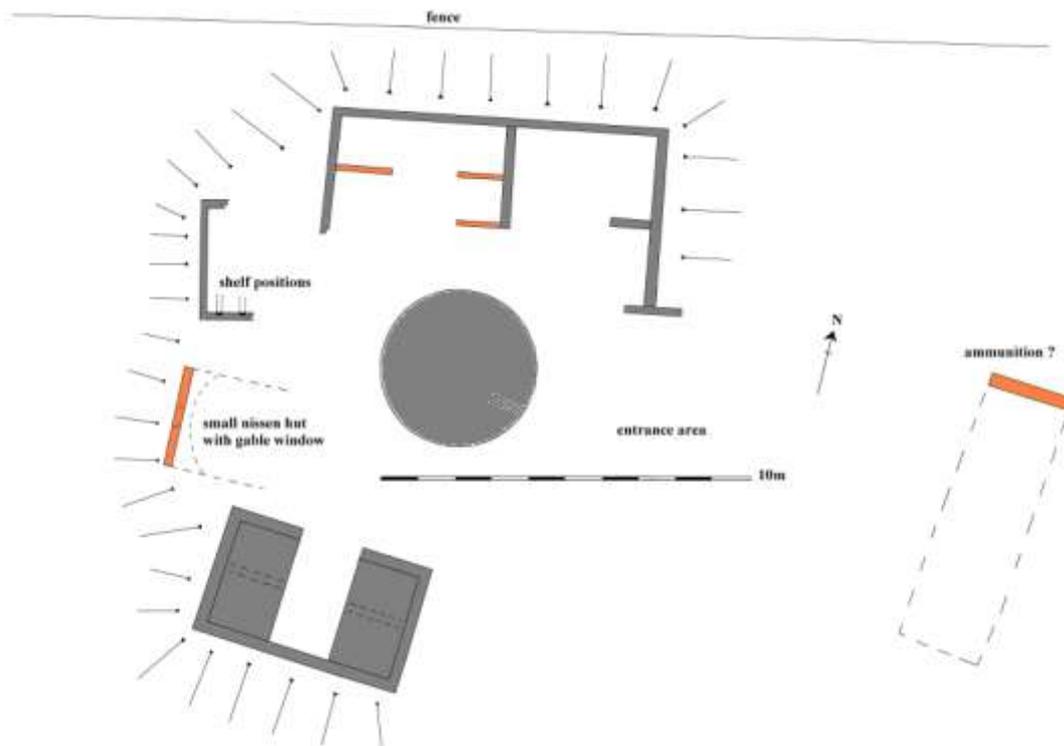
The adjacent building (Gun No 6) is similar but not exactly the same in plan, its ruinous state prevents a decent survey being made. However the remains of the small Nissen hut already given and the concrete pillars which survive over the gun mounting bolts, and some collapsed cubicles all point to that interpretation being

Fig 8. Gun position No 6. Much demolished but clearly having similarities to Gun position No 5.

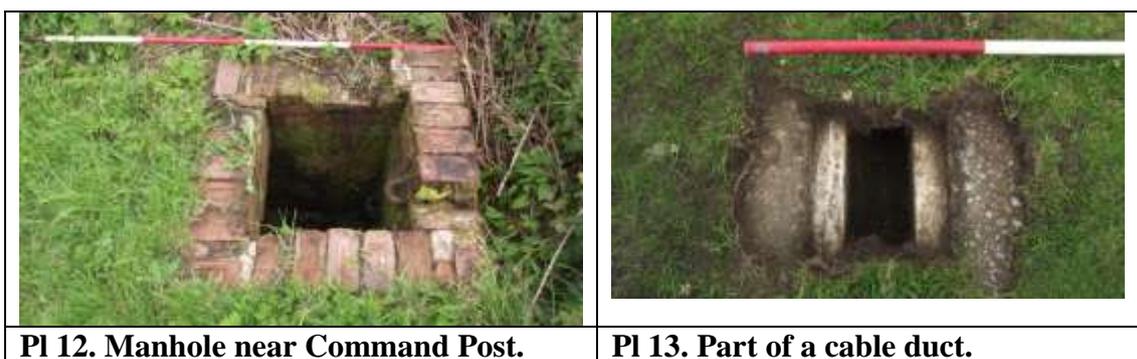
Evidence for at least three brick built manholes (PL 12) can be seen in the vicinity, one still has a concrete cover over it. Drainage must have been provided for the sunken Command Post and the drains there must have been several metres deep, such manholes would have been necessary, perhaps also for sewage from latrines etc.

A brick channel runs away from between Guns 5 & 6 (PI 13) and towards the Command Post, this is a cable duct which has been covered with a plate, it is likely that similar ducts connect all the principal features of the site.

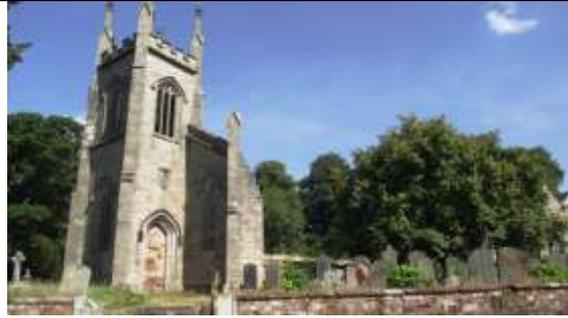
Pl 14. Cardross church.

Certainly the village suffered as both the church (PI 14) and the nearby Golf Clubhouse took direct hits. At least one person is reported to have been killed and two others died later. Several different types of bomb fell including incendiaries, and a land mine which fell of Peel St. Only the tower of the church survived and several gravestones (PI 15) show the effect of shrapnel scars. Two headstones (PI's 16 & 17) in the churchyard are testament to the reality of the time, both of young men of the Royal Artillery Regiment killed in action. The date on one is the same as the date of the bombing of Cardross. The man commemorated here was Gunner Graham (PI 16) who is recorded to have died with his wife in the same incident. Research into such stories will form major part of this project in due course.

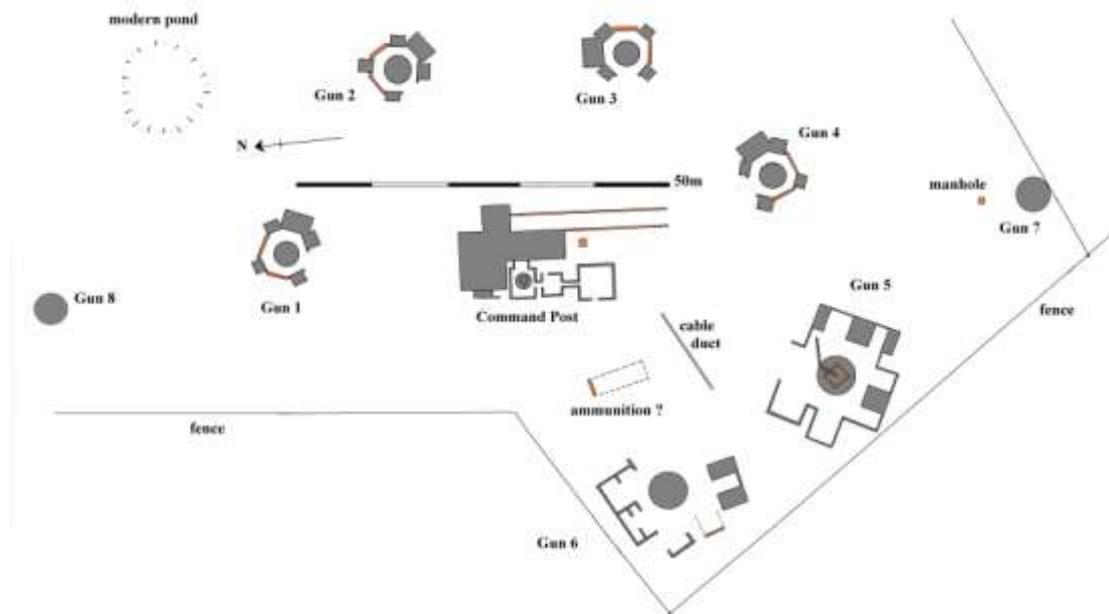
Fig 9. Principal visible structures at Geilston Farm, showing eight possible gun locations.

The Geilston site (Fig 9) has supplied additional features not yet recorded in the overall Project, especially the circular concrete structures (Guns 7 & 8) and better details of the two other features given here as Gun No's 5 & 6, and which are obviously the same as the two similar but poorly preserved examples at Woodend HAA site (part of this Project). Aerial photographs of both Woodend and Geilston give valuable phasing evidence. The photographs of the site at Woodend show at least three phases of guns; some positions surrounded by earth banks, the typical gun emplacements seen everywhere e.g. Fig 4, and the types now recorded in more details at Geilston (Guns 5 & 6).

It is now believed that the structures recorded at Geilston are all associated with guns rather than searchlights as was previously thought (Woodend Report). Gun No's 5 & 6 clearly show that storage was involved using cubicles with heavy shelves and these have been for shells (see below). The four brick built gun structures (Guns No's 1 – 4) equate well with those at South Ailey, Woodend and those seen in Mugdock Park near Glasgow, they, like the Command Posts seem to form fairly standard designs as one may expect. Certainly the Command Post at Geilston is extremely well preserved and is on a par with South Ailey, while the Woodend one appears to be demolished but is clearly given on aerial photographs. The evidence is building up to show that the HAA gun sites were under constant review and re-configuration of buildings and equipment. It is possible that both Woodend and Geilston had 4.7" guns installed later in the war.

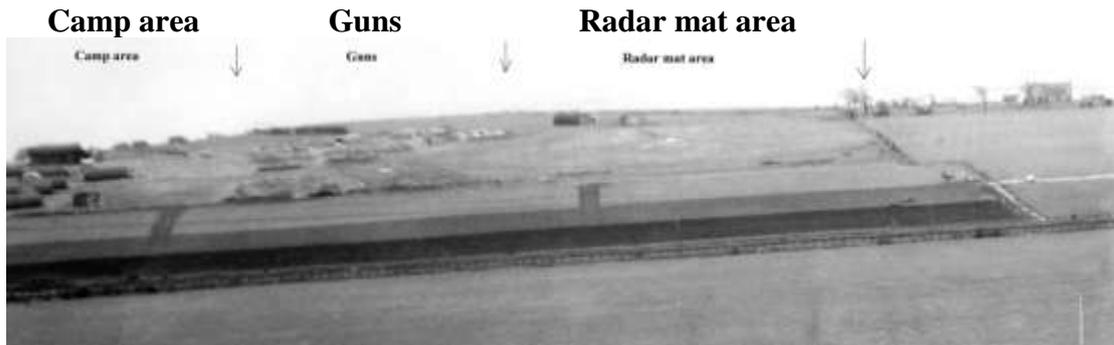
Pl 18. Part of the installation as seen on an unidentified oblique aerial photograph of Geilston, showing the radar mat and camp areas with guns between them. The railway is in the foreground.

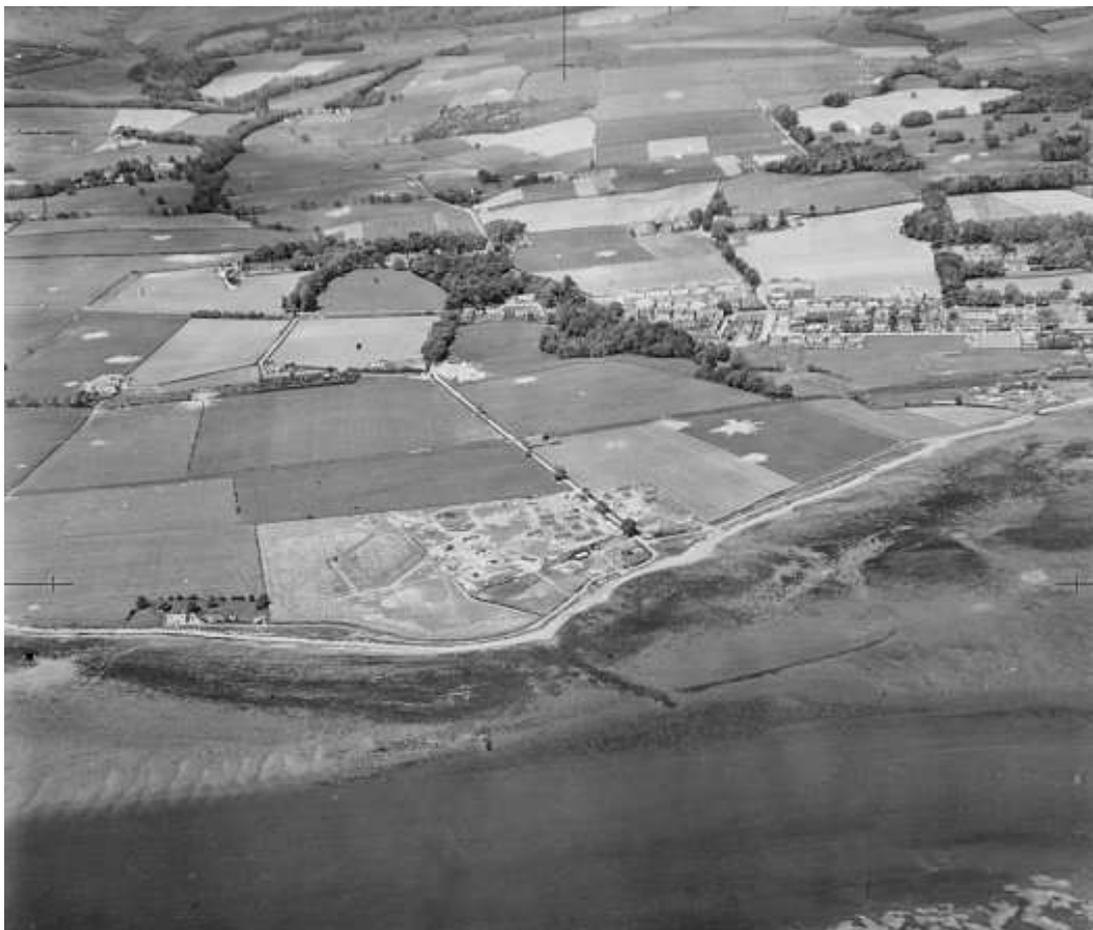
Pl 19. Geilston 6th June 1941.

The above RAF photograph of Geilston is invaluable as it shows the site during the early years of the war. The complete caption for the pic on the web site is given in total here, and the points to make are that the hexagonal radar mat is clearly shown and that gun positions 5 & 6 are not yet built. Taken along with next image (Pl 20) the extent of bombing is clearly visible, showing how randomly the bombs fell and in some instances how close they came to hitting buildings, including Geilston HAA.

Description RAF WWII oblique aerial photograph of Cardross heavy anti-aircraft battery and a accommodation camp from the W. Also visible are several bomb craters from Luftwaffe raids. The octagonal feature to the left of the gun positions is the GI-mat (probably Mk.1) for the gun laying radar.

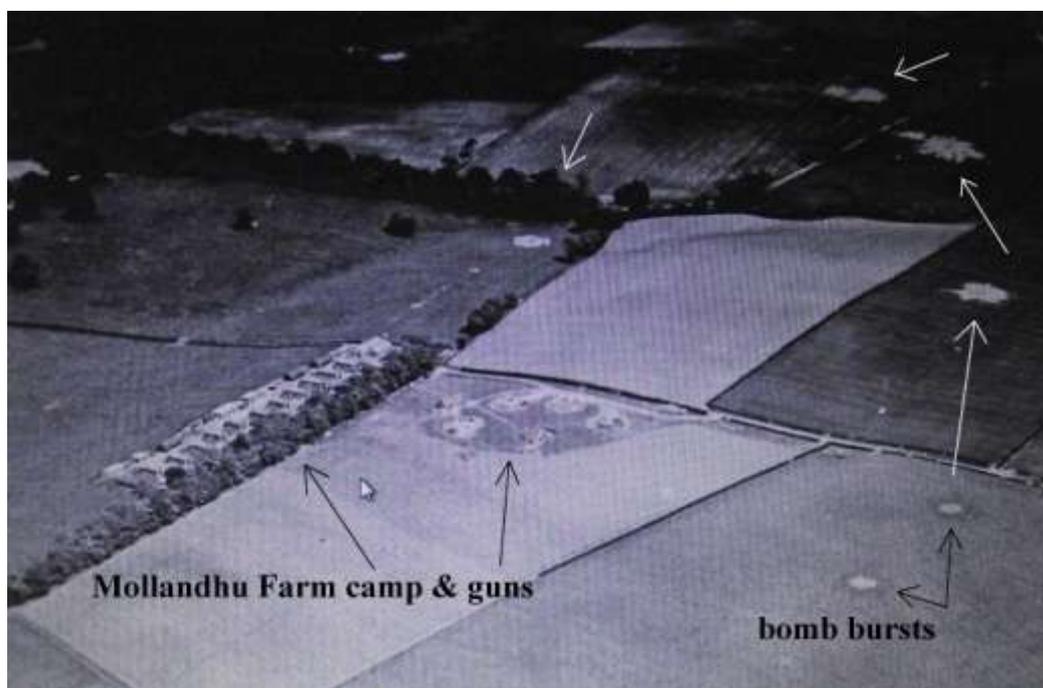
PI 20. Screen shot from web showing Mollandhu HAA site.

Aerial photographs of the Mollandhu Farm gun site show bomb craters strewn around the fields in an east/west alignment. Four gun positions, Command Post and camp are all shown – but no radar mat area, was this site controlled from Geilston?

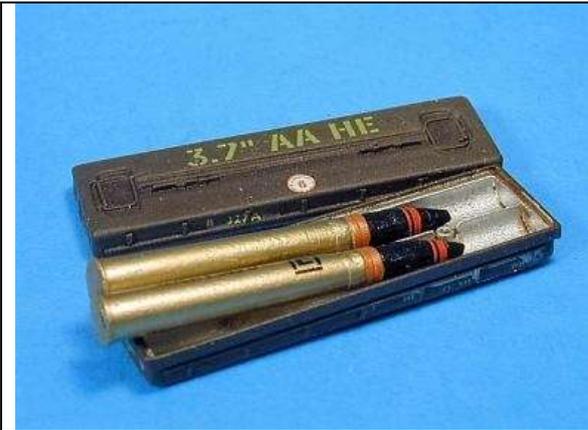
In 1930, 3.7” guns fired a 28lb (13kg) shell to reach 35,000 feet.

The units were mounted on a four wheel trailer and could be towed at 25mph, weighed between 8 to over 9 tons, and could be in action in 15 minutes. In 1942 automatic fuse setting increased the rate of fire to 20 rounds per minute! = 3 per second, the shells were hand loaded! Shell fuses changed over time and could be set for ‘burn’ time = altitude explosion.

Pl 21. 3.7" HAA gun shells came two in a box.

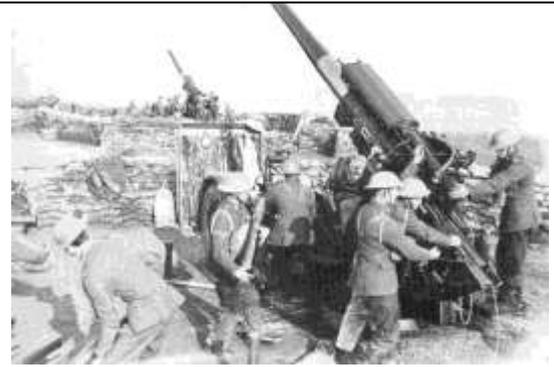
Pl 21. Showing a gun in action with a continuous movement of shells by hand to the gun

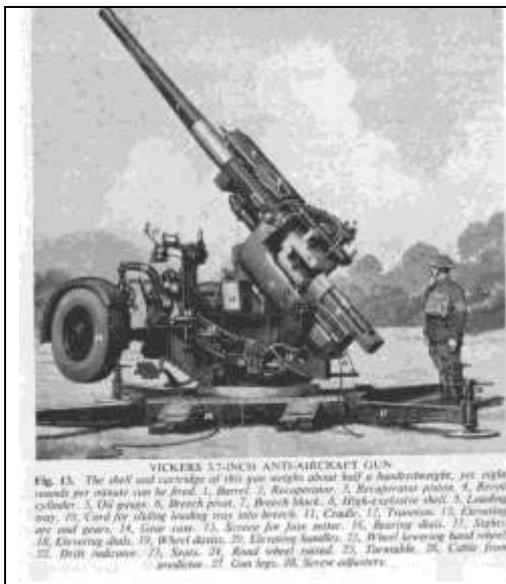
VICKERS 3.7-INCH ANTI-AIRCRAFT GUN
Fig. 13. The shell and cartridge of this gun weighs about half a hundredweight, yet eight rounds per minute can be fired. 1. Barrel. 2. Recoil spring. 3. Recoil spring. 4. Recoil cylinder. 5. Oil pump. 6. Breach post. 7. Breach block. 8. High explosive shell. 9. Loading tray. 10. Cord for sliding loading tray into breech. 11. Cradle. 12. Traverser. 13. Elevating screw and gears. 14. Screw case. 15. Screw for fine aim. 16. Bearing shell. 17. Slotted. 18. Elevating shell. 19. Wheel drum. 20. Elevating handle. 21. Wheel lowering hand wheel. 22. Draft indicator. 23. Scales. 24. Road wheel raised. 25. Trestle. 26. Collar from platform. 27. Gun legs. 28. Screw adjusters.

3.7" shell weighed half a hundredweight (28lbs) and could be fired at 8 rounds per minute, roughly every 7 seconds. The ceiling was 13,666 yards which is 7.75 miles.

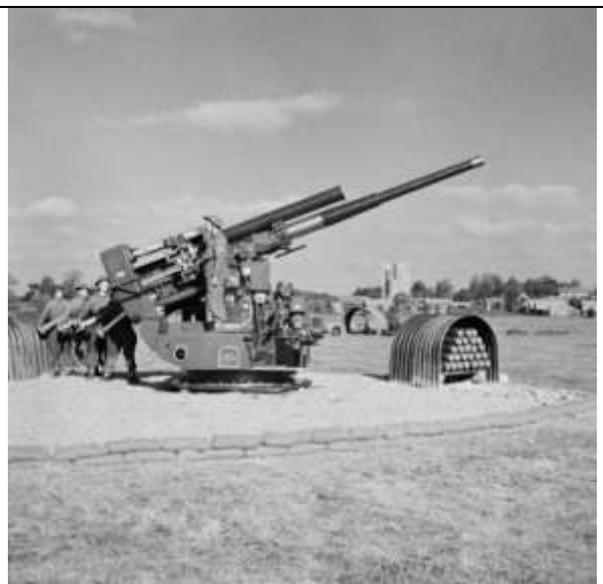
Pl 24. Gun ready for action, note the men ready with shells.

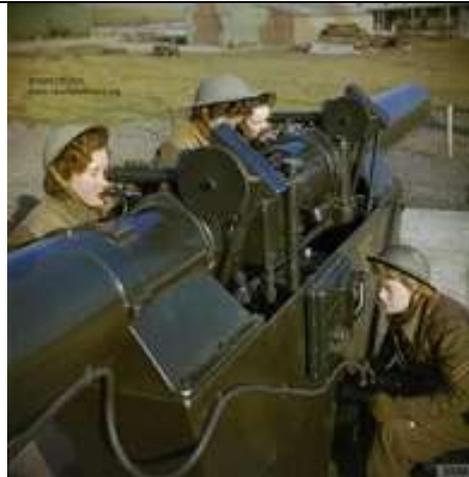
PI 27. ATS using the telescope.

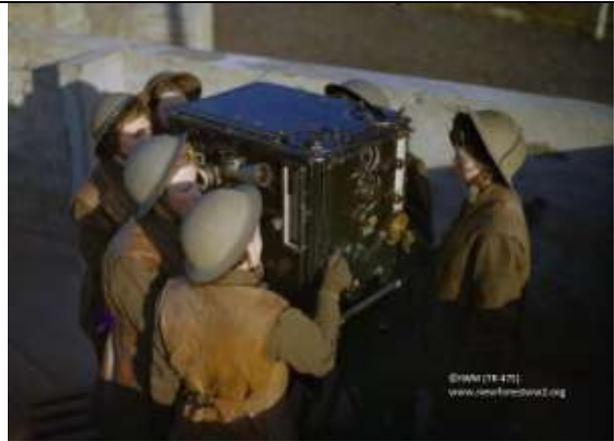
PI 28. ATS using the predictor.

Sophisticated optical equipment had been developed enabling observers to supply accurate data on the height and speed of aircraft once seen. The Vickers Armstrong Company had created their Predictor in 1920. This was a device which could accurately calculate the height, range and speed of an aircraft in conjunction with data supplied by other 'spotters' who were using telescopes and range finding instruments.

The predictor also calculated the trajectory the gun would fire at and also gave the gun the timing for the shell automatic fuse setting, it took only seconds for the predictor to give results, and the predictor also had to calculate wind speed, in reality the Predictors were the forerunners of computers. All of this and more information was supplied via hard wiring to the guns, and spotlights if they were used, all of which worked in unison, furthermore the data could be relayed to other gun locations well in
