North Clyde Archaeological Society
Military Project 2015 >
On going report updated as work commences

Mollandhu Farm Military Installations
Tam Ward. September 2016

MOLLANDHU FARM SURVEY Centred NS. 3355 7880 **OS Explorer Map 1:25,000 Series. Loch Lomond South. No 347**

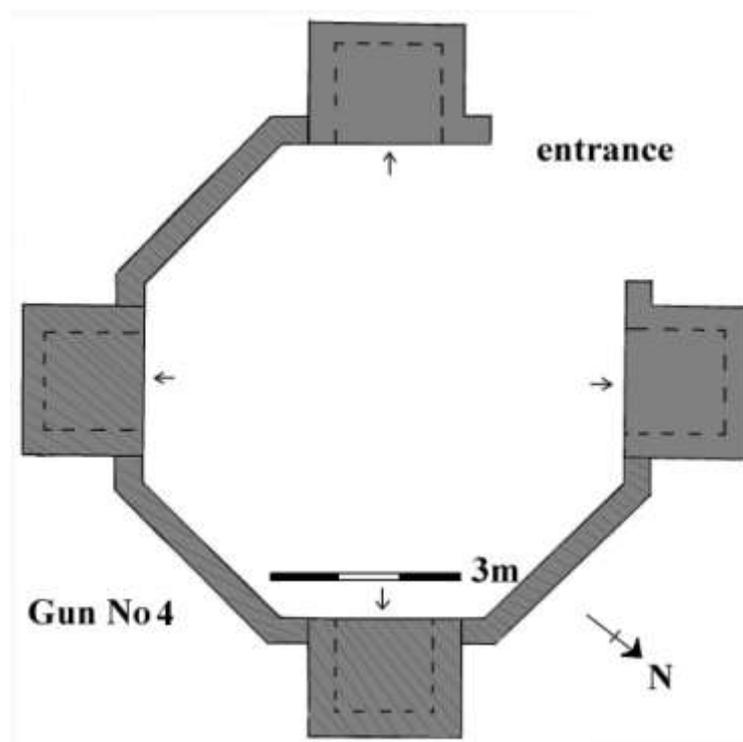
Fig 2. The short arrows indicate access to the cubicles, none of which was fitted with a door.

The four gun emplacements were recorded as a group and a single example; the best preserved and most easily accessible gun position (No 4) was surveyed in more detail. The entire site is heavily overgrown in brambles, nettles and scrub trees.

Each of the four gun positions is identical on plan and the only difference apart from alignment is that some have higher walls in places, which in turn means some of the shell storage cubicles are different in height. The height difference is uniformly 0.5m and the higher walls are shown as hatched areas on Fig's 2 & 3.

The gun emplacements follow a fairly standard design as is seen on the other surveys undertaken by NCAS on this project (Ward 2016 x 3of), although differing in a few minor details. At Mollandhu they consist of double brick walls measuring 0.4m in thickness and forming two sets of opposing cubicles, each is 1.5m wide by either 1.5 or 1m high (see each building below). The surrounding walls and each cubicle are covered in shuttered concrete slabs >150mm thick, the concrete is flush with the interior walls and has a slight overhang on the exterior side.

The octagonal interior is 7.5m across and the entrance gap measures 3m between two wall stumps of 0.4m square.

The two cubicles flanking the entrance were both 1m high internally while the other pair were 1.5m high. The height difference being accounted for by the raised walls shown as hatched on Fig's 2 & 3.

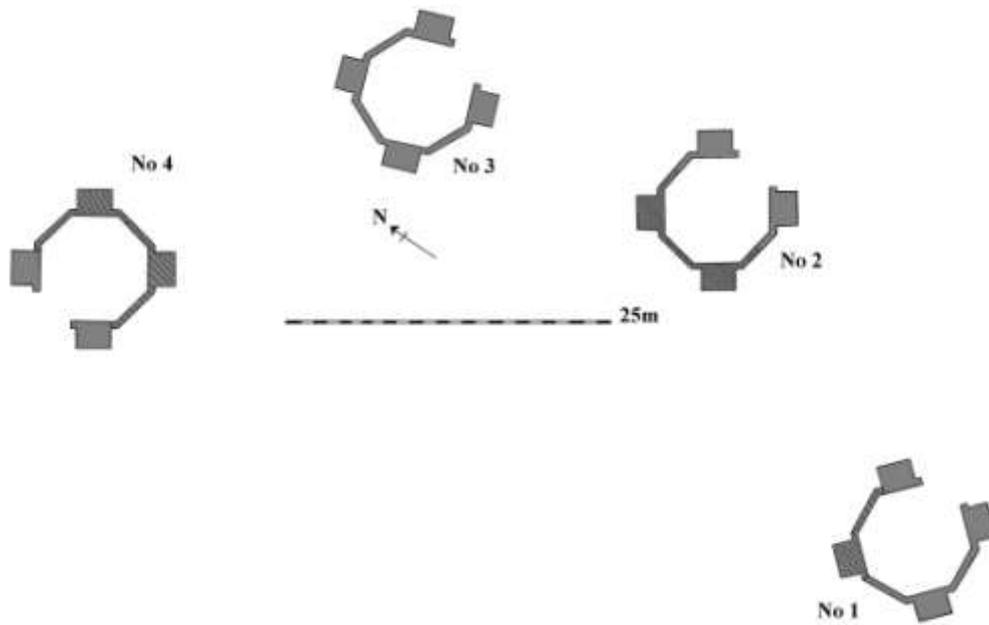
Fig 3. Showing the layout of the gun emplacements, note the elevated parts shown as hatched and the entrances all pointing away from the central area.

The site now comprises of four well preserved gun emplacements (Fig's 2 & 3) built with brick walls and concrete roofs and wall tops. The former camp and Command Post are now almost completely absent as visible evidence, only a few lumps of concrete and a single platform can be seen of the former camp area, the Command Post is entirely absent and there is no indication of a radar mat area, if it ever existed.

On this structure the wall only rises on one leg of the perimeter and is level with concrete roof slab on the southern side of the emplacement, making that one 1.5m high and the other three only 1m high.

On this structure the wall heights rise 0.5m to the levels of the rear two cubicles and share the same arrangement of cubicle heights as Gun No 4.

On this structure all of the wall and cubicle heights are uniformly the same, the cubicles are therefore all 1m high.

Why the walls and cubicles were built with varying heights is unknown, also and unusually, the entrances to all emplacements face away from the internal arc of the complex, where the Command Post is usually placed, and which may be visible on Pl 1. A third distinction at Mollandhu is the absence of small chambers adjacent the entrances to each emplacement as is seen on all previous surveys in this series. The Mollandhu emplacements are therefore more simplistic in construction.

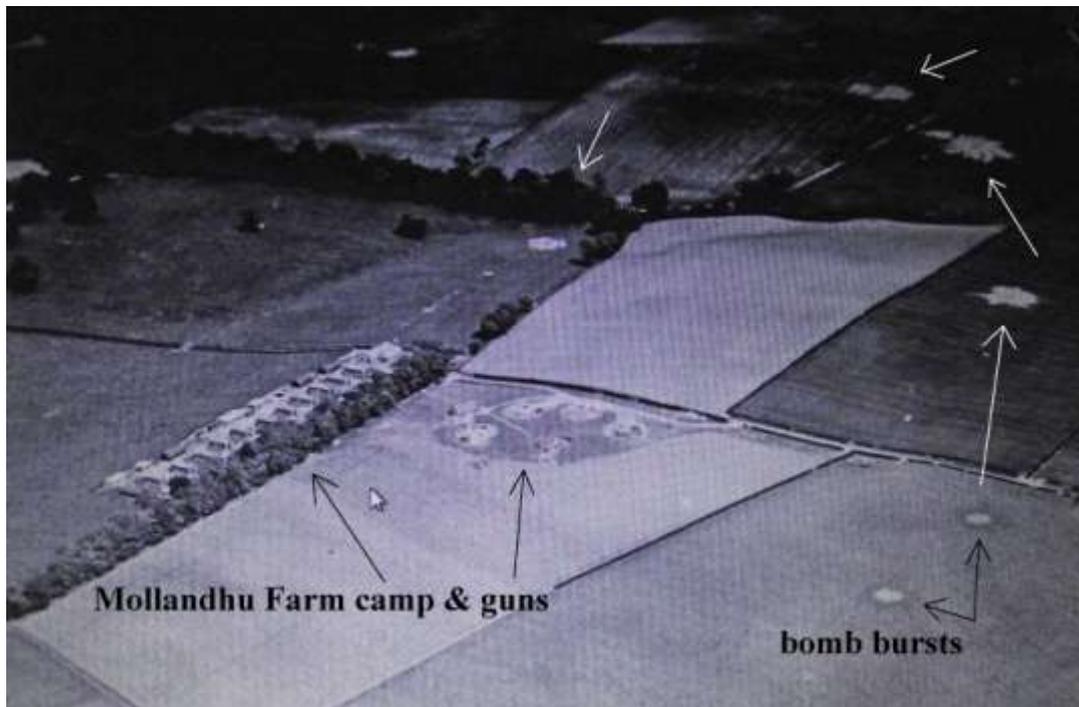
Pl 1. Showing the site layout of guns and camp, note the bomb craters. The gun positions as seen in the photograph are numbered anti clockwise 1-4 on the survey.

The camp area is known from aerial photographs of the site (Pl 1) and which show the camp as a linear arrangement of huts, some of which are Nissen types, aligned as a double row of buildings along the strip of mature woodland on the north side of the gun field. Hardly any of this is now detectable on the ground. The same photograph shows the four gun emplacements and the probably Command Post within the arc of the gun positions, a nearby Nissen hut is also visible.

Of particular interest in the image are the series of bomb bursts evident across the fields, it is likely that these occurred during the bombing of Cardross on 6th May 1941 when both the church and the golf club house were totally destroyed. Further research and access to more aerial photographs will elaborate on the general story.

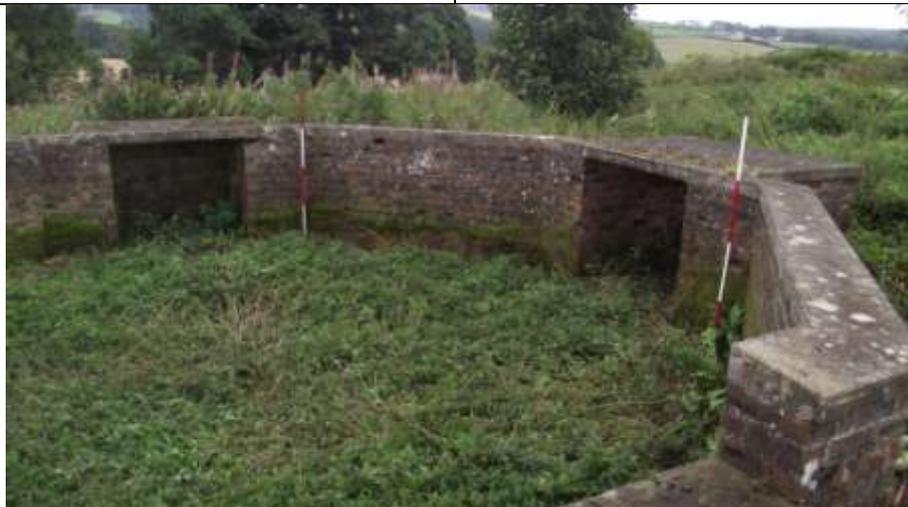
Pl 6. Gun No 4. Showing two higher cubicles.
