North Clyde Archaeological Society
Military Project 2015 >
On going report updated as work commences

South Ailey Farm Military Installations
Tam Ward. May 2015

SOUTH AILEY FARM SURVEY

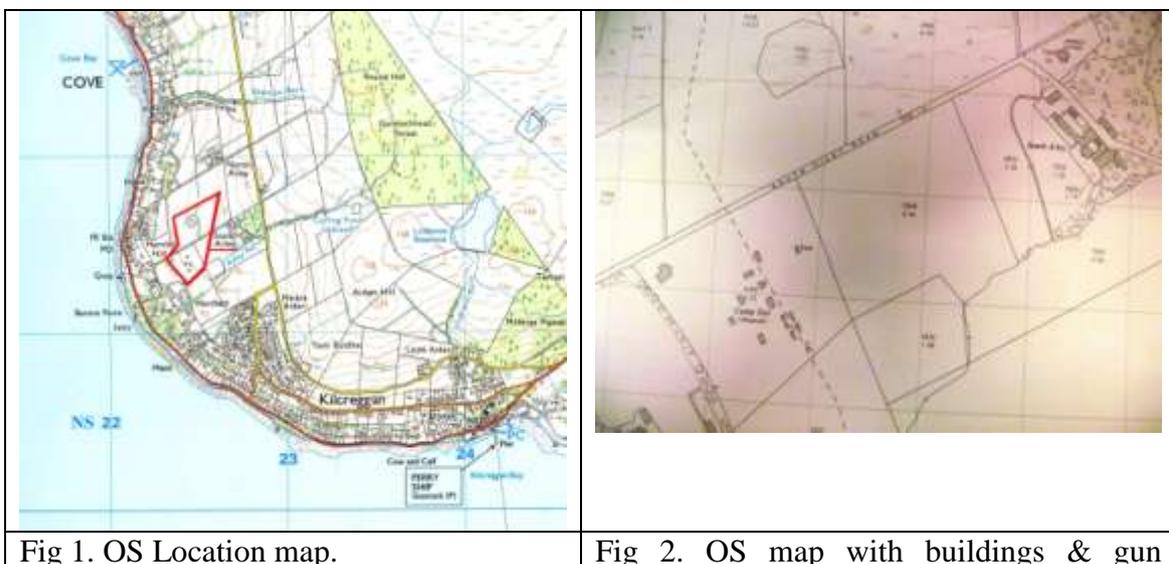
Fig 1

Possibly the best preserved WWII installations are located at South Ailey Farm (Figs 1-3) on the southern tip of Rosneath Peninsula. The site is comprised of four Heavy Anti Aircraft (HAA) gun positions, a control room complex, the radar mat site, all in Field No 1, and in Field No 2, ancillary buildings some of which stand as upstanding structures while numerous others are seen only as concrete foundations, all are located in the two fields to the west of the farm (Fig 3).

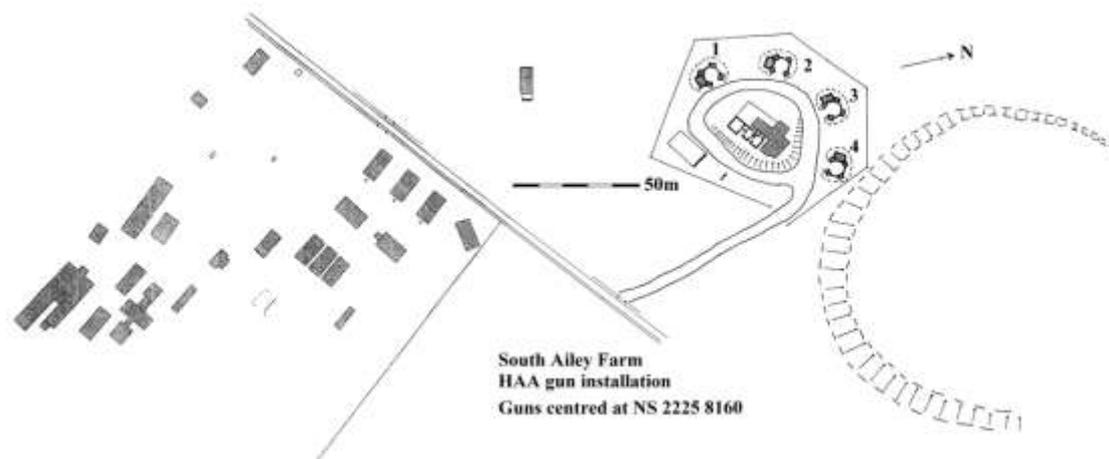
Fig 3 showing entire visible layout excepting the large building to the SW (see Fig 2).

Concrete posts survive to indicate four out of six straight lengths of the security fence which apparently only surrounded the guns and GOR, the southerly two lengths of fence given on Figs 3 & 5 have been extrapolated from the OS map (Fig 2). Interestingly there does not appear to have been a fence around the radar mat area (although this may have been removed). Thicker concrete posts were used for strainers at corners and at the gates (Pl 9).

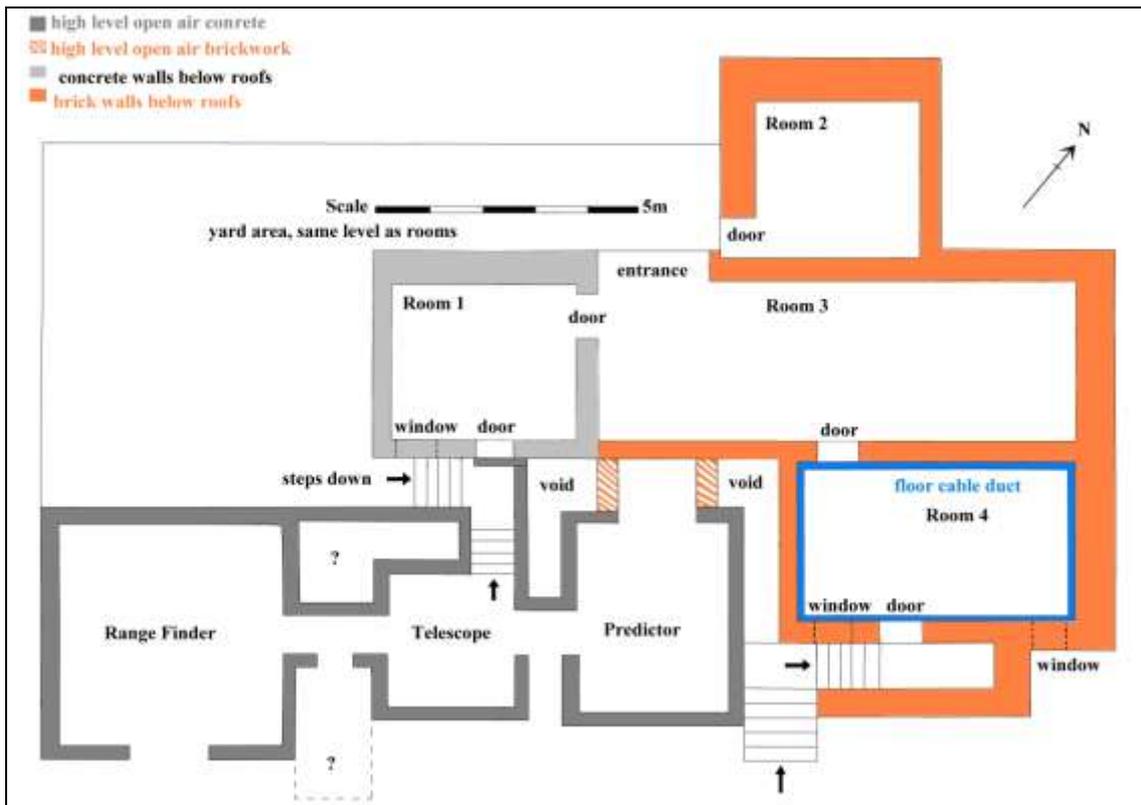
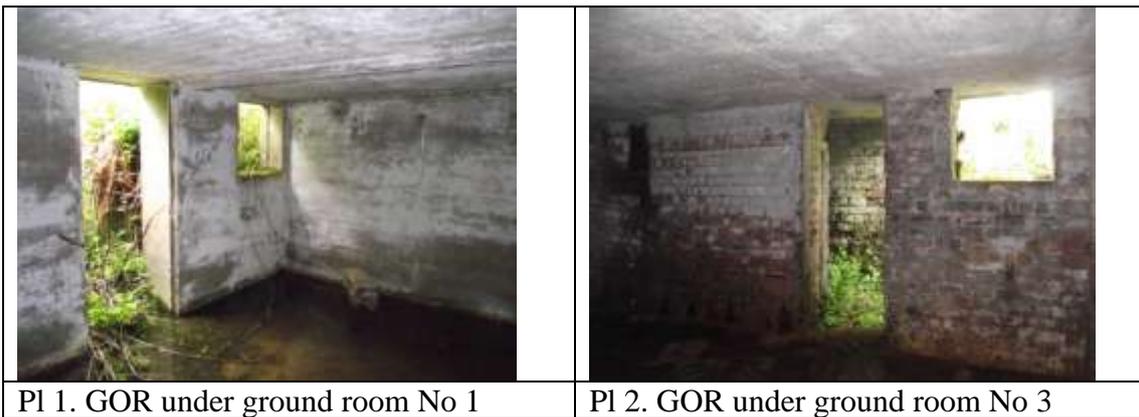
Fig 4. The Gun Operations Rooms

The GOR is extremely well preserved at South Ailey Farm (Fig's 3 & 4). The building complex is partially built below ground level, obviously for the protection of personnel; however spotters were required to operate in the open air and at roof top level with the main buildings; Rooms 1 – 4. (See Pl 24).

The complex is built with both shuttered concrete and bricks and the extent to which both materials were used will be readily appreciated on the plan. The rooms are all rectangular and measure internally 3.5m by 3m (R1), 3m by 3m (R2), 8.5m by 3m (R3) and 5.1m by 3m (R4), all are 2m high from concrete floor to concrete ceiling. Few details survive in any of the rooms apart from a cable floor duct in Room 4. Only R1 and R4 have small windows, two in the latter.

R1 is accessed via two short flights of concrete steps leading down from the higher levels; it connects to R3 by a single doorway. R2 has a single door leading to the lower level (yard?) and is next to the wider entrance to R3, the wider doorway is possibly to allow movement of larger sized equipment. Rooms 3 and 4 connect by a doorway and R4 is also accessed from outside and, similarly from the higher level via another stair which has a half landing. The stair leads directly to a covered porch area. The four rooms and porch are all roofed with shuttered concrete externally covered by a thick layer of bitumen.

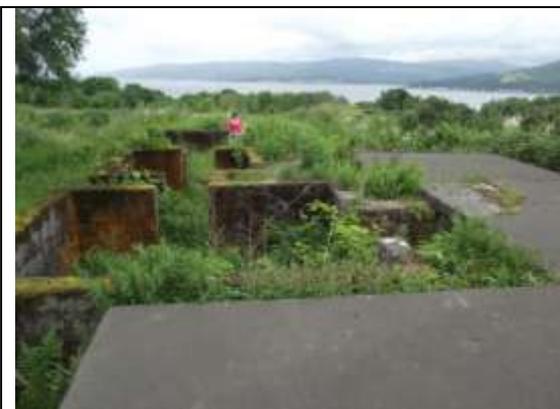
The higher levels (PI's 3-5) comprise of the open air aspect of the complex and it is known that three principal spaces were designated for the equipment of Predictor, Telescope and Range Finder (none of which is fully understood by the writer at present but see PI 24 for wartime operations). The concrete 'pens' could have been accessed from the adjacent ground level as well as to Room No 1 via the stairs. Two voids were clearly not functional however the two spaces marked '?' on plan are not understood at present. Similarly the lower 'yard' area has a scarcement along the side of the Range Finder wall and may have been partially floored to the level of the pens. The Range Finder walls are 1m high and are 0.3m thick while the remainder of the pen walls are 1.2m high and slightly thinner at 0.25m.

PI 3. GOR roof and instruments area.

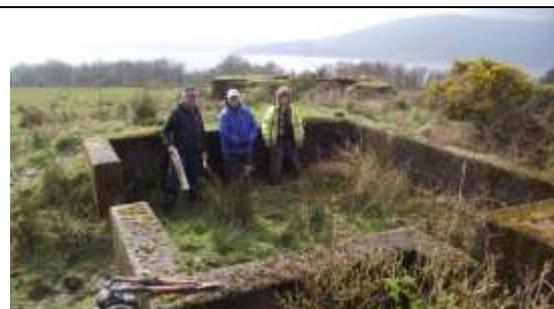
PI 4. Range Finder Area.

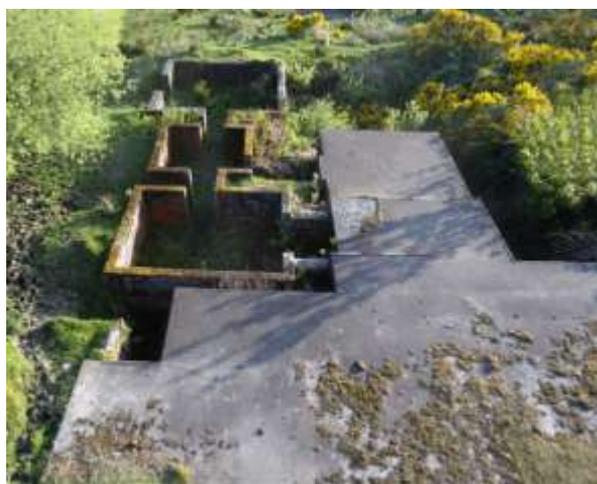
PI 5. GOR roof and instruments area

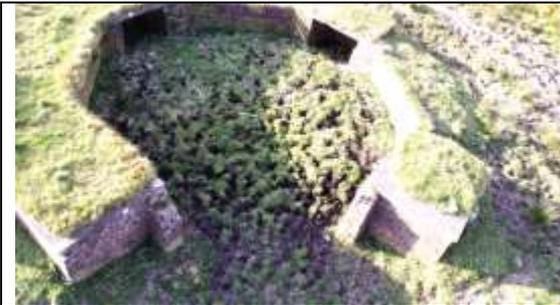
The four gun positions are located to the north and west of the GOR and arranged in an arc with each gun site building being open to a tarmac road with runs around the GOR. Apart from their alignments they are identical in constructional details and comprise of the following components; four open cubicles diametrically opposed in pairs to one another and facing inwards, a room with a central pipe through the roof and a 'floor' scarcement, and enclosing double brick walls.

Pl 6. Typical gun position

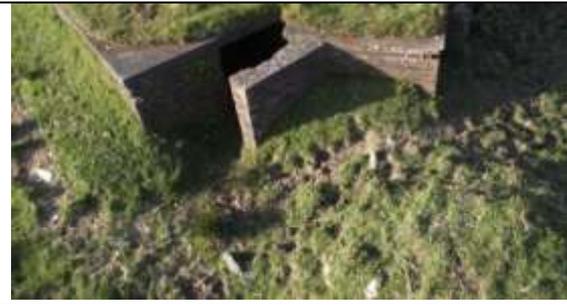
The room measures 4.5m by 2.3m and has a small aperture/window through the brick looking towards the estuary (in Gun No 1). The room is accessed by a 1m gap in the wall and has been protected by a short flanking wall. The pipe leading through the roof may have been ventilation (or a heating stove?). Two short wall stumps are on each side of the gun area entrance. None of the cubicles or the small room indicates they have had doors hung on them.

Pl 7. Entrance to side room

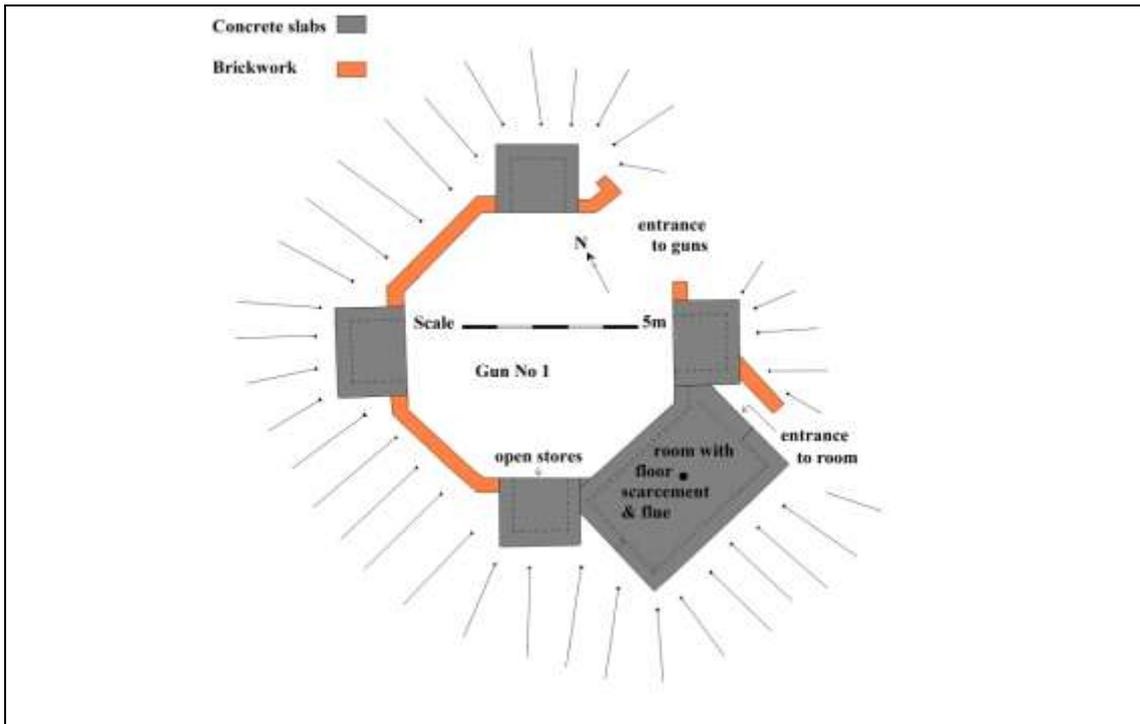
Fig 6. Gun No 1. Apart from orientation – the four gun sites are identical.

The four cubicles and the small room are all covered by a shuttered concrete slabs which have been created over double brick built walls, all the walls are brick. The roofs overhang the walls by 50mm and are all 103mm thick. Each cubicle is 1.5m square internally and 1.4m high, three channels can be observed in some of the concrete floors to indicate a possible sliding arrangement (of shell racks?), the semi circular grooves are 50mm wide and 25mm deep and are equidistantly spaced running from front to back.

Surrounding each gun position is an embankment of earth running out about 3m and coming to within 0.5m of the wall heads.

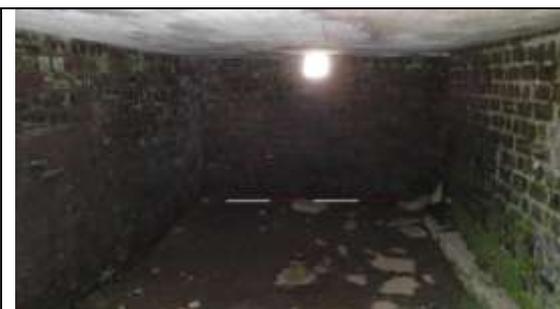
Pl 8. Typical gun room

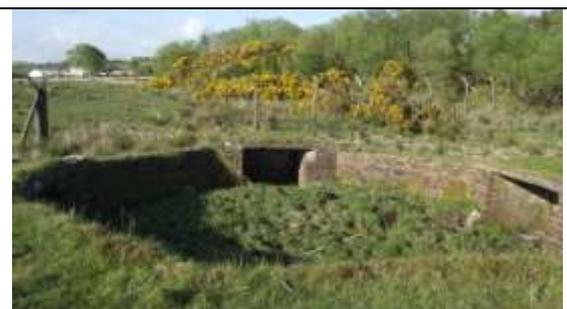
Pl 9. Gun No 3 with perimeter fence and radar mat area beyond

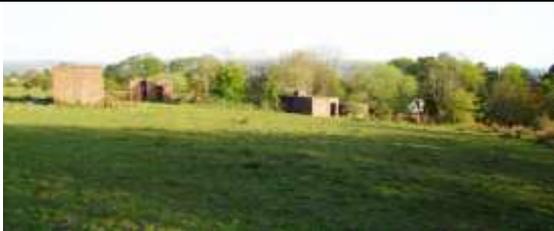
<p>Pl 11. Looking south. Field No 2.</p>

The remains of twenty three buildings are visible in the southerly field, where the messing facilities and camp appear to have been built. However, only four (B1–4) have survived nearly intact with another (B6) in more ruinous condition. The remainder are seen as either concrete bases or very ruinous brick and concrete structures or platforms, a few brick manhole like features also exist.

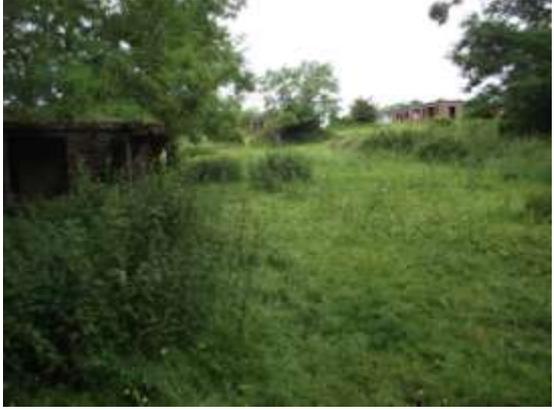
<p>Pl 12. Looking north. Field No 2.</p>
--------------------------------------------------------------------------------------------------	------------------------------------------------------------------------------------------------------------------------------------------------------------------------------------------------------------------------------------------------------------

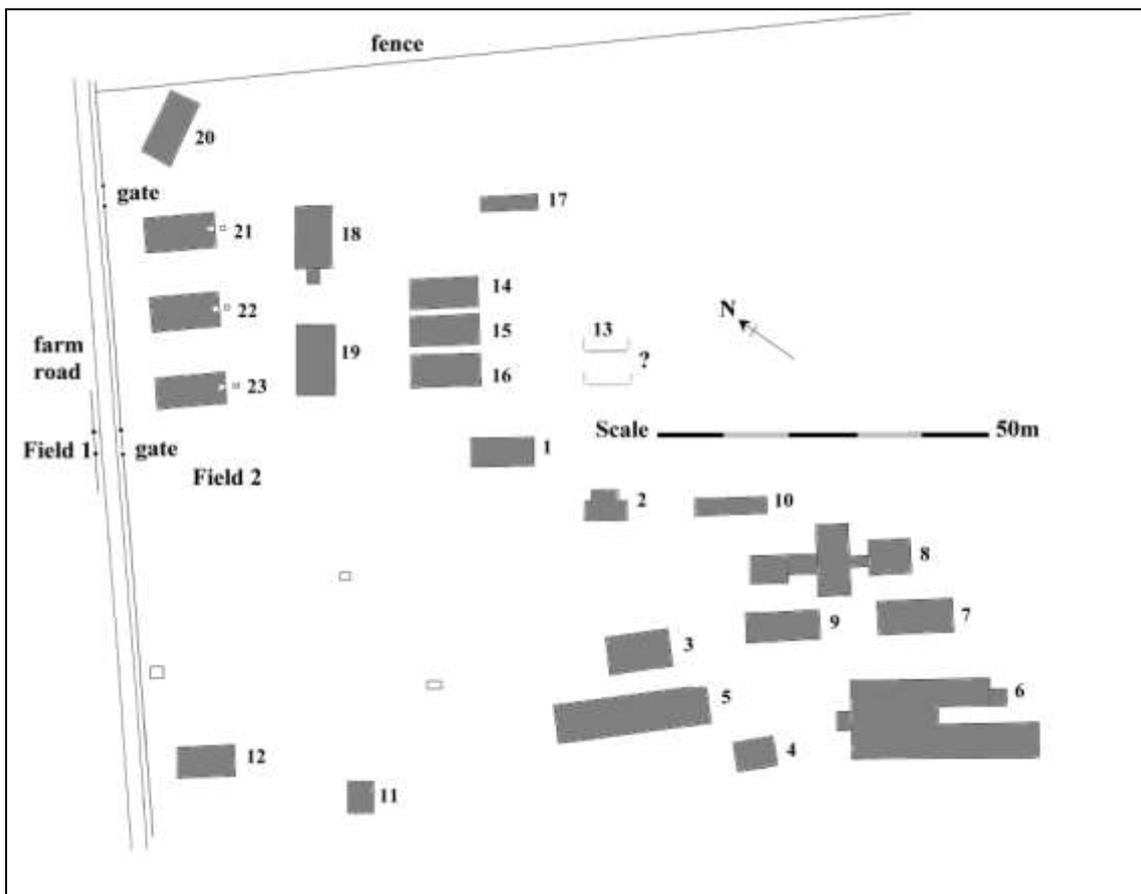
Fig 7. Field No 2 buildings. The Camp.

Where walls survive they are all single brick construction, the concrete roofs have been shuttered over corrugated sheeting the matrix of which is seen where the roofs survive, the buildings have been painted white internally but with only the bare bricks showing outside. Shower cubicles and latrine walls have been cement rendered. All lintels are concrete but the window sills were made with half round bricks with a 50mm overhang, the same as the concrete slab roofs. Some buildings show evidence of drains, roof gutters and electrical installations, the latter appear to have been lighting only, in conduit tubing, and the buildings appear to have been supplied by overhead electric lines. No doors survive but several metal framed windows remain in situ, these come in two sizes 0.6m and 1.2m wide with an upper vent section. Floor details are mostly obscured.

Building No 8 is much ruinous but has measured 25m by 11m overall, however it appears to have been built as separate areas, possibly connected along the long axis.

The structure is given on the OS map as 'Tank' and it is obvious that it is the base and catchment walls for a tank, presumably for water to supply the buildings which stand lower down in the field.

No 5	24m x 6m.
No 7	12m x 5m.
No 9	11m x 4m.
No 10	11m x 2.5m.
No 11	5m x 4m.
No 12	9m x 5m.
No 13	7m x indeterminate, more than one building?
No 14	11m x 5m.
No 15	11m x 5m.
No 16	11m x 5m.
No 18	10m x 6m with extension 2m square.
No 19	10m x 6m.
No 20	11m x 5m.
No 21	11m x 5m with 1m 'pad' = entrance side?
No 22	11m x 5m with 1m 'pad' = entrance side?
No 23	11m x 5m with 1m 'pad' = entrance side?

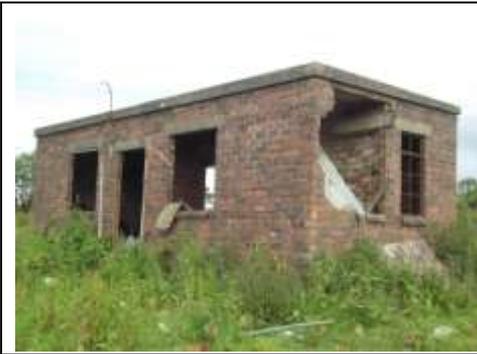
The building measures 8.5m by 3.3m and had a single entrance 0.9m wide with a concrete step, two galvanised pipes rise on each side of the step and indicate they originally protected electric cables, the fuse box survives inside the entrance and the building was supplied by overhead cables. Two large windows serve each of the main rooms and there are two smaller windows in the southern gable wall, one of the metal frames survives here, and where two small chambers exist, these may have been toilets.

Pl 13. Building No 1 looking north.

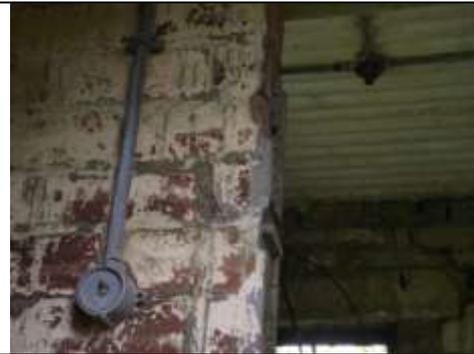
Pl 14. Building No 1 light fittings.

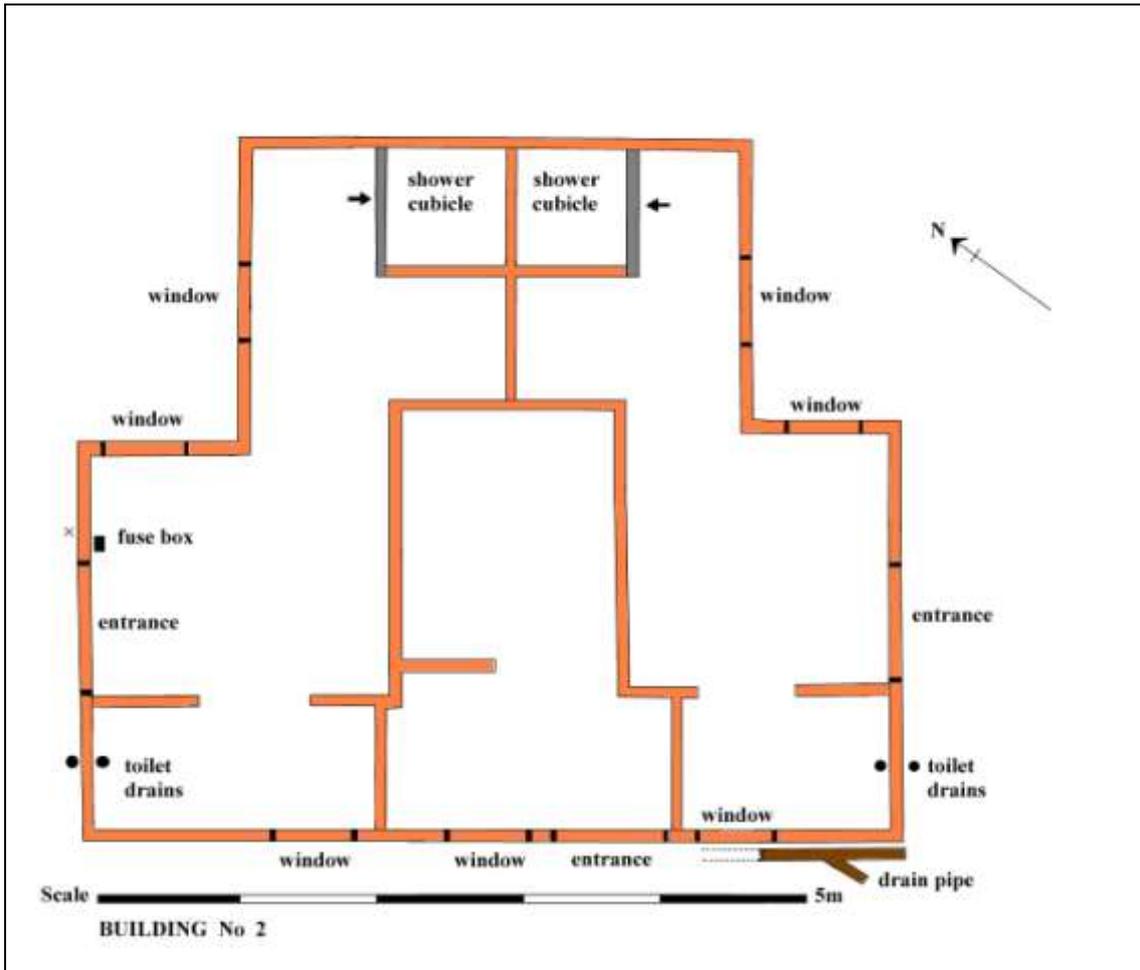
Fig 9. Building No 2

Building No 2 measures 5m by 5.3m in total, it is a 'T' shaped structure and has a shower cubicle and toilet symmetrically placed on each side and with separate entrances, suggesting Ladies and Gents? Facilities. The central area has a stove? Pipe hole in the roof. A ruinous fuse box survives and the building was supplied by overhead line. LARKHALL bricks have been used in its construction.

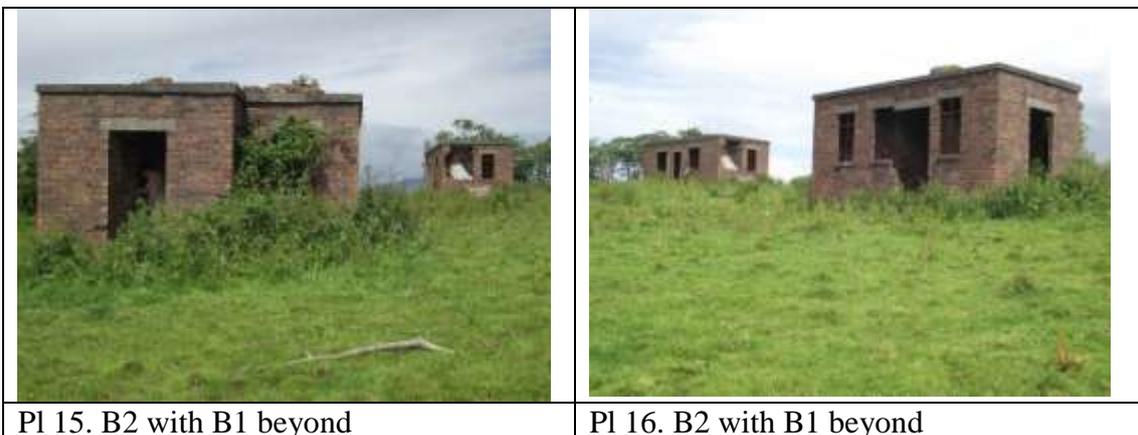
Pl 15. B2 with B1 beyond

Pl 16. B2 with B1 beyond

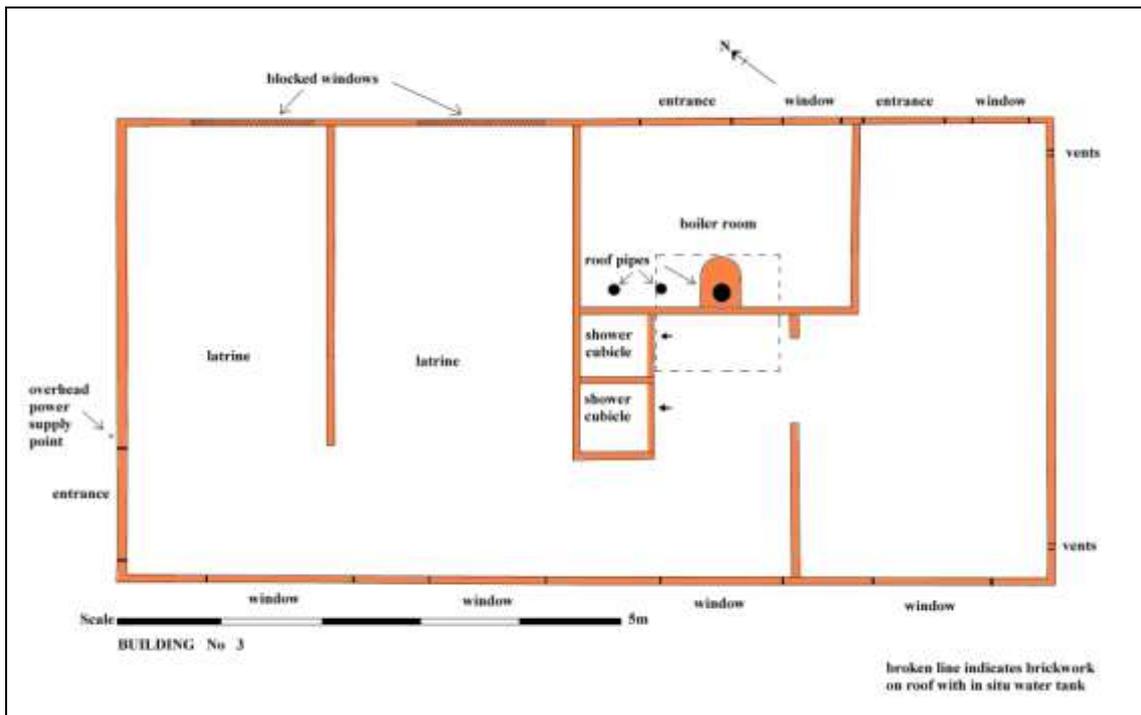
Fig 10. Building No 3

Building No 3 measures 9.3m by 4.2m and also has two shower cubicles but here they are adjacent, two rooms are certainly cement rendered for urinals there fore this building was probably ‘male only’. The latrine rooms were originally built with a wide window in each but these were bricked up as part of the finished design. A chamber on the east side has a semi circular brick pillar built for a boiler? And above it there are three roof vents. The roof has a brick structure upon it and which still contains a galvanised water tank. The overhead supply is indicated on the northern gable.

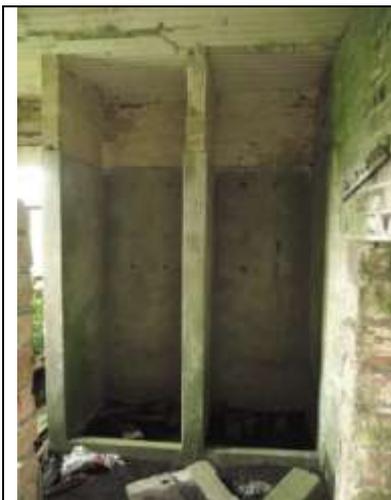
Pl 17. B3 shower cubicles

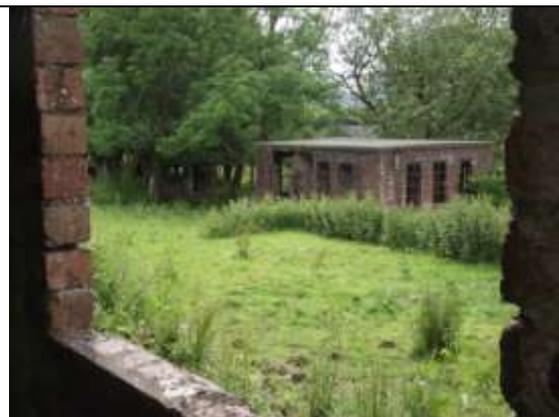
Pl 18. B4 as seen from B3

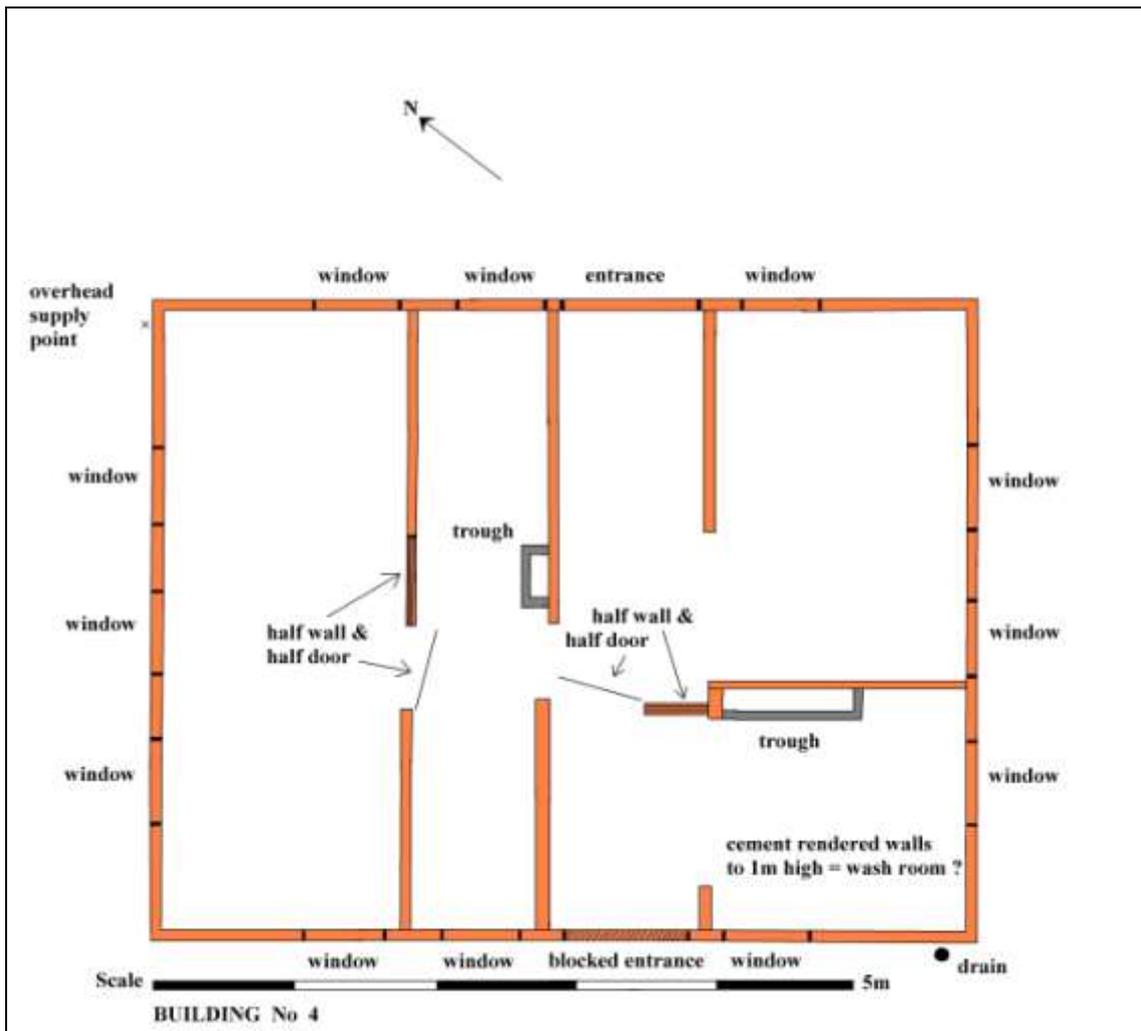
Fig 11. Building No 4

Building No 4 measures 5.8m by 4.1m and has been furnished with no fewer than twelve windows (Pl's 19-20), all being the smaller size (0.6m). It has a single entrance on the east side but originally had an opposing doorway which has been blocked up, presumably as a change of plan. A corner room has cement rendered walls up to 1m high and may have been a wash room or kitchen area. Two places have 'half walls and accesses' indicated by the surviving wooden frames and two trough structures survive on the floors. The overhead supply is indicated on the north gable.

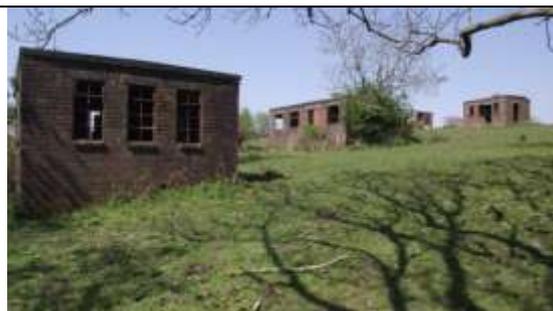
Pl 19. B4, B3, B2 and B1

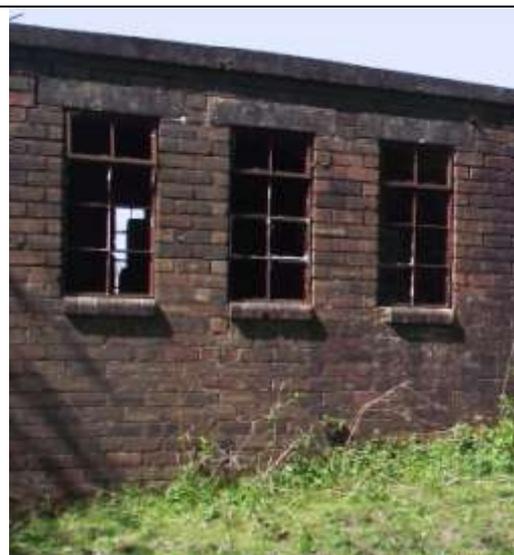
Pl 20. Detail of B4 windows

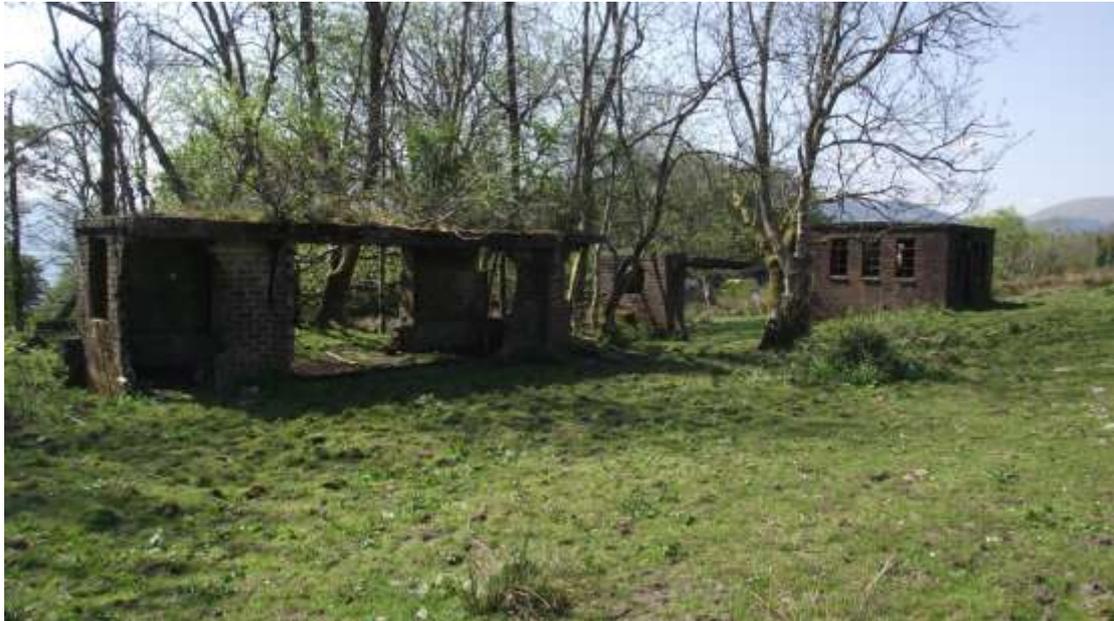
Building No 6 is much ruinous and covered in vegetation, however it measured approximately 30m by 13m overall. It certainly had single toilets projecting at each end as the remains can still be seen in each location. The only other principal detail is that the central brick area has been flanked by Nissen type structures and the curving roof trusses of angle iron survive partially in places. P M HURELL bricks have been used in its construction.

Pl 21. Building No 6 with B4 beyond.

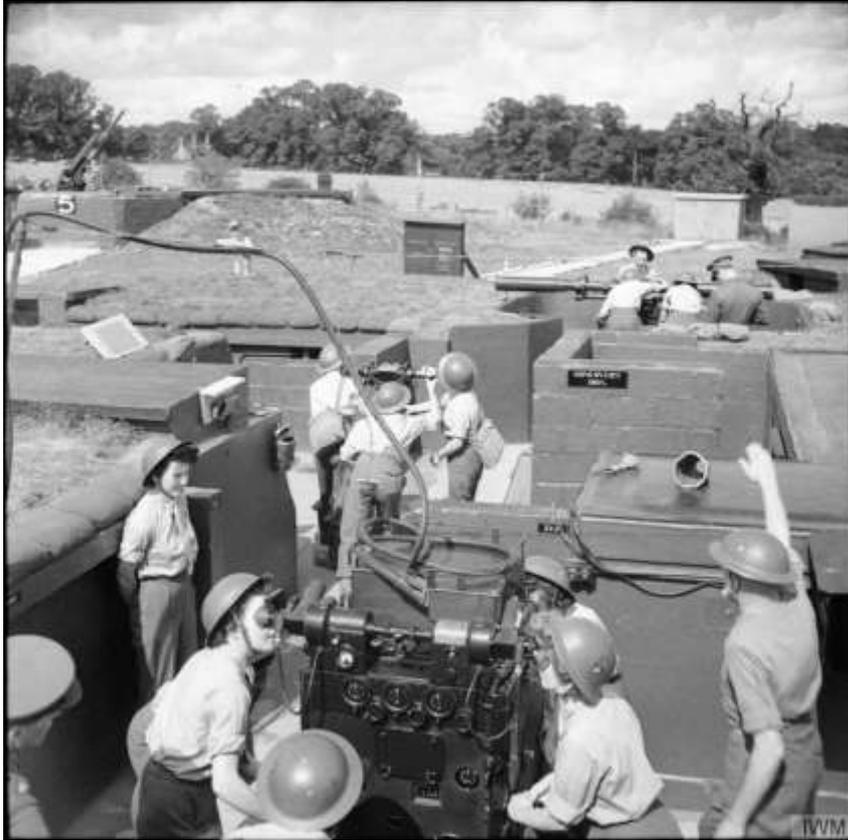
PI 24. Showing army and ATS personnel operating the detecting equipment, see PI 5 above.
