Jersey Civil Emergency Centre Conservation Statement

Dr Peter Chowne
May 2013

This Conservation Statement was commissioned by Jersey Heritage and prepared by Dr Peter Chowne in May 2013. The purpose of the Conservation Statement is to improve the understanding of the property, its significance and values. Based on this understanding policies that inform the protection, conservation and management of the structure are proposed.

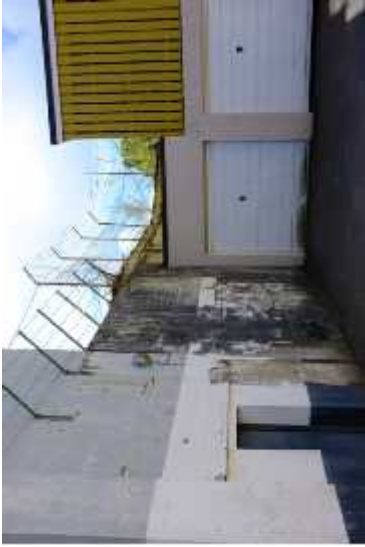
Figure 3: Garages built against west wall and blocking original entrance

The west facing wall is partially obscured by modern garages at its southern end. These cover the original blocked door and a blocked loophole that formed part of the defences of the entrance area (figure 3). The entrance in the central section of this wall was formerly an open aperture leading into original generator room. This is the current entrance. To the north of the door is a buttress like appendage that appears to be a later addition for protecting and carrying services to the roof where the water cistern and emergency generator are located (figure 4).

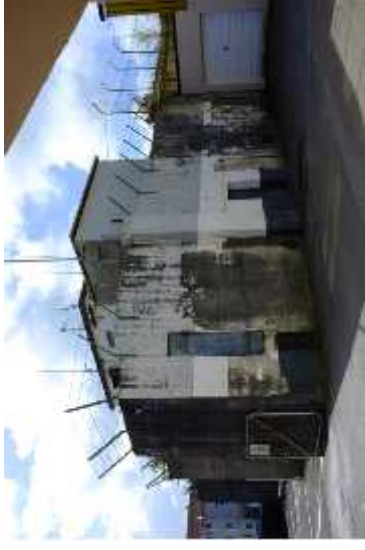
Figure 5: Car park entrance and access door to Tobruk position on roof

At the northern end of the wall is the entrance to a 'Tobruk' position on the roof. Between it and the 'buttress' is an inlet vent for the German air system. Access to the roof is via the steps up to the Tobruk position. This appears to be a type 202 with a circular aperture (figures 5 & 6).

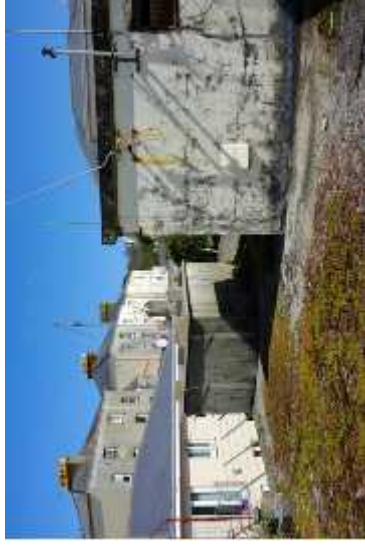
Figure 8: Generator Room from the west, the water cistern is to the left of this room

There are three structures on the roof, a water cistern and two plant rooms that house a standby generator and air ventilation and filtration unit that blows purified air through a network of ventilation trunking running into each room in the bunker (figure 7). The plant rooms have communications antennae attached and adjacent to it the remains of a collapsed mast. These are post Occupation in date. There are a number of pipes exiting through the roof that may have been part of the ventilation system, some of these have been damaged by vandals and water has been leaking into the dormitory below. Parts of the roof have been colonised by lichen, ivy and buddleia (figure 8).

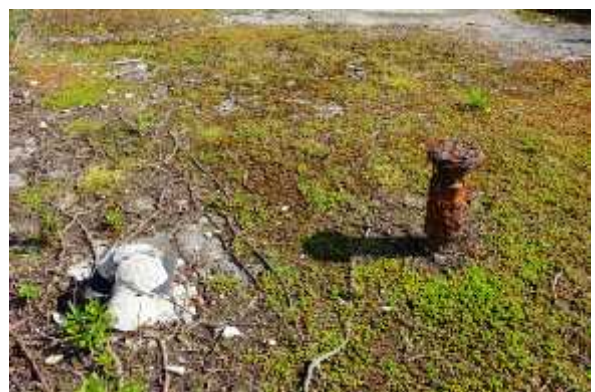
Figure 9: Damaged intact roof fittings

The external fabric of the building appears to be in very good condition. The only visible evidence of vulnerability is on the roof where damage has been caused by vandalism and in the plant rooms by water ingress and damp.

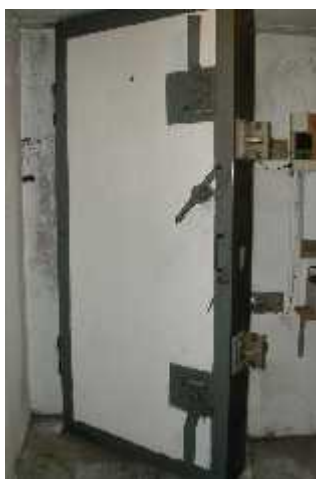
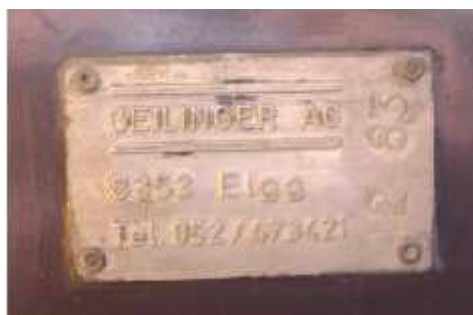
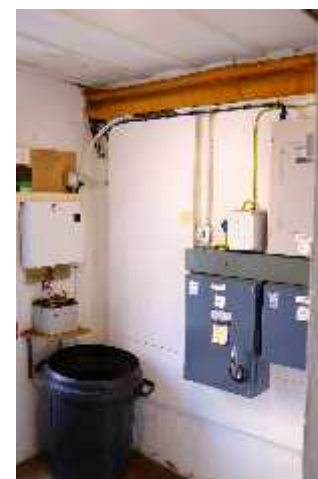
Room No.	1	Previous Use	Generator room
Room Name	Entrance	Current Use	Entrance lobby

(1a). The door was manufactured by Geilinger AG, Elgg, Switzerland and is date stamped 12 83 (1b). To the left of the door is a mains electricity junction box which appears to of recent manufacture (1c). The former generator room has been subdivided and contains two flushing WC cubicles and a decontamination area consisting of two showers (2a), two urinals (2b) and a hand basin. The alcove (40 on the CIOS plan) is currently used for storage (2c). An original two-part German steel gas tight door leads from here into the bunker (3a). Apertures and some ducting for the original German ventilation system can be seen in many of the rooms.

Floor	Concrete
Ceiling	Cast concrete with steel reinforcement, painted
Walls	Cast concrete, painted
Windows	
Doors	Steel blast door by Geilinger to exterior
Fixtures	
Built in Furniture

German Occupation 1943-1944	Original two-part German steel gas tight door leads from here into the bunker (3a). Apertures and some ducting for the original German ventilation system
States of Jersey Civil Defence	
Significance / contribution to significance	Original German features and fittings

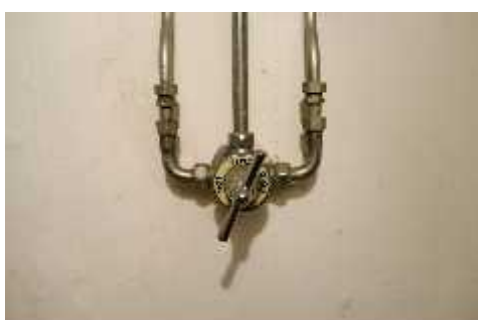
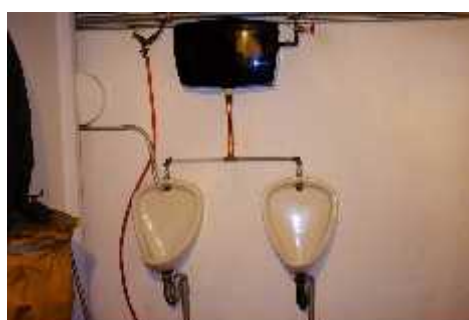
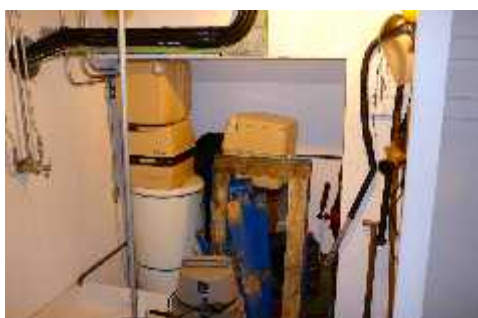
Room No.	2	Previous Use	Generator room
CIOS Room No.	30 / 40	Current Use	Decontamination room

Floor	Concrete
Ceiling	Cast concrete with steel reinforcement. painted
Walls	Cast concrete, painted
Windows	
Doors	
Fixtures	Two urinals, one shower
Built in Furniture

German Occupation 1943-1944	
States of Jersey Civil Defence	Two flushing WC cubicles and a decontamination area consisting of two showers (2a), two urinals (2b) and a hand basin
Significance / contribution to significance	Original civil defence features and fittings

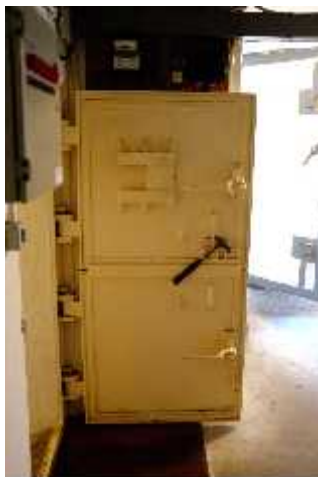
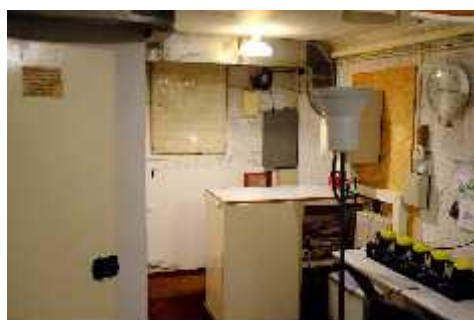
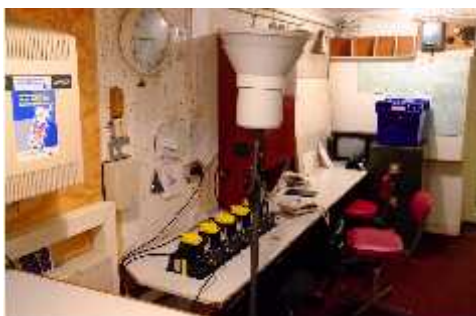
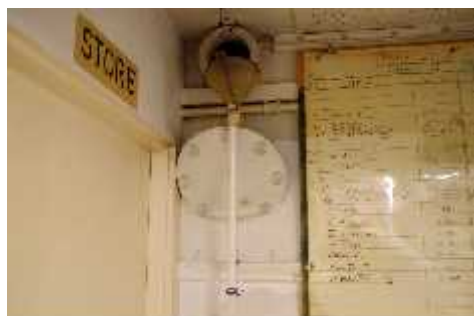
German Occupation 1943-1944	Steel air lock door
States of Jersey Civil Defence	Communications equipment

Significance / contribution to significance	Original German features and fittings, original civil defence features and fittings
--	---

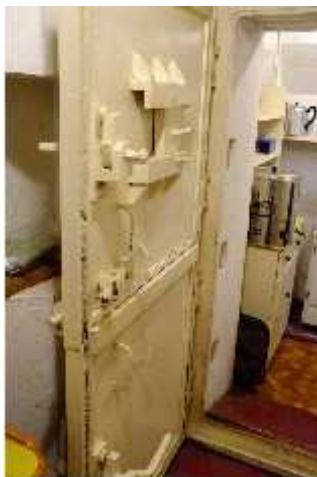
a

German Occupation 1943-1944	Two steel air lock doors
States of Jersey Civil Defence

Significance / contribution to significance	Original German features and fittings
--	---------------------------------------

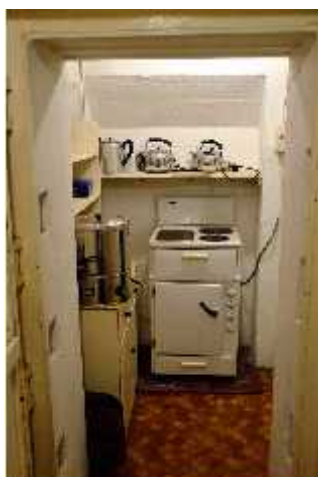
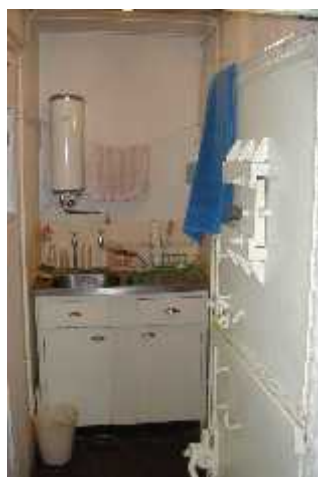
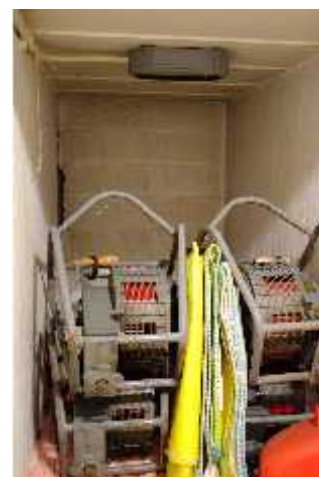
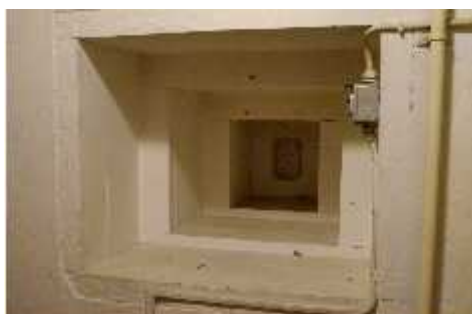
Room No.	5	Previous Use	Entrance
CIOS Room No.	2	Current Use	Kitchen

In the short entrance corridor beyond the air lock is a small stainless steel sink and draining board and a water heater (5b). A dog leg to the right leads to the now blocked entrance which contains several portable siren units (5c). Opposite the entrance and designed to protect it is a loophole suitable for a machine gun or small arms (5d).

Floor	Concrete, linoleum
Ceiling	Cast concrete with steel reinforcement, painted
Walls	Cast concrete, painted
Windows	Defensive loophole, blocked
Doors	Original two-part German steel gas tight door
Fixtures	Electric water heater
Built in Furniture	Kitchen unit and stainless steel sink

German Occupation 1943-1944	Loophole suitable for a machine gun or small arms
States of Jersey Civil Defence

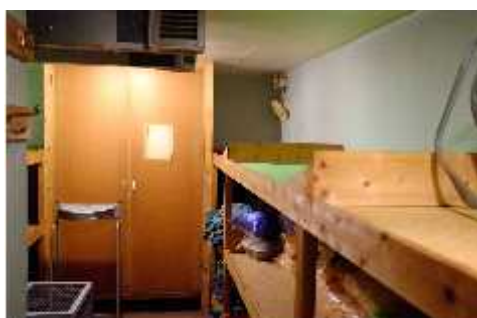
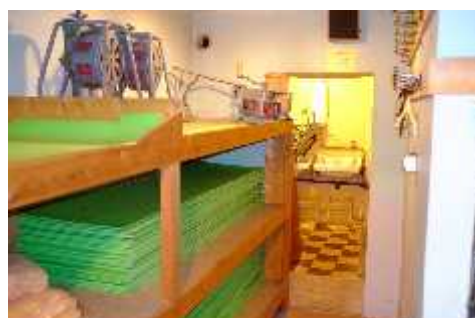
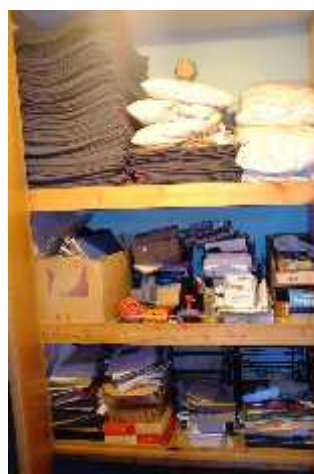
Floor	Concrete, carpet
Ceiling	Cast concrete with steel reinforcement, painted
Walls	Cast concrete, painted
Windows	
Doors	
Fixtures	
Built in Furniture

German Occupation 1943-1944	German gas door and beyond that a small room with a blocked loophole in the wall which was a defensive firing position covering the bunker entrance
States of Jersey Civil Defence	Unisex dormitory with four wooden triple bunks still in place. Foam mattresses are stored on some of the bunk beds and a cupboard contains UK government issue blankets and assorted stationary typical of the 1980s
Significance / contribution to significance	Original German features and fittings, original civil defence features and fittings

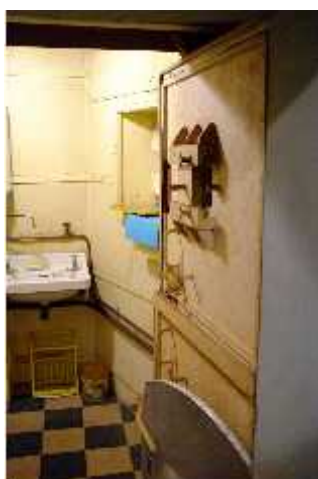
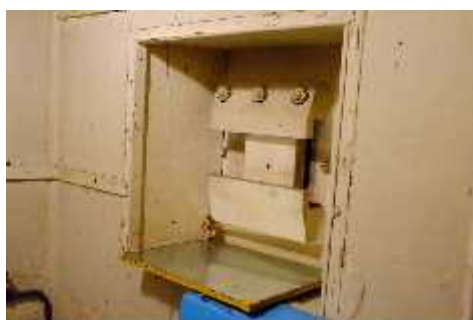
Floor	Concrete, linoleum tiles
Ceiling	Cast concrete with steel reinforcement, painted
Walls	Cast concrete, painted
Windows	Defensive loophole, blocked
Doors	Original two-part German steel gas tight door
Fixtures	Porcelain sink
Built in Furniture

German Occupation 1943-1944	German gas door and beyond that a small room with a blocked loophole in the wall which was a defensive firing position covering the bunker entrance
States of Jersey Civil Defence	
Significance / contribution to significance	Original German features and fittings

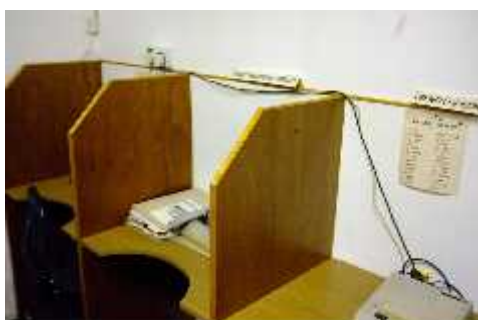
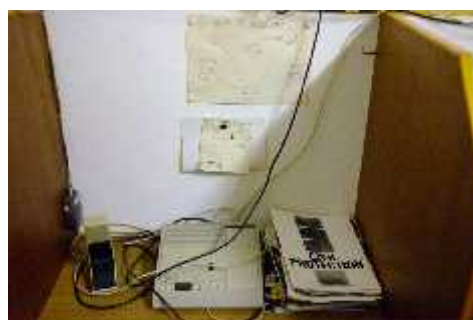
German Occupation 1943-1944	
States of Jersey Civil Defence	Partitioned acoustic booths for individual signals operators equipped with telephones

Significance / contribution to significance	Original German features and fittings, original civil defence features and fittings
--	---

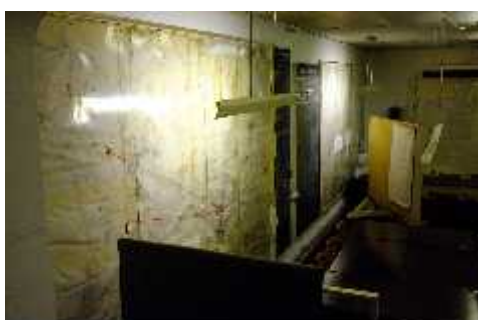
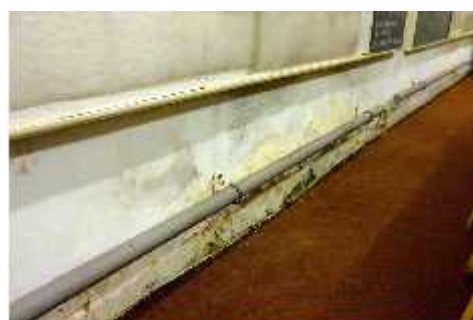
German Occupation 1943-1944	
States of Jersey Civil Defence	Original civil defence features and fittings

Significance / contribution to significance	See next sheet
--	----------------

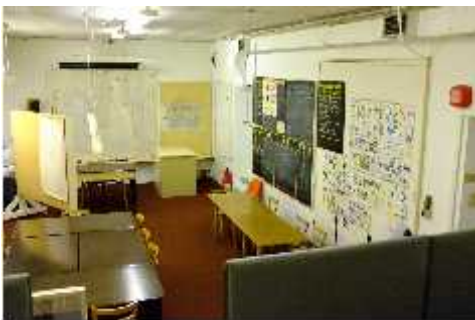
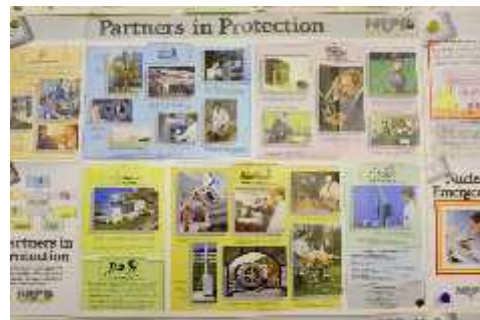
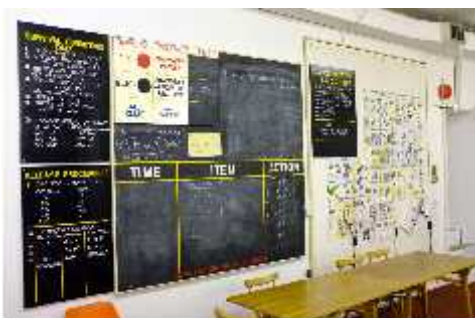
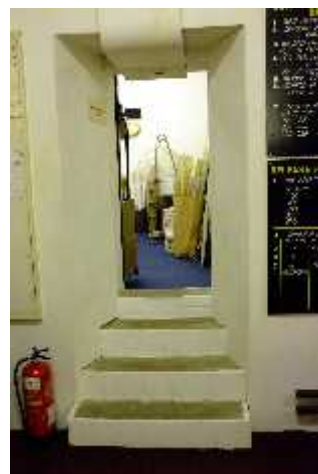
German Occupation 1943-1944	
States of Jersey Civil Defence	Original civil defence features and fittings

Significance / contribution to significance	This room one has an eerie sensation of stepping back to a moment frozen in time. The walls are covered with charts and posters creating a powerful impact
--	--

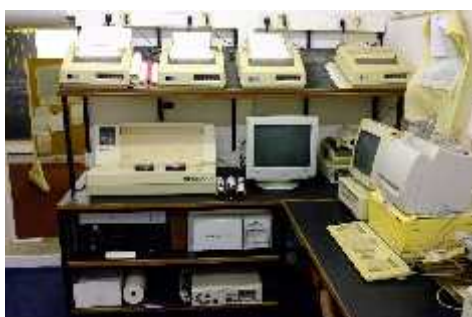
a

German Occupation 1943-1944	
States of Jersey Civil Defence	Original civil defence features and fittings

Significance / contribution to significance	An array of 1980s computer equipment and nuclear defence protective attire and equipment
--	--

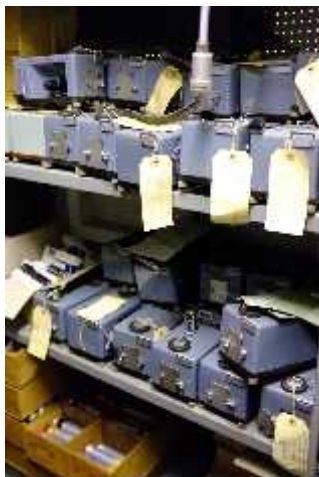
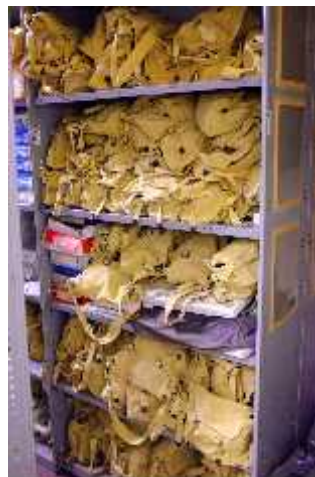
German Occupation 1943-1944	
States of Jersey Civil Defence

Significance / contribution to significance	Stored civil defence equipment, individually the objects are of interest but when seen stored as multiple items they have more significance
--	---

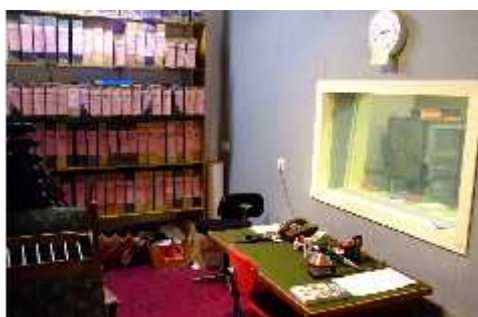
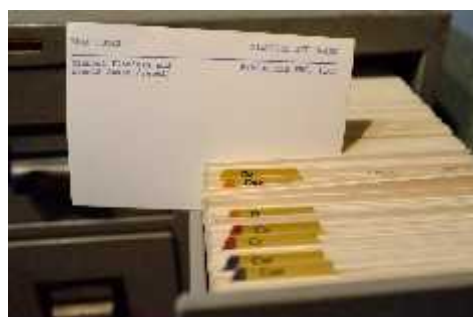
German Occupation 1943-1944	
States of Jersey Civil Defence	Stack of LP records, all from the 50's and 60's, nuclear warning cassettes

Significance / contribution to significance	Intact room with multiple with intact furnishings and equipment, the card index provides a temporal and cultural context
--	--

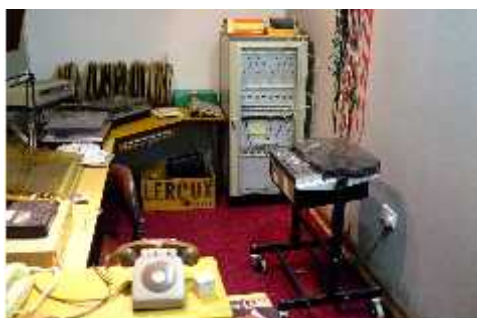
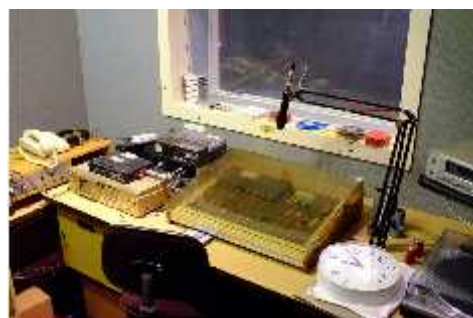
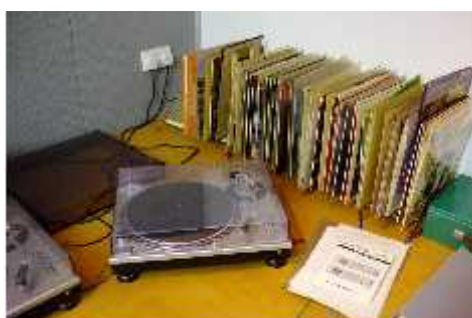
German Occupation 1943-1944	
States of Jersey Civil Defence	Equipment includes an Audix mixer, AKG D202 Microphone (Mic 1), UHER reel to reel portable tape recorder, Revox reel to reel studio tape recorder, Sony professional cassette recorder, Marantz cassette recorder, two Technics SP1200 record decks, Technics tuner, lip microphone, loudspeaker, clock and a floor standing 19" rack of line interface equipment; all incoming and outgoing audio lines pass through this unit

Significance / contribution to significance	Intact room with multiple with intact furnishings and equipment, the records provide a temporal and cultural context
--	--

The control room also doubles as a 'self op' studio and is still fully equipped with similar equipment to that found in all 1980's RGHQ's. This includes an Audix mixer, AKG D202 Microphone (Mic 1), UHER reel to reel portable tape recorder, Revox reel to reel studio tape recorder, Sony professional cassette recorder, Marantz cassette recorder, two Technics SP1200 record decks, Technics tuner, lip microphone, loudspeaker, clock and a floor standing 19" rack of line interface equipment; all incoming and outgoing audio lines pass through this unit (13a/13b).

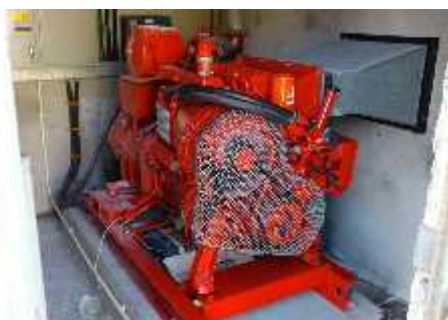
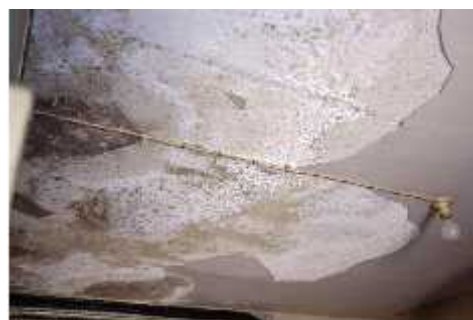
Room No.	14	Previous Use	None
Room Name	Plant Room	Current Use	Generator Room

The two plant rooms on the roof are linked internally (see plan in appendix 3). Upon entering the first room is almost totally filled by a diesel generator that until recently was regularly maintained (14a). Water seepage through the roof has led to plaster flaking on landing on the generator (14b). This deterioration is also present in the adjoining room where plaster is falling on to a Vokes Unipak air filtration and pumping unit (15a: 15b). Adjacent to this is a covered opening in the floor that leads down to the escape shaft (15c). See appendices 3 and 4 for plans. These are dated 1963 and construction probably followed shortly after.

German Occupation 1943-1944	
States of Jersey Civil Defence	Diesel generator probably in working order

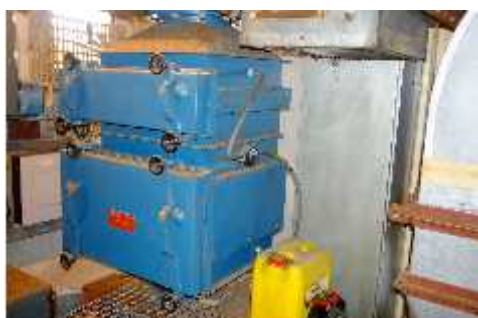
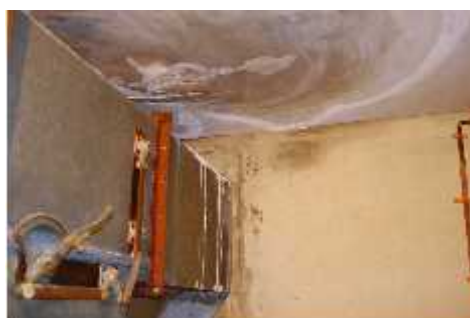
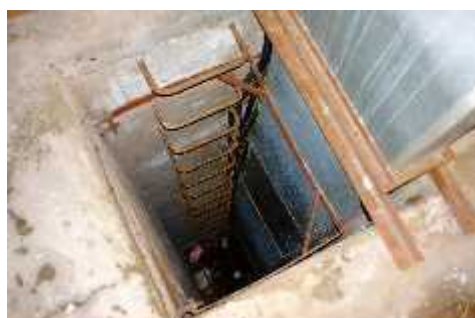
German Occupation 1943-1944	Opening in the floor that leads down to the escape shaft
States of Jersey Civil Defence	Air filtration and pumping unit

Significance / contribution to significance	Intact equipment still in situ
--	--------------------------------
