South Gloucestershire

Drainage Challenge fund bid: Carriageway Condition Assessment

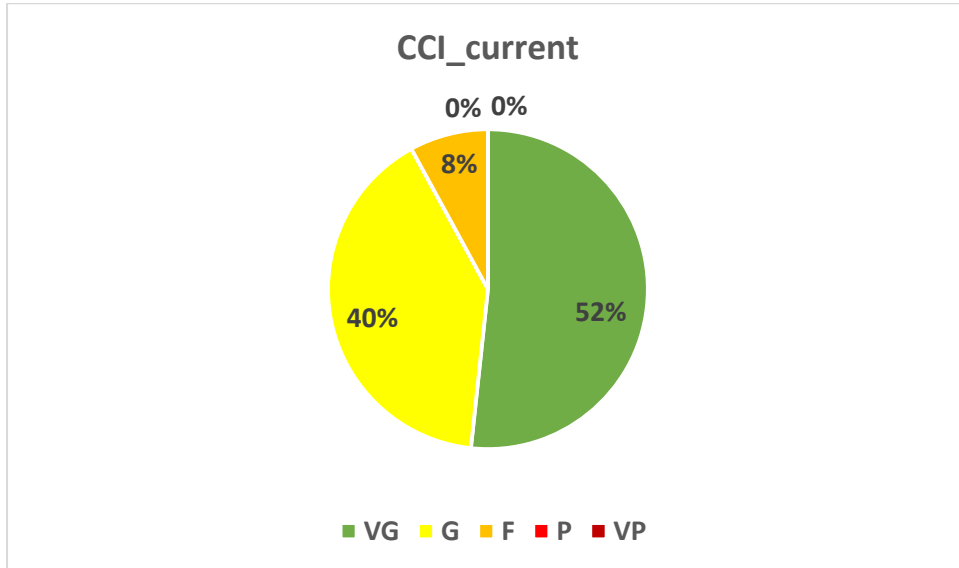
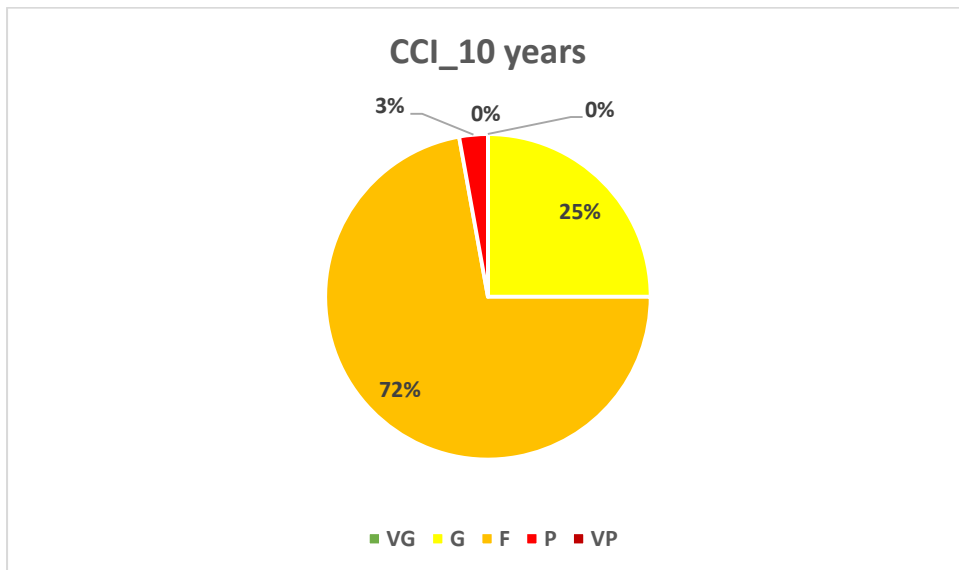
A420 Wick: High Street Wick

SCANNER survey: July/ August 2016

SCRIM survey August 2016

Condition categories for Strategic/ Main distributor (ref HMEP Lifecycle Planning toolkit: Table A1. November 2012)

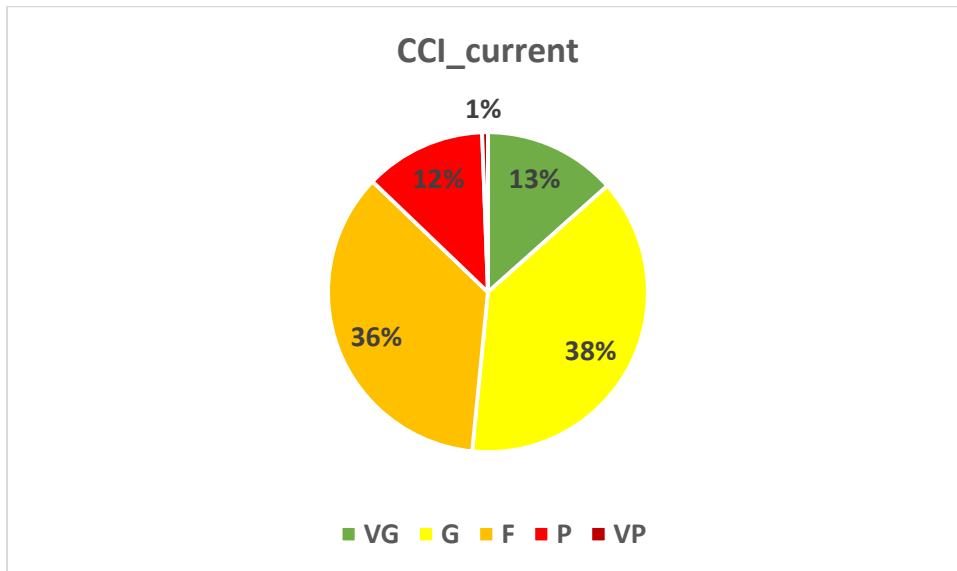
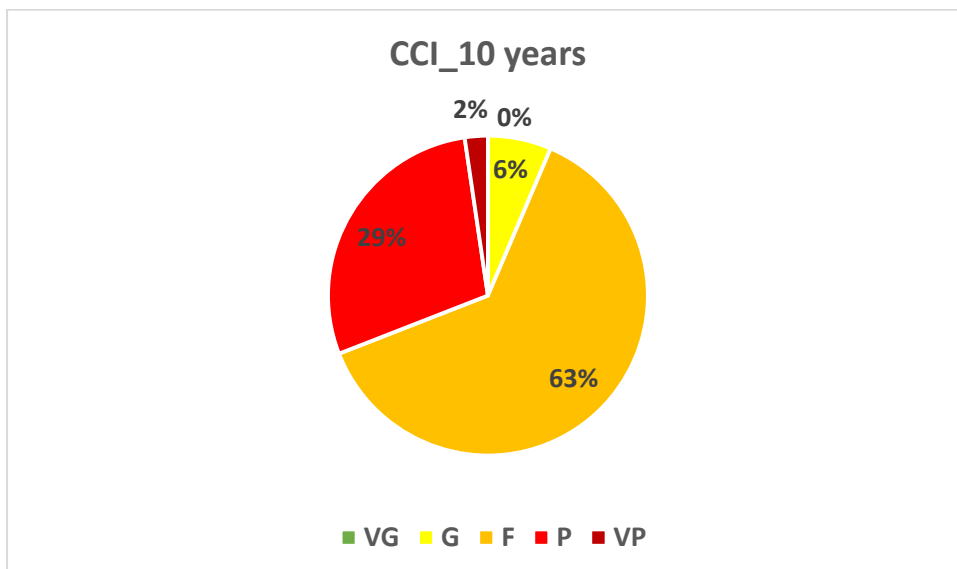
A431 Swineford: Bath Road

SCANNER survey: July 2016

SCRIM survey August 2016

Condition categories for Strategic/ Main distributor (ref HMEP Lifecycle Planning toolkit: Table A1. November 2012)

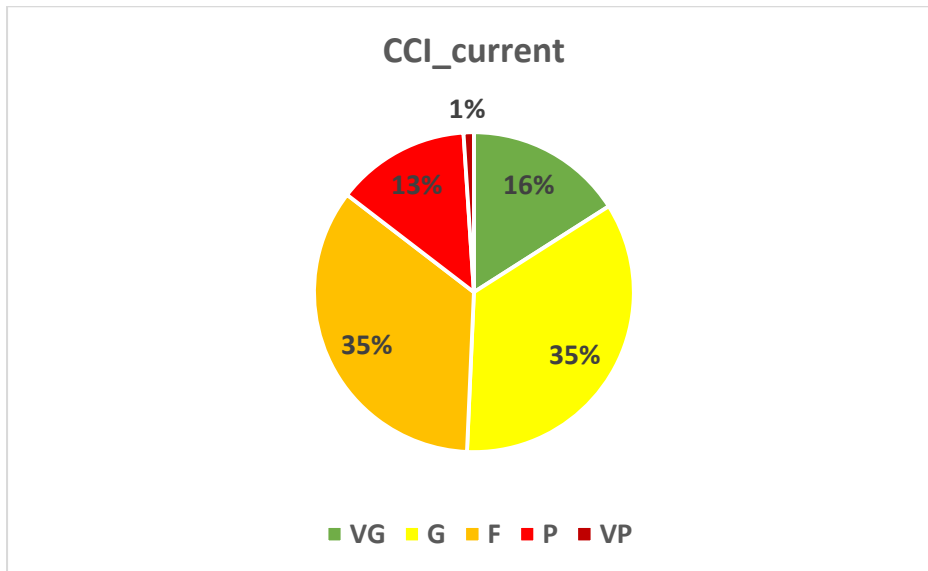
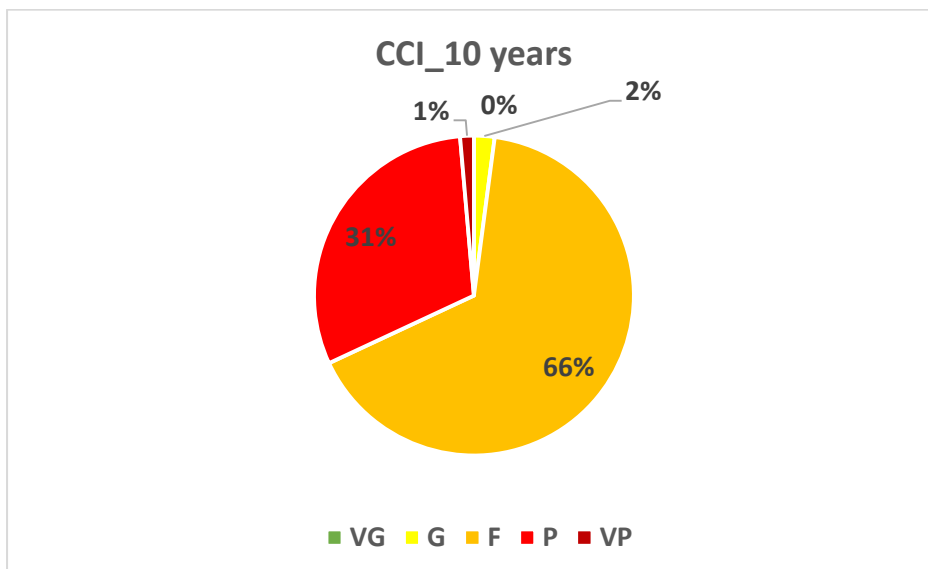
A4175 Oldland Common: Cherry Gardens

SCANNER survey: July 2016

SCRIM survey August 2016

Condition categories for Strategic/ Main distributor (ref HMEP Lifecycle Planning toolkit: Table A1. November 2012)

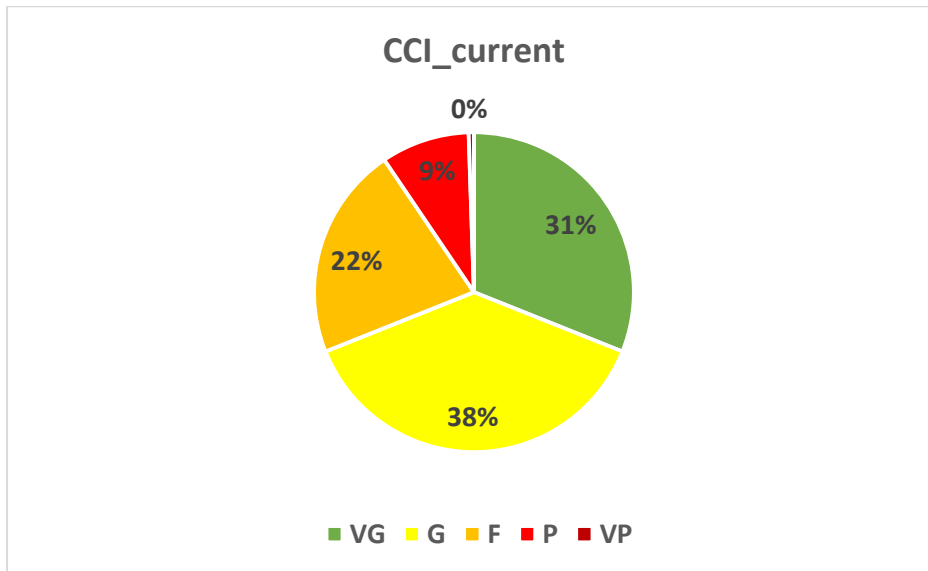
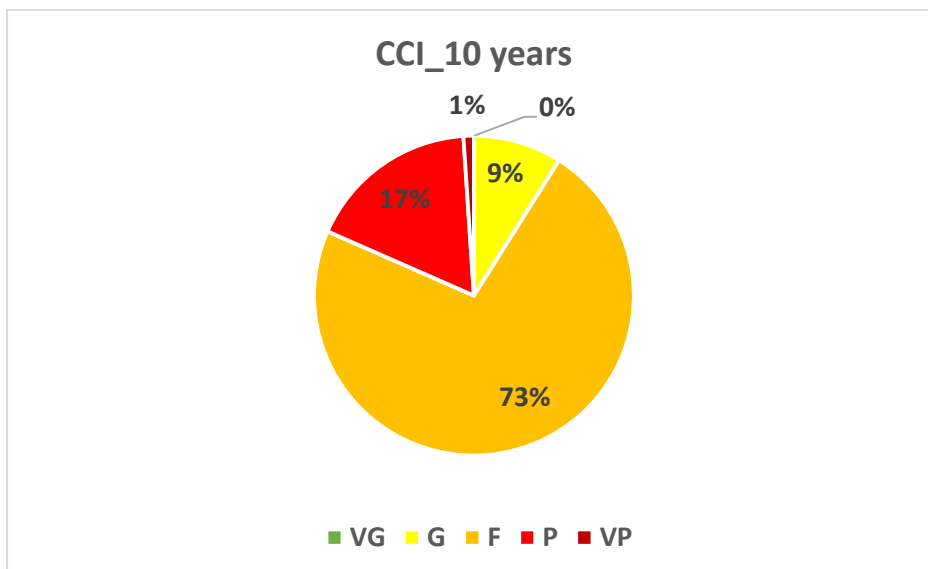
B4058 Winterbourne: High Street

SCANNER survey: May 2015/ August 2016

SCRIM survey August 2016

Condition categories for Strategic/ Main distributor (ref HMEP Lifecycle Planning toolkit: Table A1. November 2012)

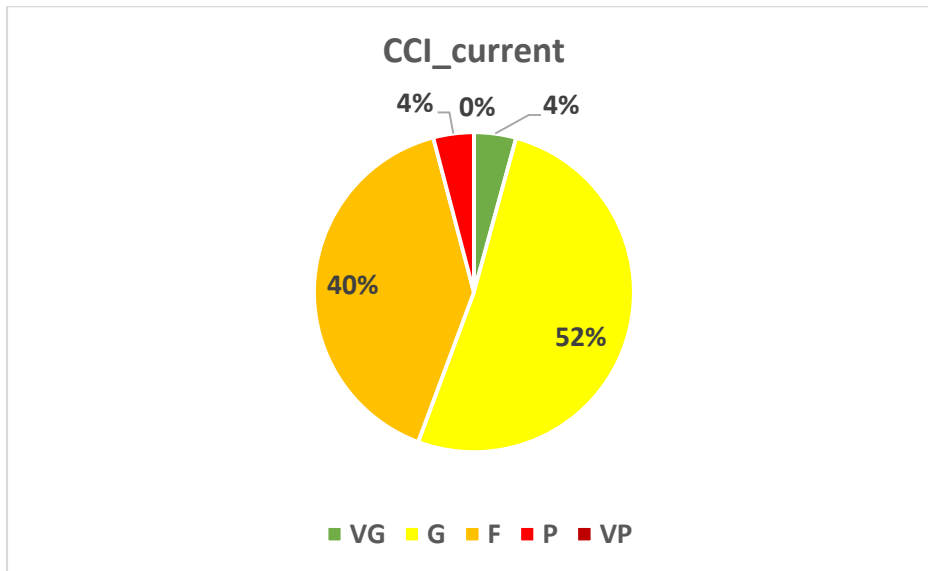
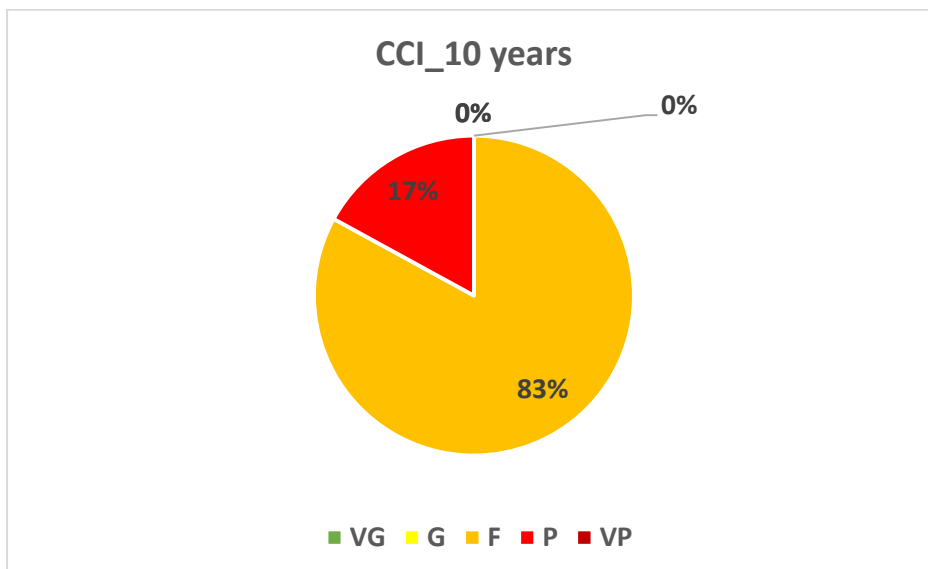
B4058 Bagstone: Bagstone Road

SCANNER survey: May 2015/ August 2016

SCRIM survey August 2016

Condition categories for Strategic/ Main distributor (ref HMEP Lifecycle Planning toolkit: Table A1. November 2012)

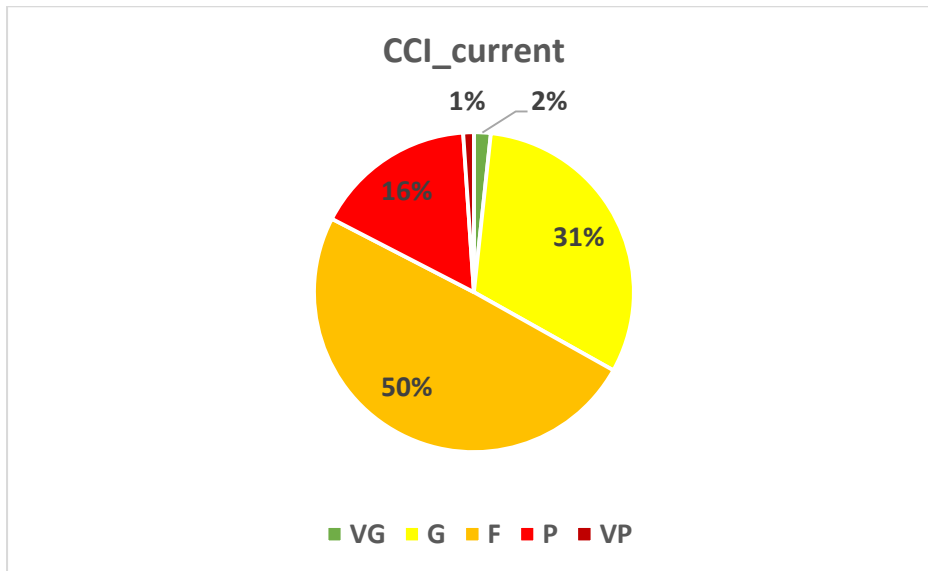
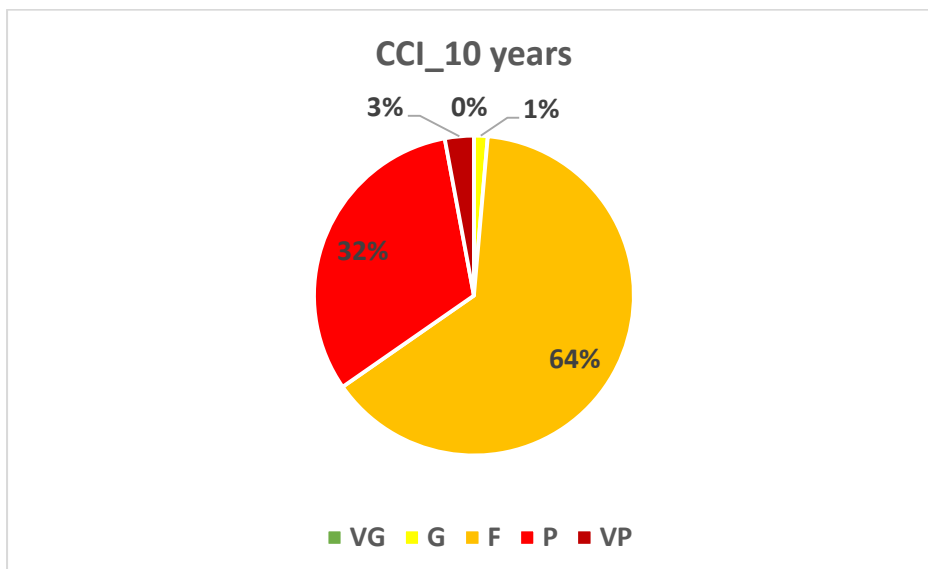
C317 Abson Road

SCANNER survey: May 2015/ August 2016

SCRIM survey August 2015

Condition categories for Secondary Roads (ref HMEP Lifecycle Planning toolkit: Table A1. November 2012)

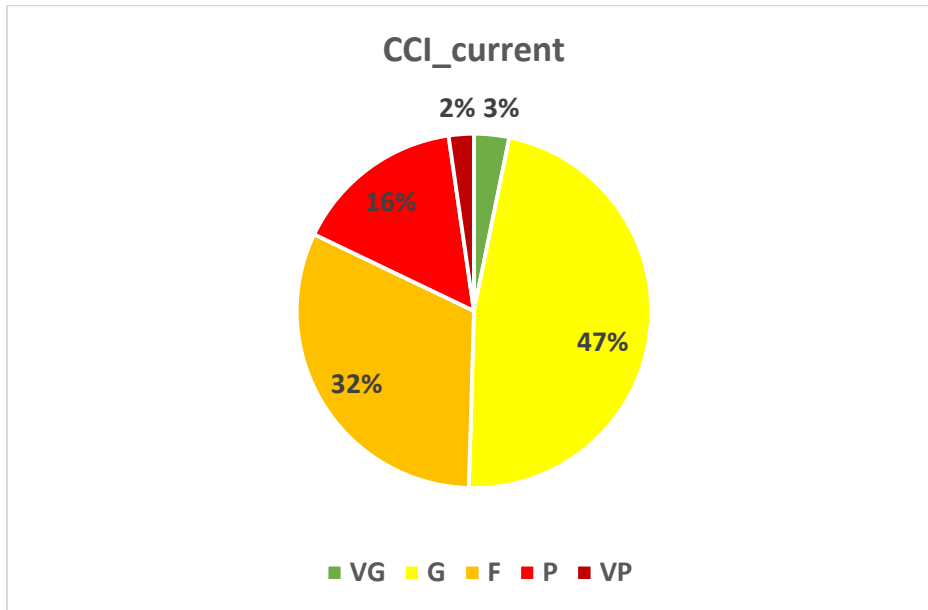
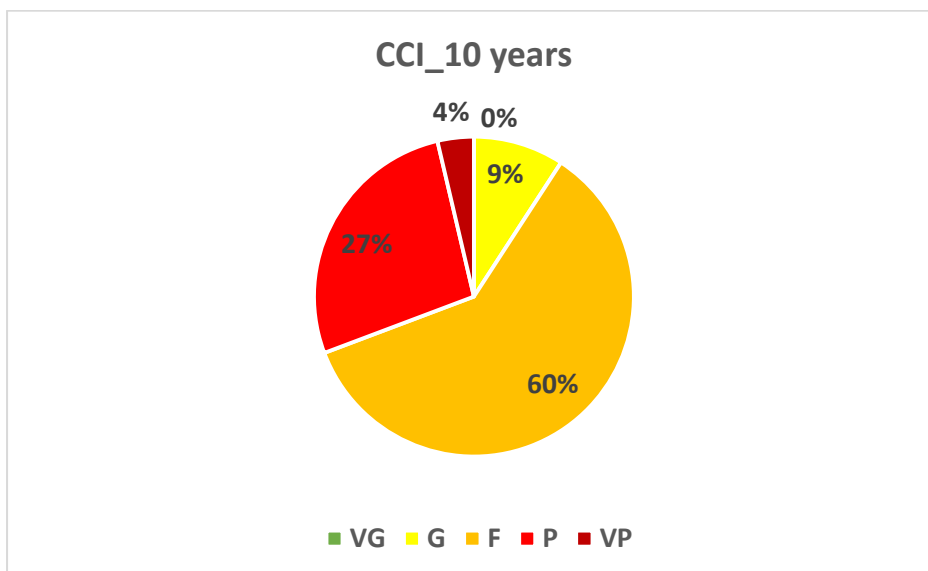
C231 Oldbury Village

SCANNER survey: May 2015/ July 2016

SCRIM survey: none

Condition categories for Secondary Roads (ref HMEP Lifecycle Planning toolkit: Table A1. November 2012)

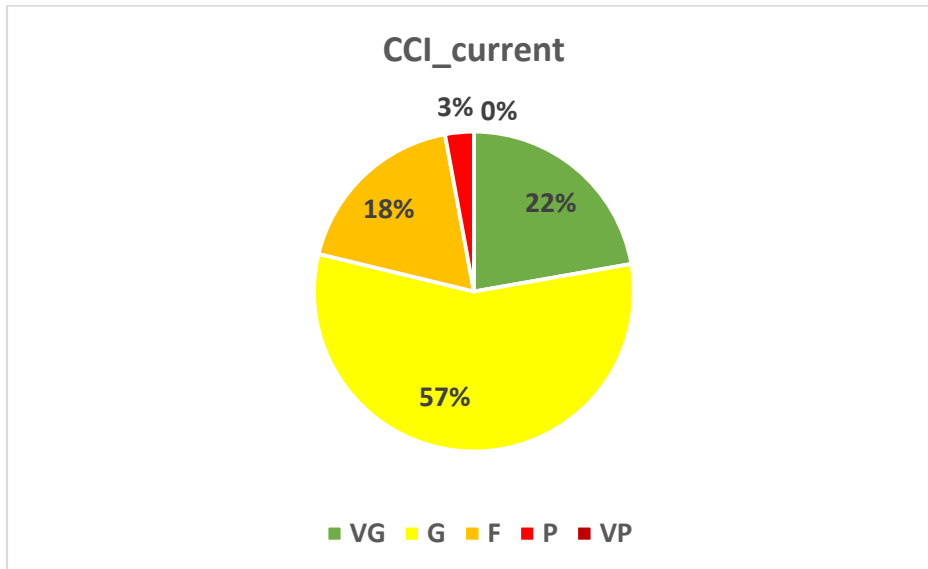
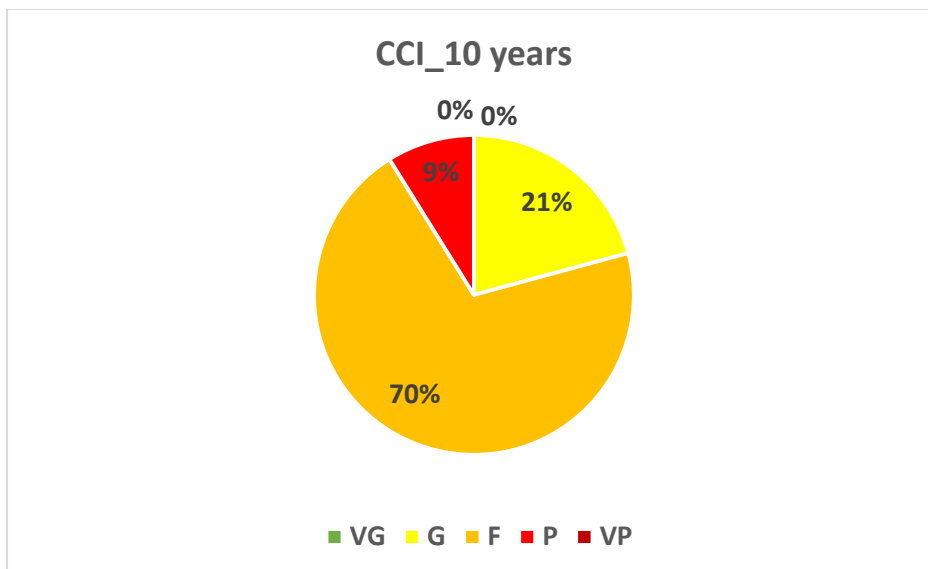
C232 Oldbury Lane

SCANNER survey: May 2015/ July 2016

SCRIM survey: August 2016

Condition categories for Link Road (ref HMEP Lifecycle Planning toolkit: Table A1. November 2012)

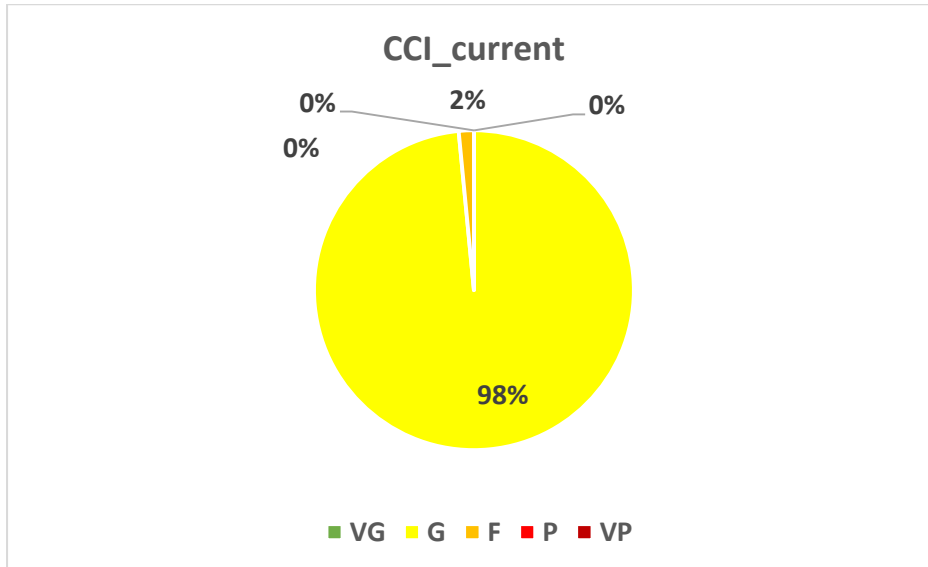
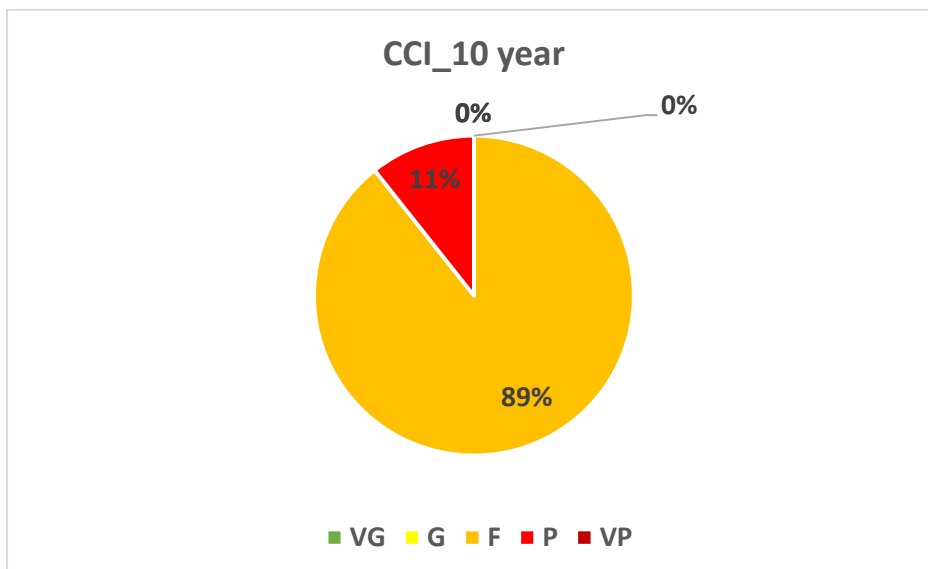
C232 Beckspool Road, Frenchay

For the CVI data available on Beckspool Road the CCI has been calculated using the TN46 methodology. Deterioration has been applied on a linear basis where it has been assumed that a road deteriorates from 'good' as defined by the CCI to very poor over 25 years. There are a limited number of defects present from the CVI survey so the overall effect is to indicate deterioration from 'good' to 'fair' over 10 years.

CVI survey:

Condition categories for Local Access Road (ref HMEP Lifecycle Planning toolkit: Table A1. November 2012)
