**ENVIRONMENTAL SCREENING FOR:**

**BUILDING 2 AND EXTERNAL LANDSCAPING  
LEEDS CITY OFFICE PARK  
HOLBECK  
LEEDS  
LS11 5BD**

**CANADA LIFE LIMITED**

**PROJECT REF: 7951**

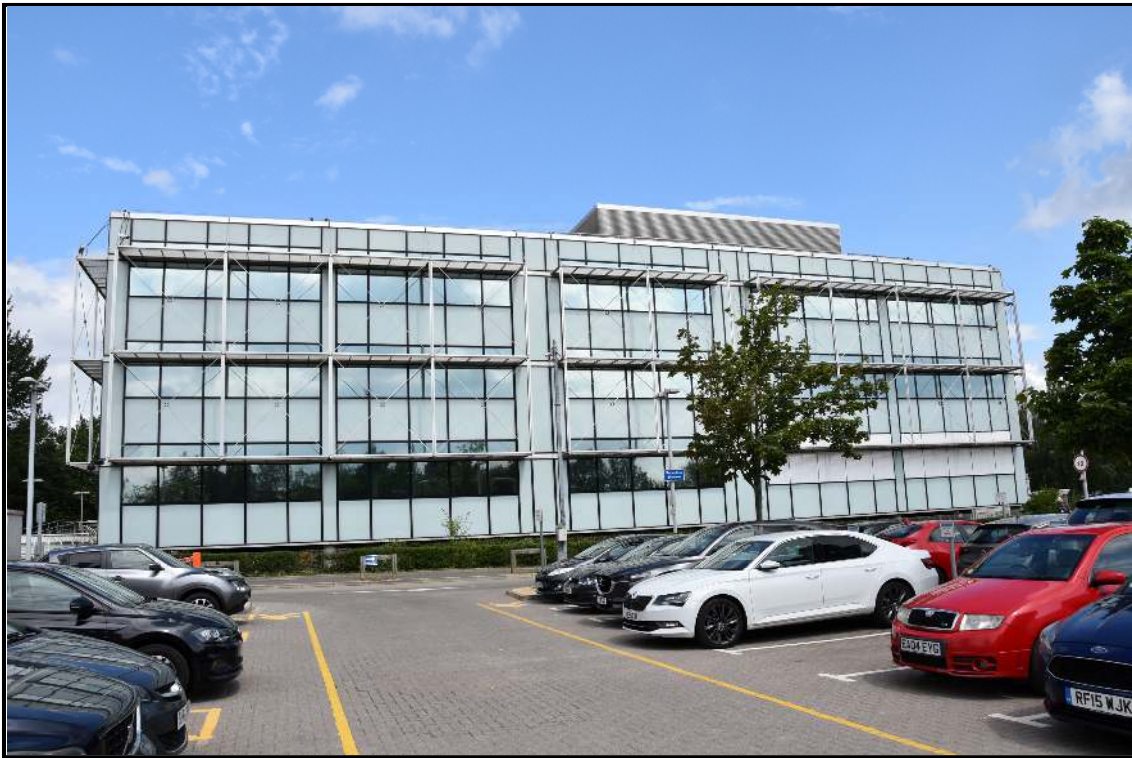
- 3.16 The inspection of 3<sup>rd</sup> March revealed that there is an extensive car park area comprising brick pavements and no evidence of damaged surface caused through either contamination or settlement was noted.
- 3.17 The landscaped areas are mature and flourishing. There was no evidence of vegetation die-back nor subsidence.
- 3.18 A pond feature exists to the west and this has no evidence of oily sheens or any contamination.
- 3.19 Although the waste management contractors are not known no waste abuses were noted.

**Plate 3 Southern elevation and car park**

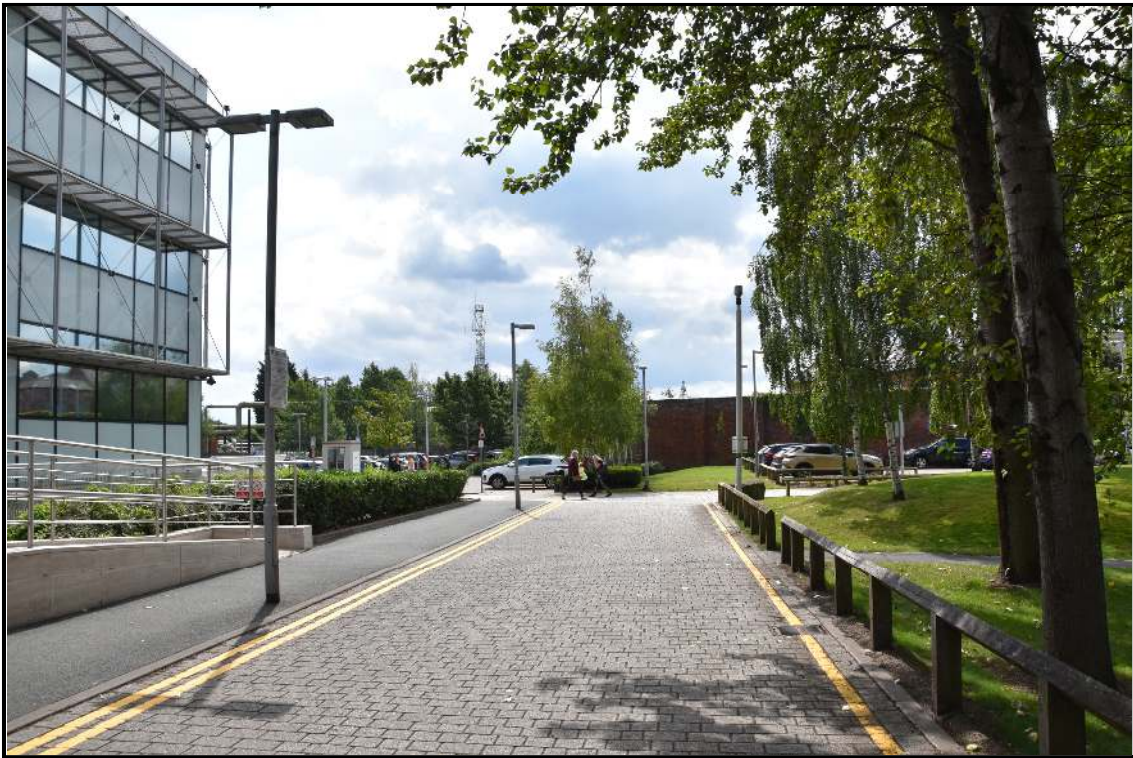
**Plate 13 Northern main access road**

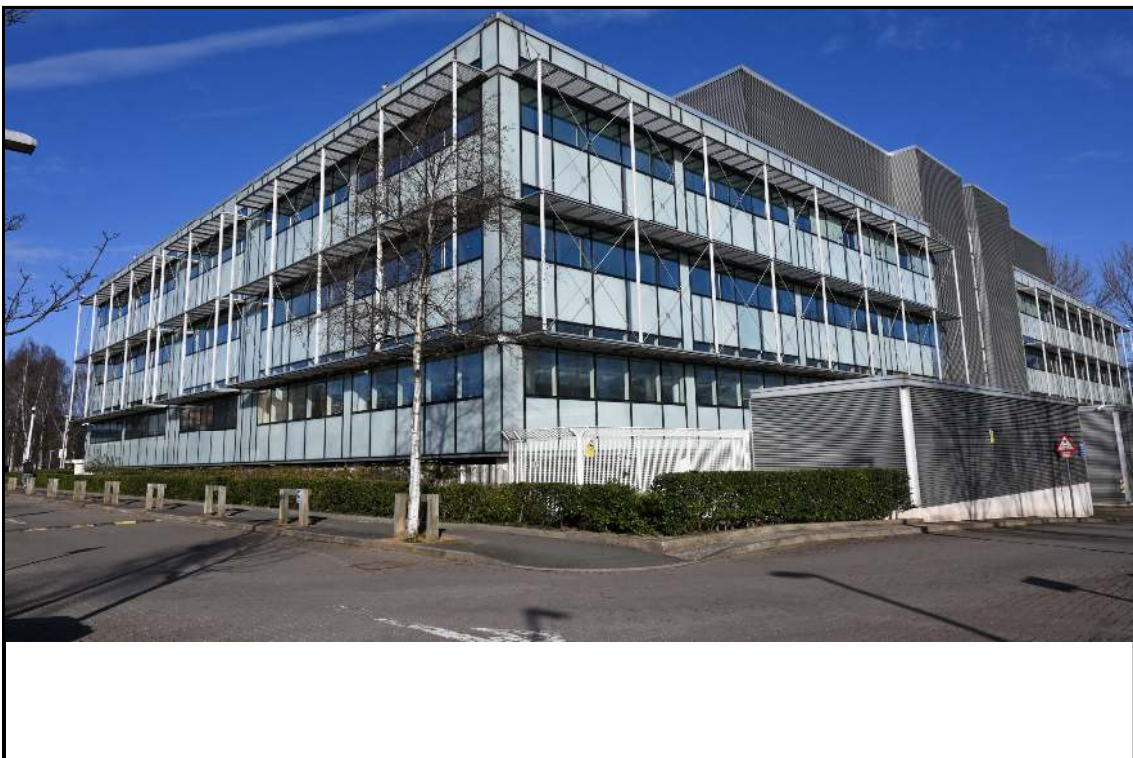
**Plate 2 Building 2 Southern and Eastern Elevation**
