SWRBD CFRAM Study

Flood Risk Review Report

February 2012
Office of Public Works

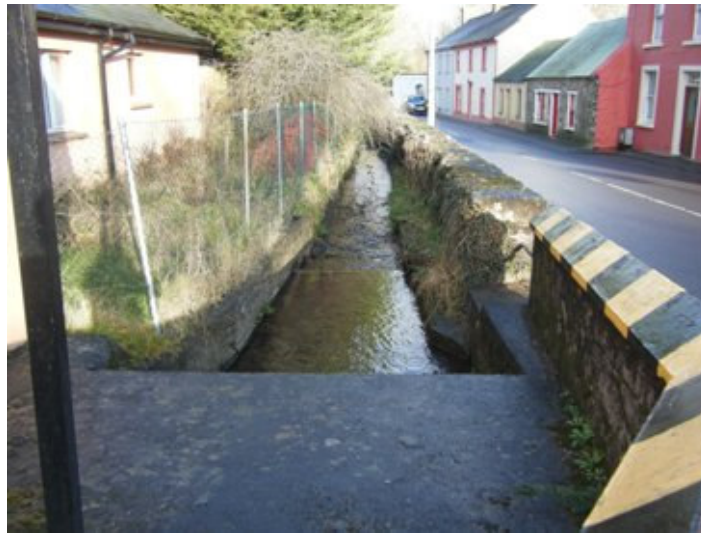
Properties adjacent to this bridge are at high risk and are vulnerable to regular flooding. In a 2010 flood event the bridge was damaged and had to be repaired. The properties adjacent to this bridge were also flooded in the 2010 flood event.

Bridge in Aglish village

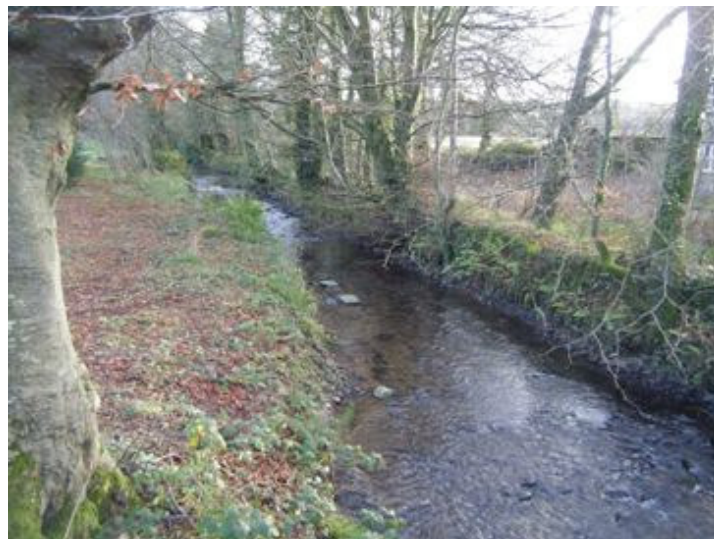
It is noted however that the AEP outlines adjacent the Ballynaparka Bridge are under estimating flood risk in the area. This amendment includes approximately 3 residential and commercial properties to the FRI.

Ballynaparka Bridge – Ballynaparka River

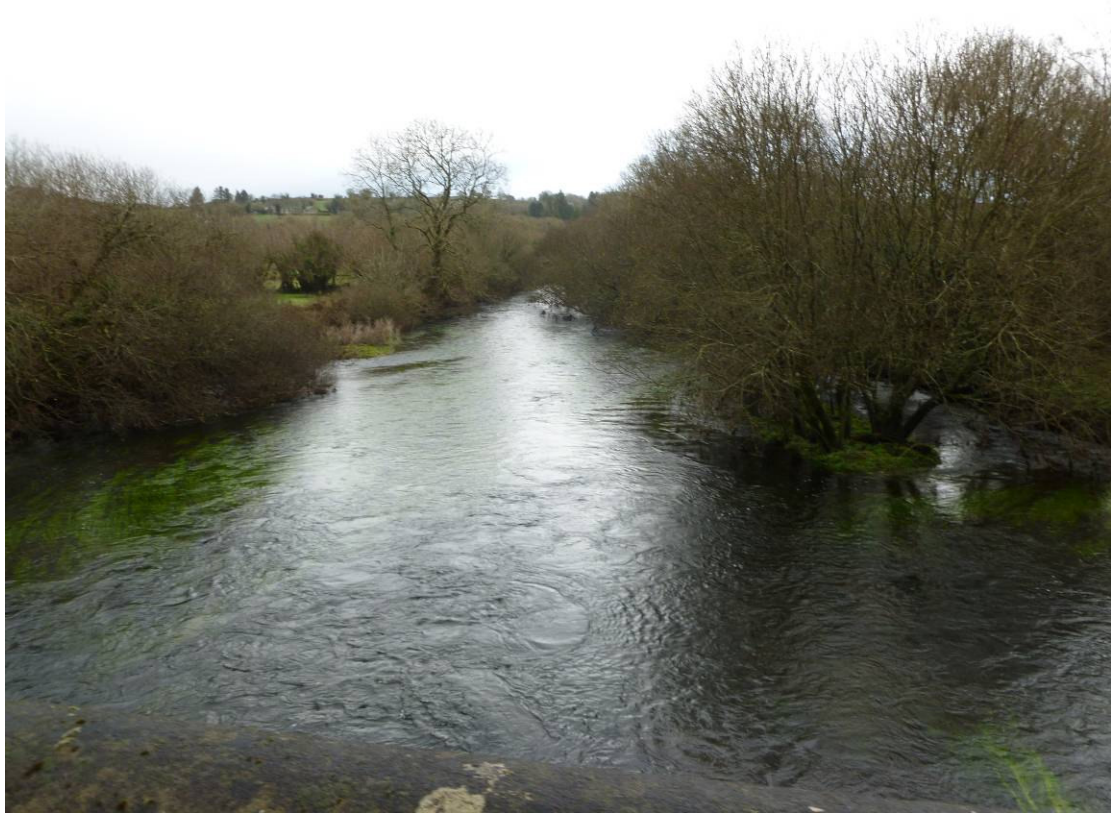
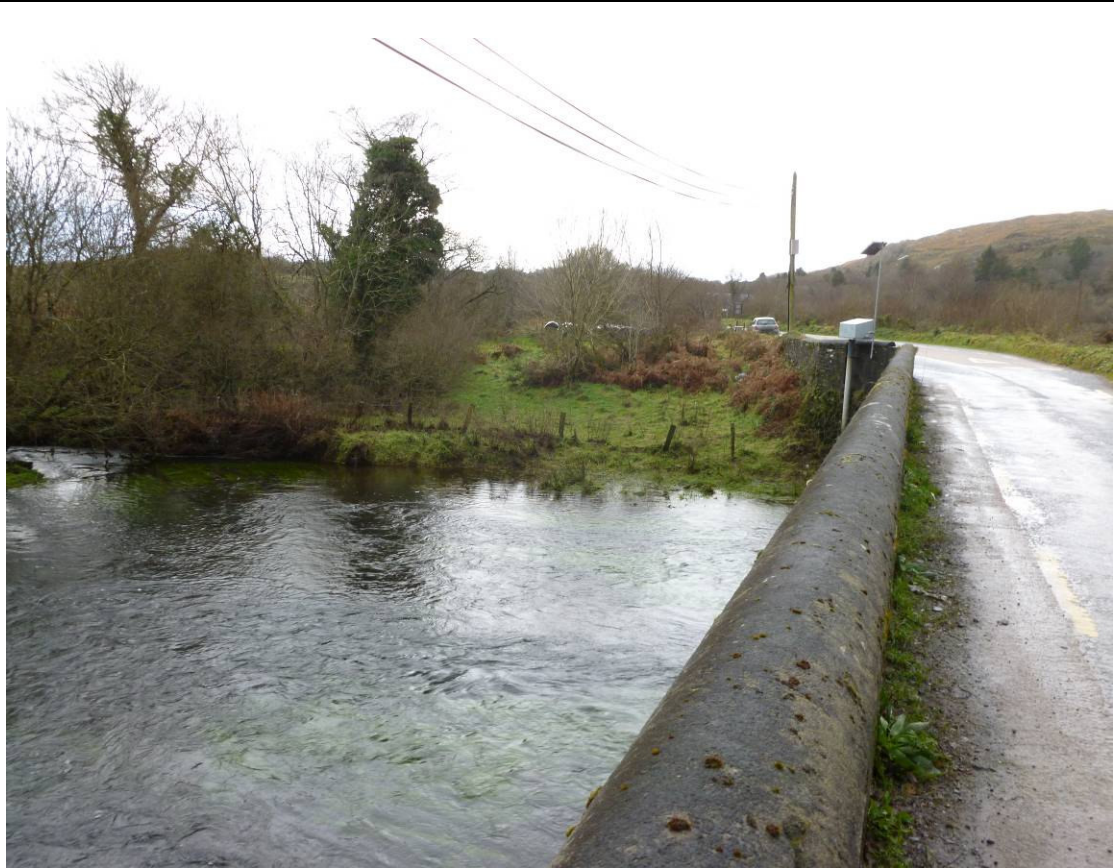
View from Ardcahan Bridge

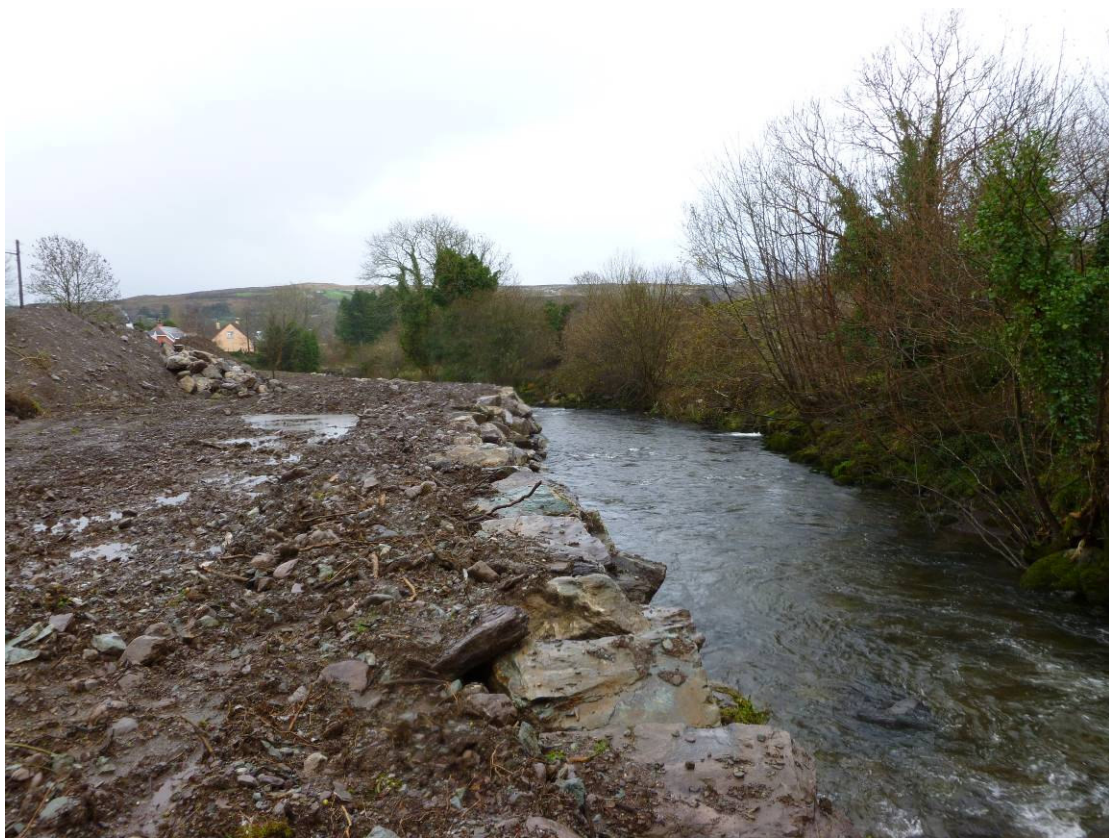
Ballingeary – recent works along the river bank upstream of the town.

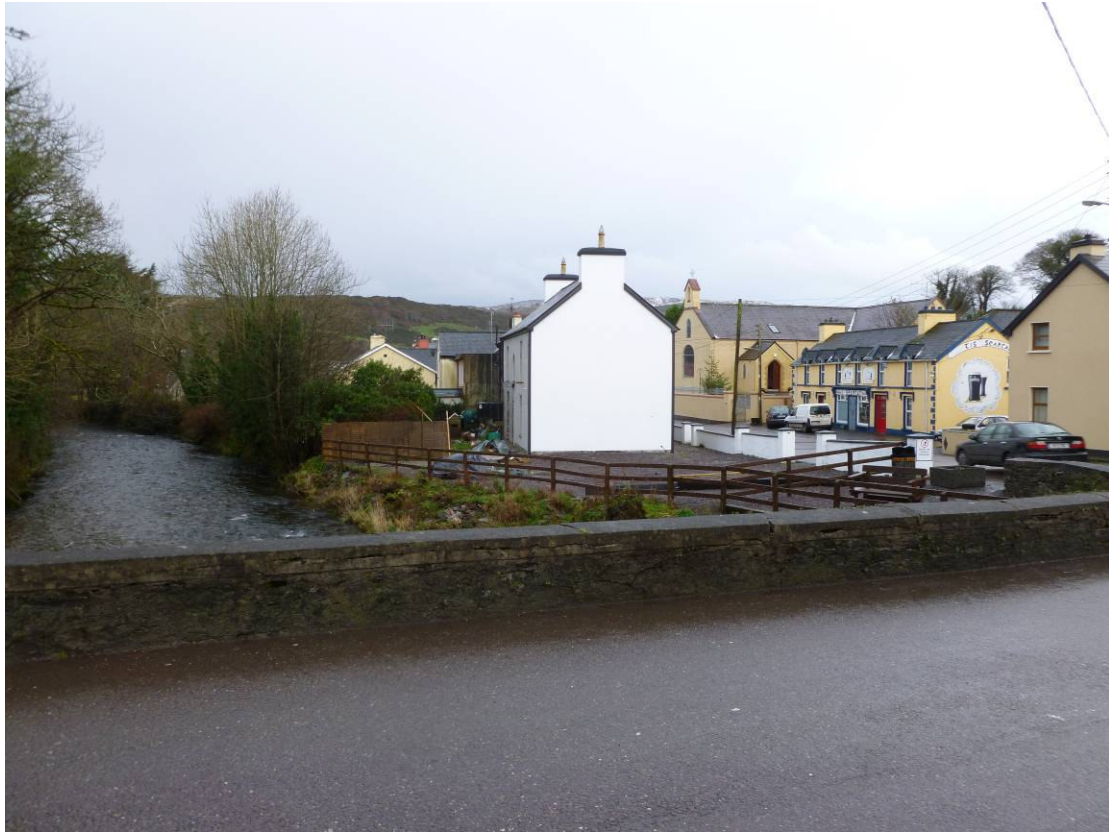
Ballingeary – view of river and town downstream of bridge.

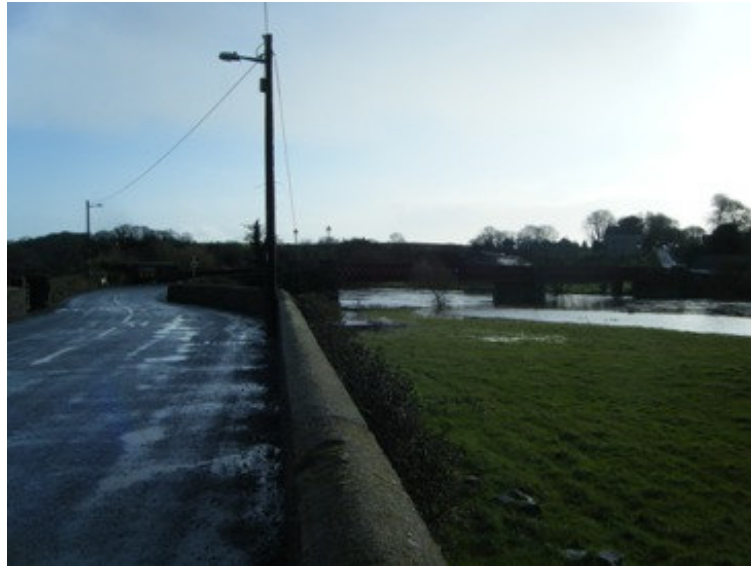
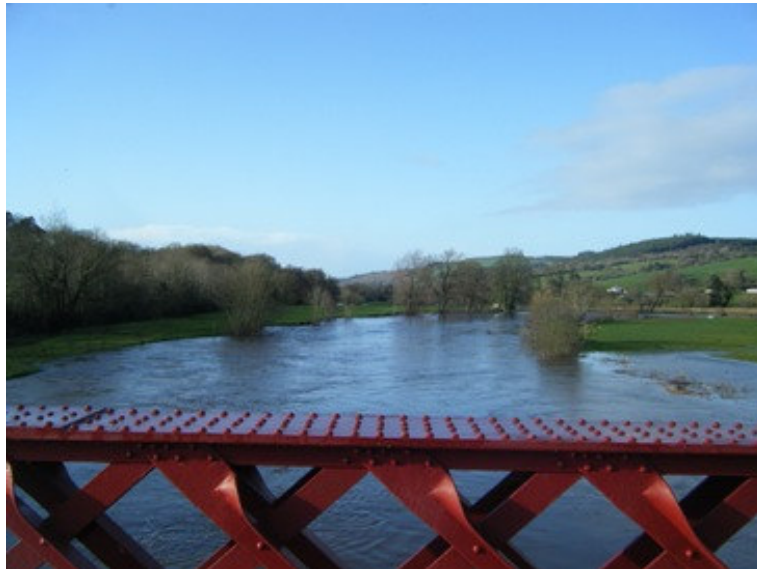
Ballyduff Bridge – Blackwater River

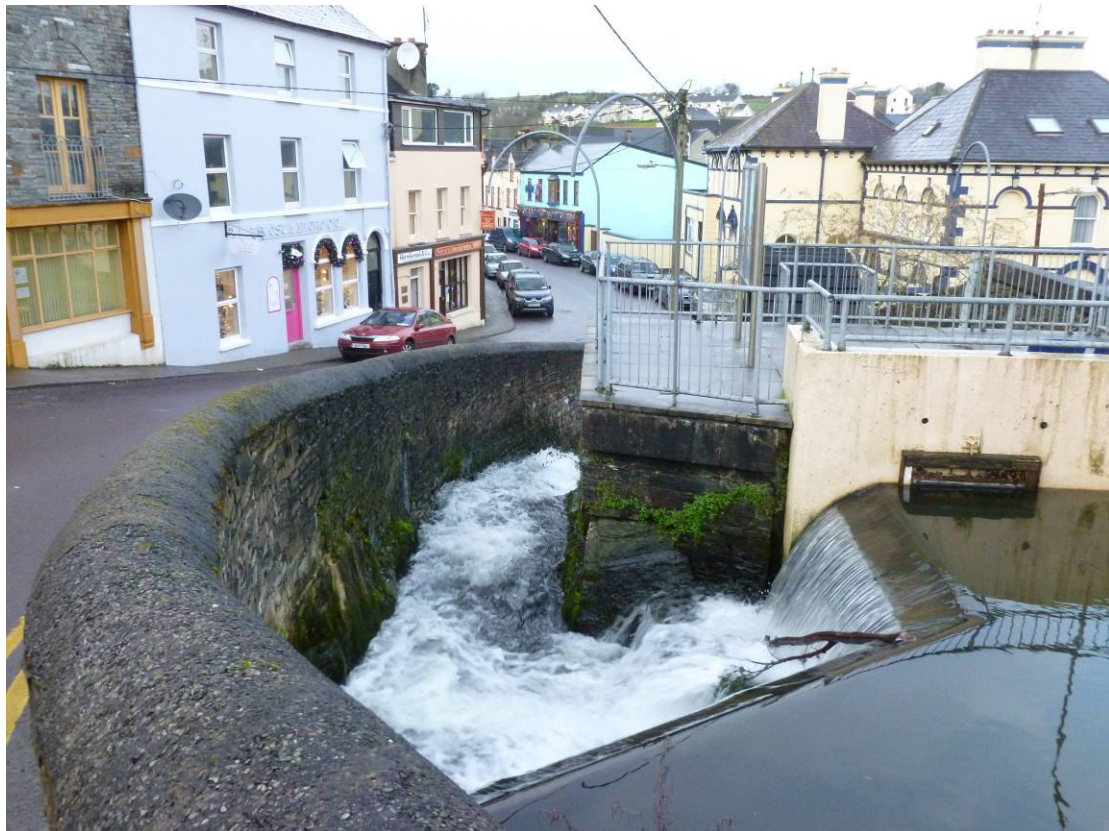
View from Library to the east of the Town

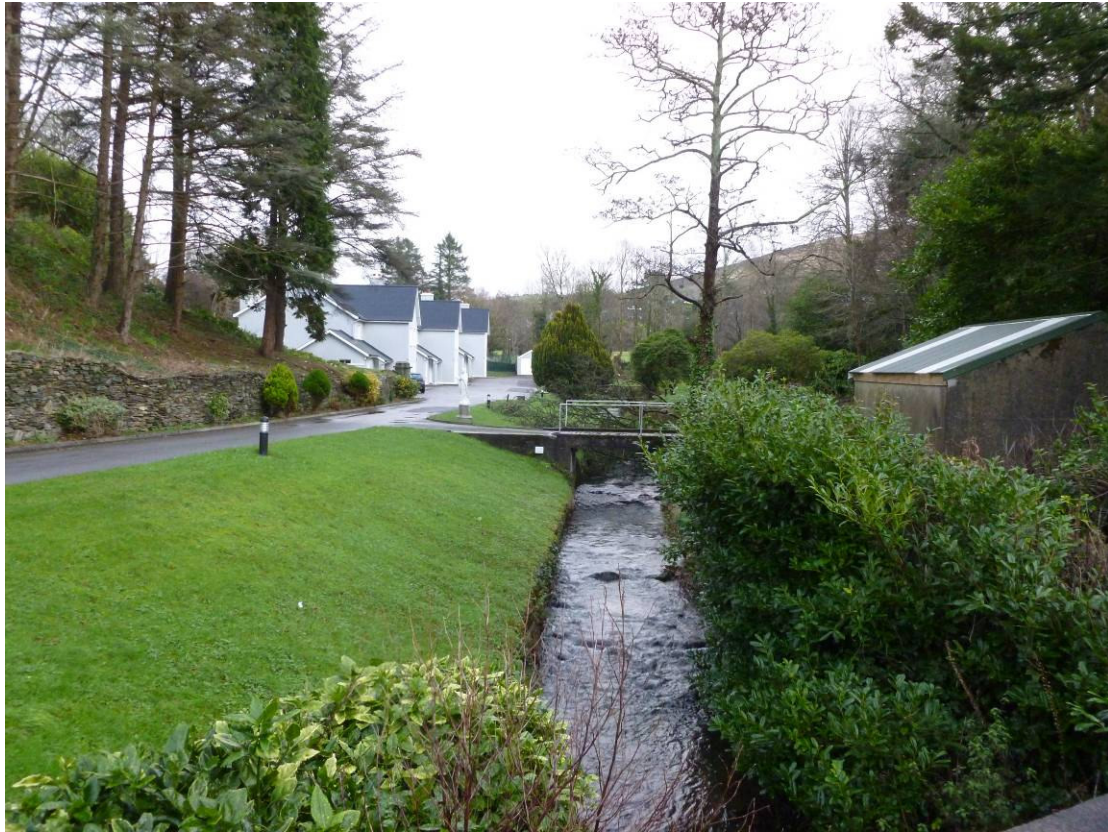
River upstream of town

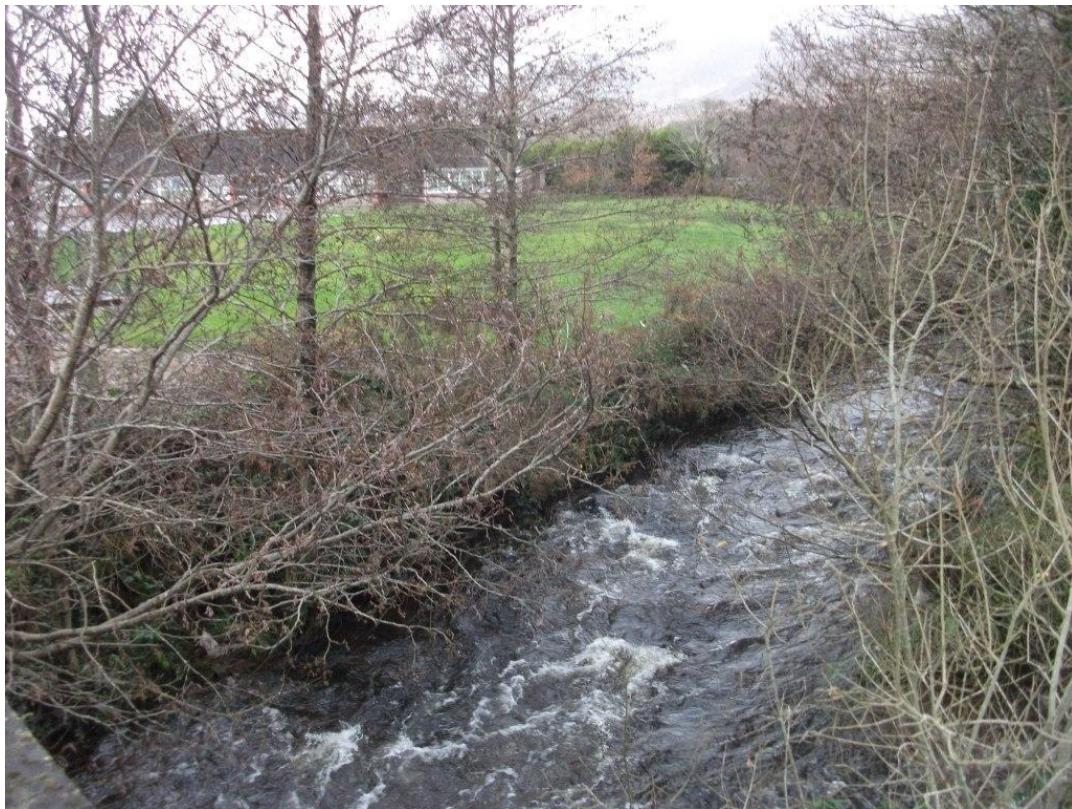
It is possible that the primary school is also outside of the predicted flood extent outline but it is difficult to say for certain. It is worth noting that although the river channel is reasonably deep along the eastern boundary of the school and at the road crossing, it is shallower further upstream (north of the school) and therefore more susceptible to over topping.

Stream level in relation to Primary School (in background)

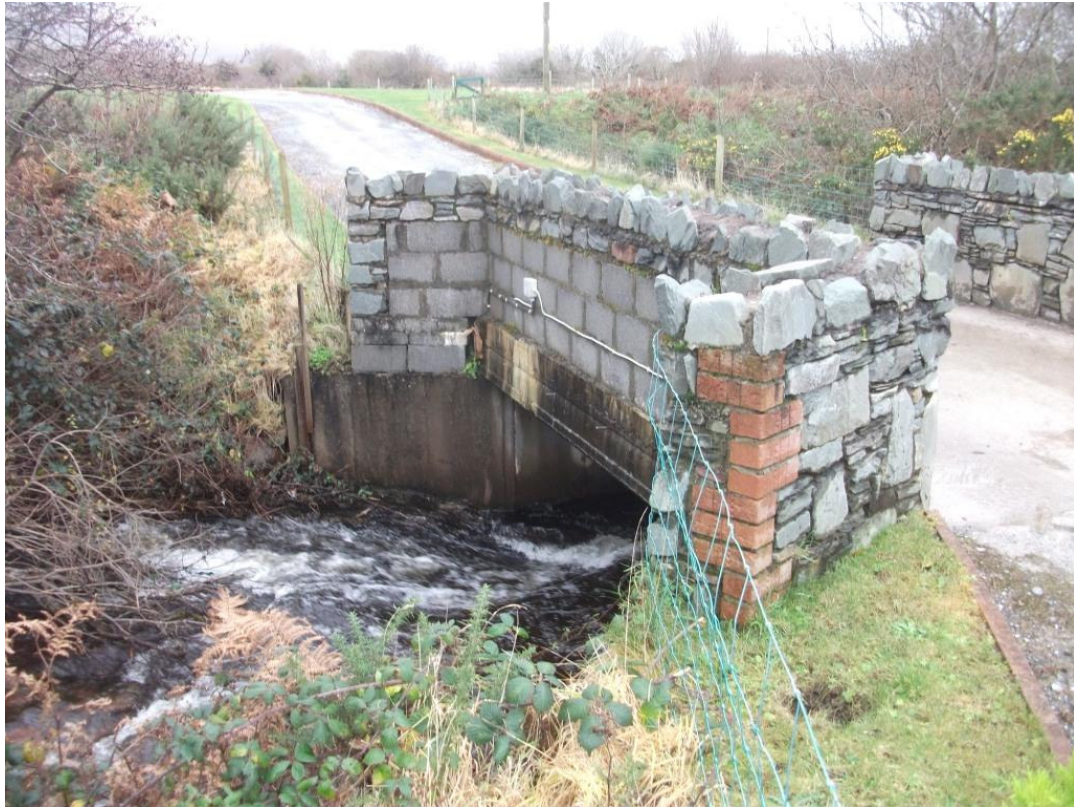
It is also worth noting that a new bridge has been constructed behind the school to provide access to a new residential house as shown in the picture below:

New residential access bridge behind school

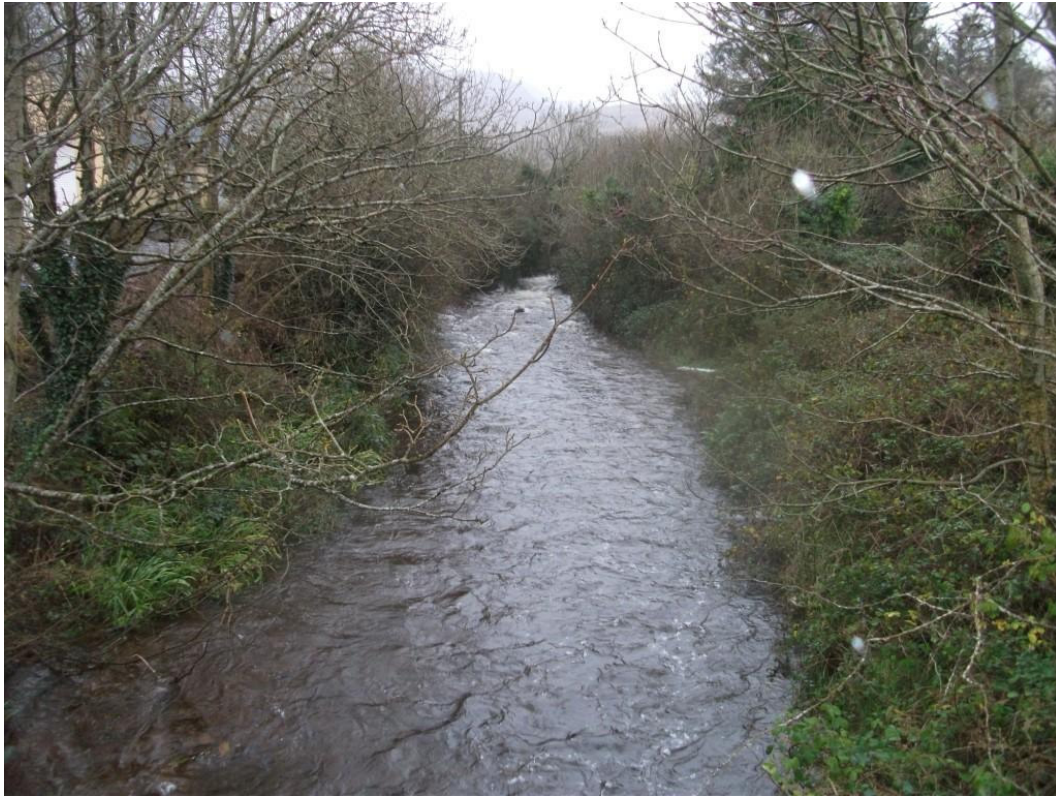
Example of house at elevated level (background, LHS) to be excluded from flood boundary.

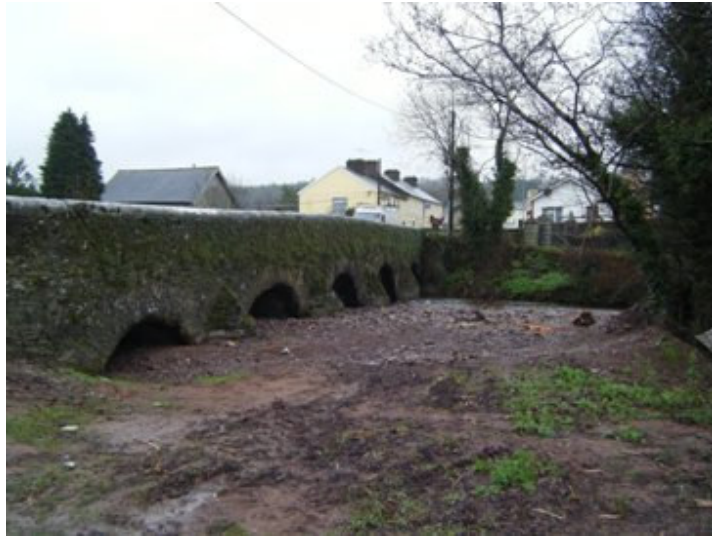
The Local Authority Area Engineer confirmed that fluvial flooding occurs quiet frequently on the Blackwater River and that the N72 National Secondary Route is regularly impassable due to recurring flooding from the Blackwater. It was noted that one house adjacent to the river is at risk.

Little Bridge – N72 National Route

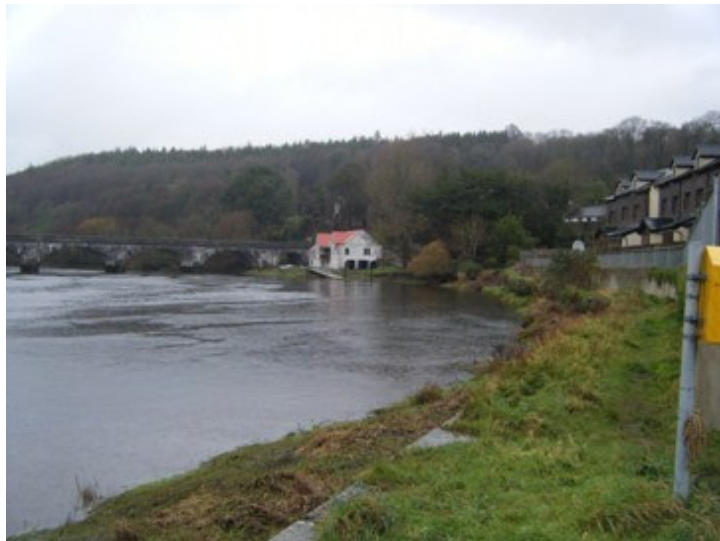
The Area Engineer was aware that the Boathouse floods quiet frequently at times of high tides and heavy rainfall. He also stated that prior to the construction of the new housing estate at Twin Bog the area was frequently flooded. He recalls the flood level adjacent to the car-park approx 2/3 feet above road level. He noted that since then a section of the Twig Bog has been raise and a new housing estate has been constructed. As of yet he is not aware if these houses have been affected.

Boathouse and new houses at Twig Bog

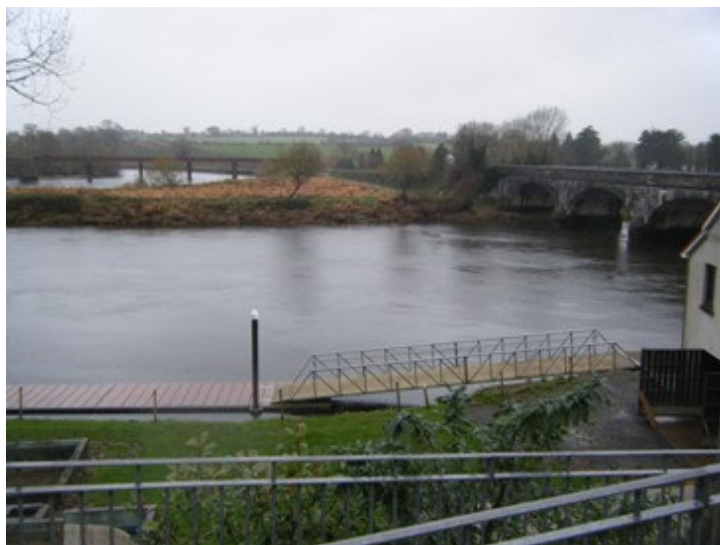
Boathouse – River Blackwater – Avonmore Bridge

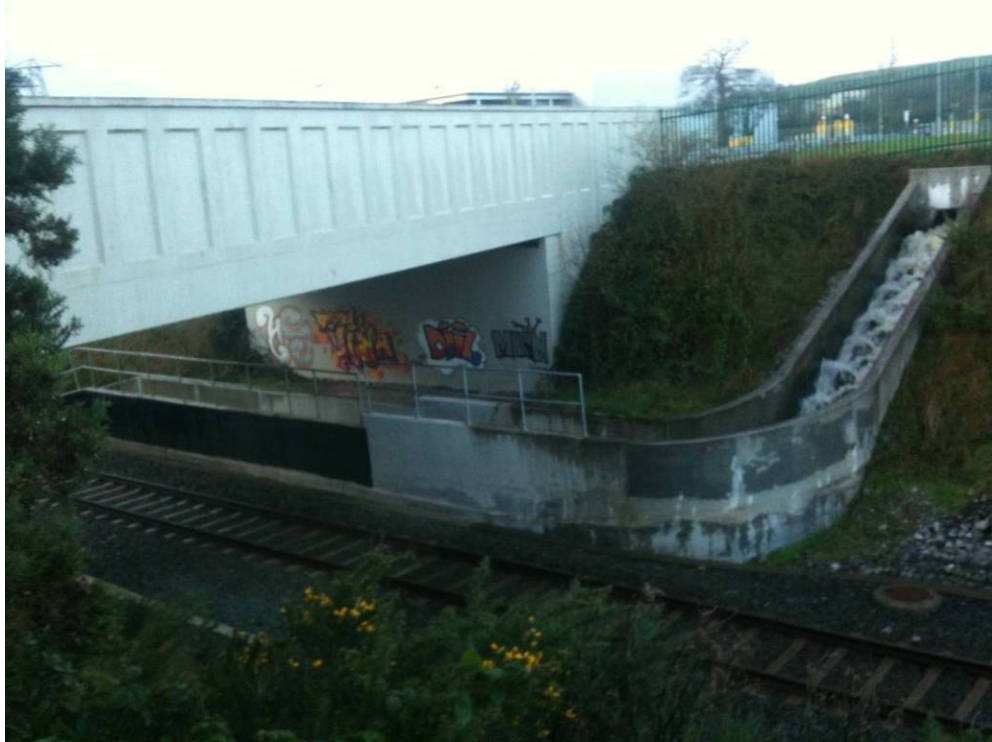
Railway cutting cascade at Annegrove stream.

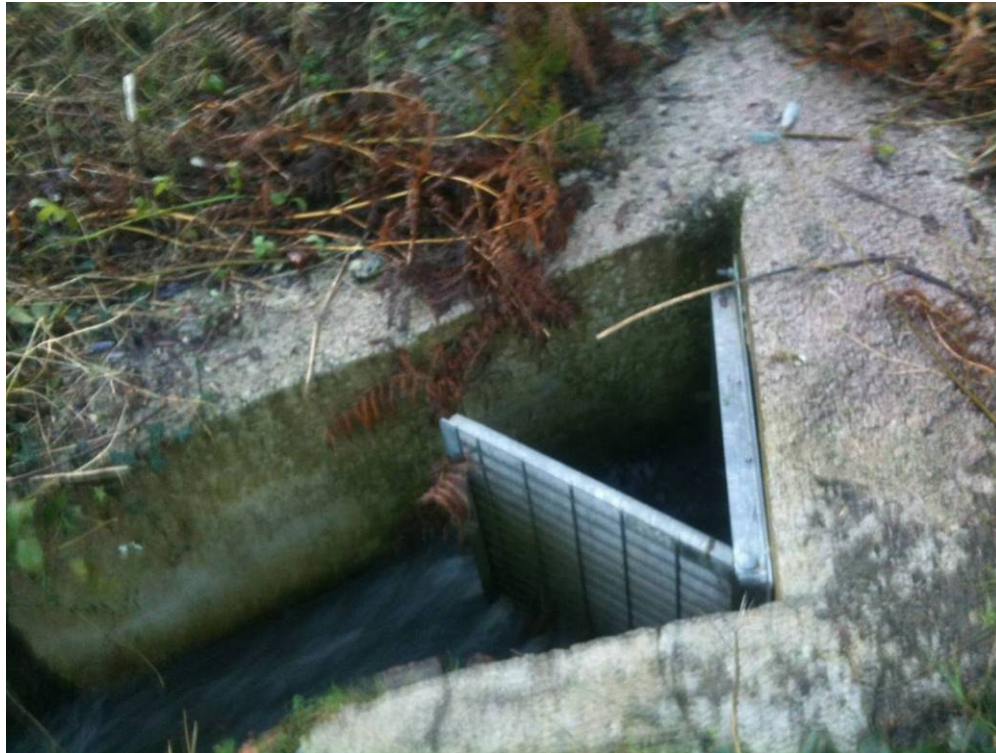
Siphon flow from Annegrove stream south of railway cutting to the IDA business park.

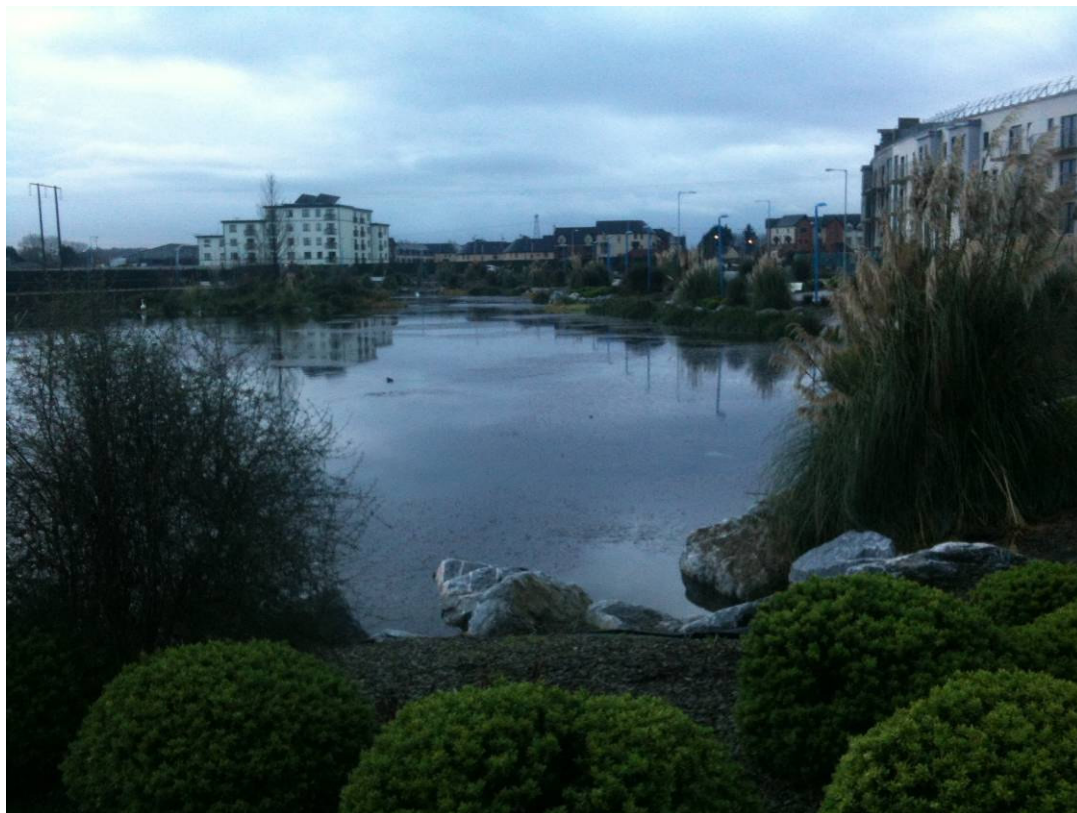
The second stream at west side of the village is in the townland of Terrysland. At the northern end of the stream a large pond feature has been constructed to attenuate flows in the stream. The PFRA outlines have been amended as shown in the attached maps included in the Appendix to this Site Inspection Report.

Pond feature at northside of Terrysland Stream

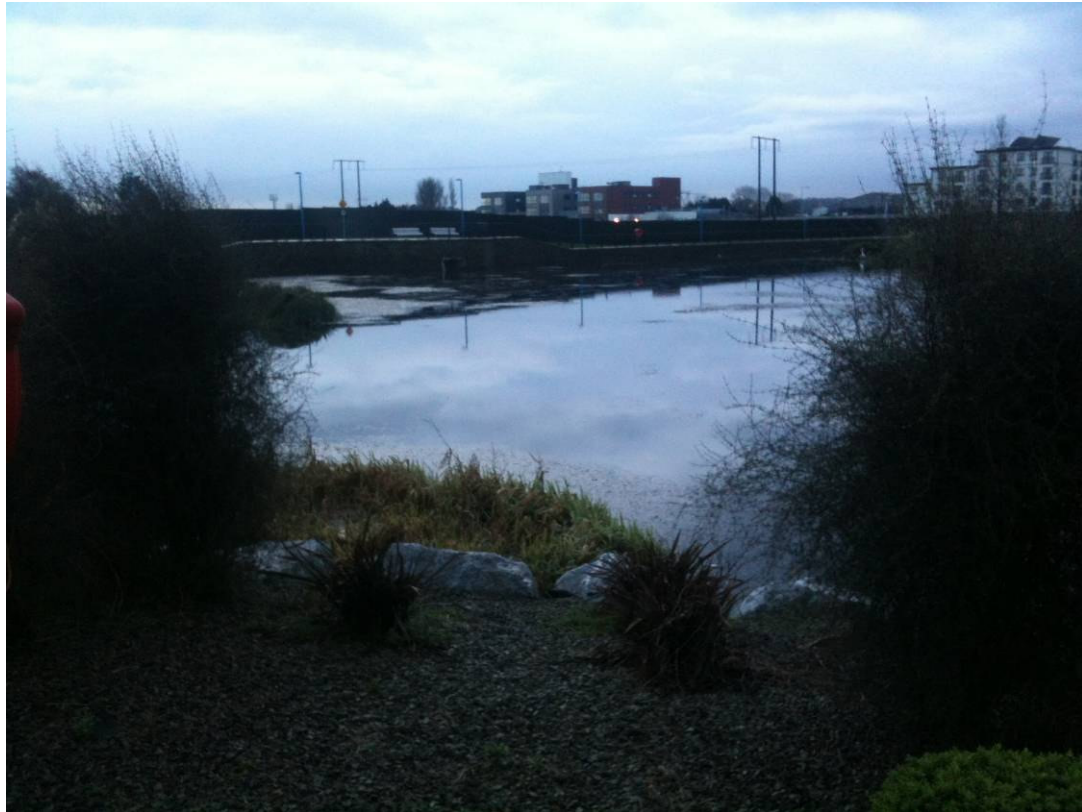
Outlet from pond feature at northside of Terrysland Stream

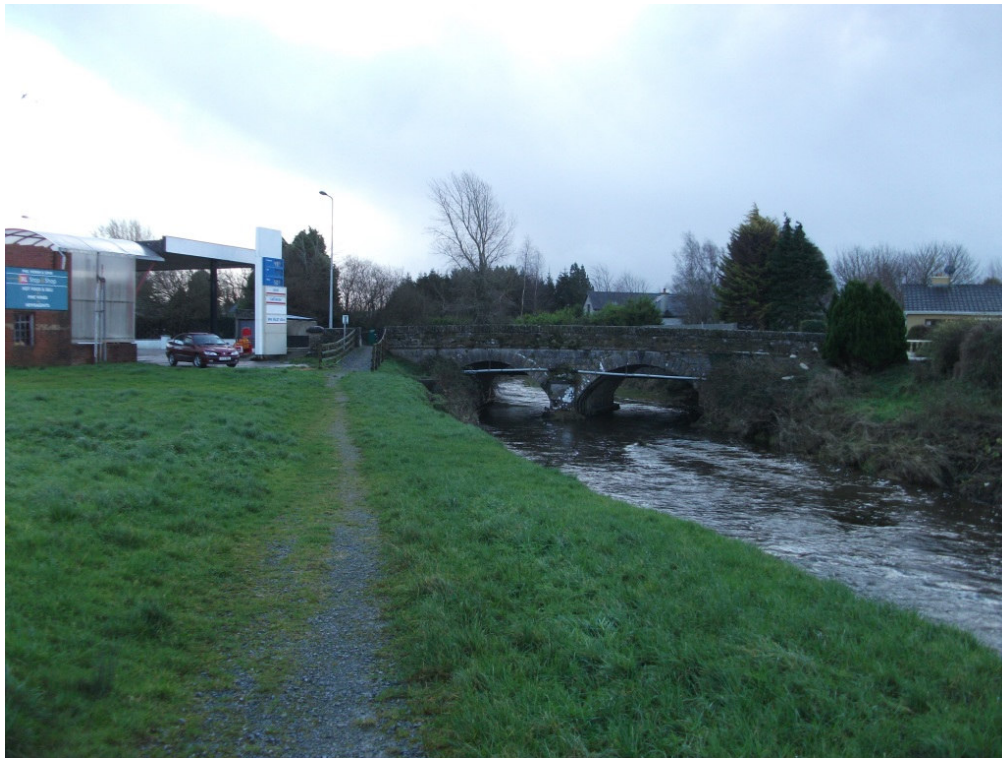
A second man living near the bridge over the River Maine on the Killarney Road (N72) advised that he had not seen the river overtop its banks or flood his own or other properties in the time he had been there (~25 years). He advised that he had seen level rise close to the top of the bridge eyes on occasion – “to within a foot of the telecom pipe strapped to the bridge”. This pipe is on the downstream, side of the bridge and is shown in the photograph below:

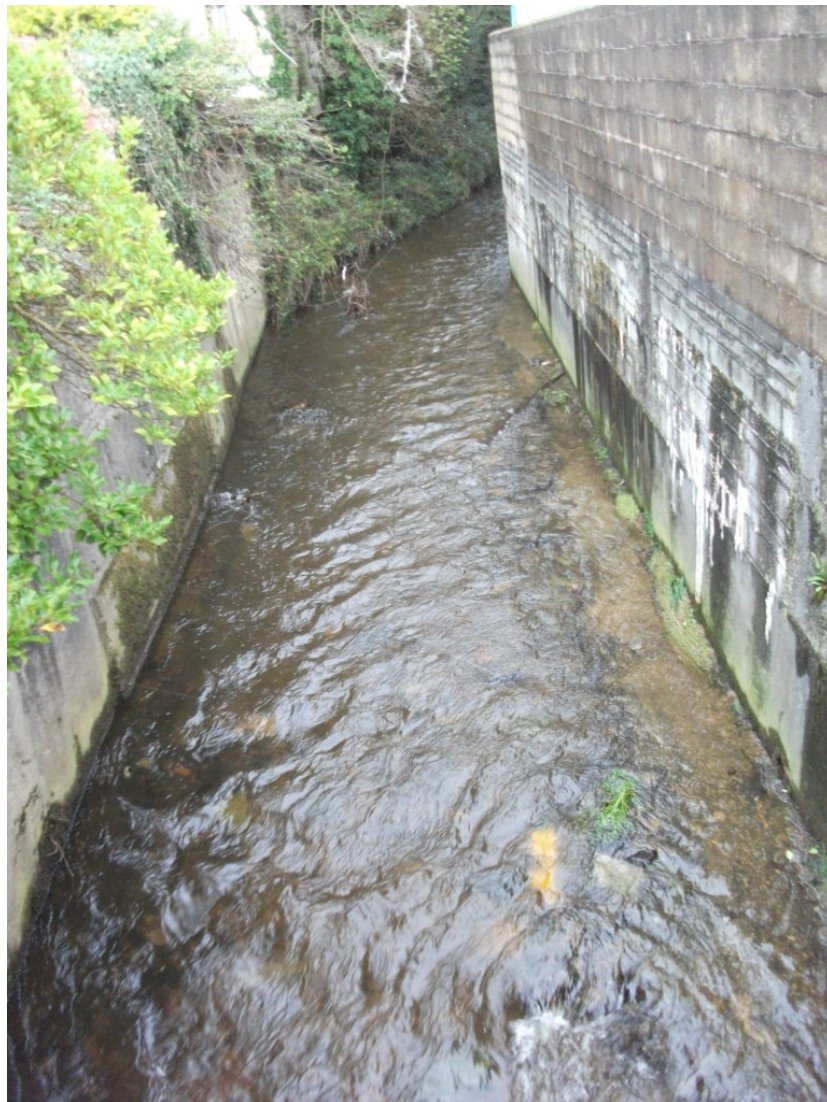
Upstream end (very deep/high walls, unlikely to spill)

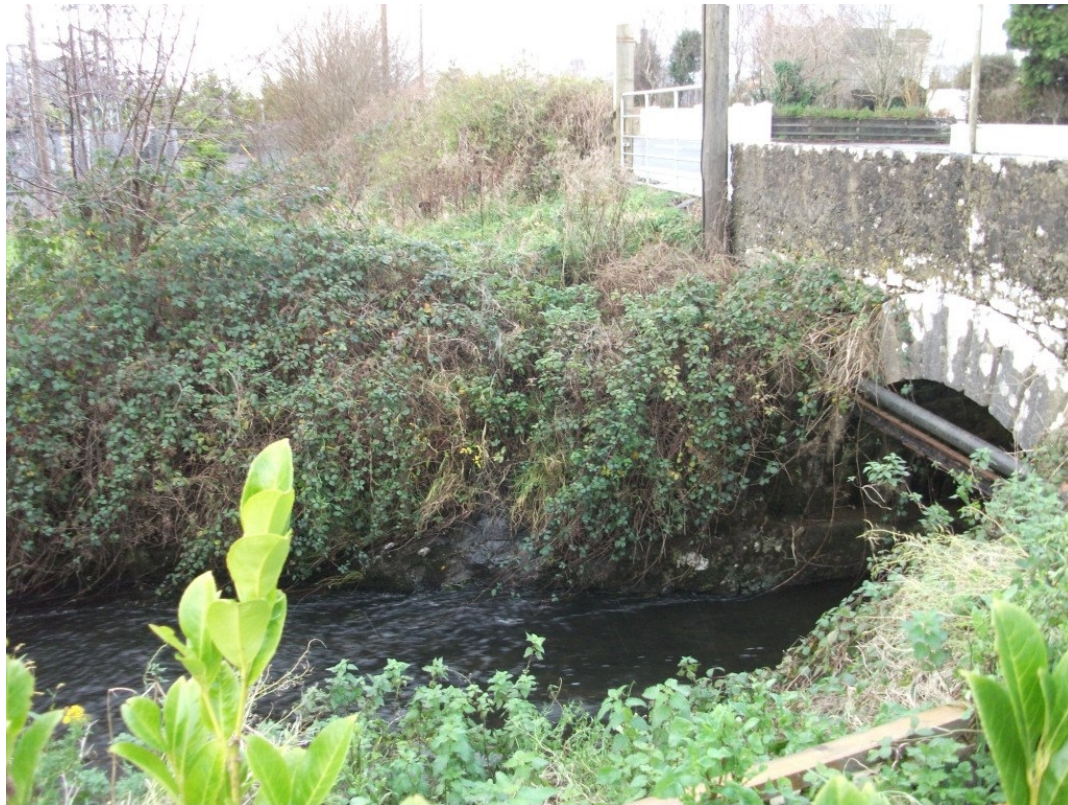
Downstream end (substation visible on LHS)

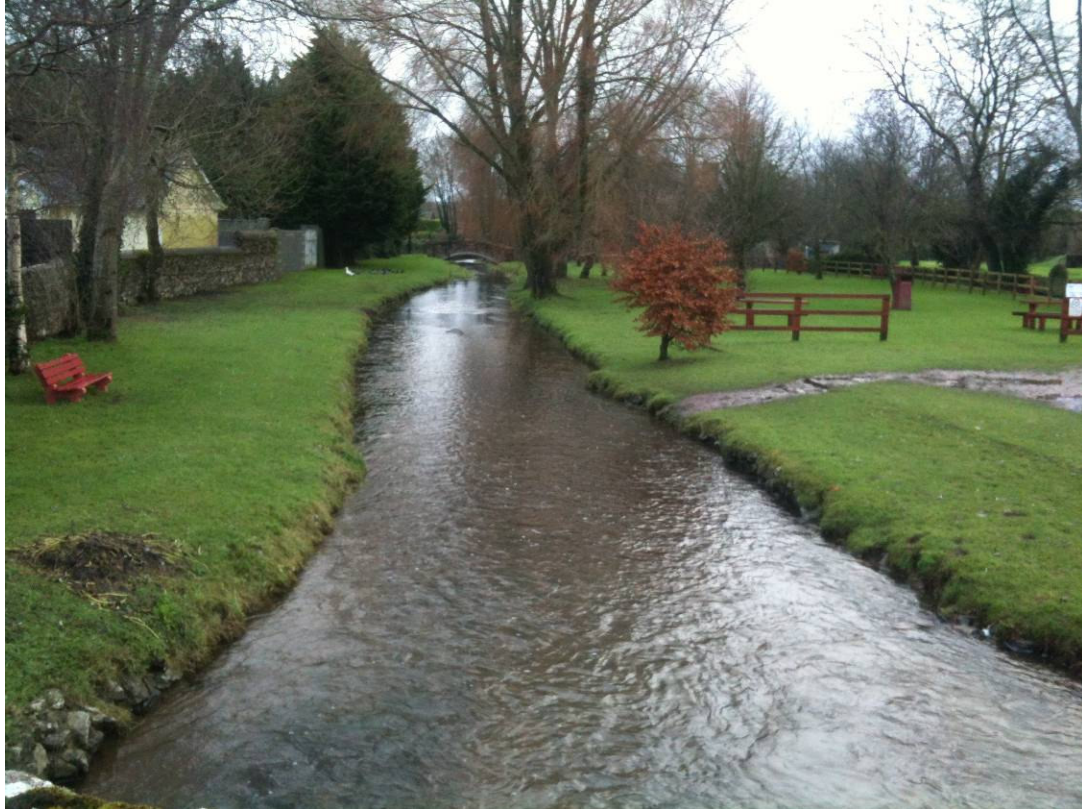
Looking south at Ramsey Lane bridge.

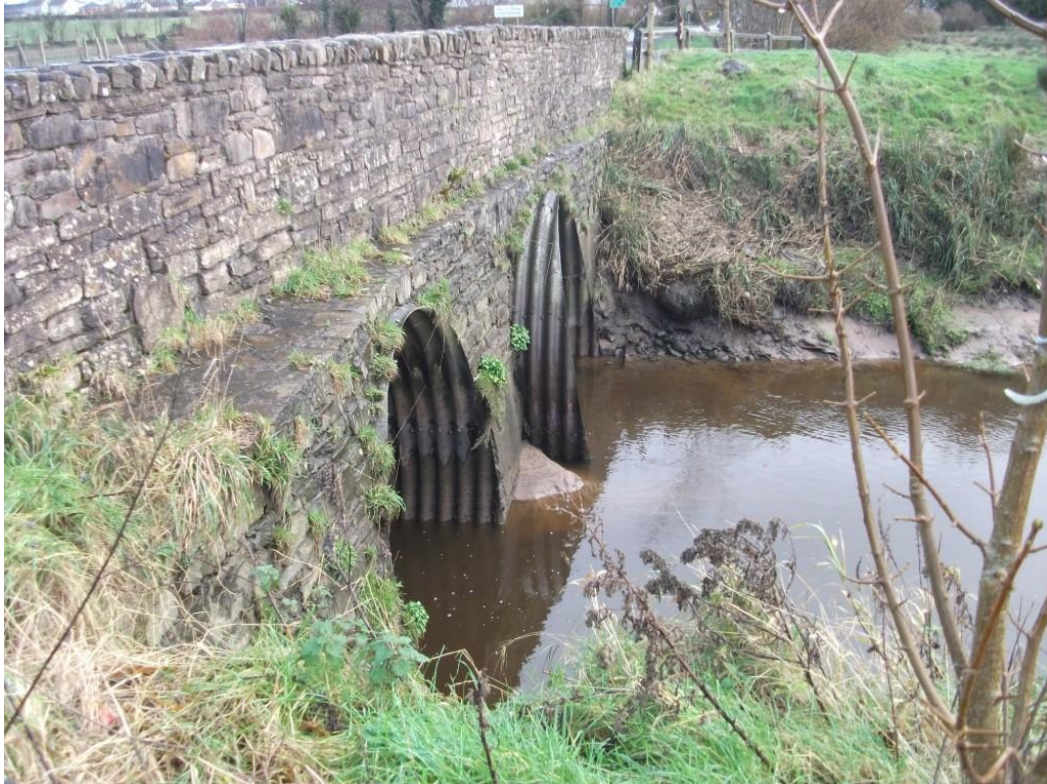
Annagh Bridge

The flood extent outlines in this area are complex due to the convergence of multiple watercourses in addition to both fluvial and tidal sources being present. Embankments are present along much of the River Maine and its tributary near the Annagh bridge.

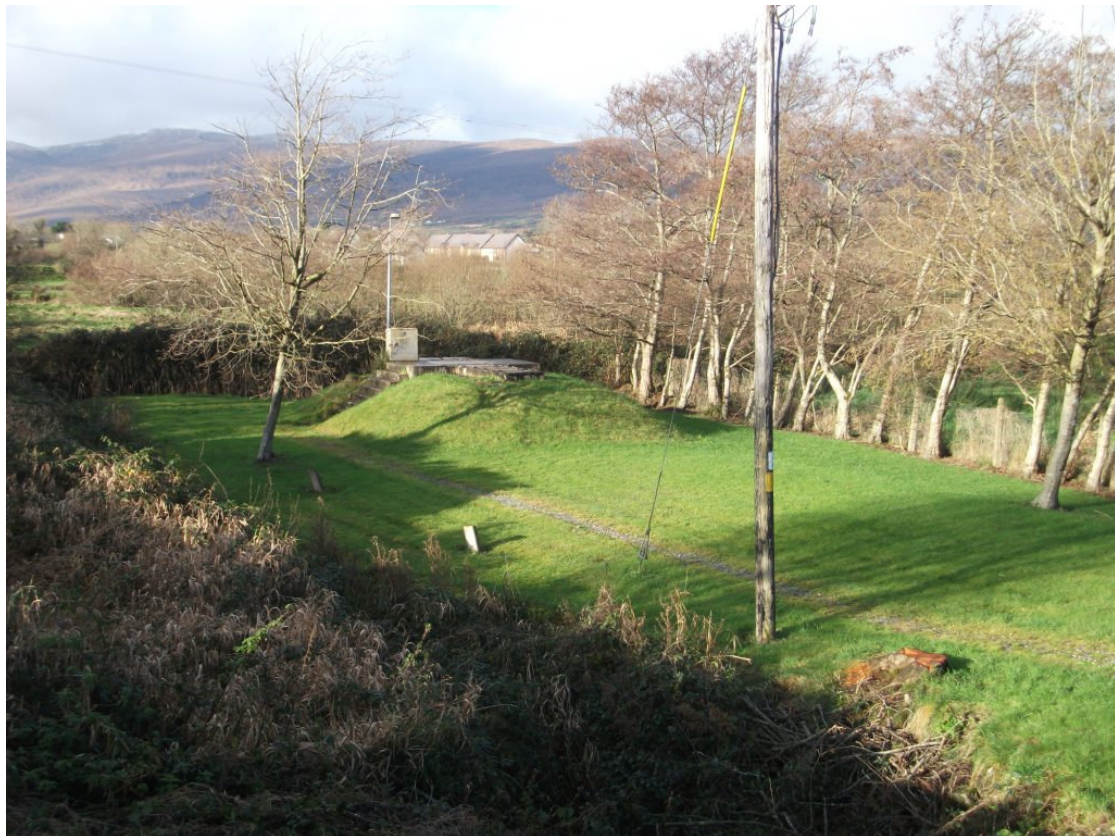
It is thought that the primary school remains at risk and that a sewage pumping station (located near the N70 bridge over the Maine) may also need to be added to the FRI score.

Sewage pumping station near N70 Bridge

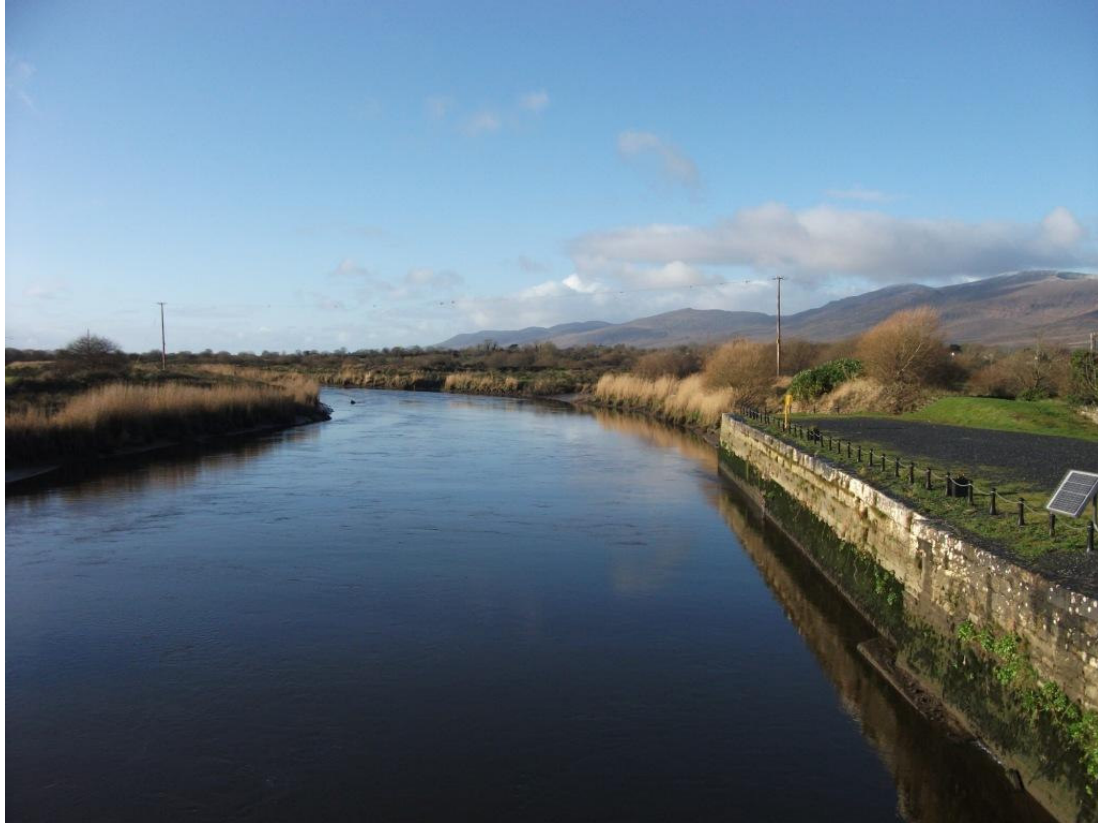
Embankments are present in this location and their condition varies. Some sections appear to be reasonably well maintained while others are quite overgrown. Additional heaped material near the Maine Bridge also appeared to be for defending either the school or the pumping station mentioned above.

High water marks appear to indicate normal high water levels as opposed to extreme flood levels. Photos from the flood maps website indicate extent of previous flood.

Overgrown embankments and high water marks at Castlemaine. (Taken from N70 Bridge, facing west (upstream))

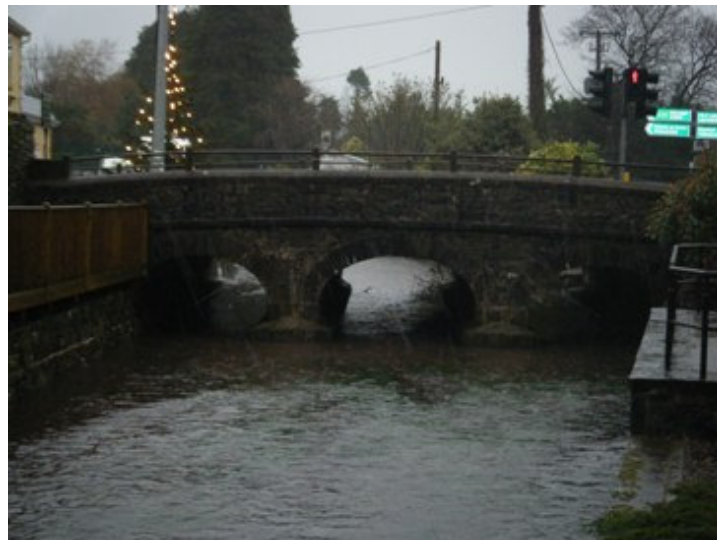
Castlemartyr Bridge - N25 National Road

The 10% AEP outline generally matches the 1% and 0.1% AEP outlines used in the PFRA analysis. From the site visit it would appear that the river flood outline west of the Castlemartyr Bridge appears to be overestimating the flood extent in this area. The ground levels rise in a western direction along the N25 National Road at this location and the outlines therefore require to be modified due to the changes in the topography.

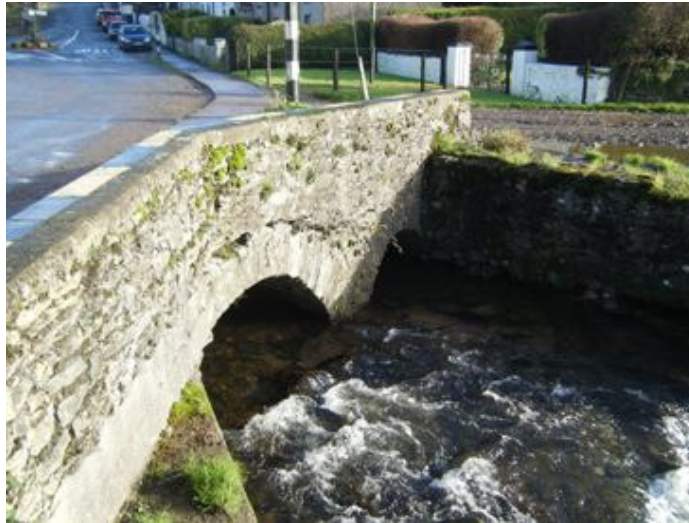
Cloobooa Bridge - R671 Regional Road

The Local Authority confirmed that fluvial floods occur quite often (every year) at the location of the Cloobooa Bridge in Clashmore, where the Greagagh River runs under the R671 Regional Road. One house adjacent to this bridge is vulnerable to regular flooding. WCC are currently looking to replace this bridge and carry out flood defence works. An assessment is currently being undertaken to determine the consequences with respect to flooding if the Cloobooa Bridge is replaced.
